AIRCRAFT ACCIDENT REPORT

CAL/2008/07/14/F

**Report on the accident involving a Boeing 737-282
Aircraft with nationality and registration marks 5N-
BIG operated by Chanchangi Airlines Limited which
occurred at Port-Harcourt International Airport on
14th July, 2008.**

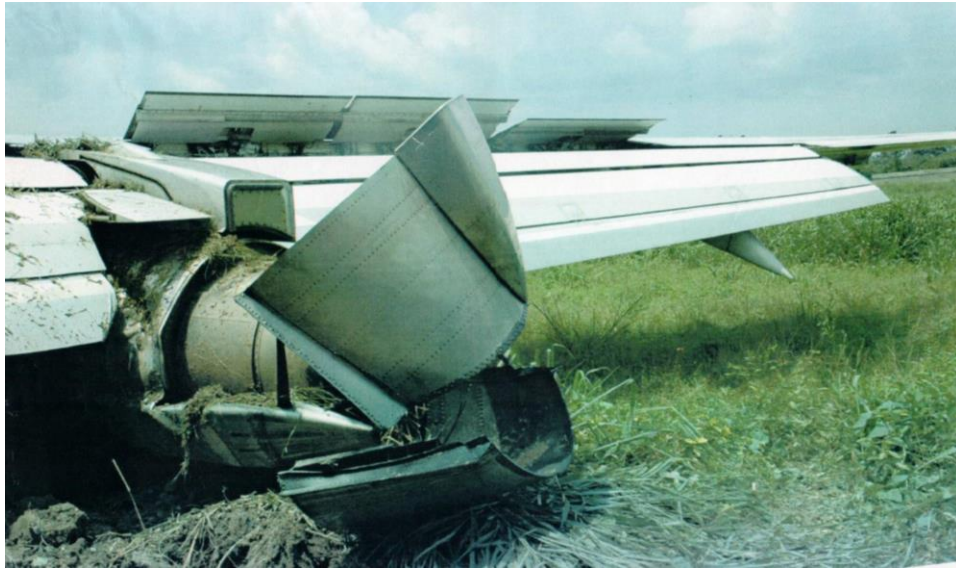
1. Nose wheel sheared off leaving the bolt behind.
2. No. 2 and 4 Main wheel assemblies were damaged.
3. No. 2 and 4 Main wheel tyres were burst.
4. Both engines ingested gravels/sand and debris.
5. No. 2 Engine tail cone and thrust reverser were damaged.

Figure 2: The number 2 engine thrust reverser damage.

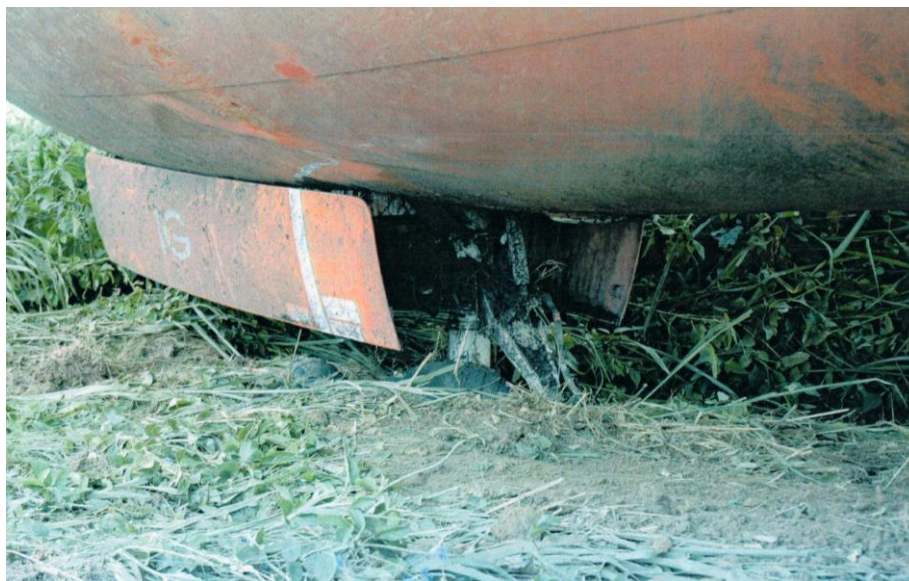
Figure 3: Damaged nose wheel gear

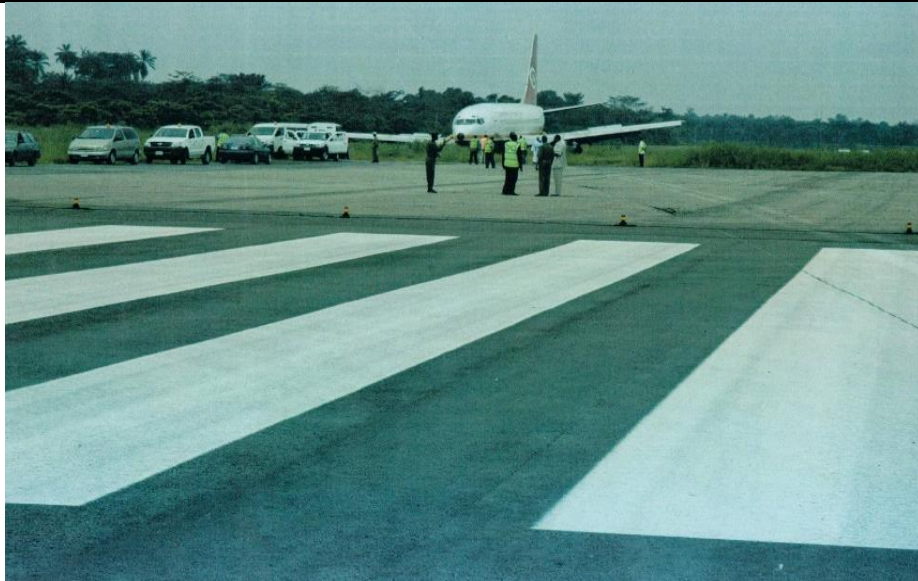
Figure 4: Final position of the aircraft relative to the runway

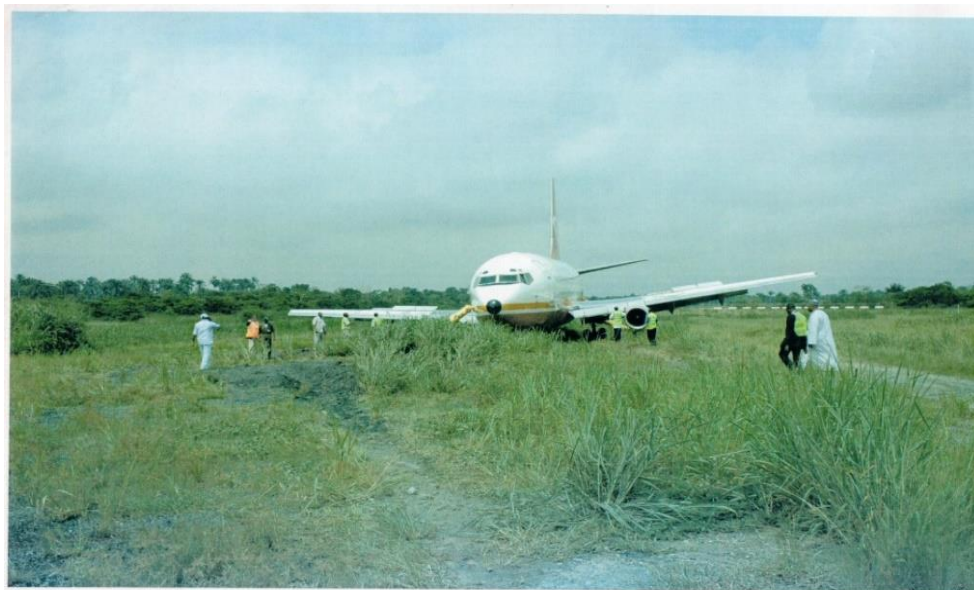
Figure 5: Final position of the aircraft

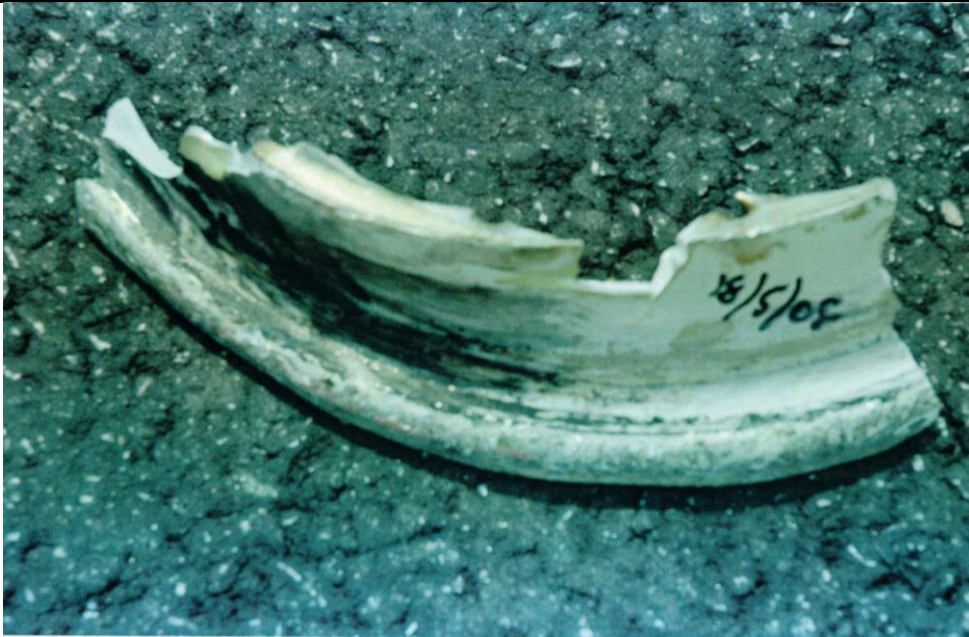
The aircraft touched down at 1700 m into runway 21, bounced several times, skidded left off the extended centre line, back to the centre and continued to the right at 2100 m. The broken pieces of the nose wheel rim and the damaged tyre were found at 2100 m and 2200 m, respectively.

Figure 6: A broken piece of the nose wheel rim

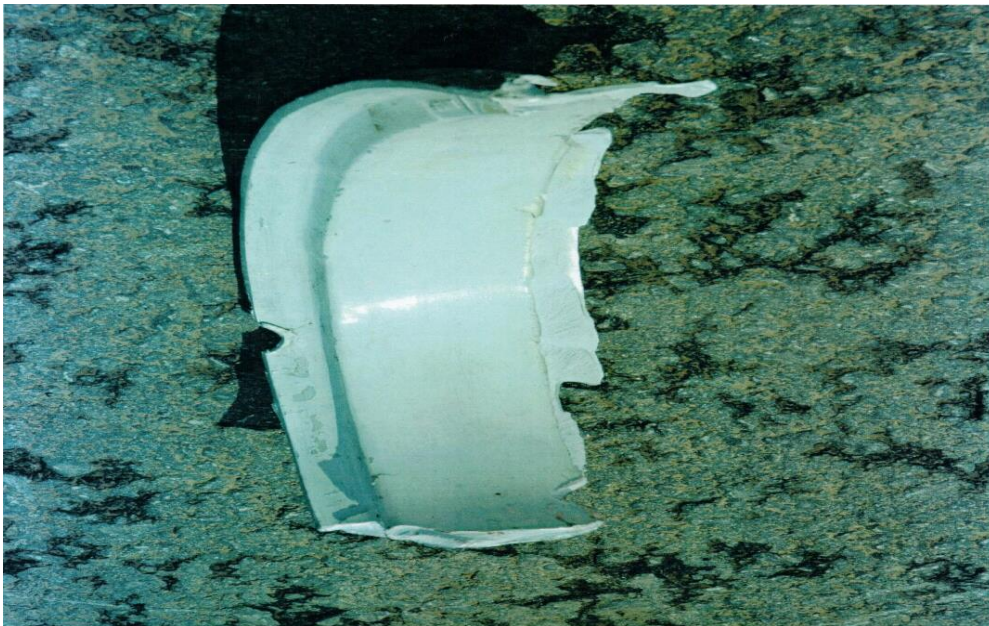
Figure 7: Another broken piece of the nose wheel rim

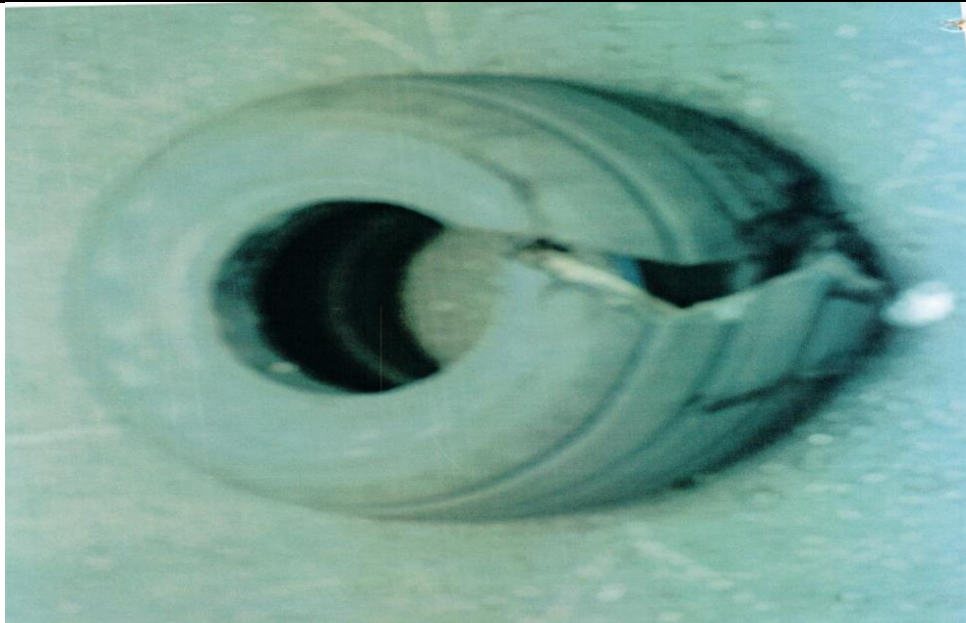
Figure 8: Damaged nose wheel tyre

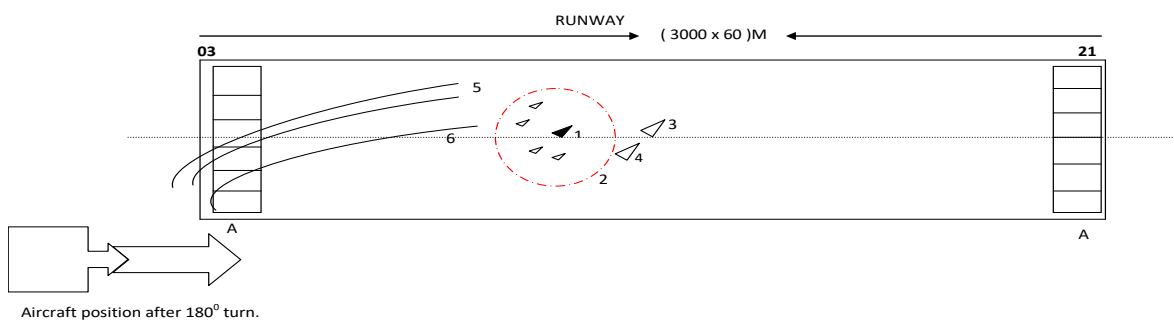
Impact and wreckage trail sketch diagram

- 1 – Impact shown at 1700 meters from end of runway 21
- 2 – Scattered debris of nose wheel and nose wheel scratches at (1600 – 1700) meters from end of runway 03
- 3 – Tyre at 1500 meters from end of runway 03
- 4 – Position of side strip at 1400 meters from end of runway 03
- 5 – Tyre markings of main landing gear on runway
- 6 – Strut marks of nosewheel on runway
- A – Threshold point
