Final Report

On the accident on **1st June 2009**
to the **Airbus A330-203**
registered **F-GZCP**
operated by **Air France**
flight AF 447 Rio de Janeiro - Paris

BEA

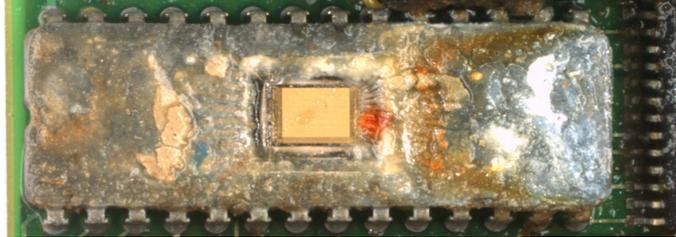
The two computers were examined. The memory components containing the data were damaged. One of the components had been torn out and the other suffered from internal short-circuits. The work was brought to a conclusion.

Figure 30: Memory component from one of the FCDC

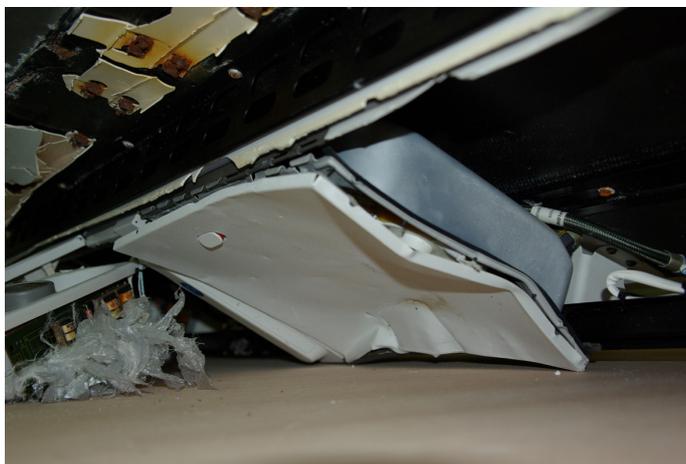
Figure 40: Passenger oxygen container recovered closed:
the deformations on the cover matched those on the box

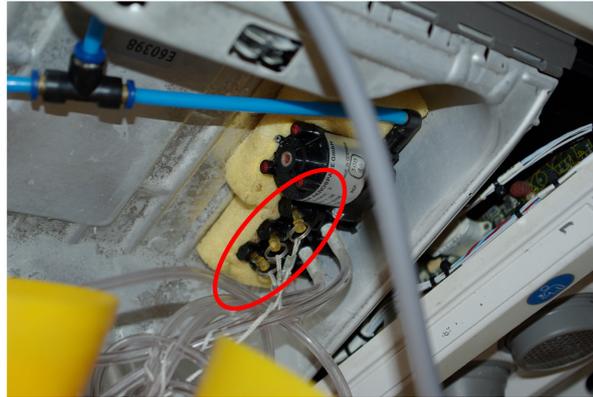
In normal operation, the oxygen is sent to the mask when the passenger releases the system's lock-pin by pulling on the mask. Several pins were found in place, closing the oxygen circuit.

Figure 41: Passenger oxygen container recovered open: the three pins are in place

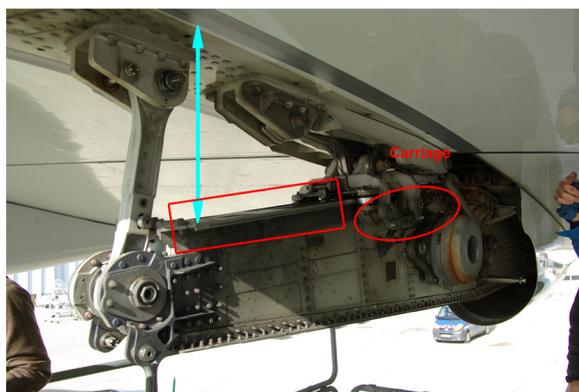
Several parts of the flap extension mechanism fairing were found. There were marks on two of them (positioned at the level of flap track N°3), made by the flap extension track on impact. Analysis of these marks (morphological and dimensional examinations) and comparison with an identical aeroplane made it possible to determine that the flaps were in the “retracted” position (see photo below) at the time of impact with the water (measurement of the distance between the track and the lower surface of the flap, position of the carriage on the track).

Figure 42: Flap extension mechanism (or flap track) No. 3 in retracted position

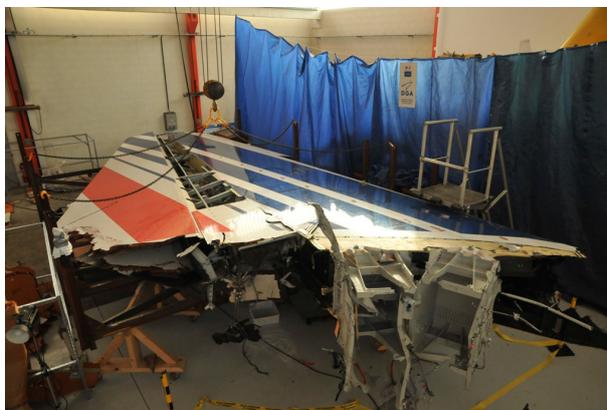
- ❑ The forward attachment (male and female lugs) and the lower part of the side panels (lug reinforcements) were missing;
- ❑ The centre and aft attachments were present: male and female lugs and parts of the fuselage frames.

Figure 44: Fin – In the foreground the base of the fin with the central and forward attachment lugs

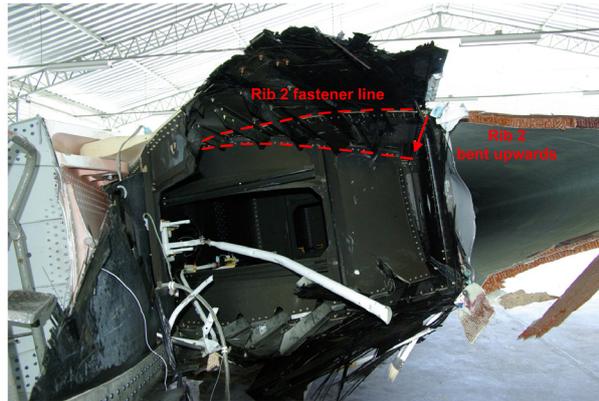
- ❑ Failure of the leading edge right- and left-hand panels
- ❑ Longitudinal cracking of the leading edge stiffener
- ❑ HF antenna support (attached to the forward spar): failure of the lower part, crumpling indicating bottom-upwards compression loads.

Figure 45: Rib 2 bent upwards as a result of bottom-upwards compression loads

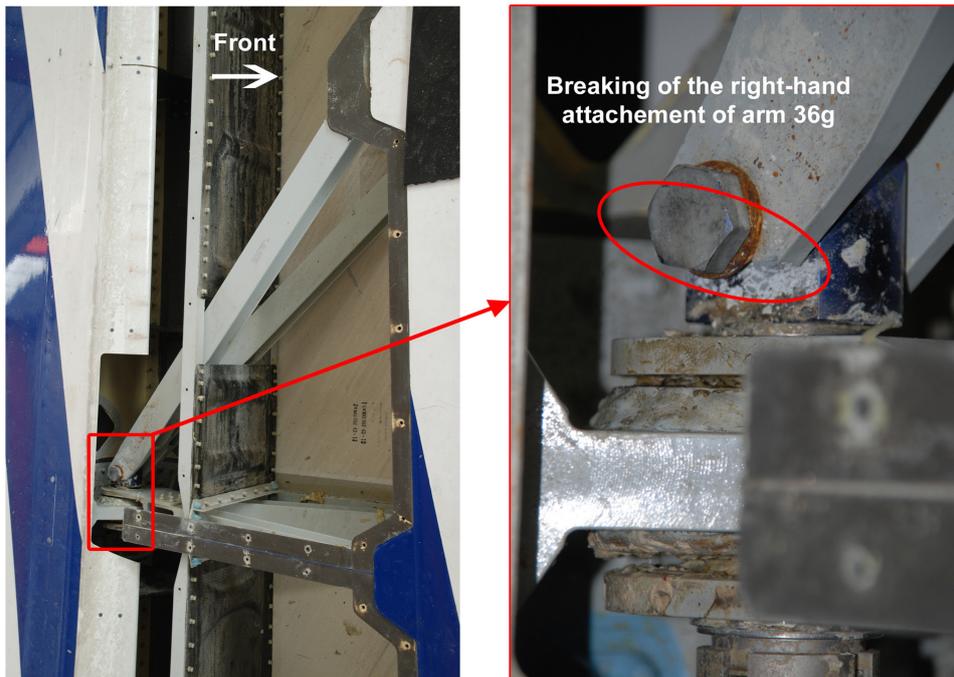
The size of this arm is calculated to withstand a maximum load of 120,000 N, corresponding to a relative acceleration of 36G of the rudder in relation to the vertical stabilizer.

Figure 47: Arm 36G, right view: failure of the rudder attachments

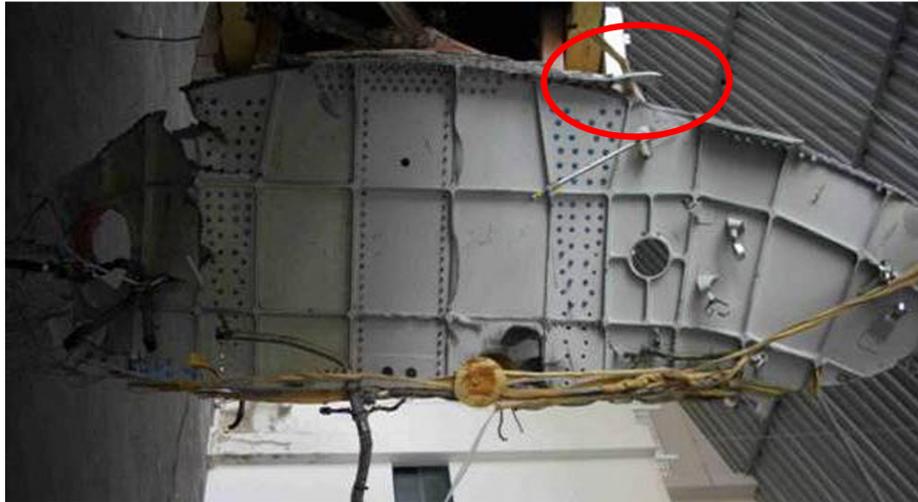
The fuselage was sheared along the frames and centre and aft attachment lugs by loads applied bottom-upwards.

Figure 48: Frame 87: shearing of the frame and fuselage skin along the frame

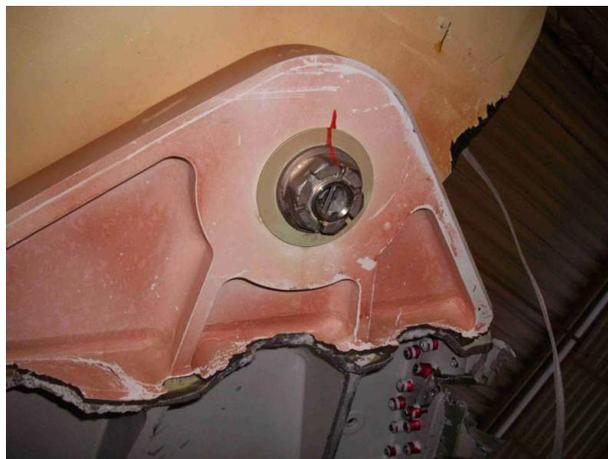
Figure 49: Right-hand aft lug: shearing of the fuselage along main frames 86-87

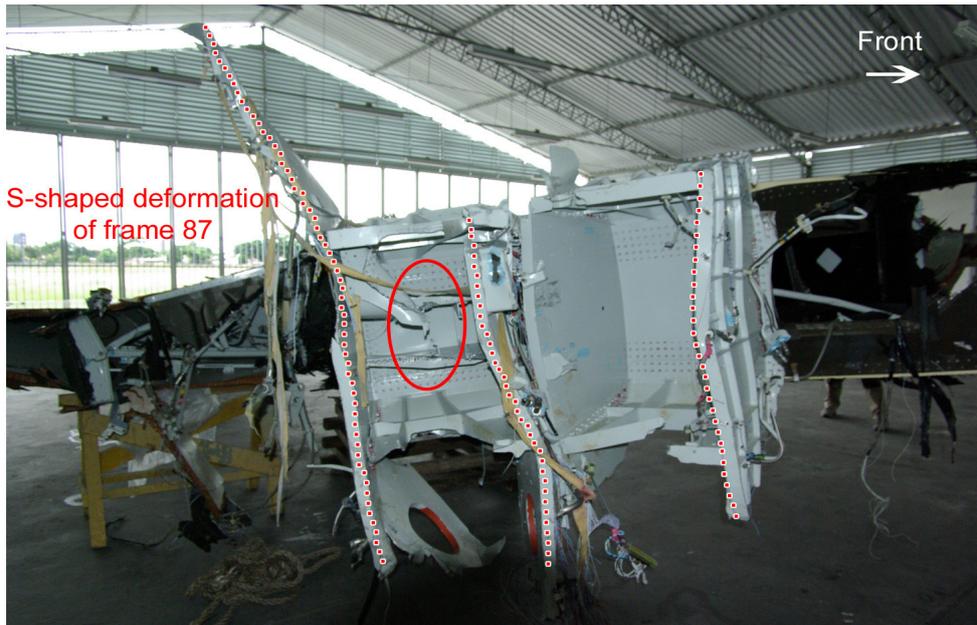
The part of frame 87 that can be seen had undergone S-shaped deformation: the left-hand side forwards, and the right-hand side backwards. The horizontal stabiliser actuator supports were deformed and broke in a backwards movement from the front. These observations indicate a backwards movement of the trimmable horizontal stabiliser.

Figure 50: Frames 84 to 87: S-shaped deformation of frame 87, with frames 84 and 85 pushed in backwards;
failure of the horizontal stabiliser actuator supports between frames 86 and 87 (red circle)

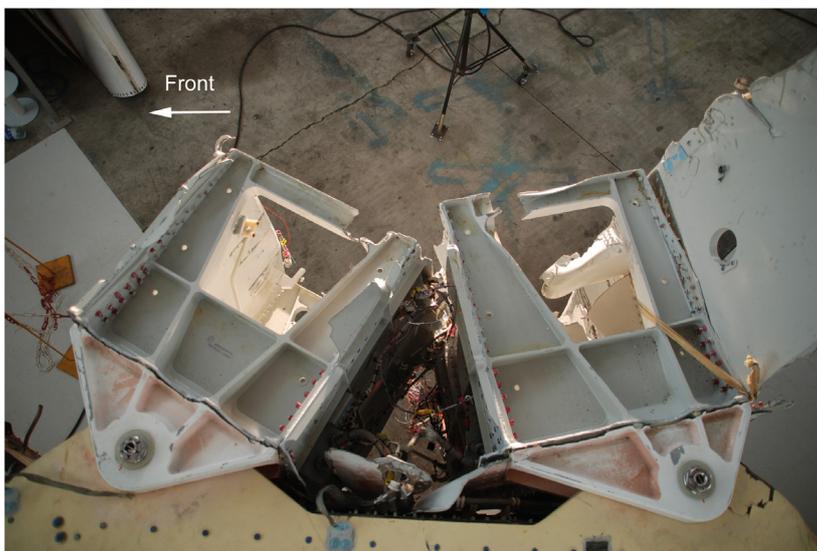
The centre attachment had pivoted backwards with the parts of the frames and web frames that were attached to it. The aft attachment had pivoted forwards with the parts of the frames and web frames that were attached to it.

Figure 51: Fin centre and aft attachments

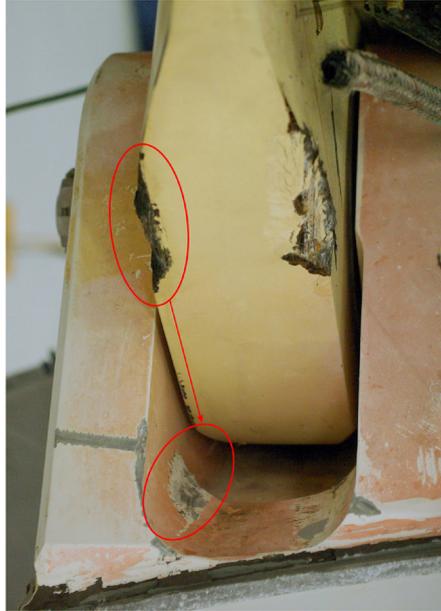
The aft attachment lugs (male on the fin and female on the airframe) had marks indicating a backwards movement of frames 86 and 87 as a whole.

Figure 52: Rear view of the left-hand aft lug: there were marks showing a backwards pivoting of frames 86 and 87

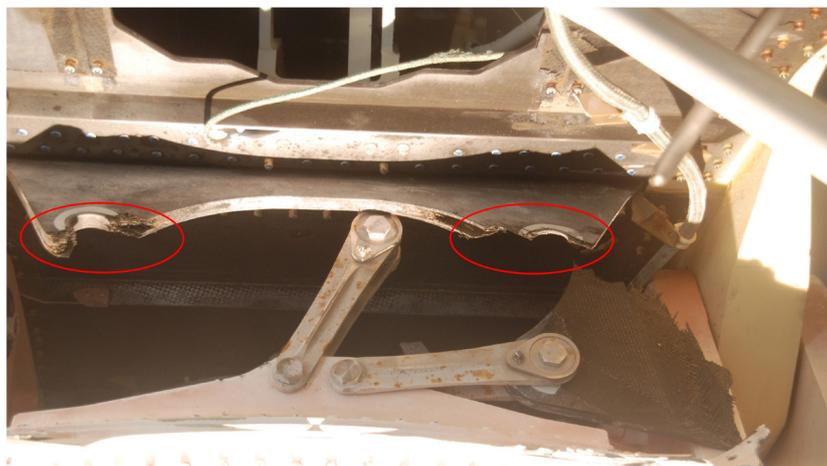
- ❑ Tensile failure of the centre spar at the level of the centre rod attachments;
- ❑ Compression failure of the aft spar at the level of the aft rod attachments and failure of the left-hand rod by buckling.

Figure 53: Tensile failure of the centre spar at the level of the attachment of the lateral load pick-up rods

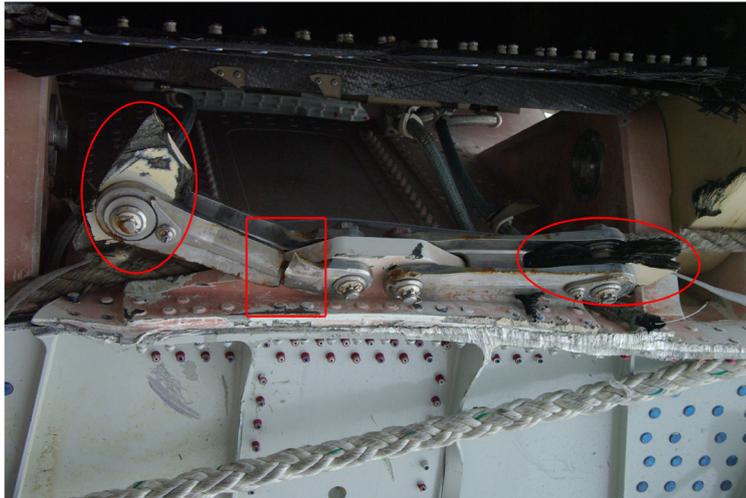
Figure 54: Compression failure of the aft spar at the level of the attachments of the lateral load pick-up rods and failure of the left-hand rod by buckling

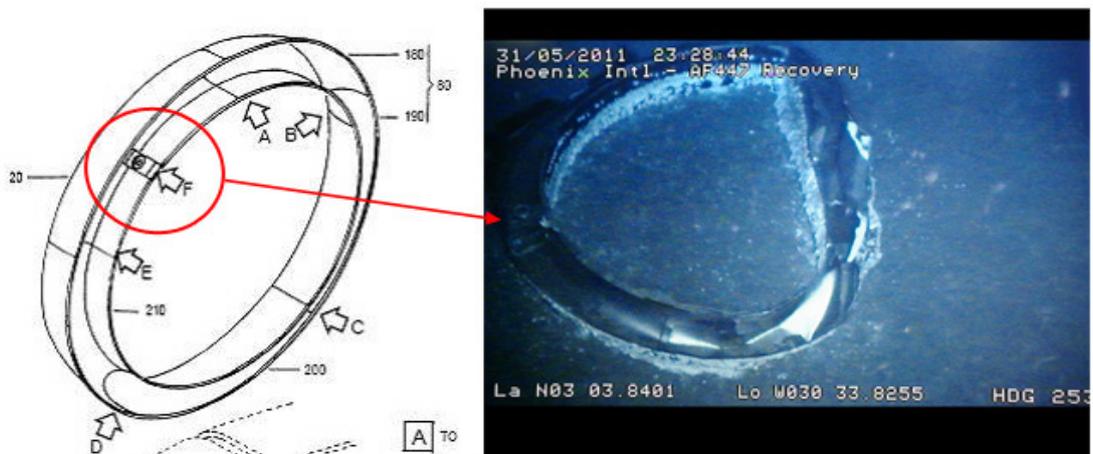
The left engine air entry leading edge had significant deformation on its lower part.

Figure 57: Left engine air intake
