Report A-044/2007

Accident involving a
Britten-Norman Islander
BN2A-21 aircraft,
registration G-CHES,
in Guadalcanal (Seville),
on 17 October 2007

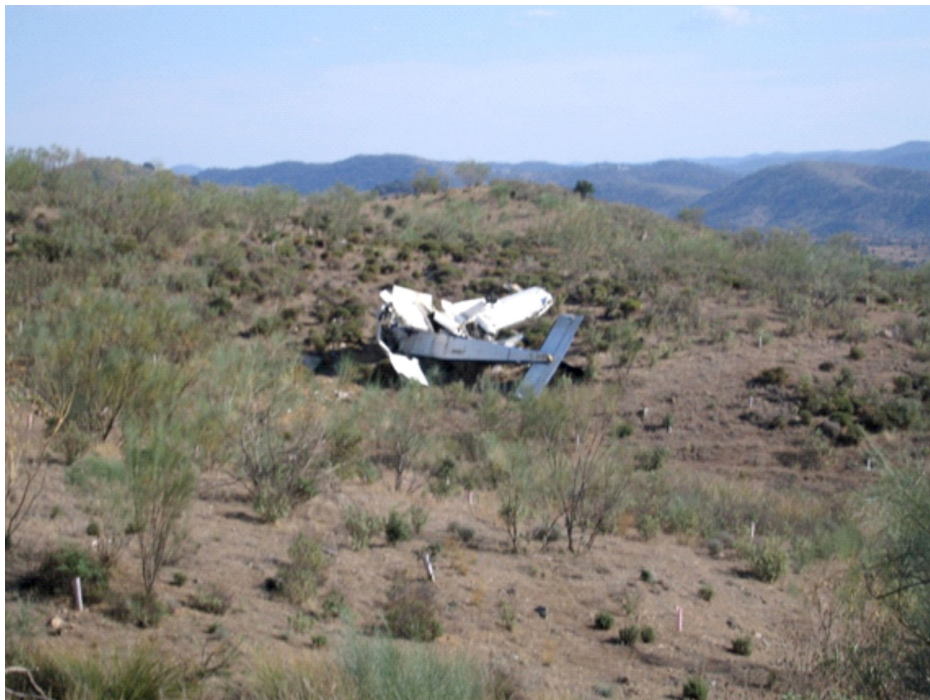
The aircraft was seriously damaged and was essentially destroyed. There was no fire after the impact.

Figure 1. Aircraft wreckage

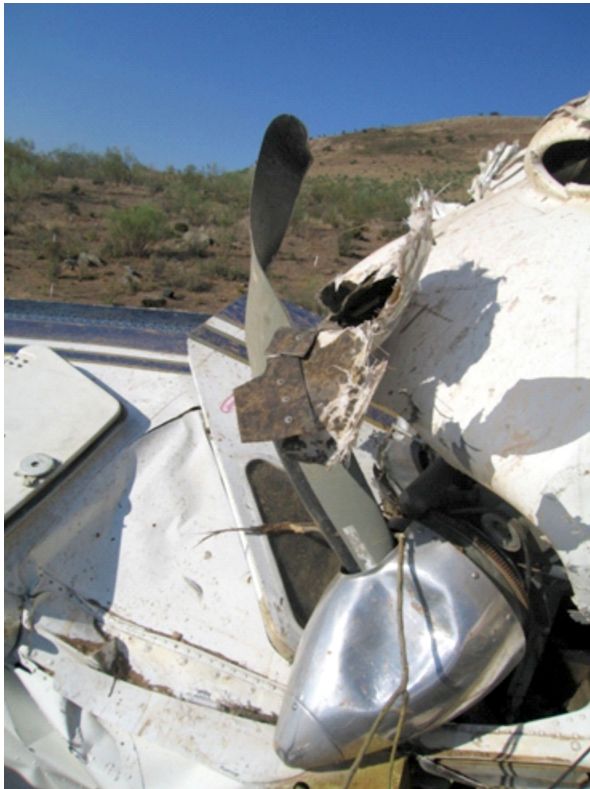
Figure 3. Left propeller

The blades on both propellers, especially those on the left engine, were twisted and bent by the impact against the ground. The engines partially detached from their mounts and exhibited general damage as a result of the impact.

The propeller blades had been bent as a result of the impact against the ground. The blades on the left propeller turned with the hub, due to the fracture of the fixing bolts and the reduction gear for the pitch control. Both the fractures at the junction of the blades as well as the type of twisting and bending they evidenced were consistent with an impact at high rpm's. The left showed more damage, possibly because it was the first to impact the terrain.

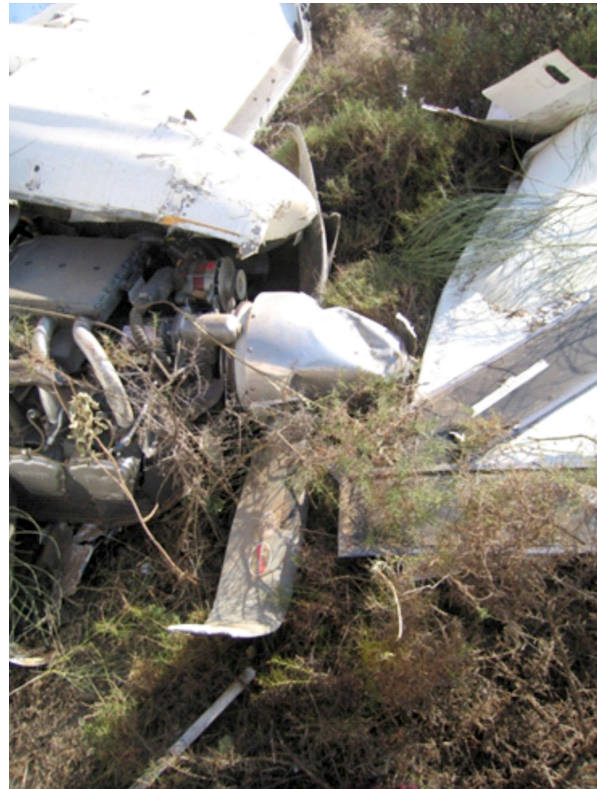
Figure 4. Right propeller and engine

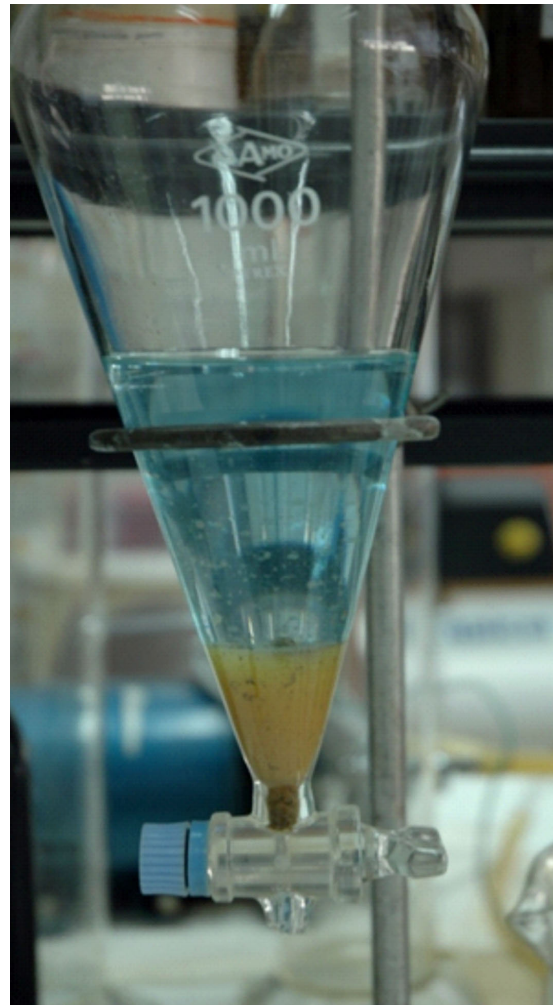
Figure 5. Fuel analysis

The analysis showed that the fuel taken from the tank complied with the ASTM D 910 specification for AVGAS 100LL aviation fuel, with some exceptions.

The only anomaly found that could have caused the abnormal operation of the engine was contamination by water and suspended particulate matter found in the left main fuel tank. The laboratory analyses of the fuel, however, are not absolutely conclusive since no traces of these contaminants could be found in the filters, the fuel lines or the injectors. There is also the possibility, however, that small amounts of water could have been supplied to the engine, leaving no trace of said contamination once the water was replaced with a steady flow of uncontaminated fuel following the fuel system manipulations made by the pilot in command.

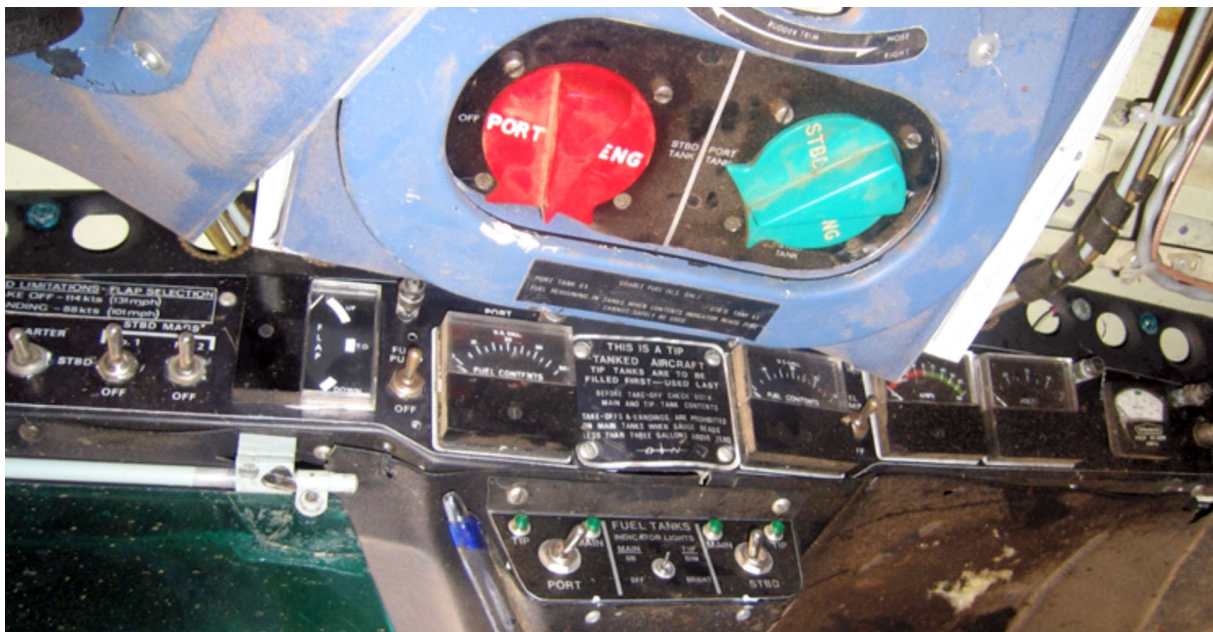
Figure 6. Fuel selector valve controls in their as-found positions

It was noted during the on-site inspection that the selector valve for the right engine (green in color) was in an intermediate position. While testing the valve in the workshop, it was noted that in any of its intermediate positions, whether supplied from the same-side tank or in the cross-feed position (arc between the 6 o'clock position for same-side feed and 9 o'clock for cross-feed), fuel always flowed out the discharge line without any reduction to or interruption in the flow. The only variation was in the source of the fuel, the same-side or opposite tank.
