Safety Investigation Report

ACCIDENT TO A BOEING B747-228F OPERATED BY CARGO B IN BRUSSELS ON 27 OCTOBER 2008

Ref. AAIU-2008-18- EBBR
Issue date: 26 January 2015
Status: Final v1

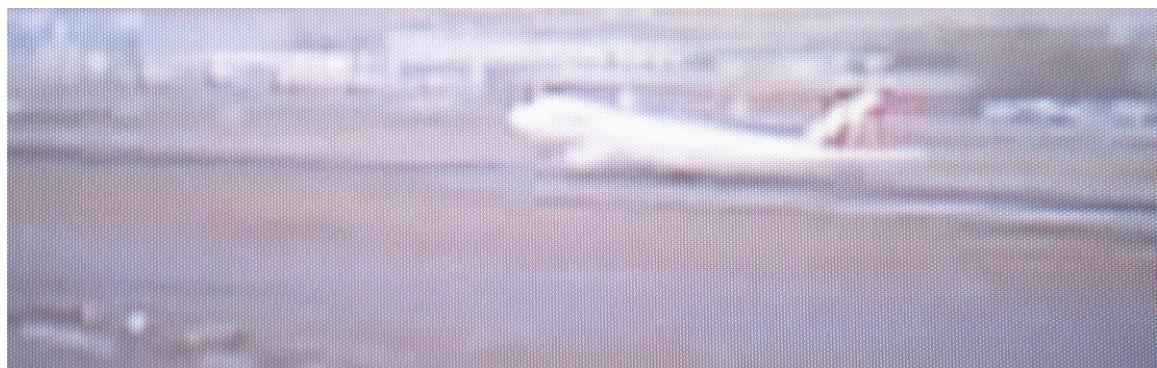
Figure 3: Start of rotation

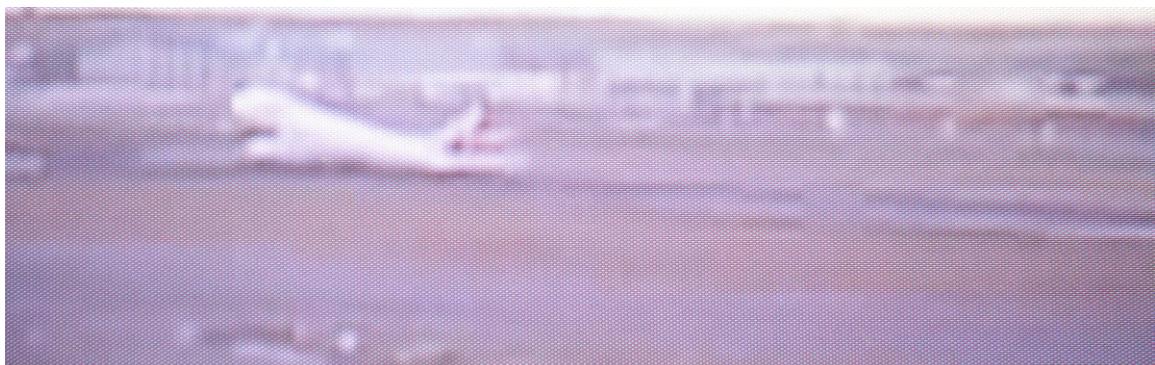
Figure 4: The airplane tail hit the runway.

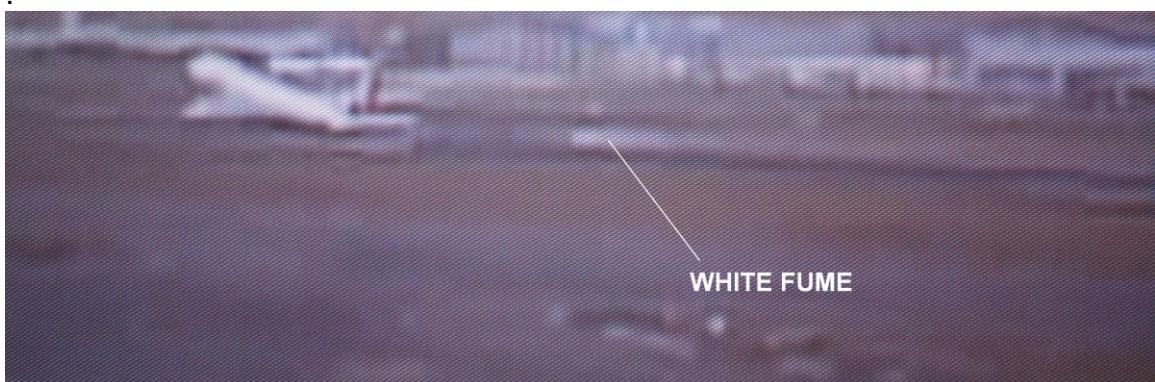
Figure 5: The airplane continues the take-Off, scraping the tail on the runway

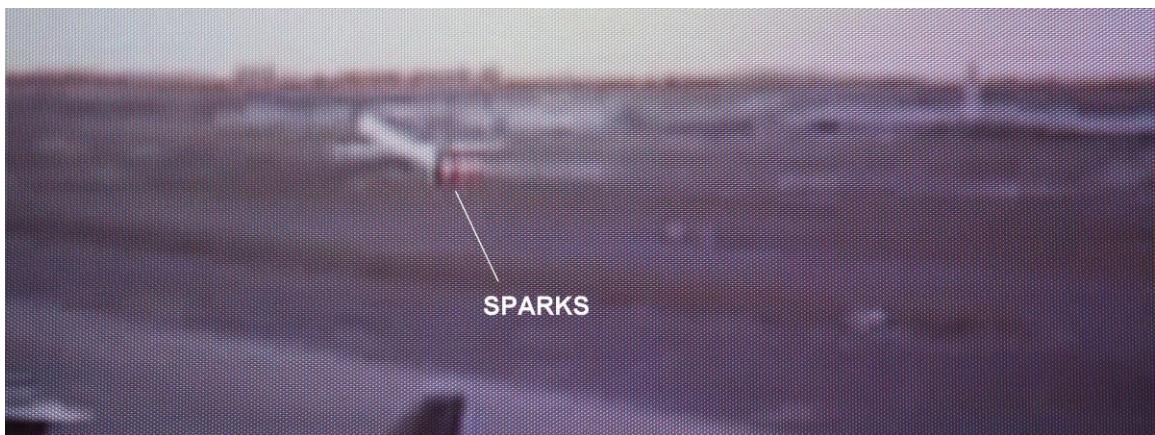
Figure 6: Sparks are visible

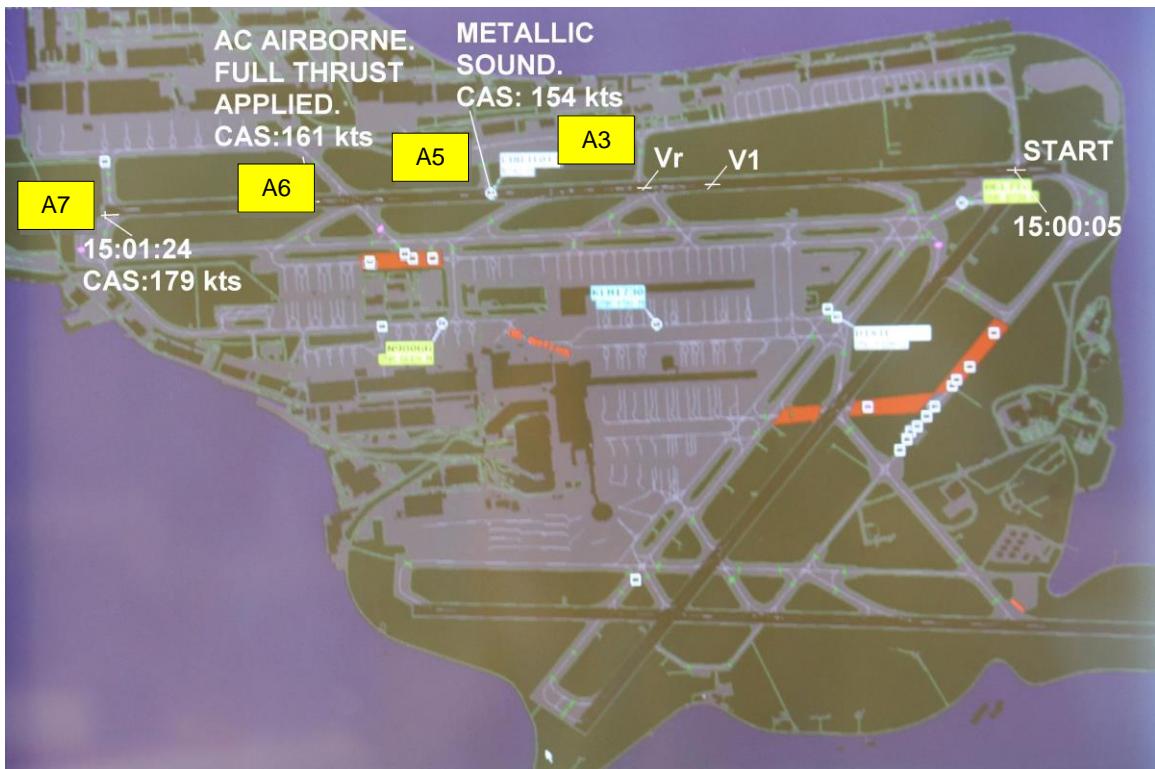
Figure 7: Ground radar image of the event

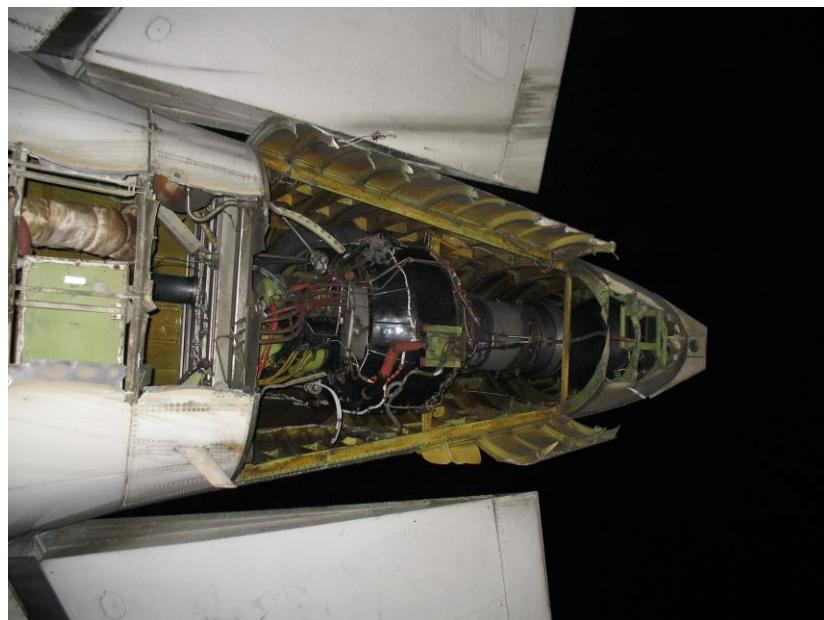
The B747 tail suffered significant damage.

The sections 46 and 48 were damaged. In detail;

Section 46

The following structural items were damaged by the tail strike:

- All the frames from Body Station (BS) 2080 on.
- The lower half stringers on BS 1961 – 2181.
- LH outflow door.
- Skin panels

Figure 8: Tail end damage

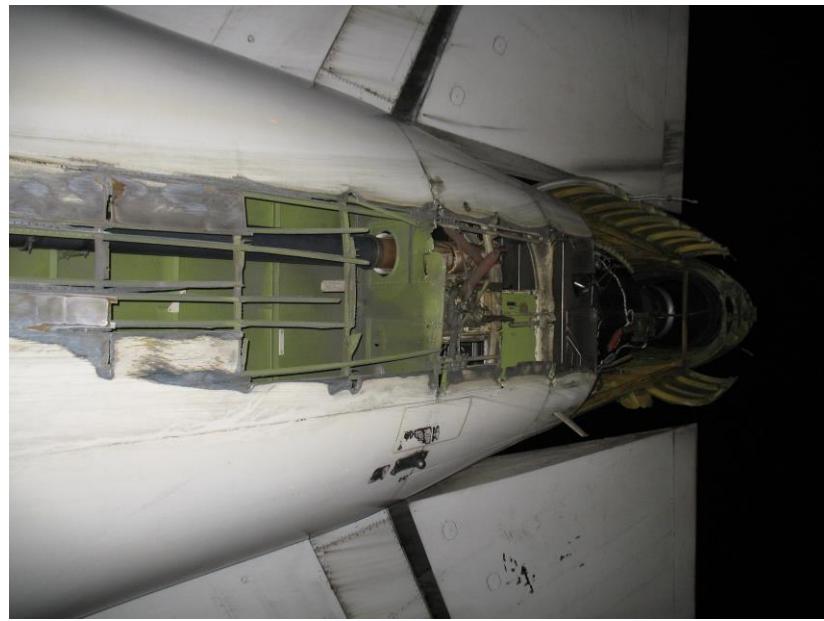
Section 48

The following structural items were damaged by the tail strike:

- Light damage on the pressure dome.
- All the frames from BS 2460 on,
- Lower skin panels,
- Firewall BS 2658.

The APU doors were damaged, and there were damages on the APU tubing and wiring.

Figure 9: damage forward of the APU compartment.

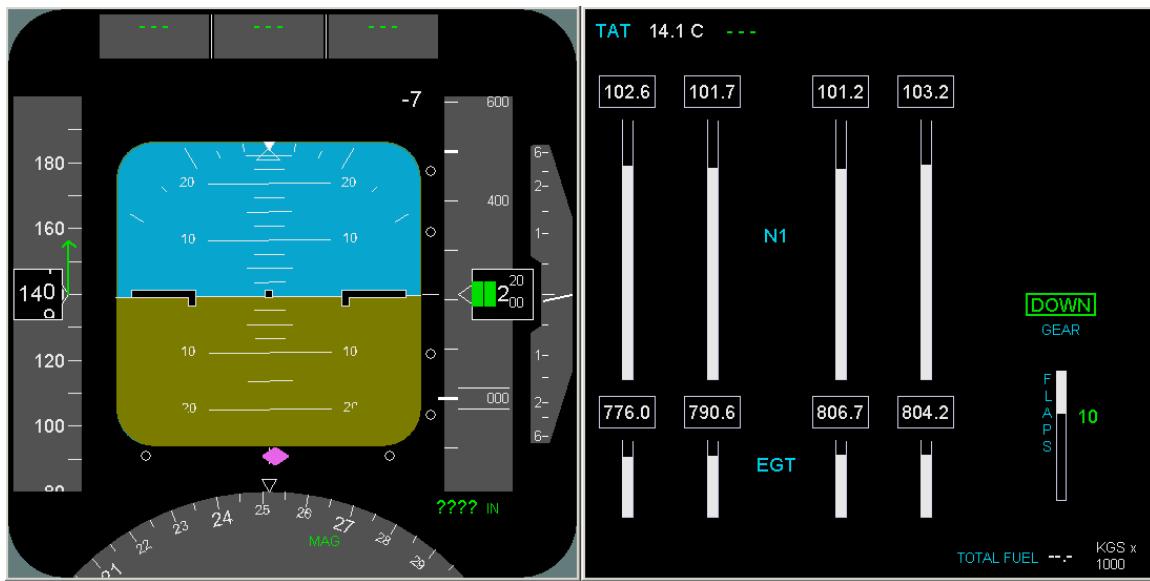
Figure 16: flight deck simulation screenshot: Start of rotation

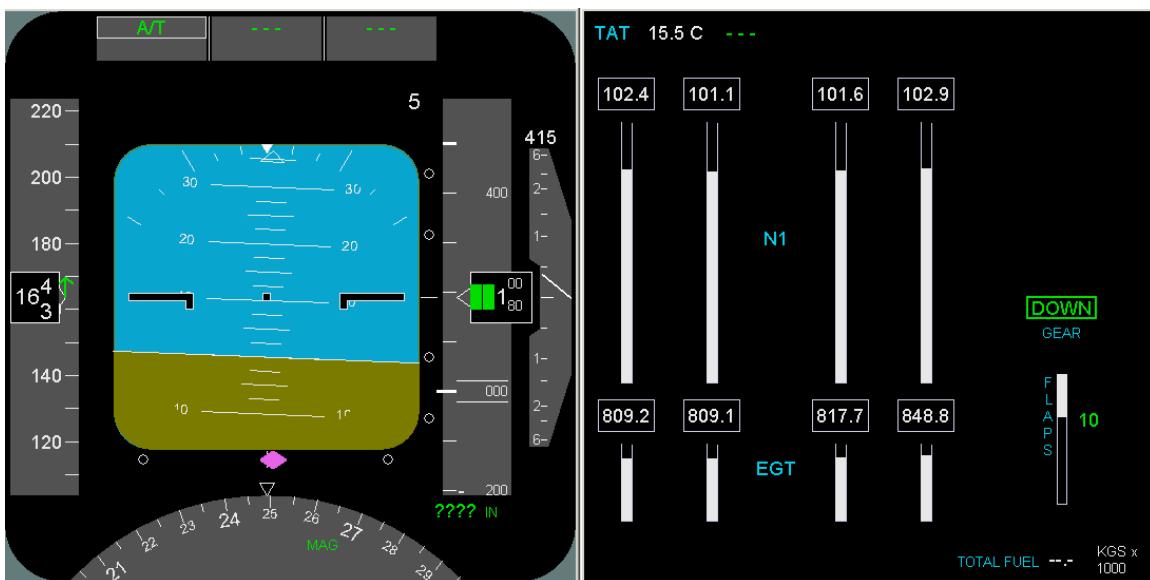
Figure 17: flight deck simulation screenshot: moment of rotation

The aircraft was rotated for take-off at a speed that was more than 30 kts lower than the required speed in the given conditions. At this low speed the aircraft was aerodynamically unable to fly and the risk of tail strike very high.

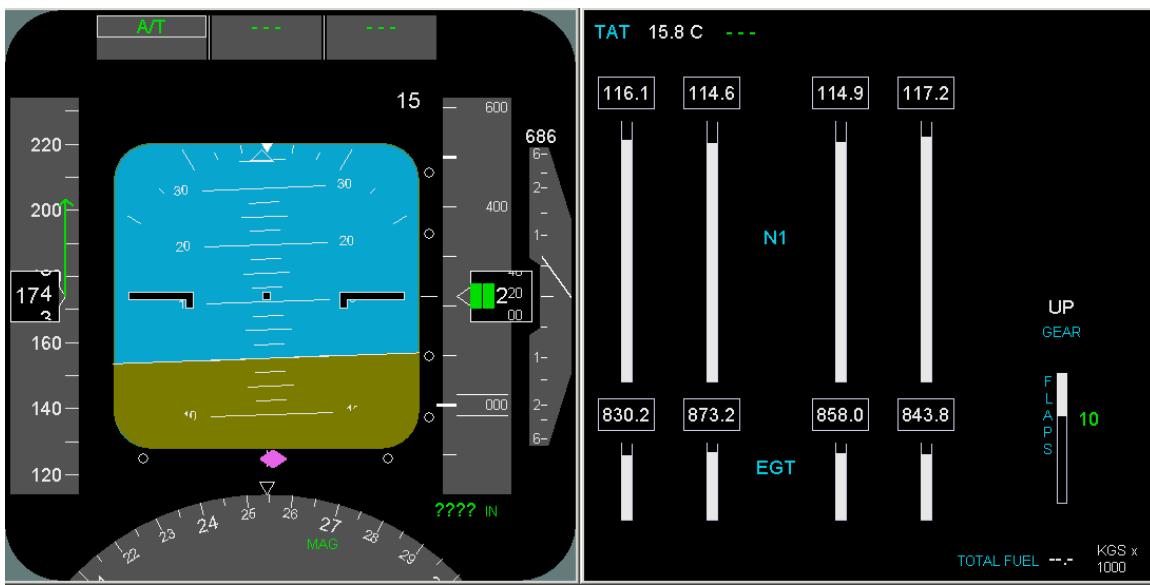
Figure 18: flight deck simulation screenshot: moment of lift-off

By that time, the airplane reached 170kts; sufficient for lift-off.
