**FINAL**  
KNKT.07.10.16.04

**Aircraft Accident Investigation Report**

**Sinar Mas Super Air  
Fletcher FU-24-950 ; PK-PNZ  
Libo Airstrip, Samsam Village, Kandis, Riau  
Republic of Indonesia  
5 October 2007**

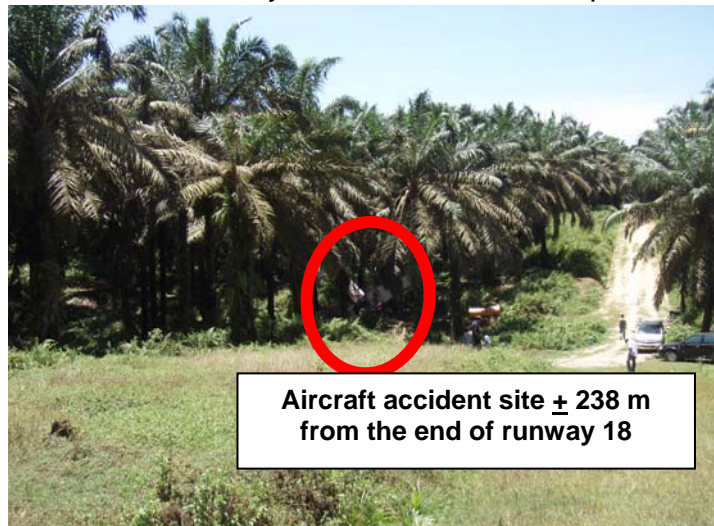
The pilot informed while the aircraft turned to the left, he felt the strong wind from the right. Then the aircraft was descending and the left wing hit the palm tree. After losing the wing tip, the aircraft difficult to control and crashed into the palm trees on the left runway for about 238 meters from the end of runway 18.

Figure 1: Aircraft accident site

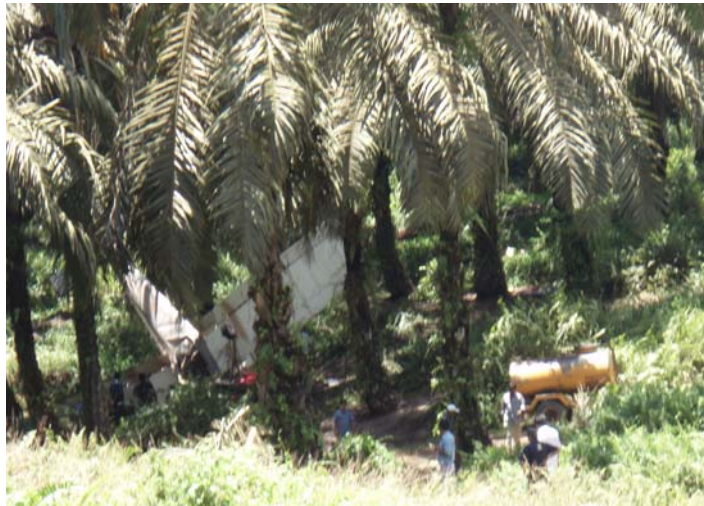
The aircraft was substantial damaged.

Figure 2: The aircraft crash in the oil palm plantation

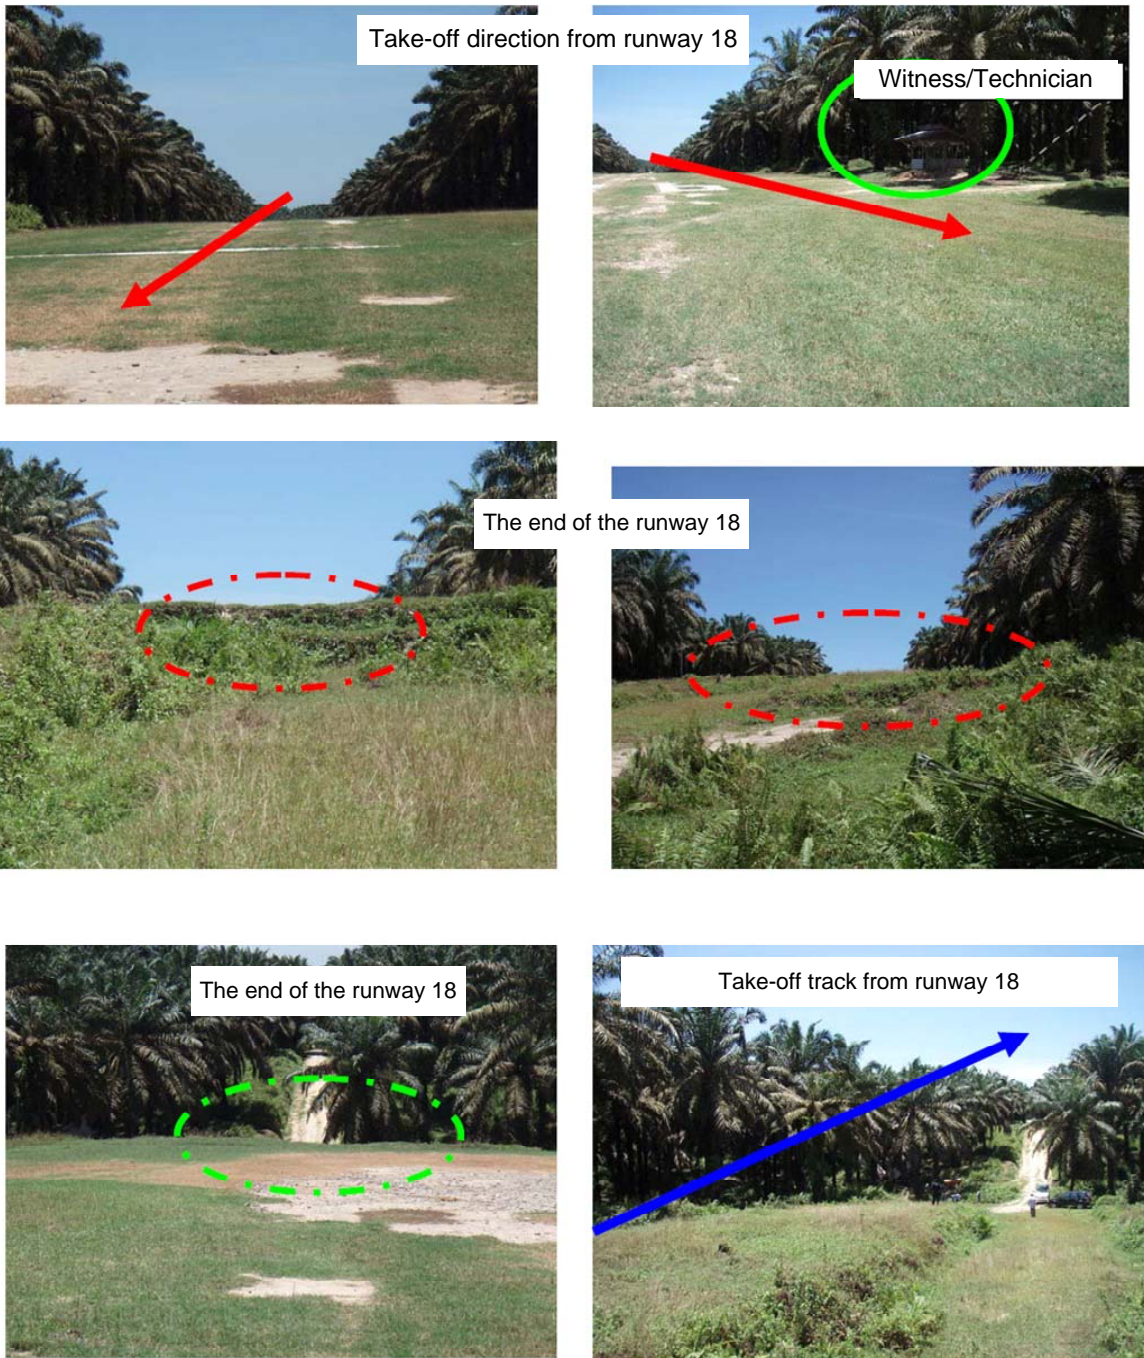
Runway 18

There was a private airstrip operating by PT. Sinar Mas Super Air in the palm plantation area. The runway was 800 meters length and 12 meters width, the strip width was 30. Runway direction was 18 and 36. The runway surface was hardness ground (see Figure 3)

The strip was configuring as palm three tunnels on the left and right.

Figure 3: Runway condition

PT. Sinar Mas Super Air advised the NTSC that it had taken safety action to airstrip in the fertilization area that the runway safety area at the end of the runway and refer to the applicable regulations. The windsock has been located end of runway and the position higher than the palm trees. Distance between palm trees beside the runway becomes wider and the runway width 45 meters.

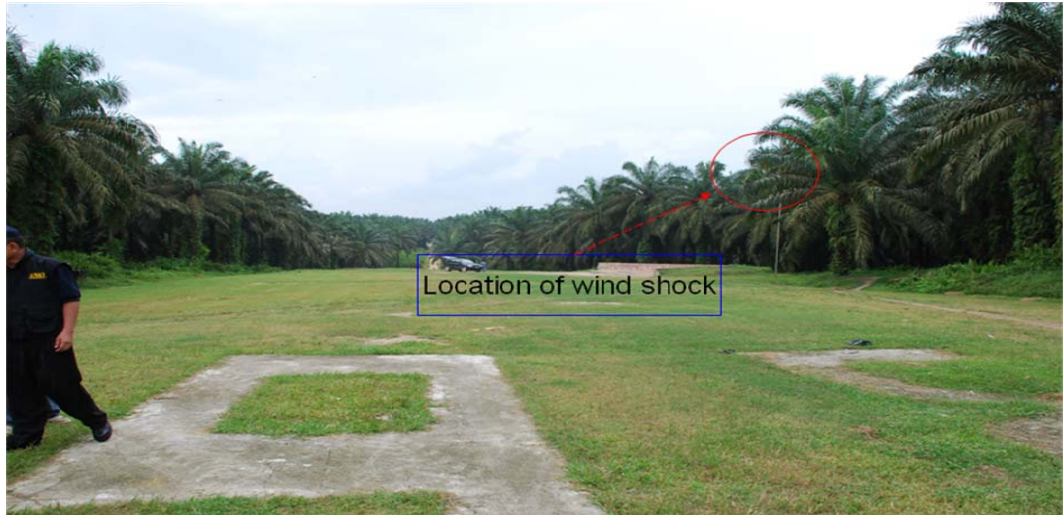
The runway equipped with wind shock, however, the wind shock was lower than the palm tree trunks (see Figure 4). There were palm trees at both side of runway, approximately 30 meters from centerline and with an average height 15 meters.

Figure 4: The wind shock location at the time of accident

The wind sock was covered by the palm tree leaves and it was not visible from the aircraft.

- Wind shock position was under the palm trees, so that the wind speeds different from above and under the palm trees, the wind direction could not be observed by pilot prior takeoff.
- The runway strip width was 12 meters and the palm trees between the airstrip for about 30 meters and height 15 meters. It indicated the airstrip look likes a tunnel.

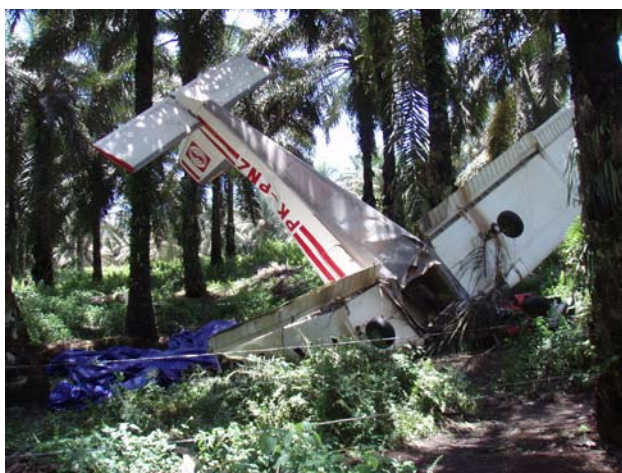
The aircraft was destroyed during the accident and had come to rest in an inverted, nose down altitude. The damaged was as follows:

Figure 5: The aircraft last position

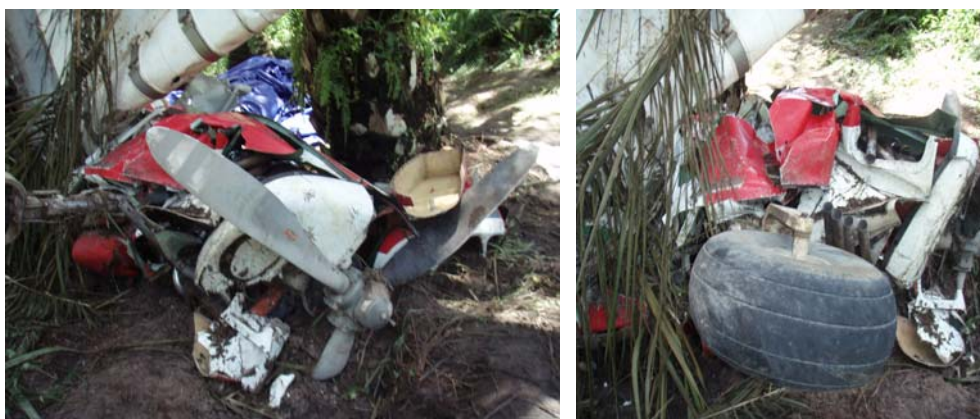
- The nose landing gear was detached from the nose section of the fuselage, the main landing gear still attached to the fuselage.
- The fuselage was damaged.
- The left and right wings were broken. There was damage consistent with left wing was hit the palm tree.
- All propeller blade was bent, none detached from the engine.

Figure 6: The aircraft damaged

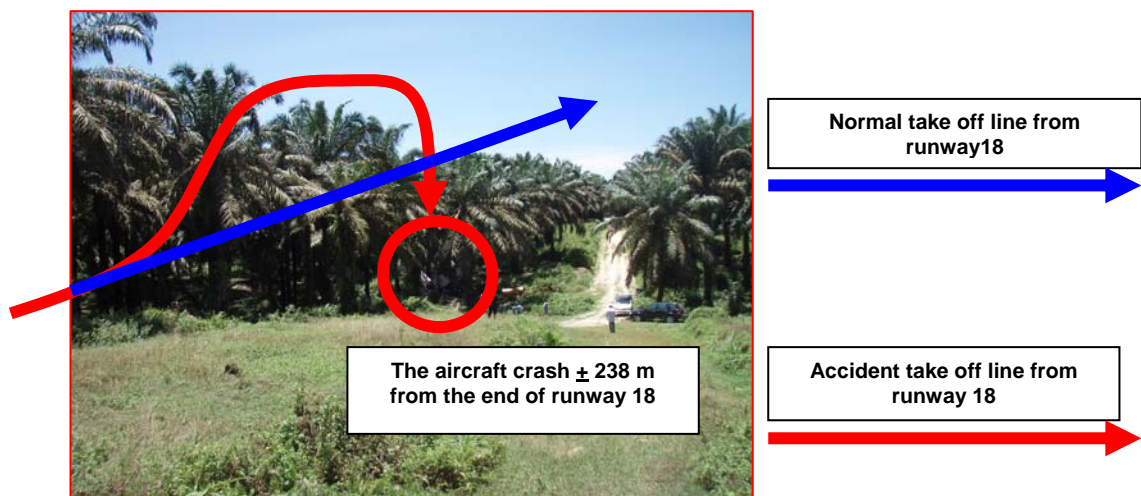
During climbing and turning to the left, suddenly the strong wind from the right side of the aircraft, so when the aircraft takeoff and climbing below the palm tree, the cross wind effect did not sensed due to tunneling effect.

The cross wind was not realized by the pilot due to the wind sock was not in his visibility or covered by the palm tree leaves, it was late since the aircraft sink and the left wing hit the palm tree, which caused the wing tip and separated of the left wing was collapsed. The aircraft crashed between of the palm trees, within + 238 meters from the end of runway 18.

Figure 7: The aircraft normal take-off and accident tracking
