MINISTRY OF CIVIL AVIATION

The final technical report of the accident of the cargo aircraft operated by AERO LIFT registered S9-SVN of type : AN-12B while taking off from the runway 02 in Luxor airport Flight No. LFT 1015, destined to the airport NIKOLAEV ,Ukraine in 20/2/2009

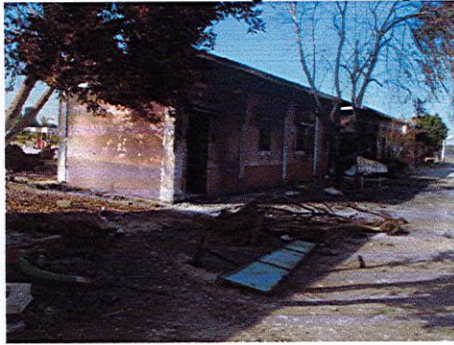
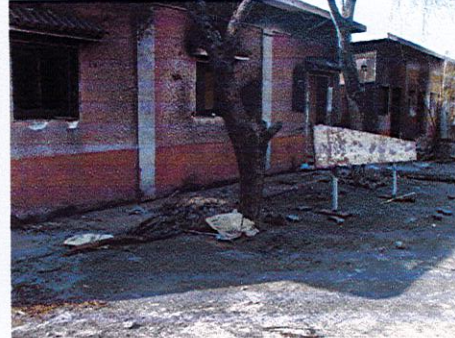
1.4.1 First Building (Water Buildings)

- A part of the south wall and a part of the building's ceiling were destroyed. Several fire marks on the building and also severe fire marks on the two buildings next to first building were detected. The contents of the first and second buildings were completely burnt.

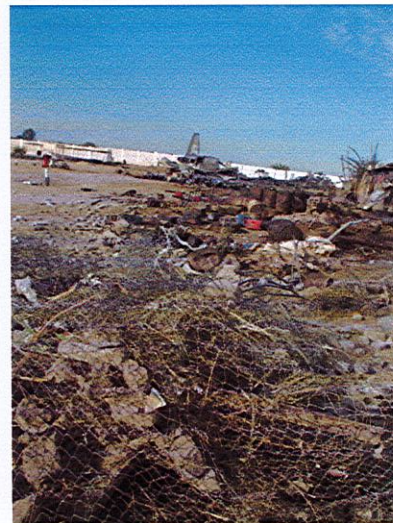
1.4.2 Second Building (Fuel Buildings)

- One of the buildings at which the aircraft wreckage was found inside it was completely destroyed. A part of the fence of the unit located on the Tiba-Luxor road was destroyed.
- Several engine vehicles oil barrels were burnt.
- The fence between the airport borders and the military zone was destroyed by 10 meters and the fence between the two units was destroyed.

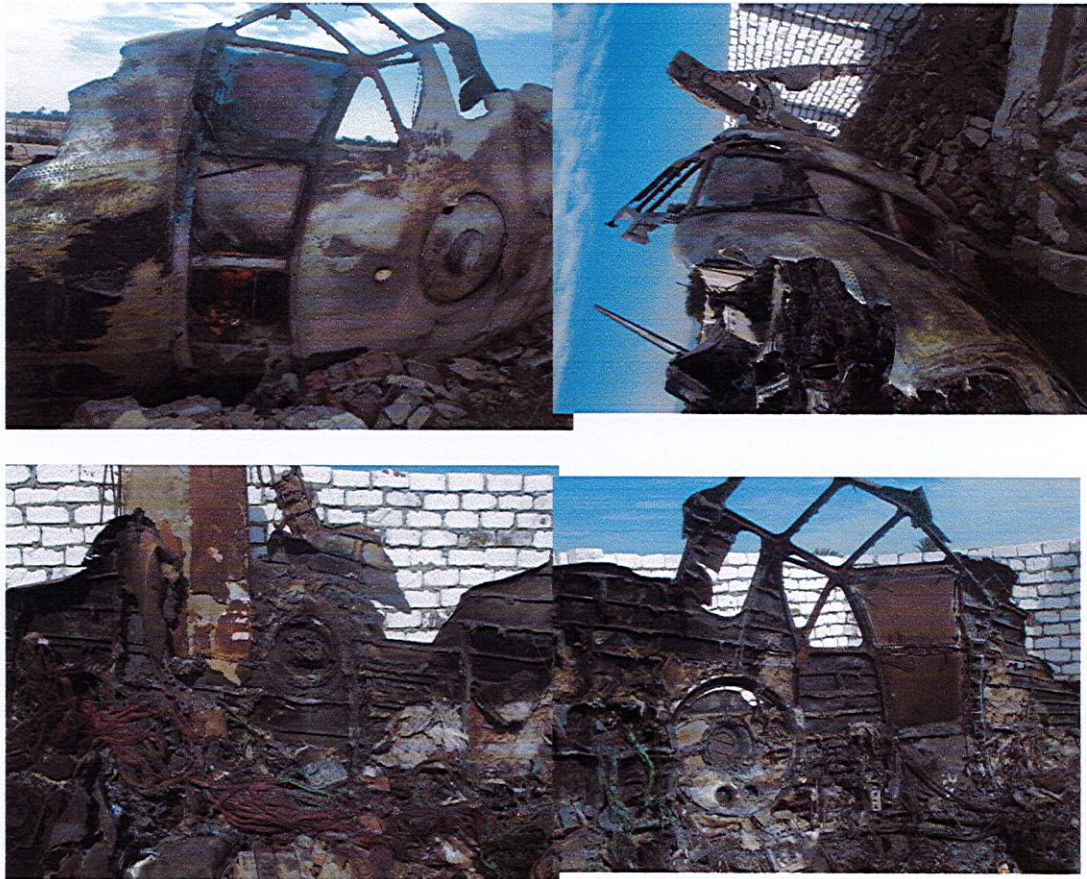
1.12.3.1 THE COCKPIT AND CARGO COMPARTMENT

- The frames No. 9-13 were in a complete destruction status and the fire turned it to ashes (some fragments from the steel light fragments and the cockpit cover).
- The cargo compartment (the frames from No. 13 to 43) was totally destroyed and the fire turned it to ashes.

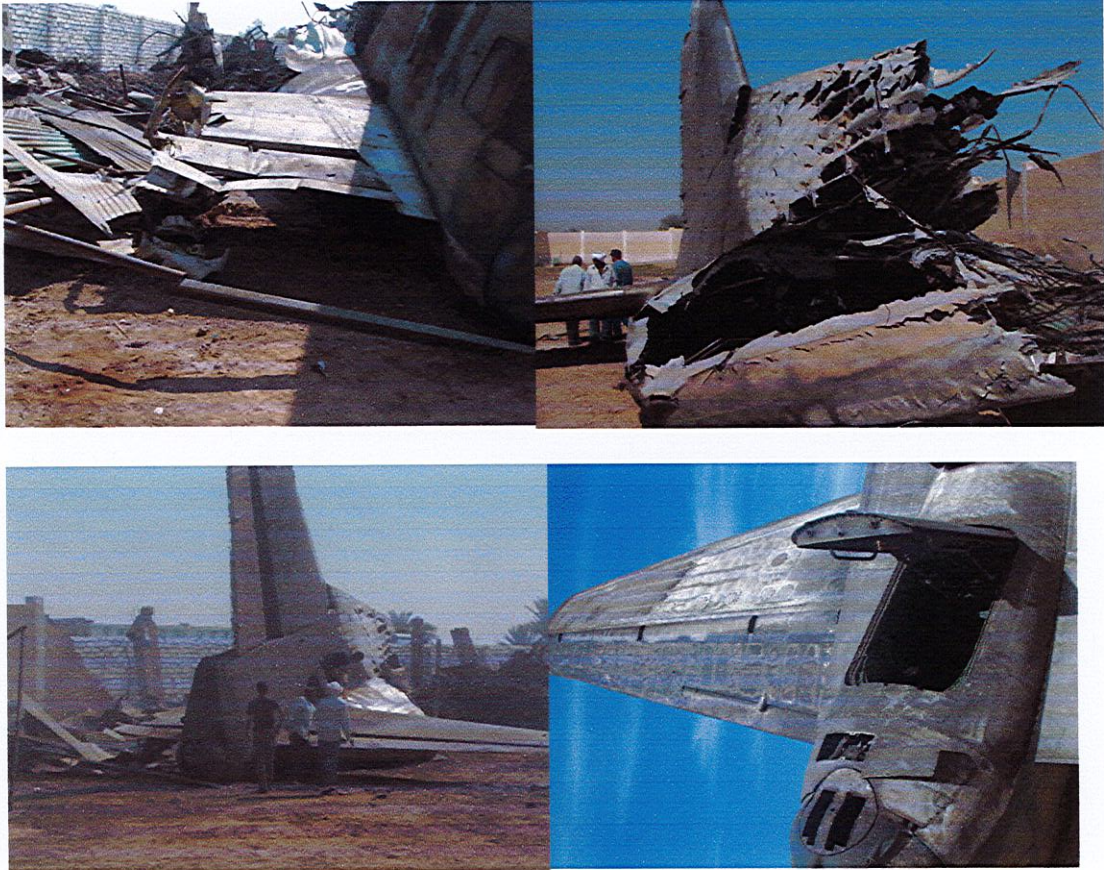
1.12.3.2 TAIL UNIT

- Frames 43-47 were totally destroyed and the fire turned them to ashes.
- Left tail unit was partially destroyed, elevators were found in the max upward position at 28 degrees, and the rudder was found on 20 degrees to the left.
- Right stabilizer was found broken near the fifth rib.
- Fin tip was found destroyed due to its collision with the concrete fence.

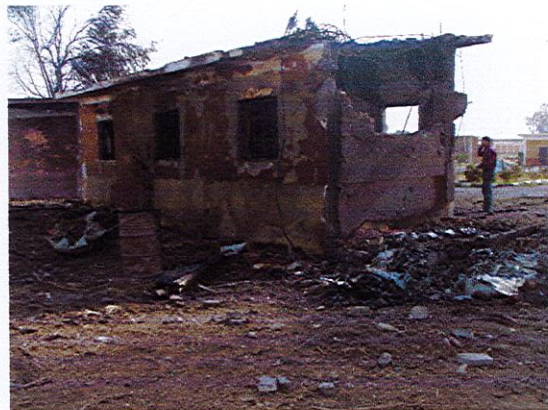
1.12.3.3 WINGS

- Intermediate wing, panel right outer, collided into the military unit buildings and caught fire. Its parts were found in destruction and burnt state next to the military unit buildings.
- The flaps and ailerons of the right wing were found next to the building into which the aircraft crashed and the remaining of the rear spar of the upper right intermediate wing panel (11-13 NK) were found as shown in relevant photographs.
- The aileron, elevator and rudder control linkages were burnt in the ground fire. The remaining rod fittings were finger tight and locked. All the flight control damage resulted from the impact and the ground fire.
- Three flap jackscrews were found at the site of the aircraft collision with the buildings and the ground.

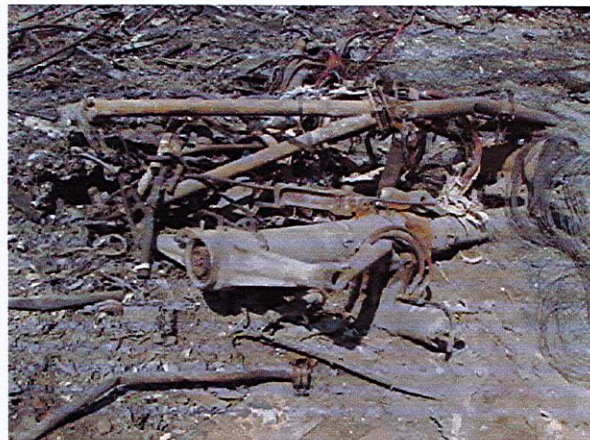
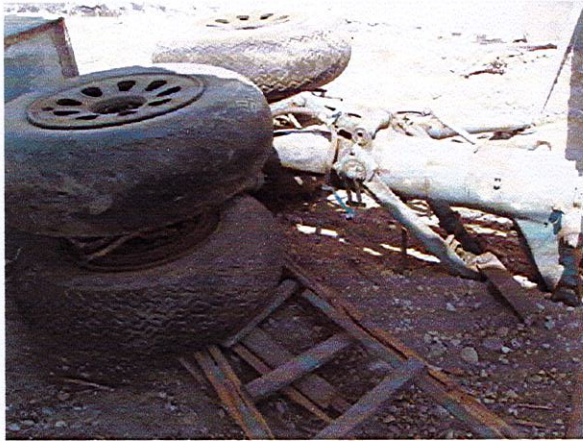
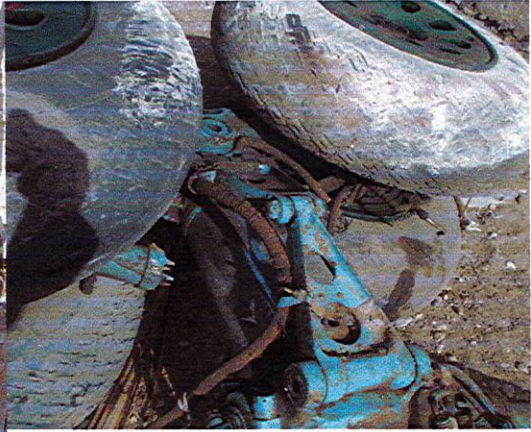
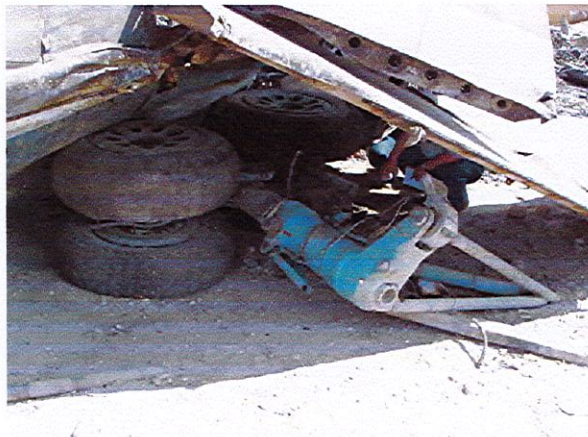
- The Nose landing gear was found without tires (burnt).
- Left main L/G was found near the big part of the wreckage partially destroyed.
- The bad status tires:

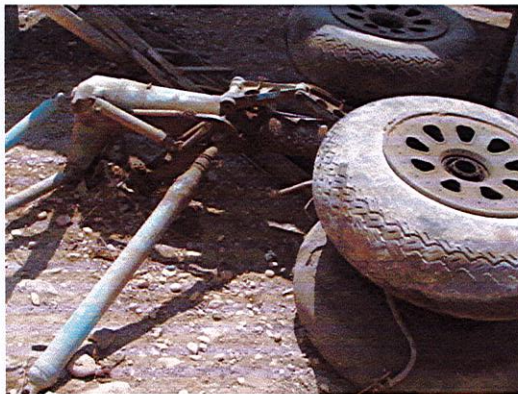
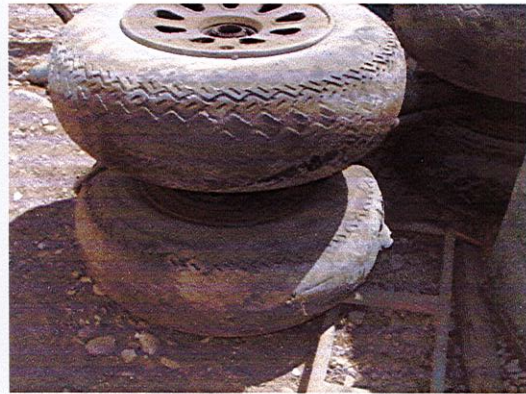
Right main L/G found 50 meters away from the wreckage and partially destroyed.

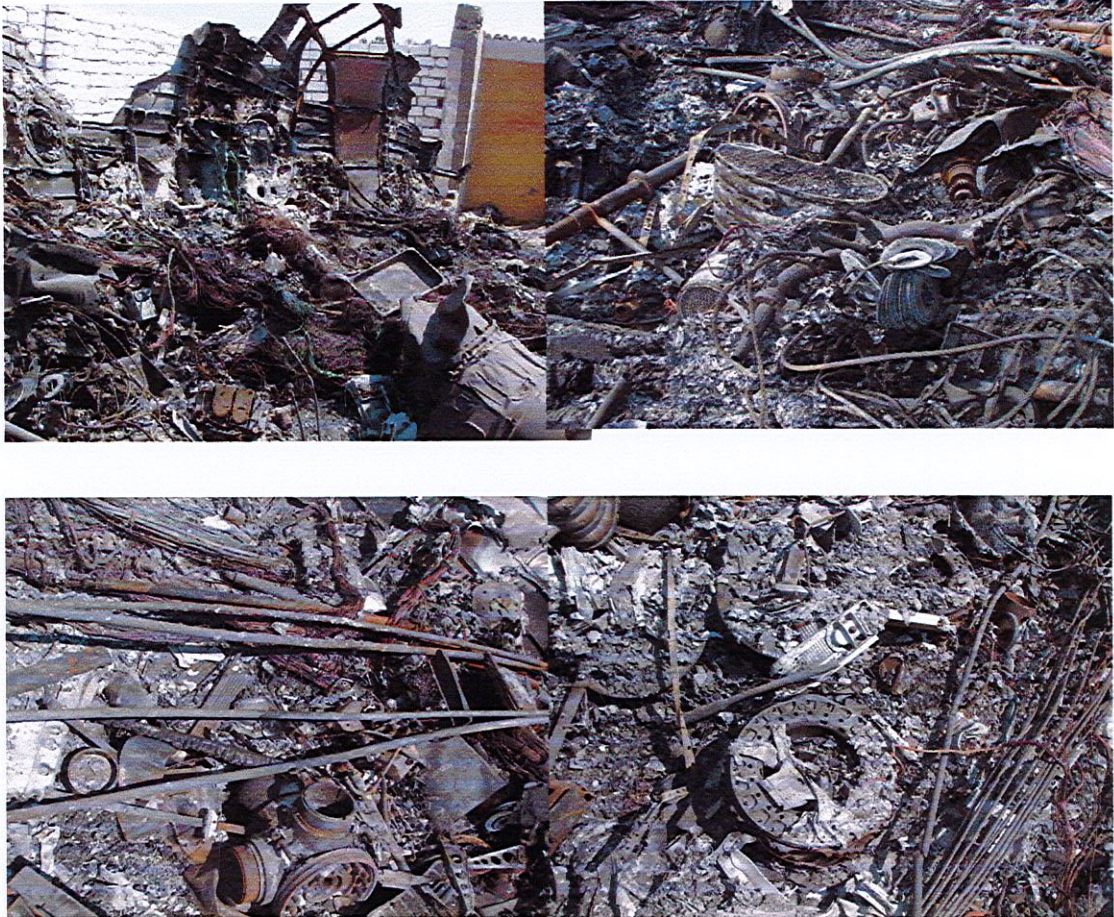
1.12.3.8 CARGO COMPARTMENT

- Was found in the middle of the main wreckage and the following items were found:
 - Three brake discs (KT-77);
 - Two propeller hubs;
 - Two heat exchangers;
 - One wheel assembly (KT-77).
- other than the traces of wood fire.

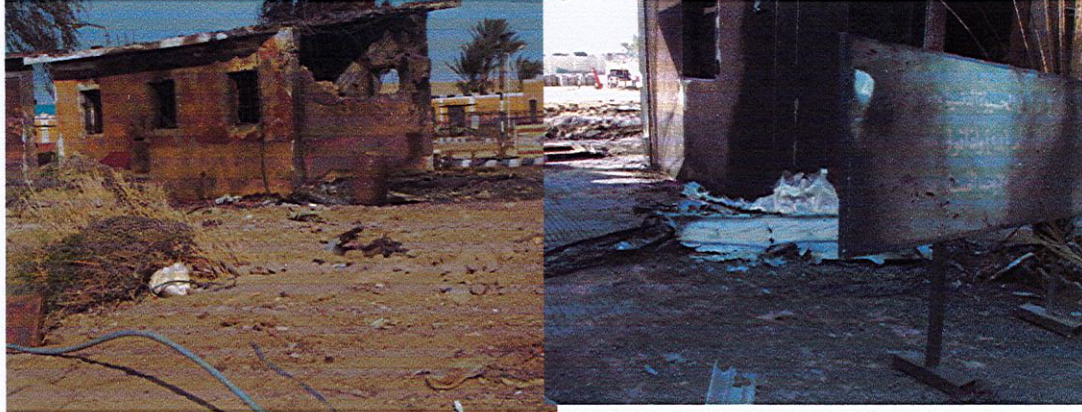
- **First Unit (water buildings)**
 - Have three buildings, separated and close to each other, built with concrete; walls and a ceiling, one floor. The first building has dimensions of: 9.5 x 4.5 and is divided into two partitions. Destruction was found in the south wall from in its upper part till its middle and a part from the ceiling. Also there are carbon contaminations on its walls and the doors and windows and the fire burnt all its components.
 - The second building is 2 meters away from the first from the north side. It has dimensions of 14.5 m x 4.5 m and is divided into two partitions. There are cracks in the building and heavy contaminations

on its walls. The doors and windows were affected with the fire. The fire burned all its components.

- The third building is next to the second one from the north side and divided into 5 partitions. There are carbon contaminations on its walls from outside.
- The trees in front of the building were affected by the fire.

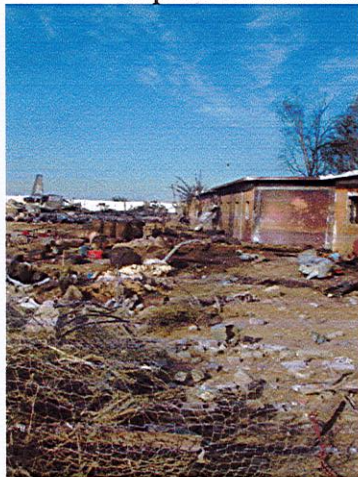
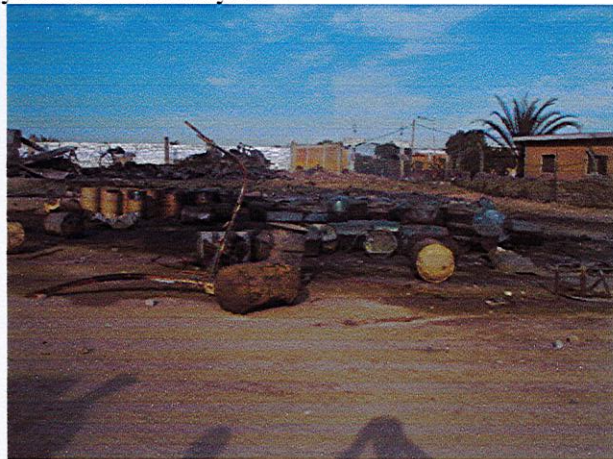
- **Second Unit (fuel buildings)**

- Total destruction was detected for the building that was in the aircraft's path.
- Destruction in a part of the fence on the Tiba-Luxor road and where the aircraft wreckage settled.
- Several vehicle engine oil barrels were burned.
- A part of 3 meters long of the airport fence which separates the airport from the military zone was destroyed.

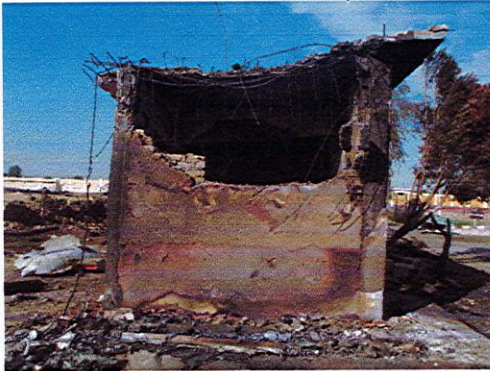
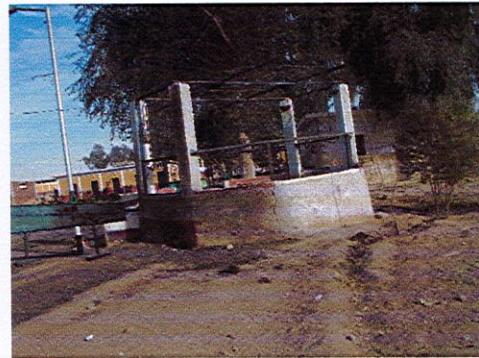
- The crash of the right wing into the building belonging to the military base caused fire in all the aircraft except the tail section.

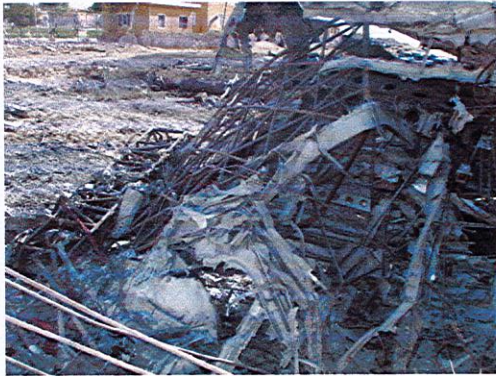
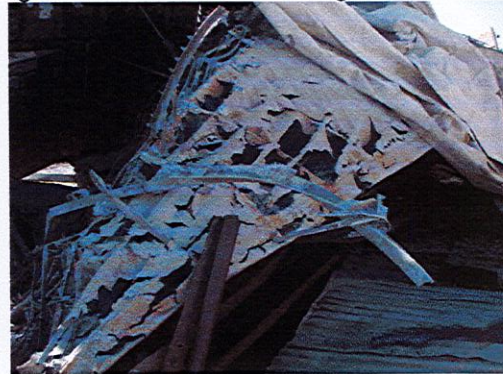
- The fire caused the metal to melt and also parts of the engine and wings.
- Fire was caused due to the crash and the rotation of the engines and the existence of 14 tones of fuel in addition of 2 tons existing in the tanks before refueling.

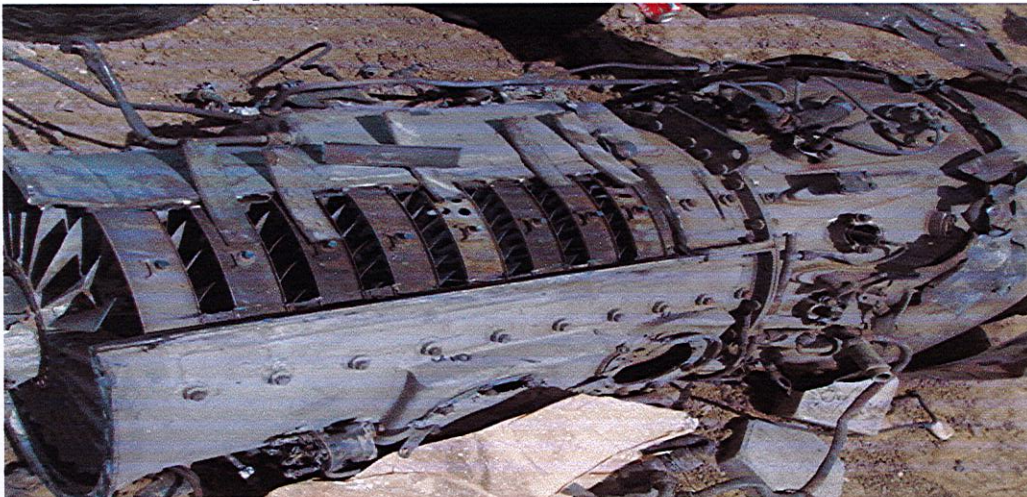
- The inspection showed that the compressor blade had no damage.

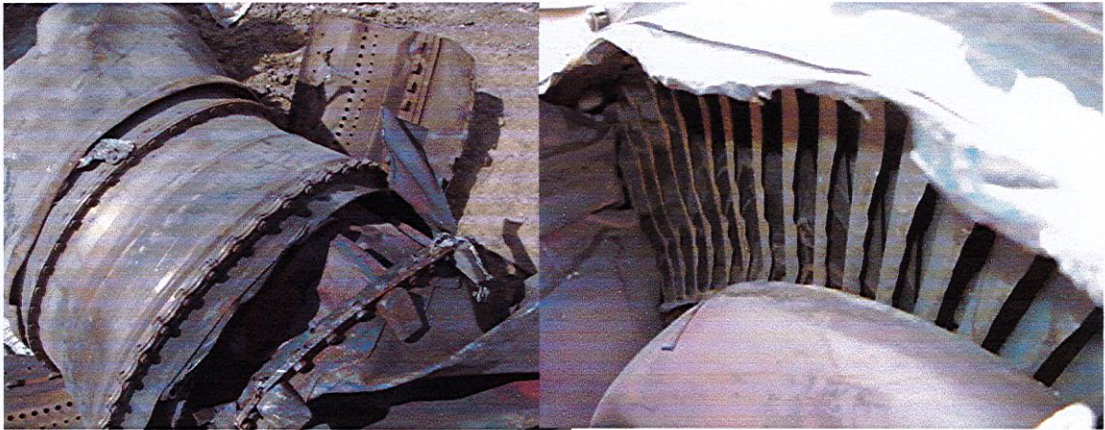
- The inspection of the turbine blades through the nozzle case showed that the last turbine stage is damaged due to the collision.

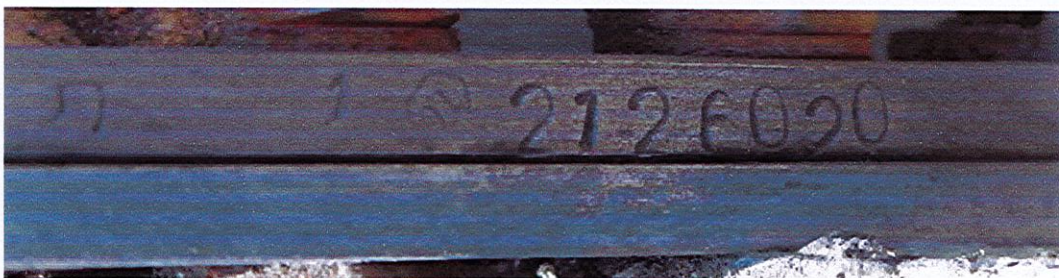
- But there are numbers that were reprinted.

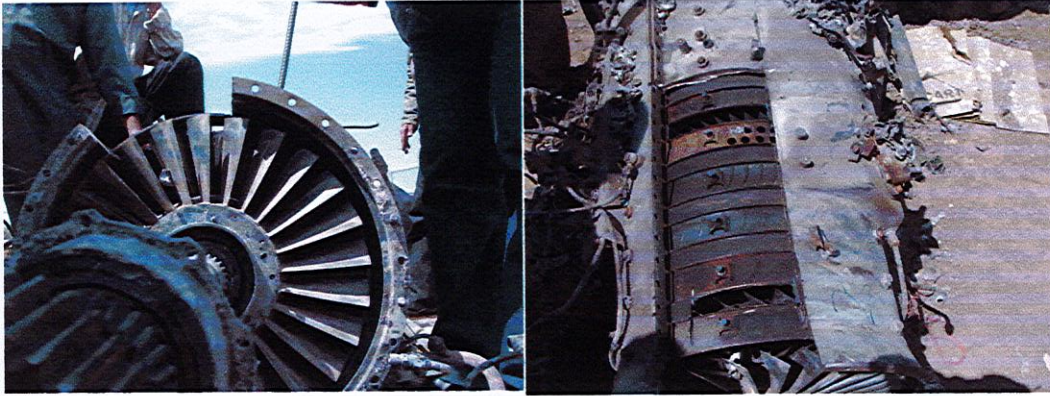
- The blades were sound but starting from the fifth stage there was a layer of soot which indicates that the engine was in surge.

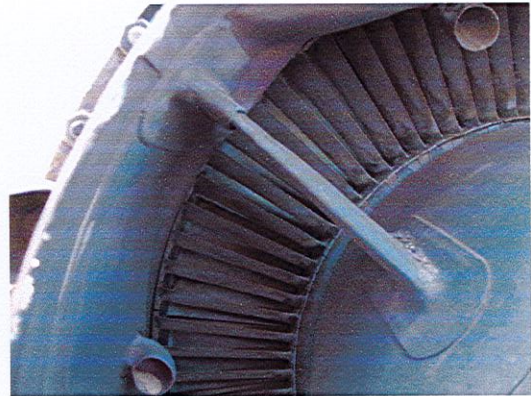
- The inspection of the turbine blades through the nozzle case shows no damage in the last stage of the turbine.

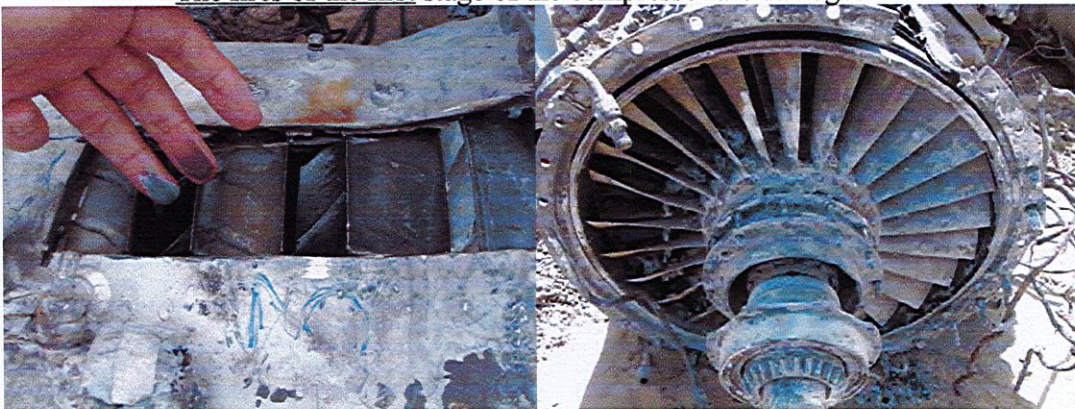
- The fires of the first stage of the compressor are damaged.

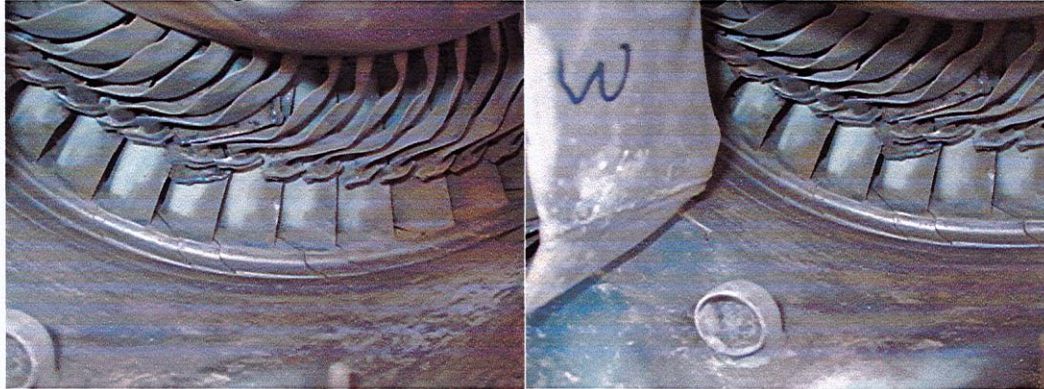
- The last stage of the turbine blades are substantially deformed and bent in the direction opposite to the rotation.
- The nature of the deformation shows that the engine was running during the accident.

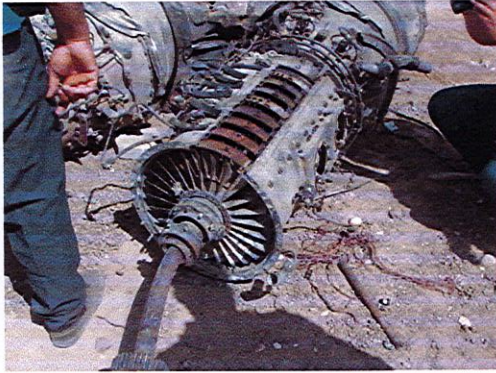
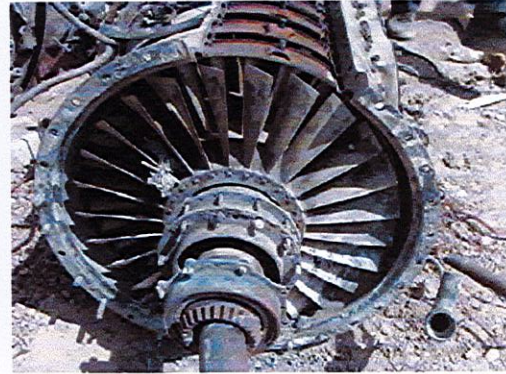
- None clear number.
- 2545065
- The compressor blades are in normal state and fixed.
- There was a layer of soot on the blades of the second stage which indicates that the engine was not running during the accident.

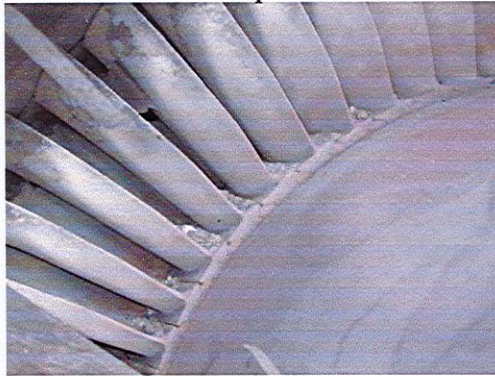
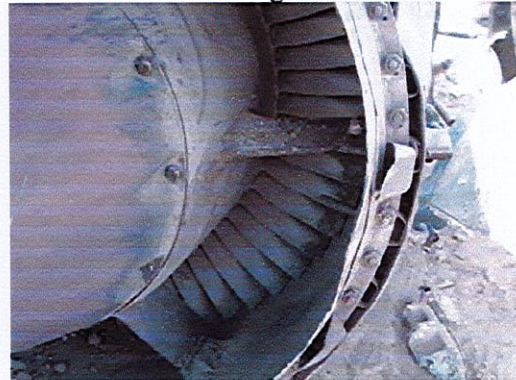
- The inspection of the turbine blades showed no damage.

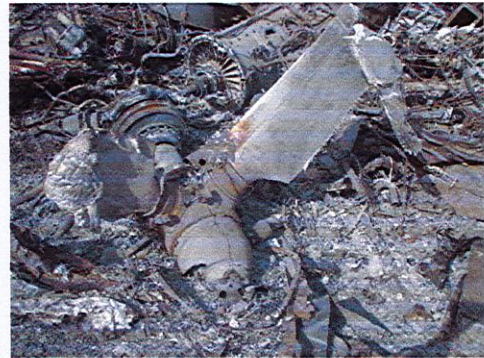
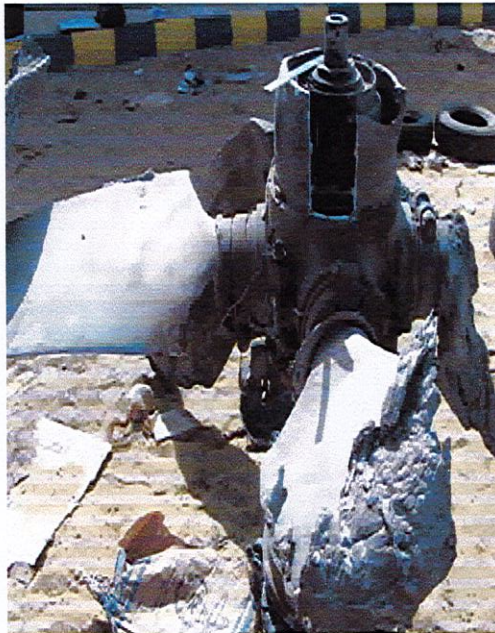
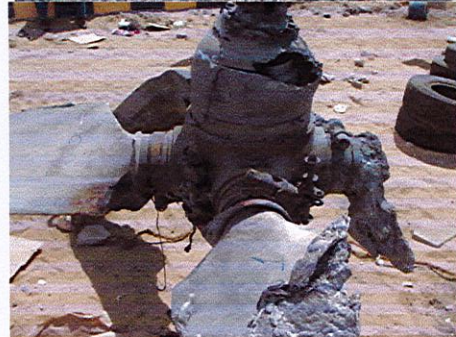
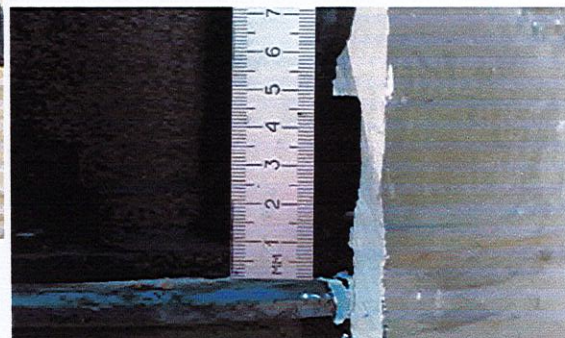
Propeller No.1

- The propeller was in the highest temperature area which caused the blades to melt and Blades, the cylinder had a hole with irregular shape 15 to 17 squared centimeters in the radial part which caused the cylinder case to melt and the butts to separate leaving the propeller in a "rotating freely" state and because of the failures in the cylinder, there was no oil in it.
- And by the assembly of the propeller, it was clear that:
 - The piston stroke is 49 mm.
 - The slotted protrusion of the mechanic stop is 31 mm.
- And it was clear that the propeller was in the operation mode.

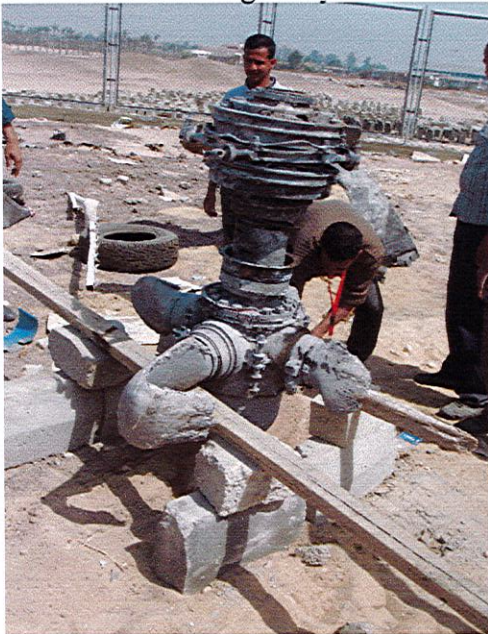
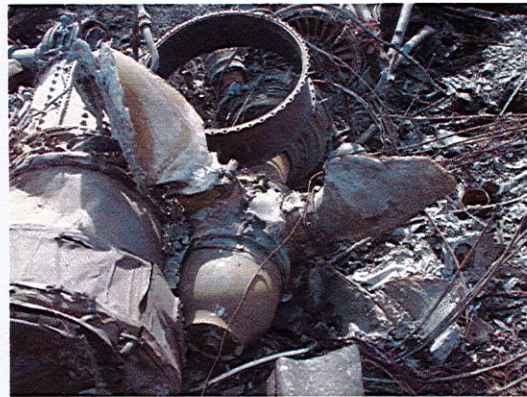
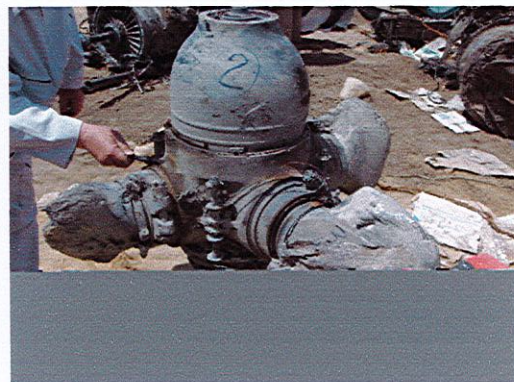
Propeller No.2

- The propeller was in the fire area, in a melting state and the cylinder had a crack along the perimeter; 50 mm length and 2mm width in the lower part. Also one rod was ripped off and the blades butts were rotating freely.

- And because of the failures in the cylinder; there was no oil in it.
- Three butts of the blades were in feathering position and lost all sealing and dust caps, rubber washers, and coarse pitch hollow.

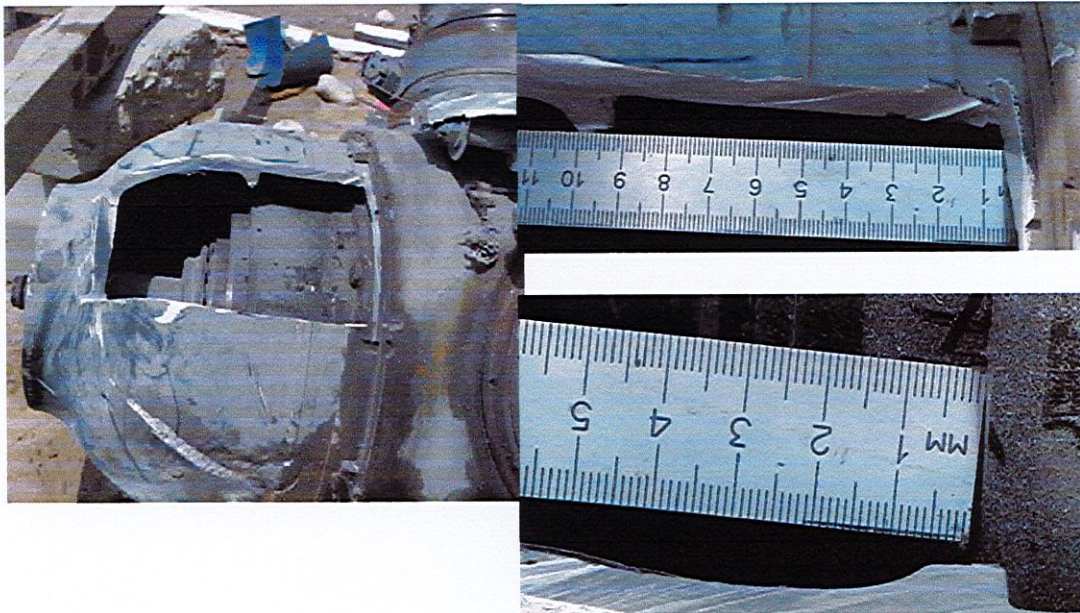
- And by the assembly of the propeller, it was clear that:
 - The piston stroke is 93 mm.
 - The slotted protrusion of the mechanic stop is 16 mm.
- And it was clear that the propeller was in the non-operating mode.

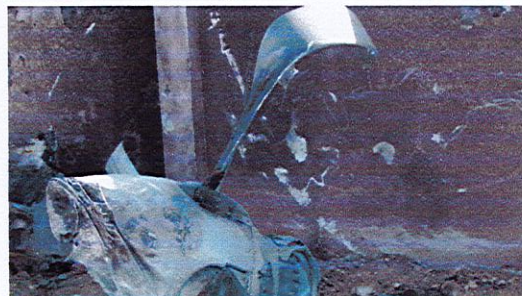
- The propeller was in the lower temperature area and all the blades had mechanical and thermal deformation along the blades and also the connecting rods were ripped off and the blades were rotating freely.

The cylinder had no external failure. The main lock and the insulator in relief fitting

were missing. There were 3600 cubic centimeters of oil in the cylinder.

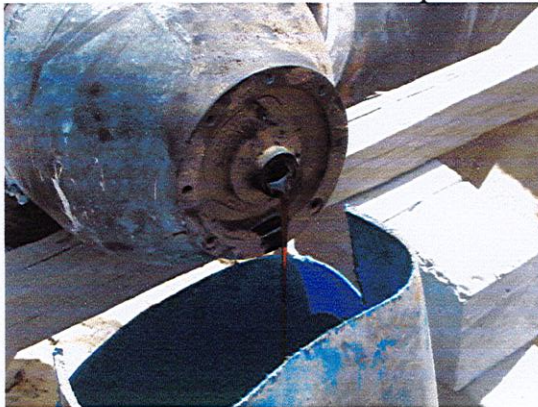
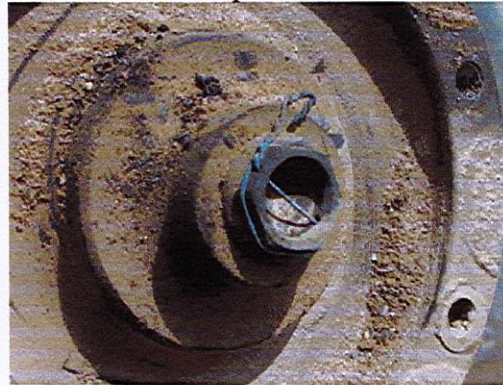
- And by the assembly of the propeller, it was clear that:
 - The piston stroke is 25 mm.
 - The slotted protrusion of the mechanic stop is 28 mm.

- And it was clear that the propeller was in the operation mode.

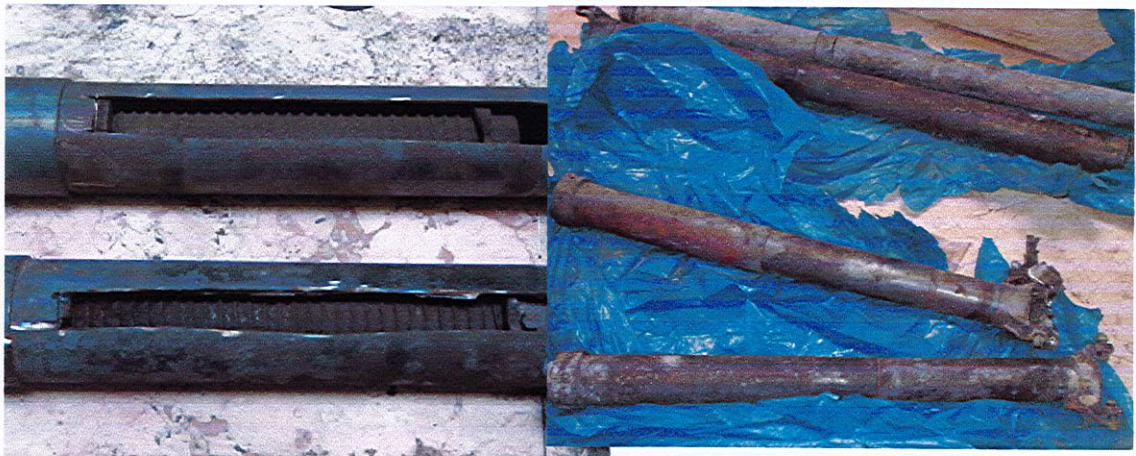
1.16.3 Tests Performed on FLAPS JACKSCREW

- The main columns of the flaps jackscrew were tested by measuring the distance of the flaps track (left and right) and comparing it by the flap track design and assembly tolerances and it was found that the flaps were on the 25 degrees position.

According to the An-12 FCOM in the actual conditions the takeoff should have been performed with Flaps 15. As the analysis showed, at the time of the impact the flaps were set at 25
