**AIR ACCIDENT INVESTIGATION & AVIATION SAFETY BOARD**

**ACCIDENT REPORT  
A/C SX-SKY  
AT HERAKLION AIRPORT  
“N. KAZANTZAKIS”  
12<sup>TH</sup> FEBRUARY 2009

Report no 08 / 2009**

**Accident of the a/c SX-SKY of Sky Express  
at the Heraklion Airport “N. Kazantzakis” on 12<sup>th</sup> February 2010**

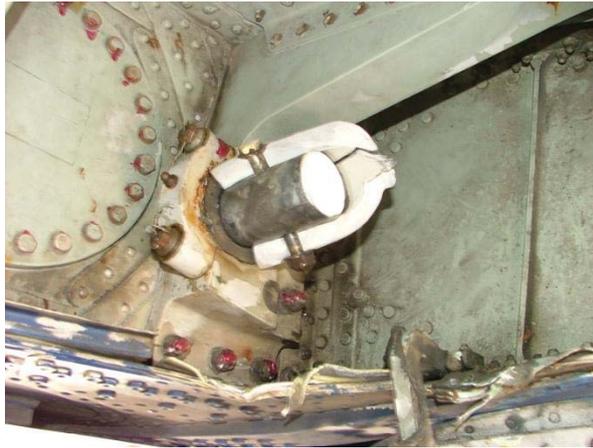
**Photo 1**

The cylinder located at the upper end of the landing gear, which is fitted to spigots, was fractured at its front part, in the region of the fastener holes, as well as in Region A (Photos 1 & 2 and Figure 1/Appendix A ).

The strut of the main landing gear was damaged. The MLG side mounting bracket was bent backwards, damaging its base fittings on the frame. The tire was burst and suffered severe deformation.

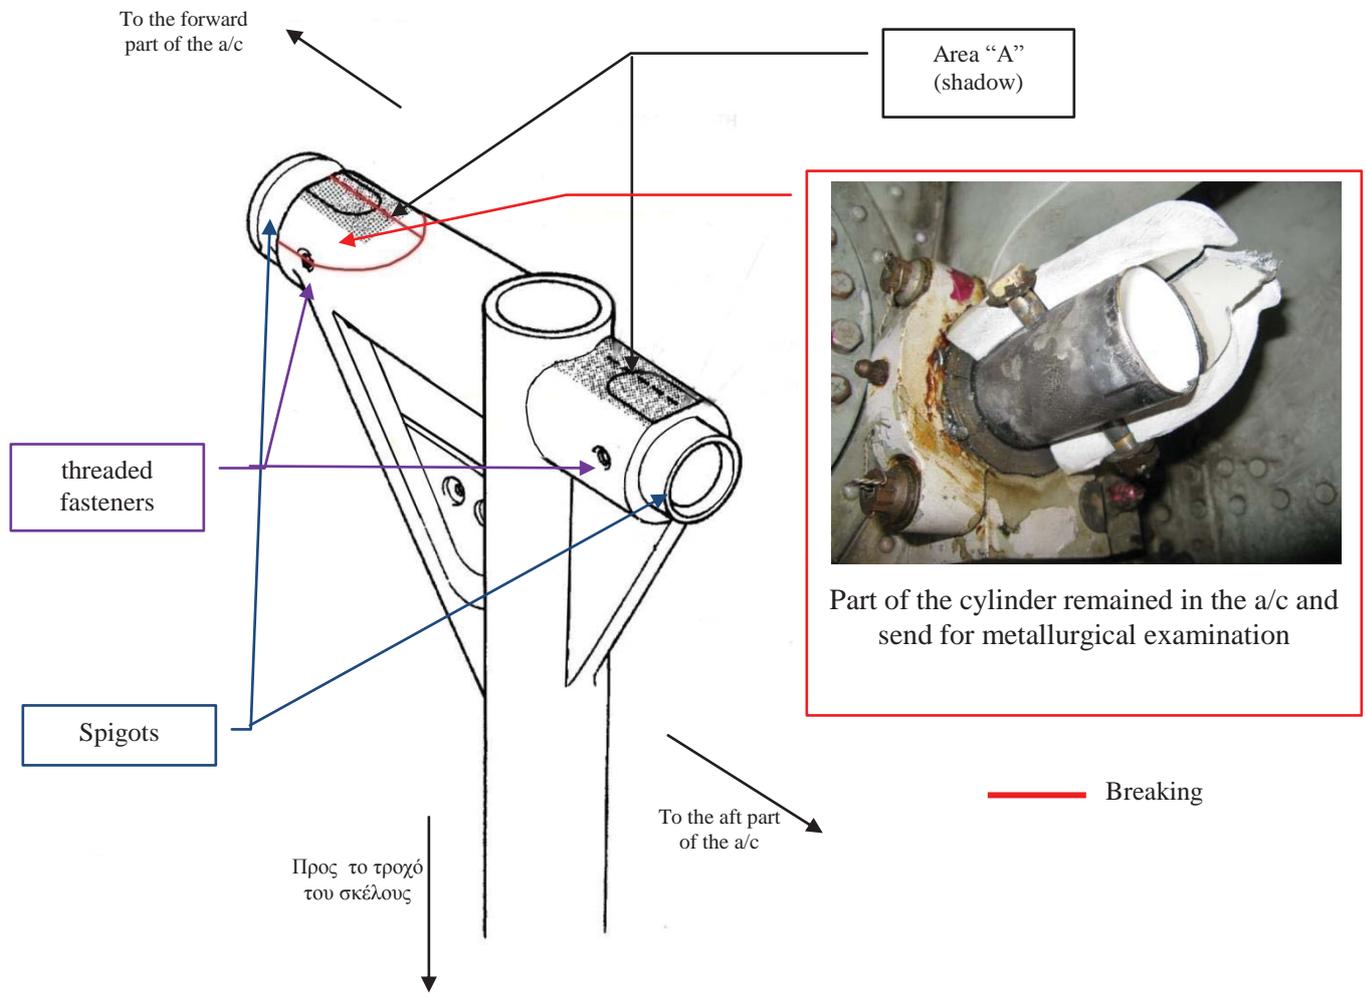
Figure 1

The cylinder had been reduced in thickness in the region of area "A", Figure 1/Appendix A, in order that the anticipated fatigue cracking resulting from the cyclic loading would occur at this location.

Due to the fact that the regular checks after the removal of the landing gears from the aircraft had revealed cases of cracks in the above-mentioned area “A”, the manufacturer had issued Service Bulletin (SB) 32-A-JA851226 for Non Destructive Test (NDT) and visual inspection for traces of cracks in the area “A”. Next, the UK Civil Aviation Authority issued an Airworthiness Directive (AD G-003-01-86), adopting the above mentioned SB.

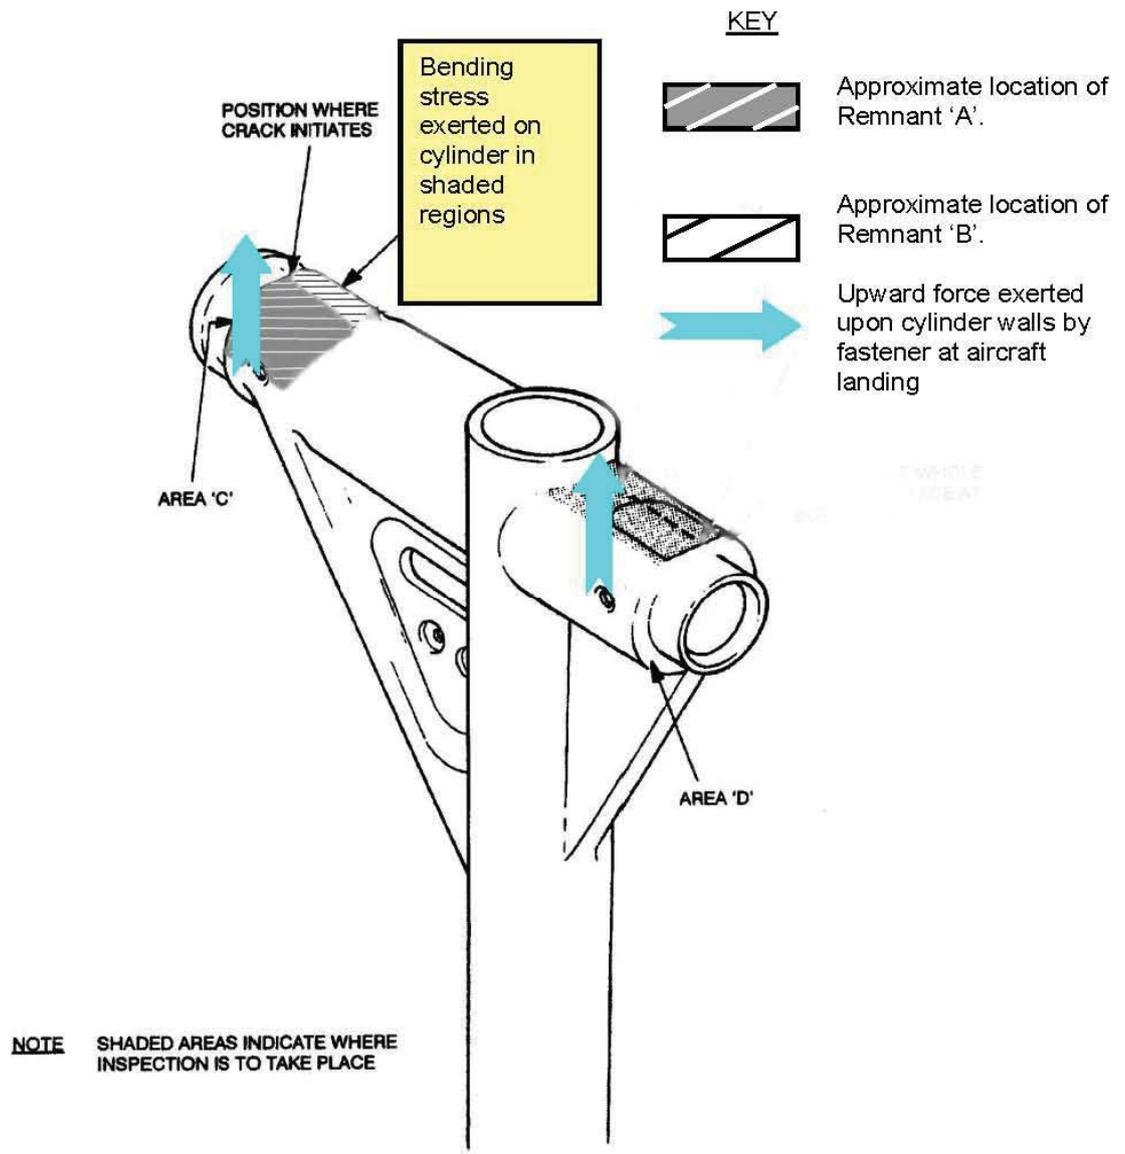
4.1.1 The two remnants of the undercarriage cylinder were received by MIG (Reference A) designated Remnants 'A' and 'B', Figure 2. Remnant 'A' was still attached to the spigot, Figure 3 and Figure 4, whilst Remnant 'B' was loose, Figure 5 and Figure 6. There were two main fracture surfaces present upon Remnant 'A' designated 'A1' and 'A2', Figure 3 and Figure 4 respectively, and similarly on Remnant 'B' designated 'B2' and 'B1', Figure 5 and Figure 6 respectively. All the fracture surfaces were subjected to a visual examination using a binocular microscope.

Figure 2: Showing the: undercarriage cylinder; location of Remnants 'A' and 'B'; the loading imposed on aircraft landing.

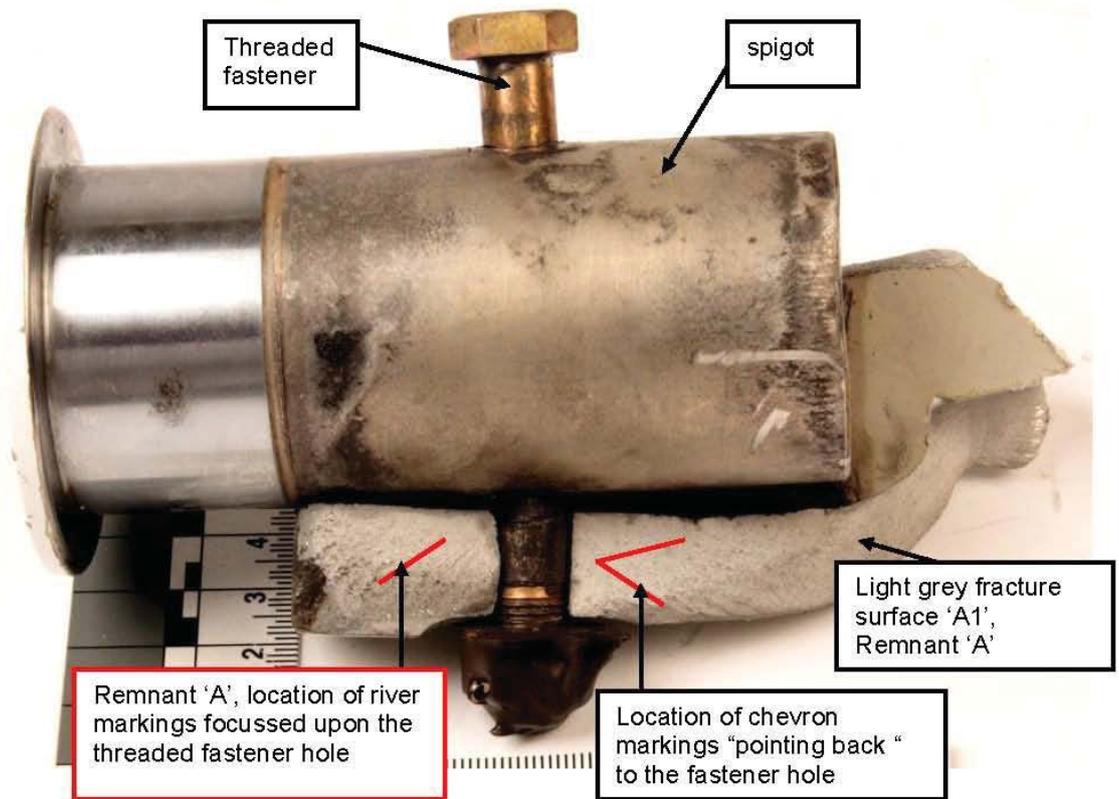
place at this location. These fracture surfaces were more heavily corroded than “A1” and “B1” (Appendix C, Figures 3 & 6), and were likely to have been formed prior to the two cracks that had formed “A1” and “B1”. Therefore, fracture surfaces “A2” and “B2” formed the first crack in the failure sequence. This first crack initiated and propagated in Region “A” (Appendix C, Figure 1), as would be anticipated since this was the region where the NDT was carried out. The first crack propagated from the inboard edge of the cylinder, increasing the loading upon the cylinder material surrounding the threaded fasteners, sites of stress concentration. The second and third cracks then initiated at these sites of stress concentration and propagated within the cylinder to form fracture surfaces “A1” and “B1”. In support of this the chevron markings on fracture surfaces “A1” and “B1” pointed back to the regions of the threaded fasteners.

4.1.2 Fracture surface 'A1' was rough and matt light grey in appearance with chevron and river markings present "pointing back" to the fastener hole where the threaded fastener had been fitted, Figure 3, Figure 7 and Figure 8. The light grey appearance was consistent with extensive post failure corrosion being absent.

Figure 3: Showing the as received spigot and remnant 'A' of the undercarriage cylinder.

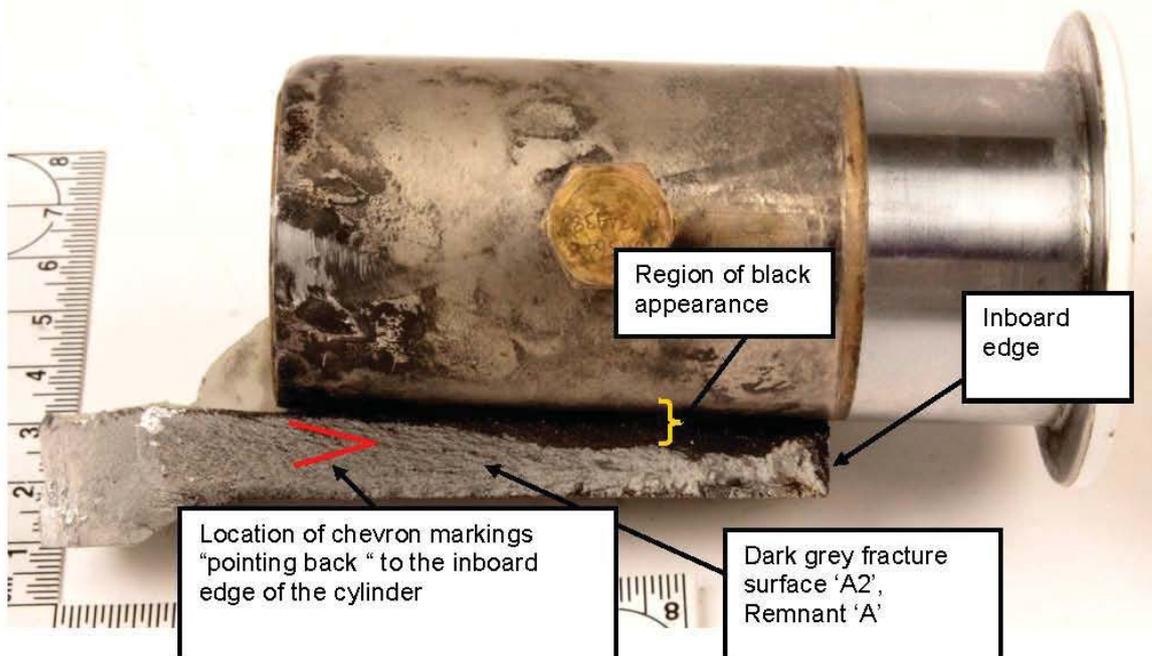
The chevron markings on fracture surfaces "A2" and "B2" 'pointed back' to the inboard edge of the cylinder (Appendix C / Figures 4 & 5), indicating that initiation had taken

4.1.3 Fracture surface 'A2' was also rough and matt dark grey in appearance with the exception of an area that was black in appearance where the fracture surface had been adjacent to the spigot, Figure 4, Figure 9 and Figure 10. The remainder of the surface was dark grey in appearance consistent with post failure corrosion having taken place. The chevron markings were again present "pointing back" to the inboard edge of the cylinder, Figure 1 and Figure 9.

Figure 4: Showing the as received spigot and remnant 'A' of the undercarriage cylinder.

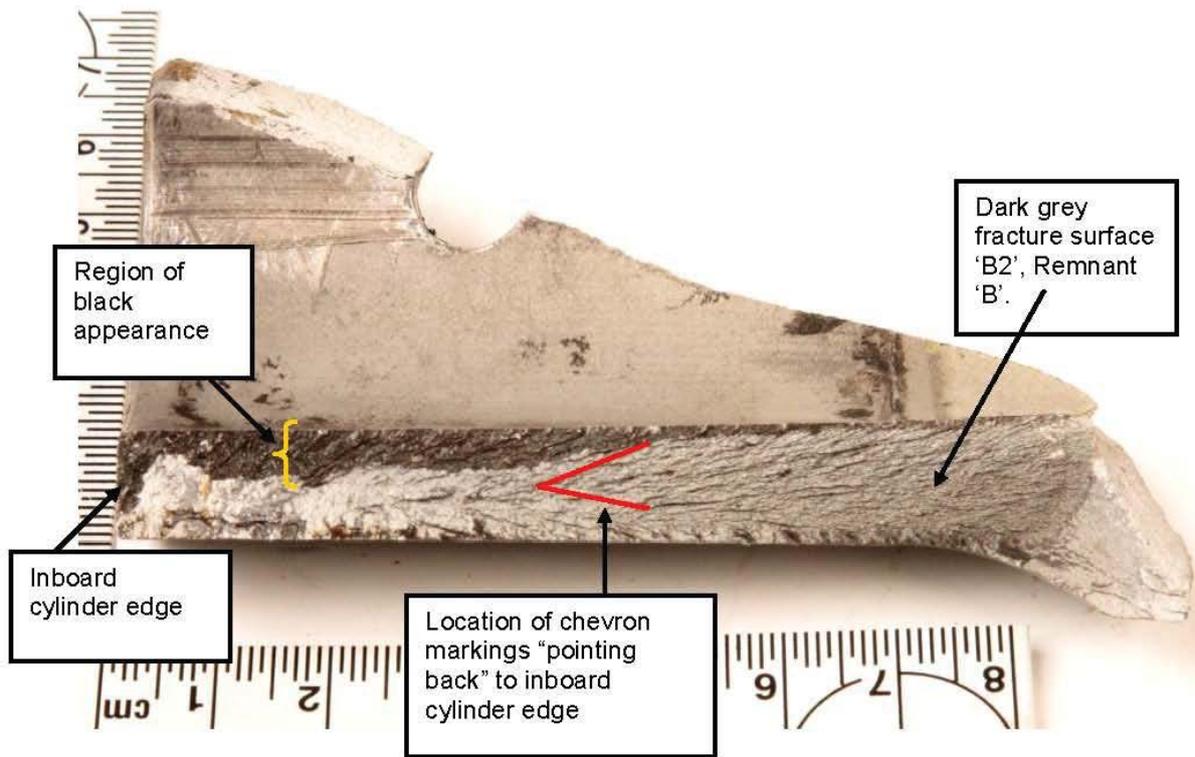
Figure 5: Showing the as received remnant 'B' of the undercarriage cylinder and fracture surface 'B2'.

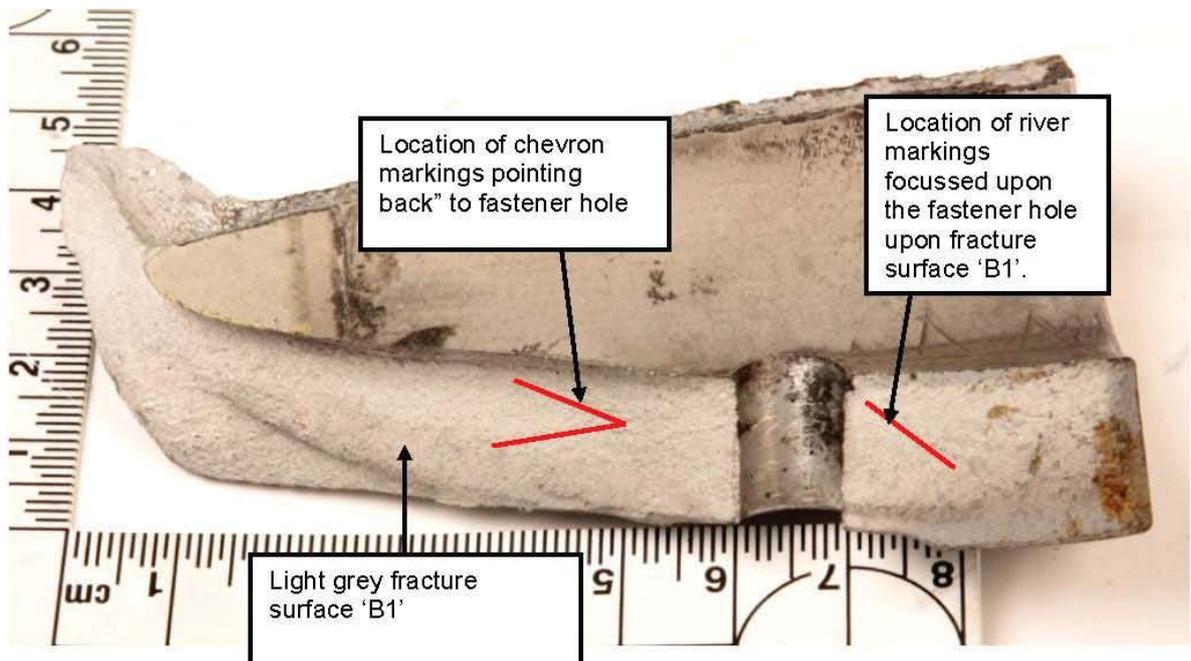
Figure 6: Showing the as received remnant 'B' of the undercarriage cylinder and fracture surface 'B1'.

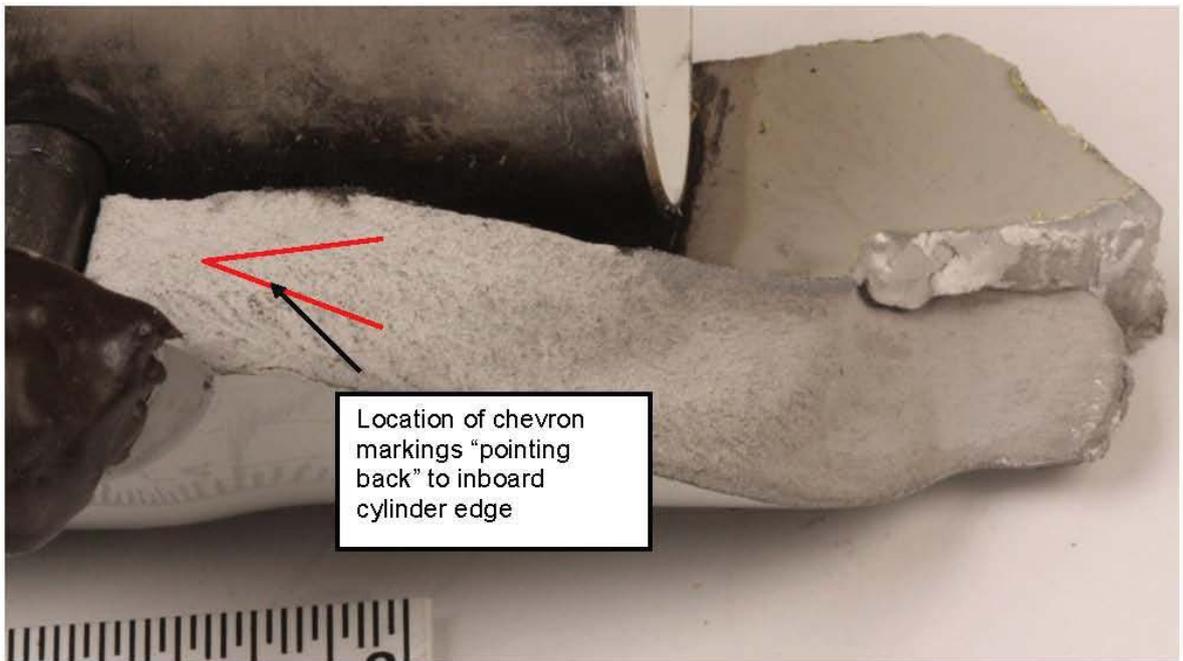
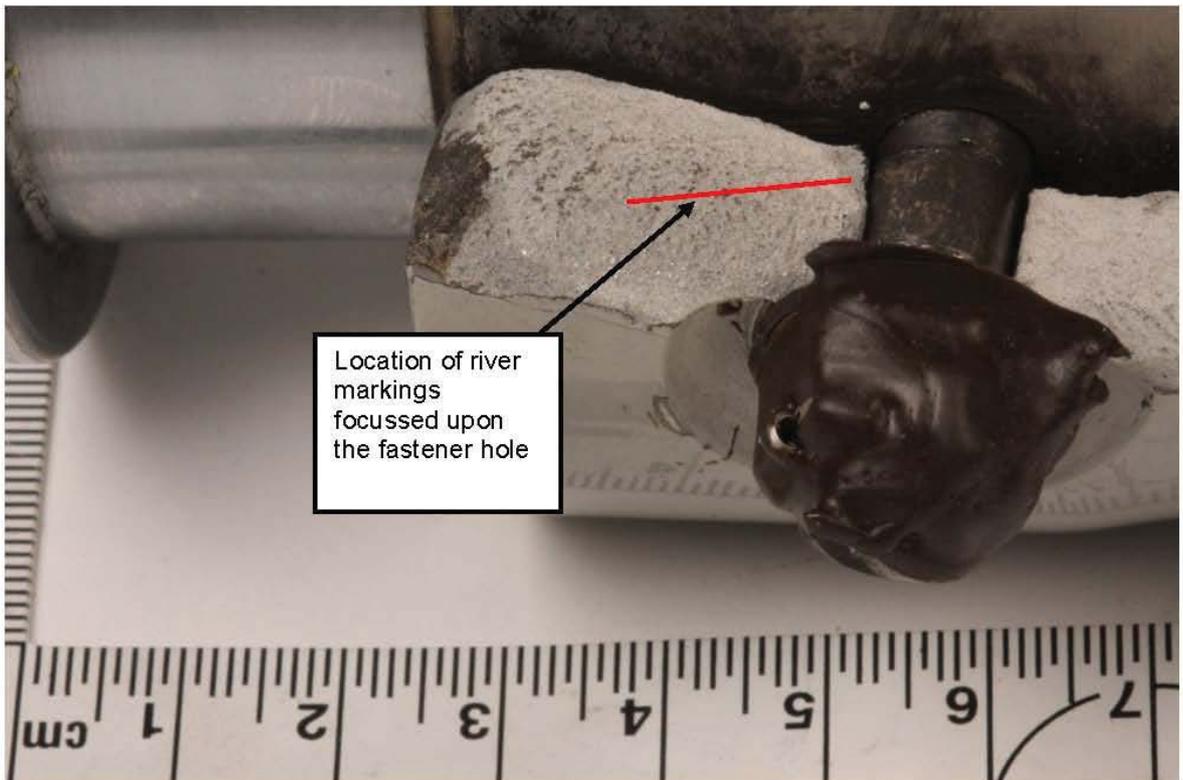
Figure 7: Showing fracture surface 'A1' in detail.

Figure 8: Showing the details of fracture surface 'A1'.

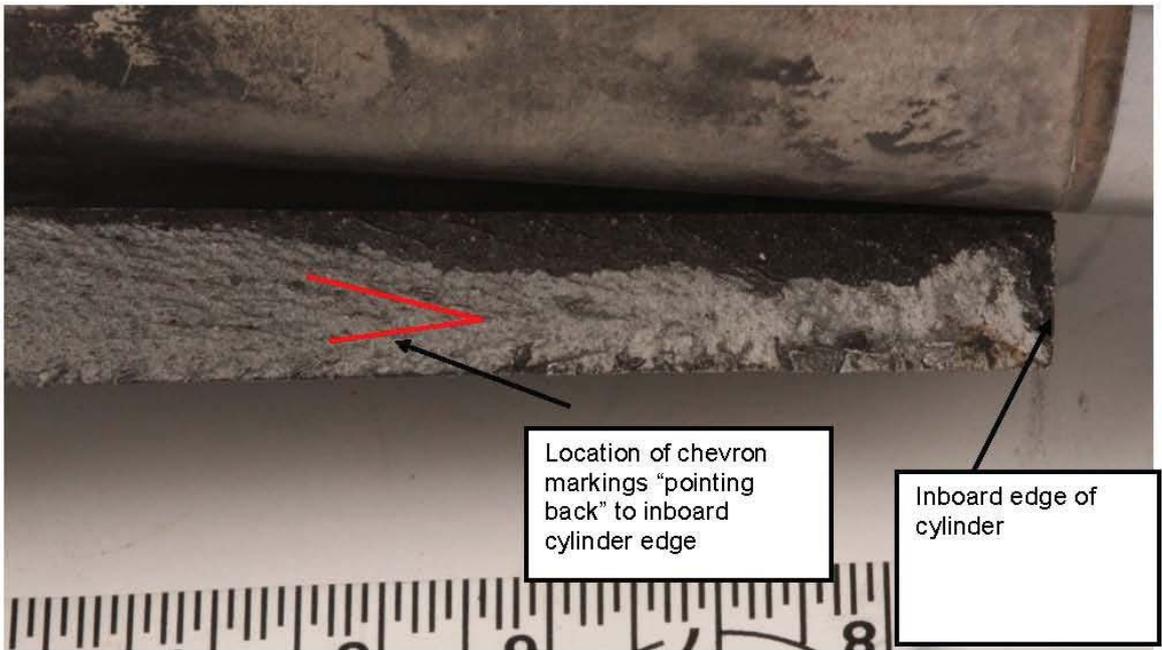
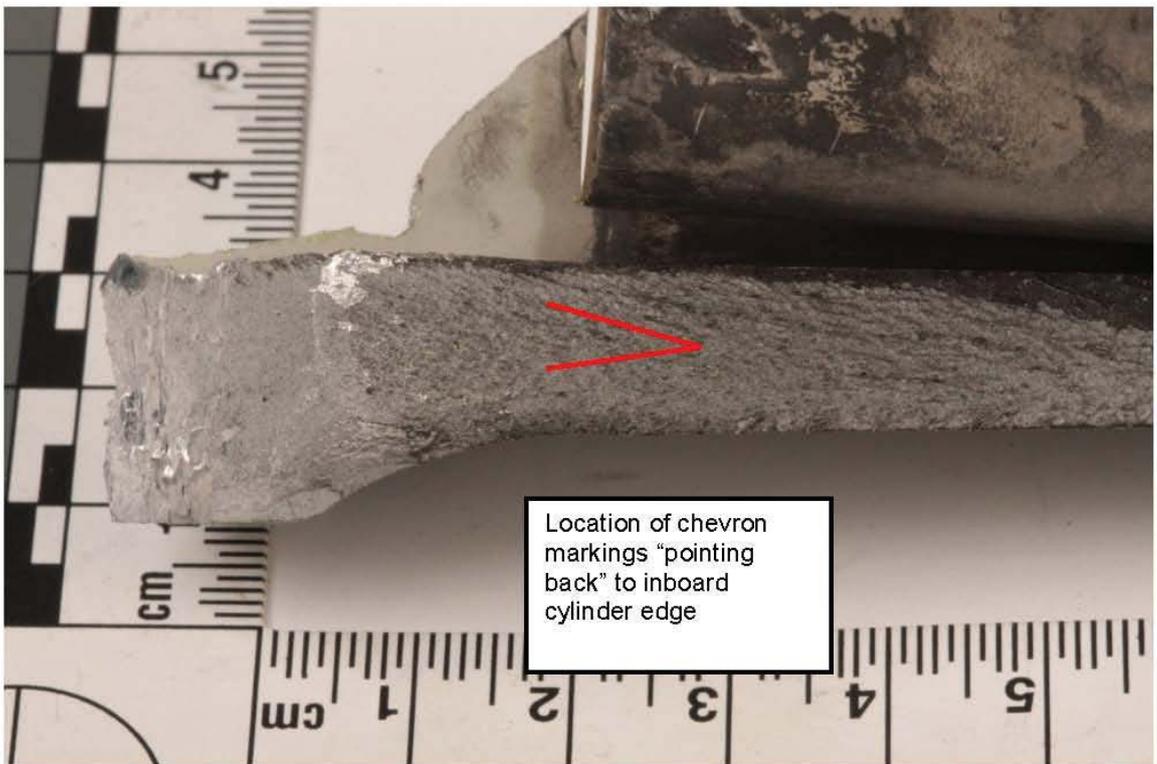
Figure 9: Showing the detail of fracture surface 'A2'.

Figure 10: Showing the detail of fracture surface 'A2'.

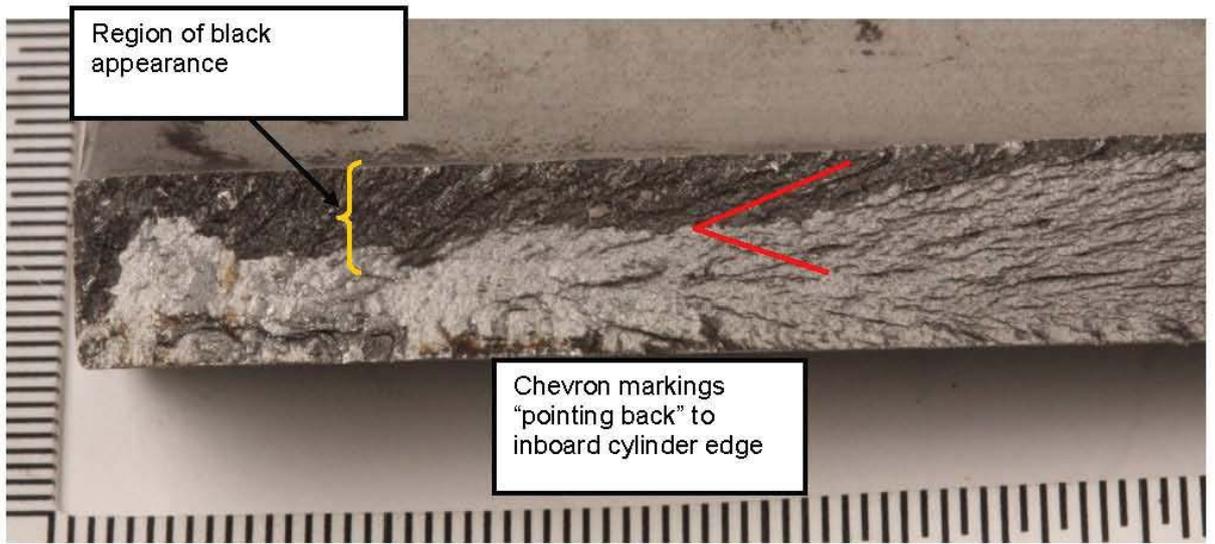
4.1.4 Fracture surface 'B2' had mated with 'A2' and had similar features to those revealed on 'A2' as would be anticipated, Figure 11.

Figure 11: Showing the detail of fracture surface 'B2'.

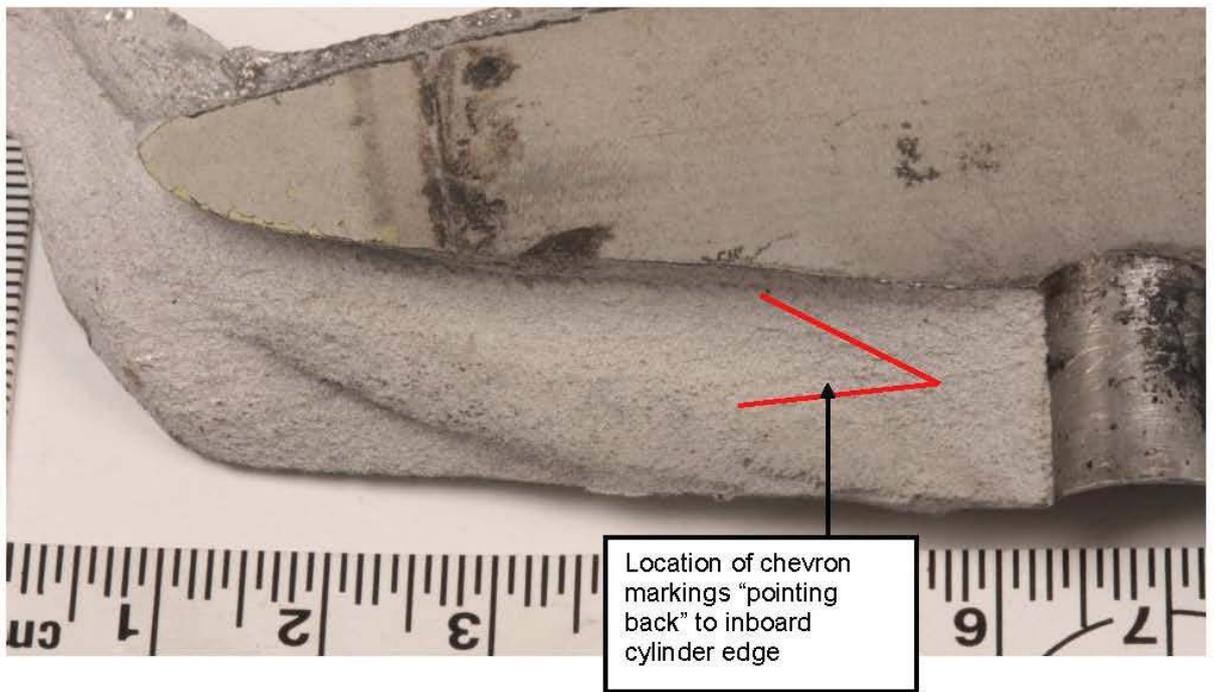
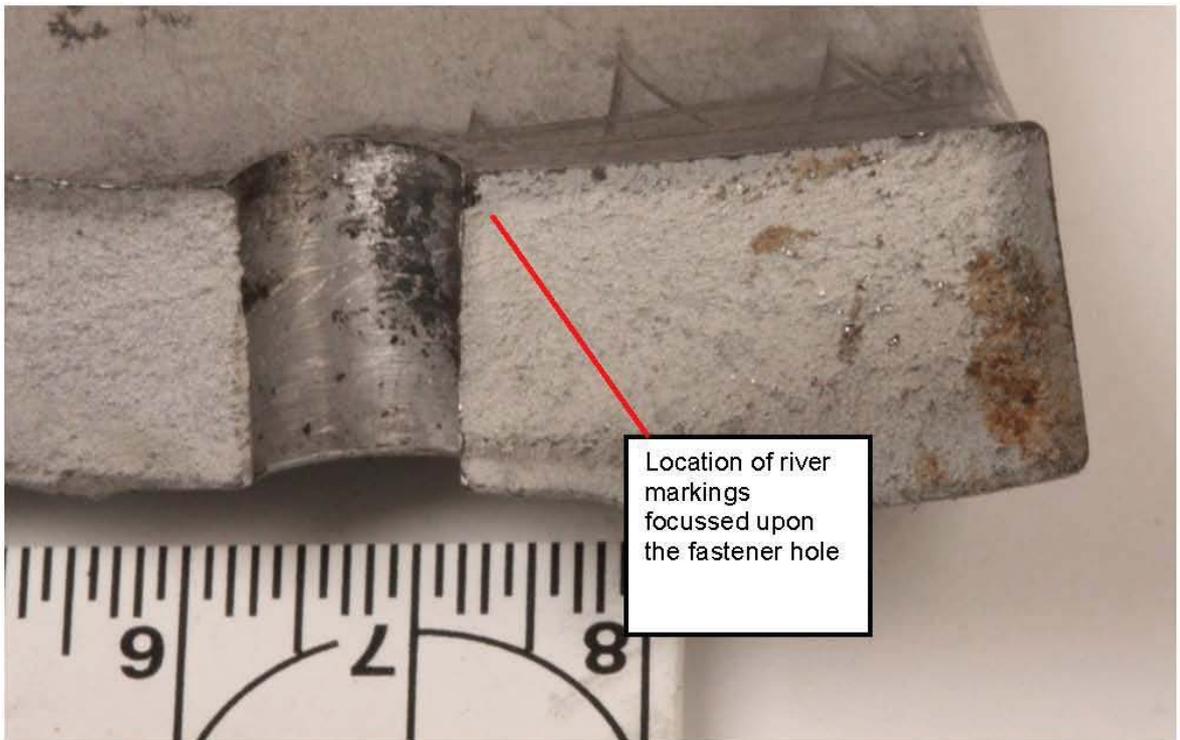
4.1.5 Fracture surface 'B1' was similar in appearance to 'A1', rough and matt light grey in appearance with chevron and river markings present "pointing back" to the fastener hole where the threaded fastener had been fitted, Figure 12 and Figure 13.

Figure 12: Showing the detail of fracture surface 'B1'.

Figure 13: Showing the detail of fracture surface 'B1'.

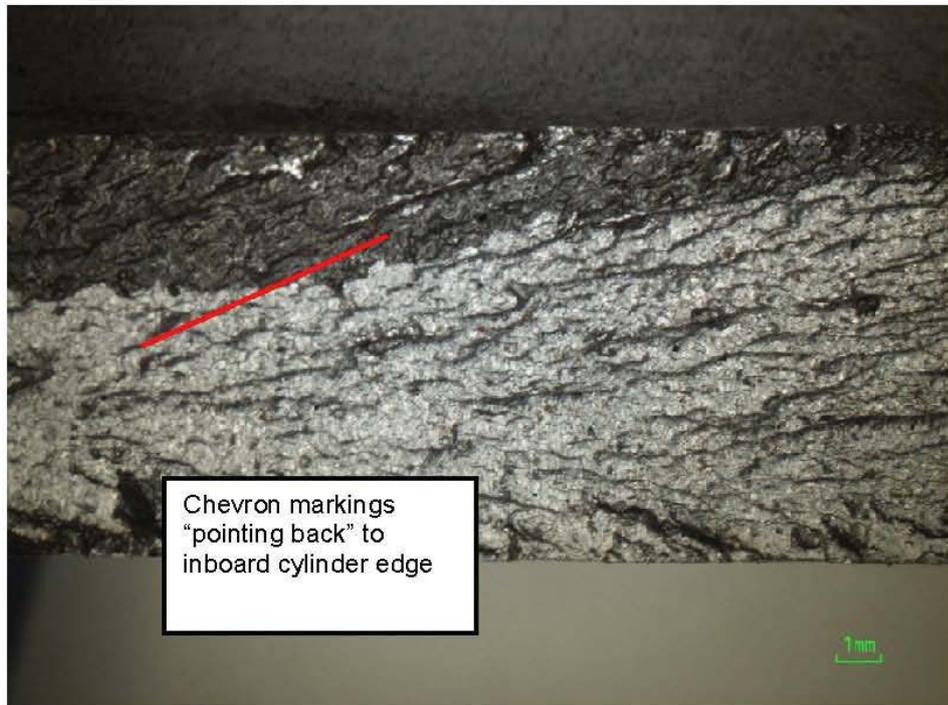
4.1.6 The chevron markings present upon fracture surfaces 'A2' and 'B2' that had mated together were examined in greater detail revealing the markings traversed the region that was black in appearance, Figure 14.

Figure 14: Showing the markings present upon fracture surface 'B2'.

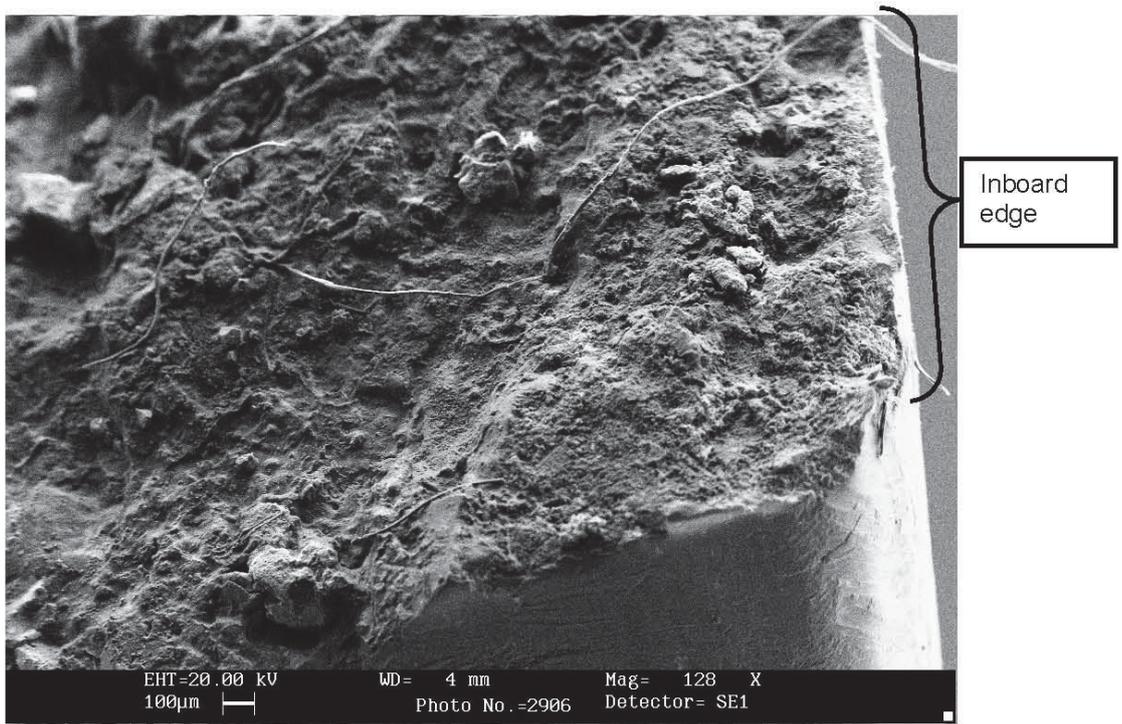
4.2.1 Fracture surface 'B2' was examined using Scanning Electron microscopy (SEM) in order to reveal any features of interest at the inboard edge of the surface and the region of black colouration. Features were revealed consistent with the fracture surface being corroded and smeared at the inboard edge, Figure 15.

Figure 15: Scanning electron micrograph showing the smeared and corroded condition of the initiation site of the failure at the inboard edge of fracture surface 'B2'.

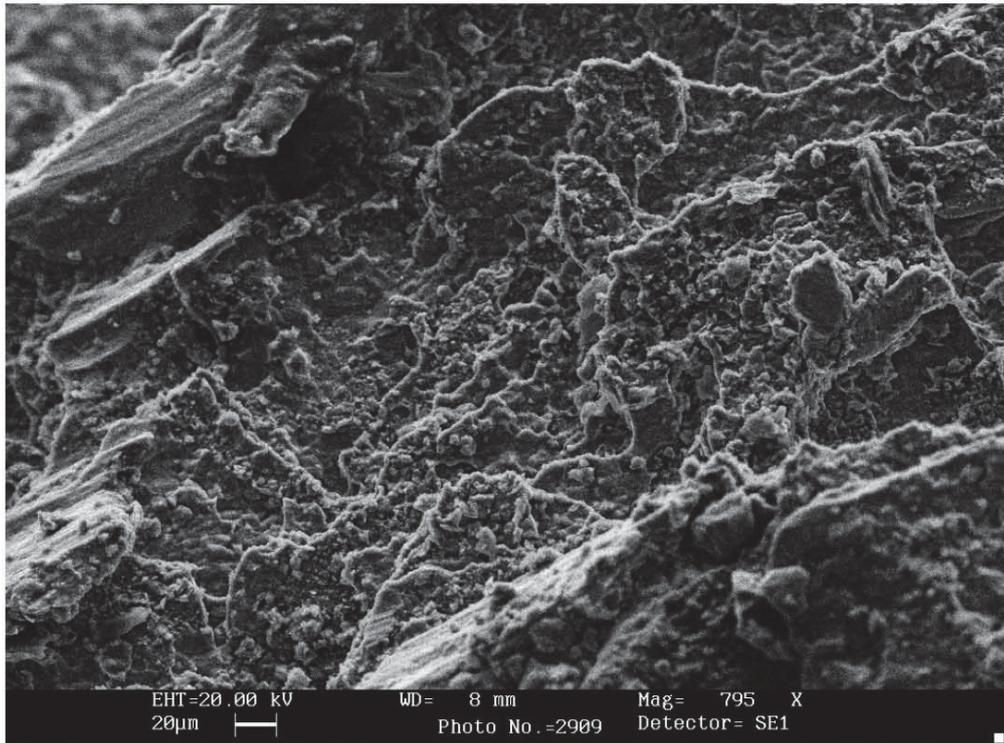
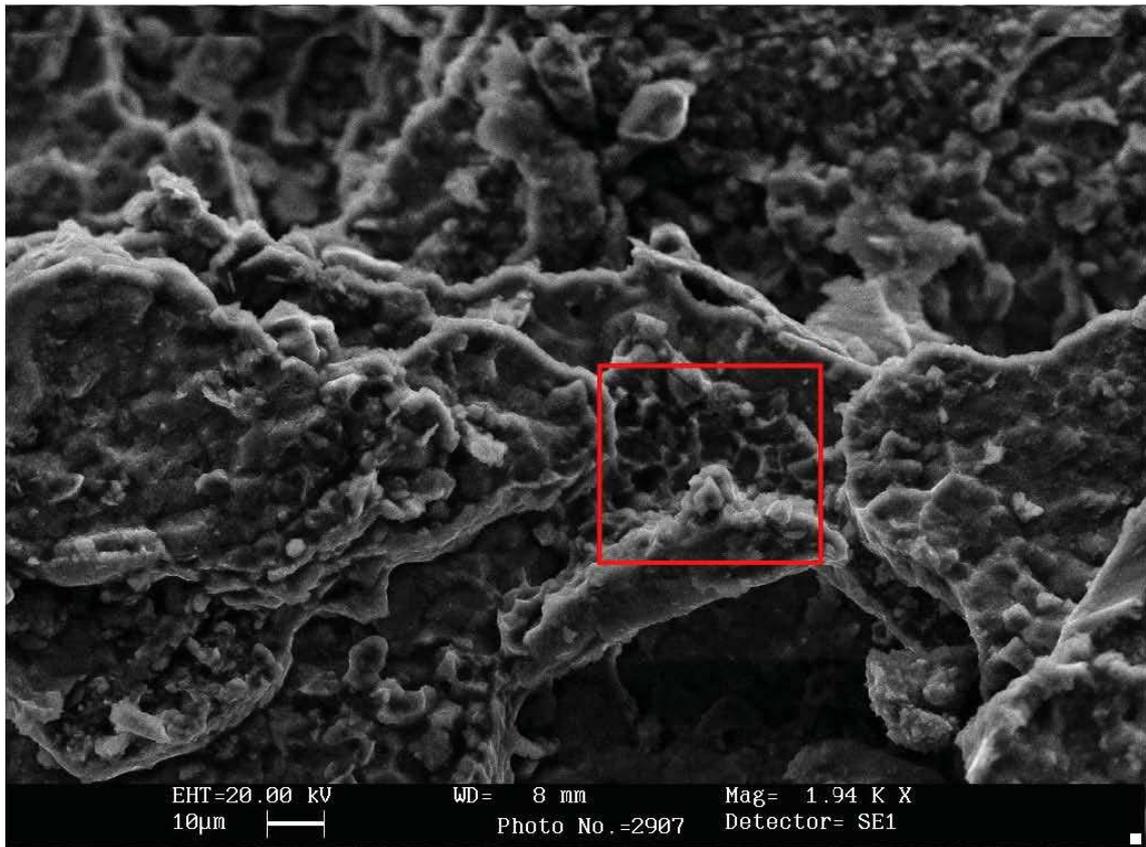
4.2.2 However within the region of black colouration and dark grey regions, features consistent with ductile microvoid coalescence and corrosion were revealed, Figure 16 and Figure 17. It is considered that the corrosion had occurred post failure. There was an absence of features associated with either fatigue or stress corrosion.

Figure 16: Scanning electron micrograph showing the features present upon the fracture surface consistent with post failure corrosion.

Figure 17: Scanning electron micrograph showing the features present upon the fracture surface consistent with ductile microvoid coalescence. Examples are shown within the red box.
