ATSB TRANSPORT SAFETY REPORT
Aviation Occurrence Investigation AO-2008-072
Final

Missing aircraft
Buckingham Bay, Northern Territory
16 October 2008
VH-WRT, GA-8 Airvan

Report No.	Publication date	No. of pages	ISBN
AO-2008-072	July 2010	50	978-1-74251-078-1

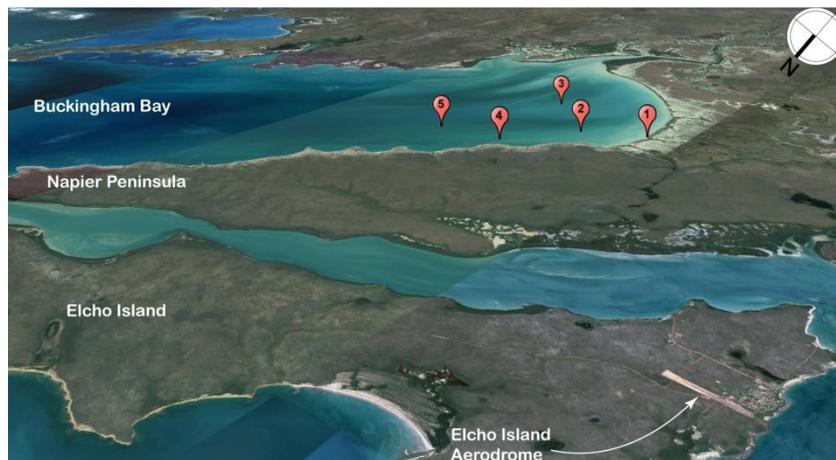
Figure 4: Location of wreckage items retrieved from Buckingham Bay

The following day, items of wreckage (cargo and a number of aircraft parts) were found floating or beached in the south-western part of Buckingham Bay (Figures 3 and 4).

1. Black jerry can and aircraft wheel.
2. Seat cushion.
3. Unspecified floating debris.
4. Small school whiteboards.
5. Eight jerry cans and other debris.

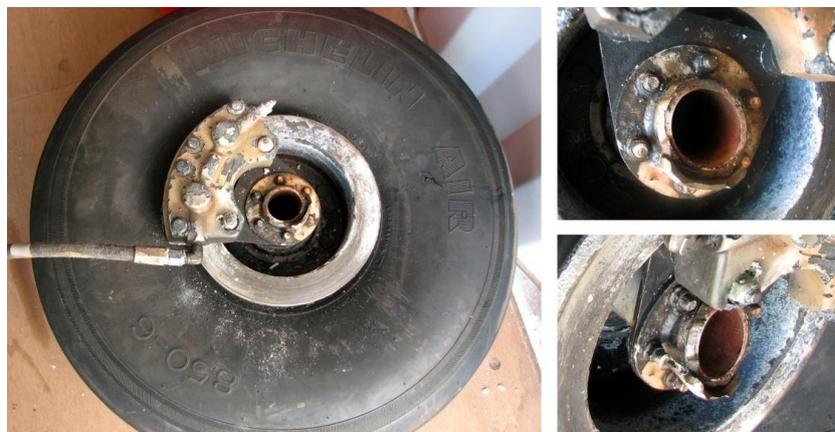
Figure 10: Left main wheel

A fracture of the left main landing gear wheel had occurred transversely through the welded transition between the stub axle and landing gear leg (Figure 10). The fracture surfaces were typical of a ductile shear mechanism and their form was consistent with failure occurring under bending overstress conditions. The nosewheel yoke had separated from the oleo at the bolted connection between the two components. Both the left main wheel and the nosewheel components showed significant levels of corrosion and associated metal-loss as a result of their immersion in salt water.

The aircraft was reportedly airworthy and all appropriate maintenance had been conducted. The nature of the wheel fractures and the way in which eleven of the jerry cans failed suggest that the impact with water occurred at high speed. The damage to the wheels was consistent with that impact, and not a result of a mechanical failure of any kind. There was no evidence that the airworthiness or maintenance of the aircraft contributed to the occurrence.

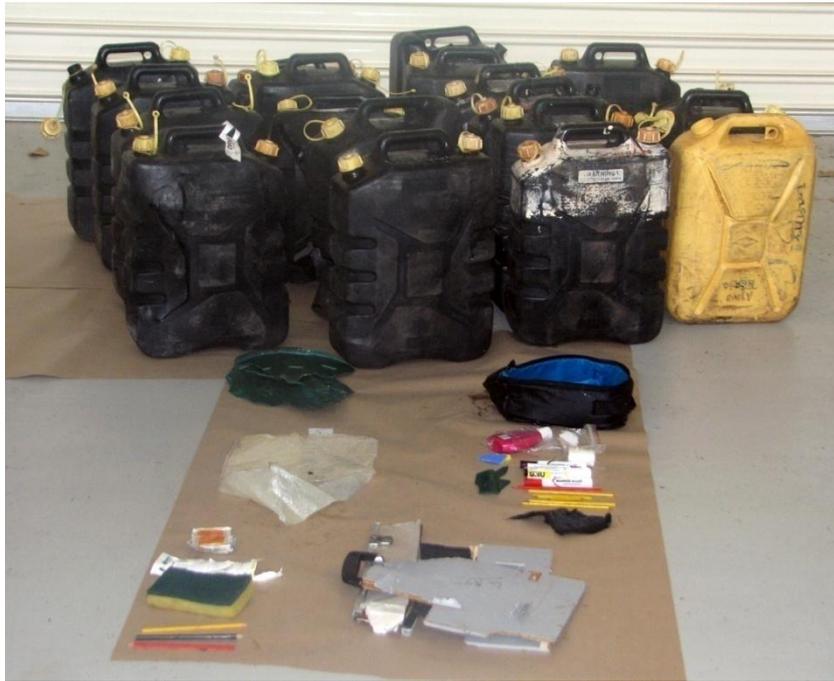
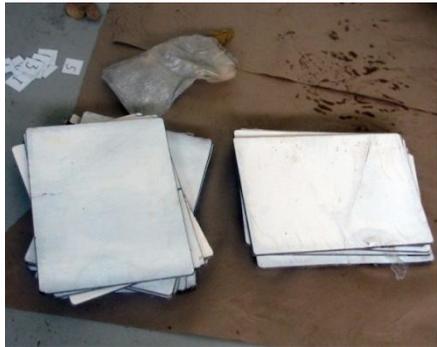
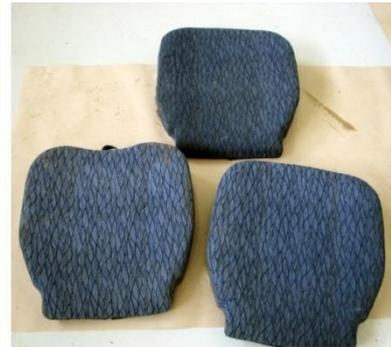
Figure 12: Cargo and wreckage items recovered from Buckingham Bay

In addition to the black 20 L fuel jerry cans, a single yellow 20 L fuel jerry can (Figures 12 and 14) was retrieved from Buckingham Bay among the other items of floating debris. No-one on Elcho Island recalled filling a yellow 20 L jerry can with fuel at the time that the black jerry cans were filled and no-one remembered seeing it among the other cargo that was loaded onto the aircraft. Nevertheless, this jerry can exhibited the same type of long, fresh rupture (indicative of failure under very high internal pressure) as 11 of the black jerry cans, and was therefore probably aboard the aircraft and filled with fuel.

Fragments of the green plastic rubbish bin were retrieved from Buckingham Bay (Figure 12). No trace of the box or the food it contained was found, and the items of stationery that were retrieved from the bay were mainly small whiteboards and whiteboard markers.

None of the wreckage items that were recovered showed any sign of fire.

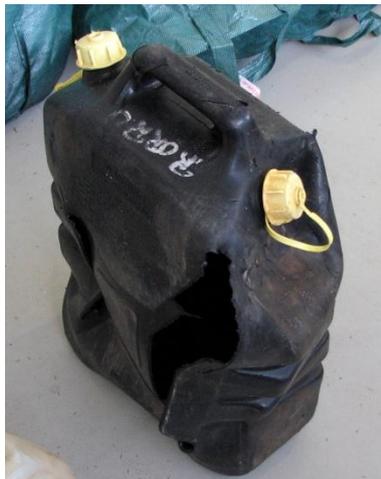
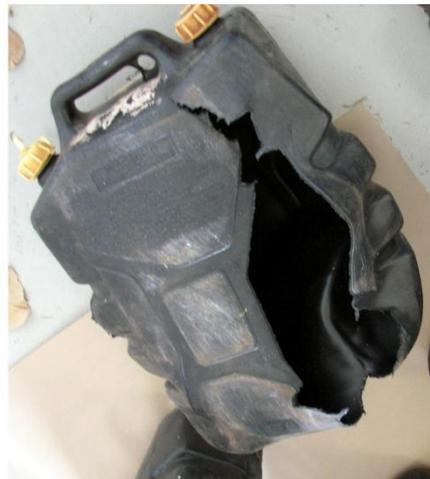
Figure 13: Fuel jerry cans showing evidence of bursting under internal pressure

Eleven of the 20 L jerry cans recovered had ruptured in a manner consistent with their exposure to the abrupt hydraulic pressure effects created within the internal liquid when the aircraft impacted the water (Figures 13 and 14). The remaining eight jerry cans were either wholly or largely intact (two of them exhibited punctures). The handles of the jerry cans were undamaged and showed no sign of distortion.

Eleven of the 19 jerry cans were ruptured during the impact, and this would have released 220 L of fuel in addition to any released from the aircraft's fuel tanks. The other eight jerry cans either remained intact or had punctures which were relatively small, so that the 160 L of fuel within them would have been either contained or would have leaked out slowly over time. The amount of fuel on the surface of the water in the immediate aftermath of the impact, and therefore the amount of smoke which could be expected from any fuel-fed fire, is not known.

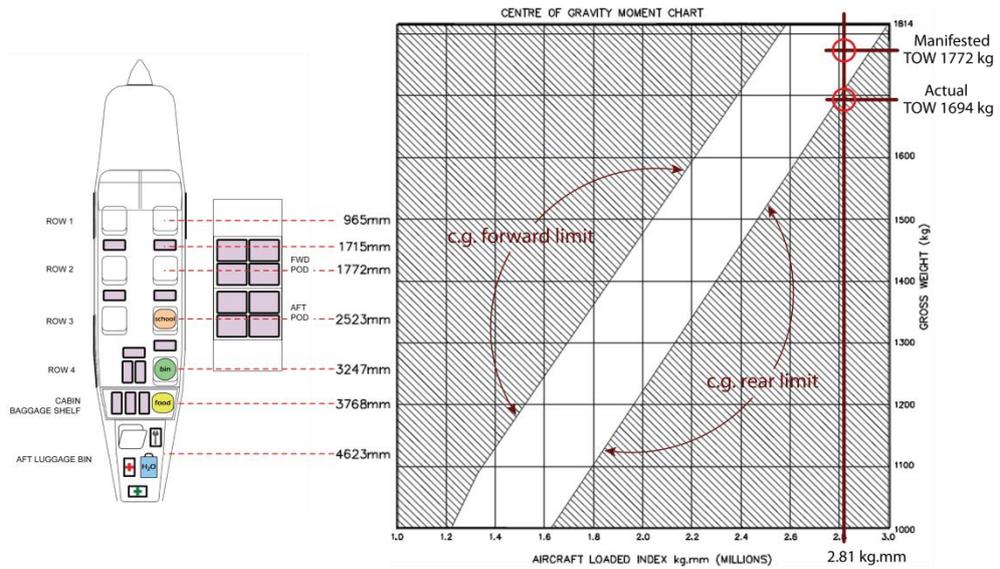
Figure 18: Scenario 1, reflecting the pilot-recorded trim value

Scenario 1 - Cargo distribution corresponding to the manifested trim value of 2.8. The distribution of cargo depicted in Figure 18 corresponds to the trim value of 2.8 that was entered on the Manifest Load Sheet by the pilot. The actual c.g (on the basis of a take-off weight of 1,694 kg) would have been slightly to the rear of the aircraft's rear c.g limit.

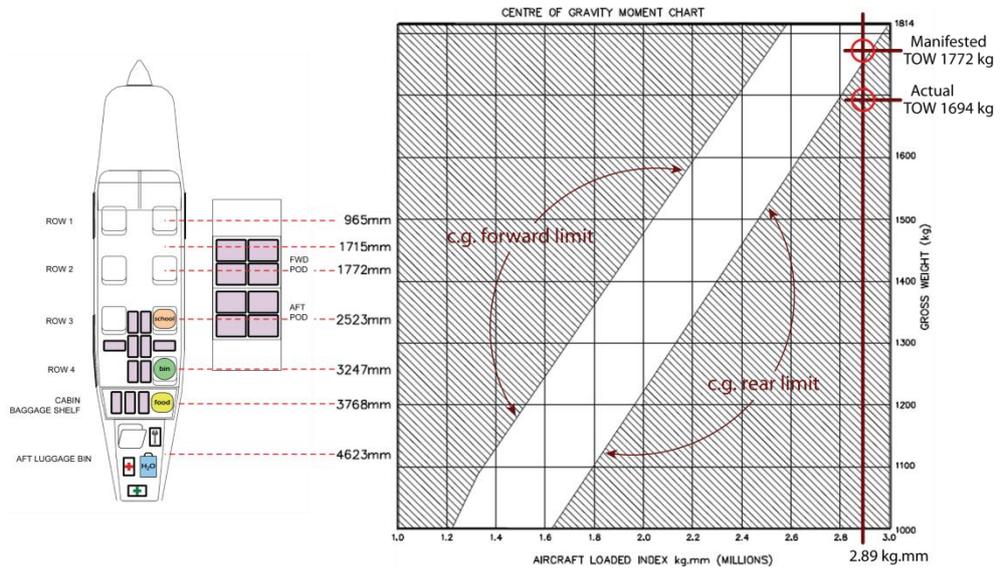
Figure 19: Scenario 2, most rearward c.g.

Scenario 2 – Cargo distribution resulting in the most rearward permissible c.g.
 If the pilot had placed all of the cargo close to the rear door to make loading and unloading easier, the situation would have been similar to that depicted in Figure 19. If the take-off weight had been 1,772 kg¹⁸ as the pilot calculated, this distribution would have resulted in a c.g. close to the rear limit, and a trim figure of 2.89. The actual c.g. (on the basis of a take-off weight of 1,694 kg) would have been to the rear of the aircraft's rear c.g. limit.

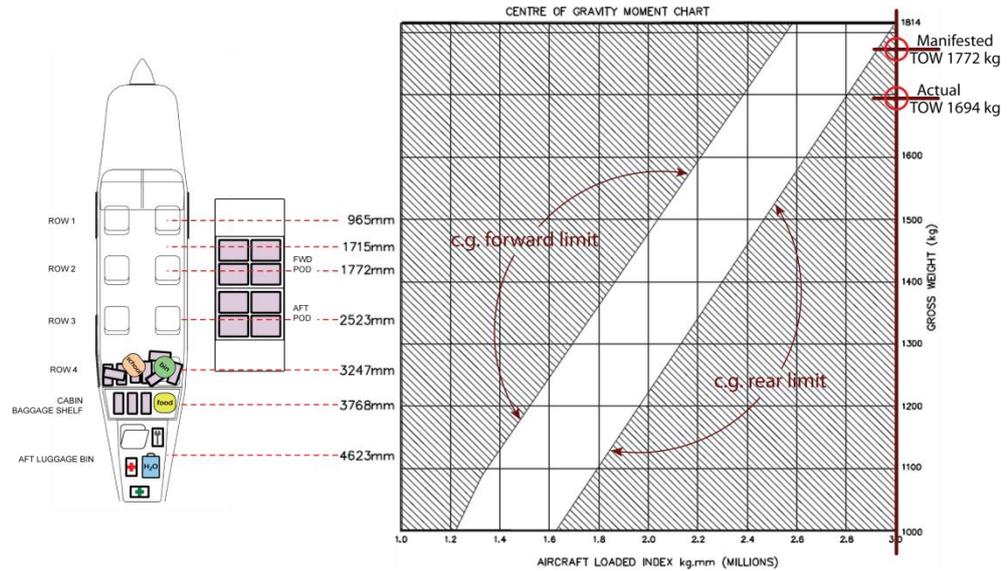
Figure 20: Scenario 3 - All cabin cargo in row 4

Scenario 3 – All cabin cargo in row 4. Figure 20 illustrates the situation if all the cargo had moved to the rear of the cabin during flight, and illustrates the c.g for both the pilot's (incorrect) calculated take-off weight (1,772 kg) and the estimated take-off weight (1,694 kg).

To determine the potential effect on the controllability of the aircraft if all of the cargo had moved to the rear of the cabin during flight (Scenario 3), expert opinion was sought on the flight characteristics of the Airvan with a c.g position of 44.5% MAC at a weight of about 1,700 kg. The expert advice was that, unless the aircraft was flying slowly and with a high angle of attack, it would have been controllable with conventional control inputs and the pilot would have been able to lower the nose.
