**Report 07-012, Fletcher FU24-950EX, ZK-EGV, collision with terrain
near Opotiki, 10 November 2007**

Report 07-012

Fletcher FU24-950EX ZK-EGV

collision with terrain

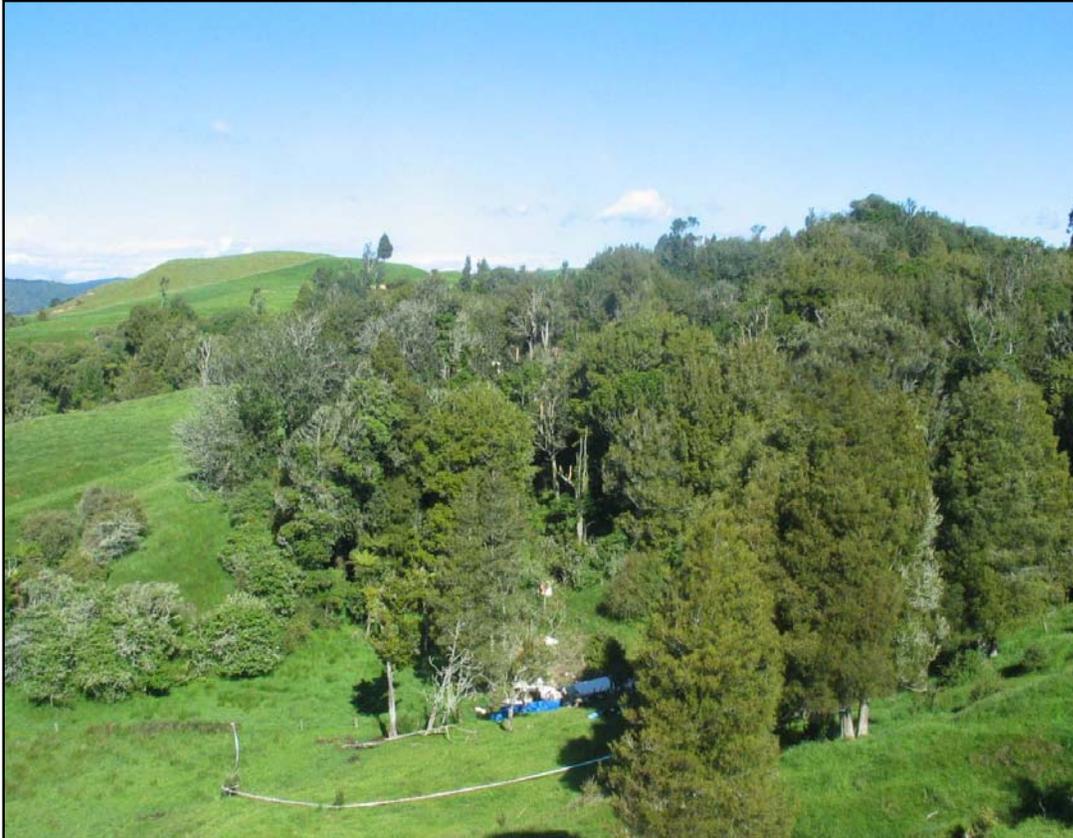
Figure 2
Accident scene, looking to the east

- 1.2.5 Both wings were severely damaged by multiple tree strikes. The left wing was attached, but the outer half of the outboard wing had been sheared off early in the impact sequence. The remainder of the outer left wing had been almost separated and was split open along the trailing edge. The inboard fuel tank had been hit from below and partly rolled under the wing. The outboard tank was lying just ahead of the wing. The left wing flap hung down on broken hinge brackets, but the skin damage did not indicate whether the flaps had been lowered prior to impact.

- 1.2.6 The right wing tip and aileron were sheared off, with fresh wood found in the inside panels around the break. The next approximately 60 cm of the wing were not recovered, but were determined to be among a few pieces seen high in the trees near the start of the impact path. The remainder of the outer right wing had been removed by another tree strike.

- 1.2.7 The inboard right wing had pivoted about the rear attachment and penetrated the fuselage side before completely detaching. It was found alongside the fuselage, inverted and with the tip forward. The fuselage was folded about 20° to the right through the point of penetration. Both right-wing fuel tanks had detached and were punctured. There was an obvious, but light, smell of fuel 24 hours after the accident, and signs of fuel in the marsh.

- 1.2.8 The tail fin forward attachment, which had been modified with a doubler, had been wrenched out as a result of a tree or branch strike, and the stabilator³ had dislocated rearwards and to the left. The outer right half of the stabilator had been detached when it impacted on a stump, end on, at about the first point of ground impact. The rudder had slight damage, but had detached as a result of the fin being disrupted.

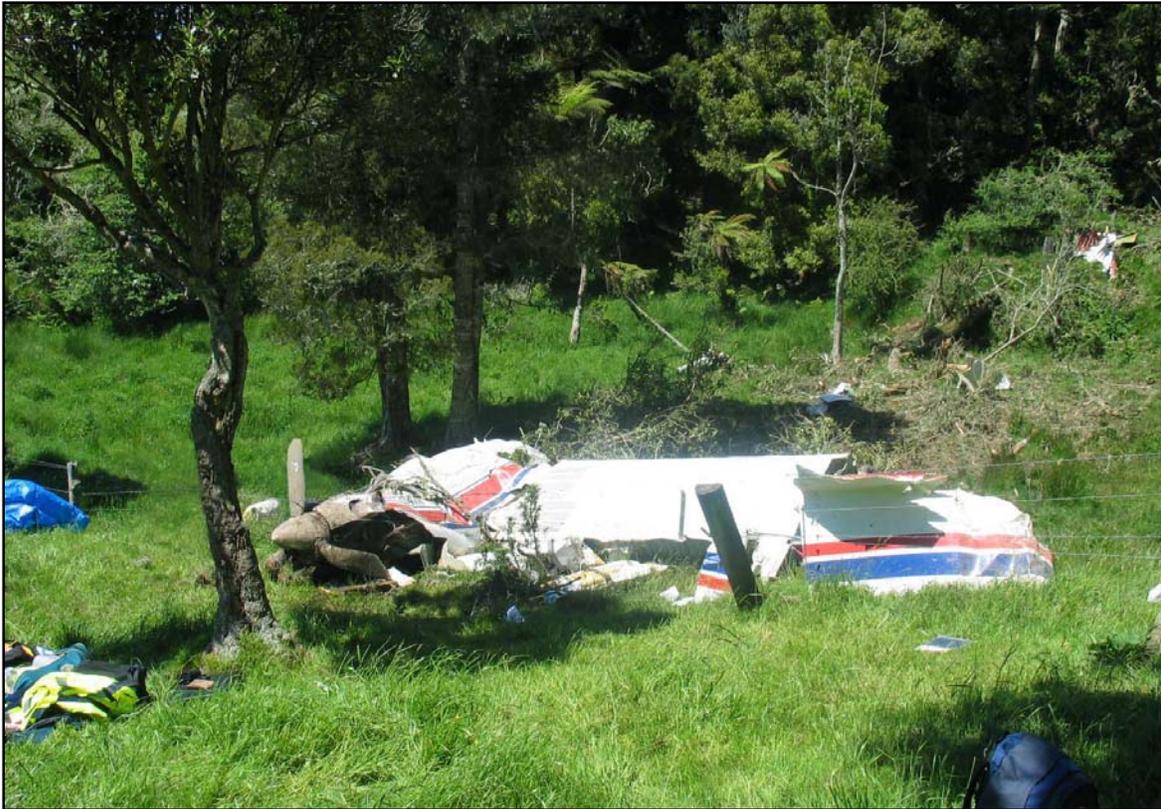
Figure 3
Accident scene

- 1.2.9 The pilot's harness was correctly fastened, with the inertia reel unlocked. The passenger harness was not fastened. There was a known risk that the unfastened passenger's right lap belt could obstruct the elevator torque tube bell crank by the cockpit right-side wall or an aileron pulley below the passenger seat. However, the belt was found clear of that area and there was no sign of the flight controls having been obstructed.

- 1.2.10 The pilot's helmet was found outside the cockpit, but he had been seen to be wearing it at the last refuel. The helmet had damage that was consistent with its having been worn during an impact.

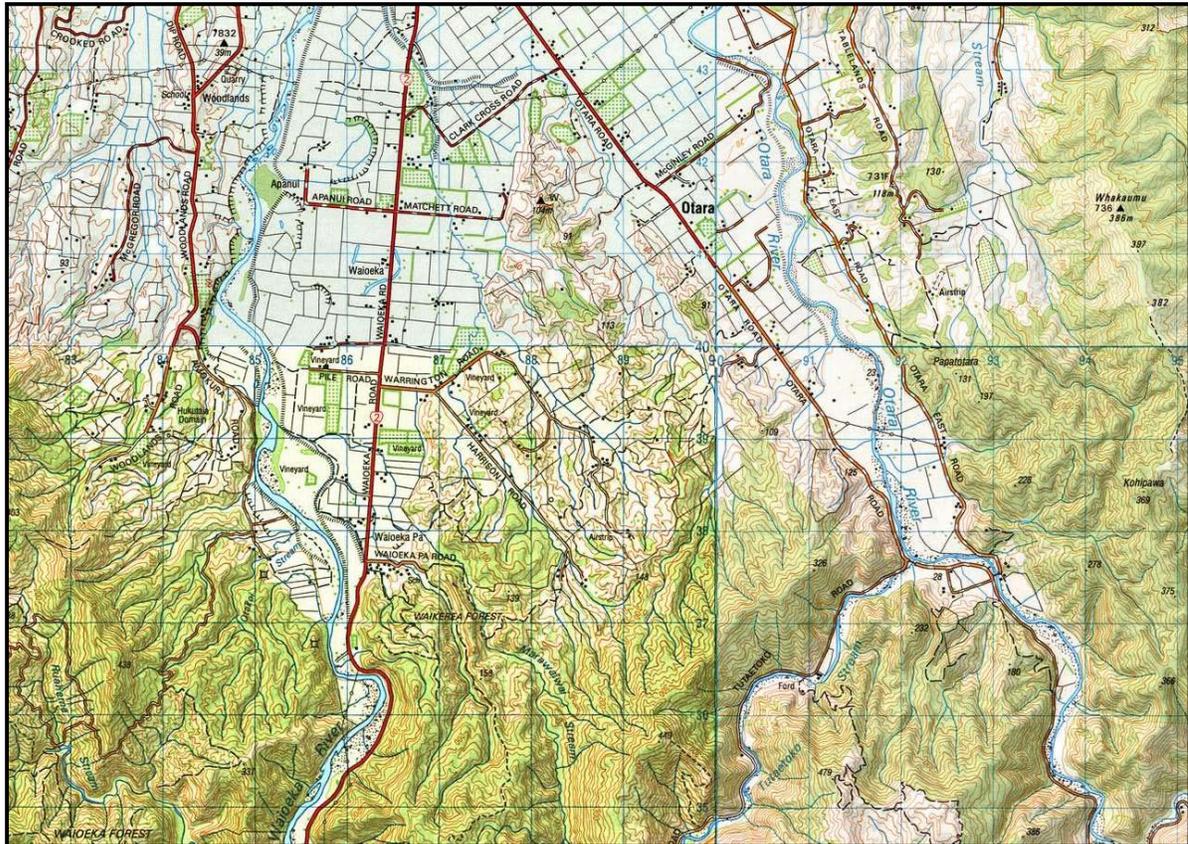
Figure 4
Approximate flight paths before the accident

- 1.8.13 Comparison with the sowing patterns of earlier loads suggested that at the end of the second run the pilot would have turned left slightly and pulled up before making a right-hand dumb-bell turn leading into the third run. The second run was to the northwest, and the accident site was about 280 m west of the widest of the reversal turns made on previous sowing runs in that area.
