FINAL ACCIDENT REPORT

AVIOARTE SERVIÇOS AÉREOS, Lda
Beechcraft 99

F-BTME

FINAL ACCIDENT REPORT Nr. 29/ACCID/2009

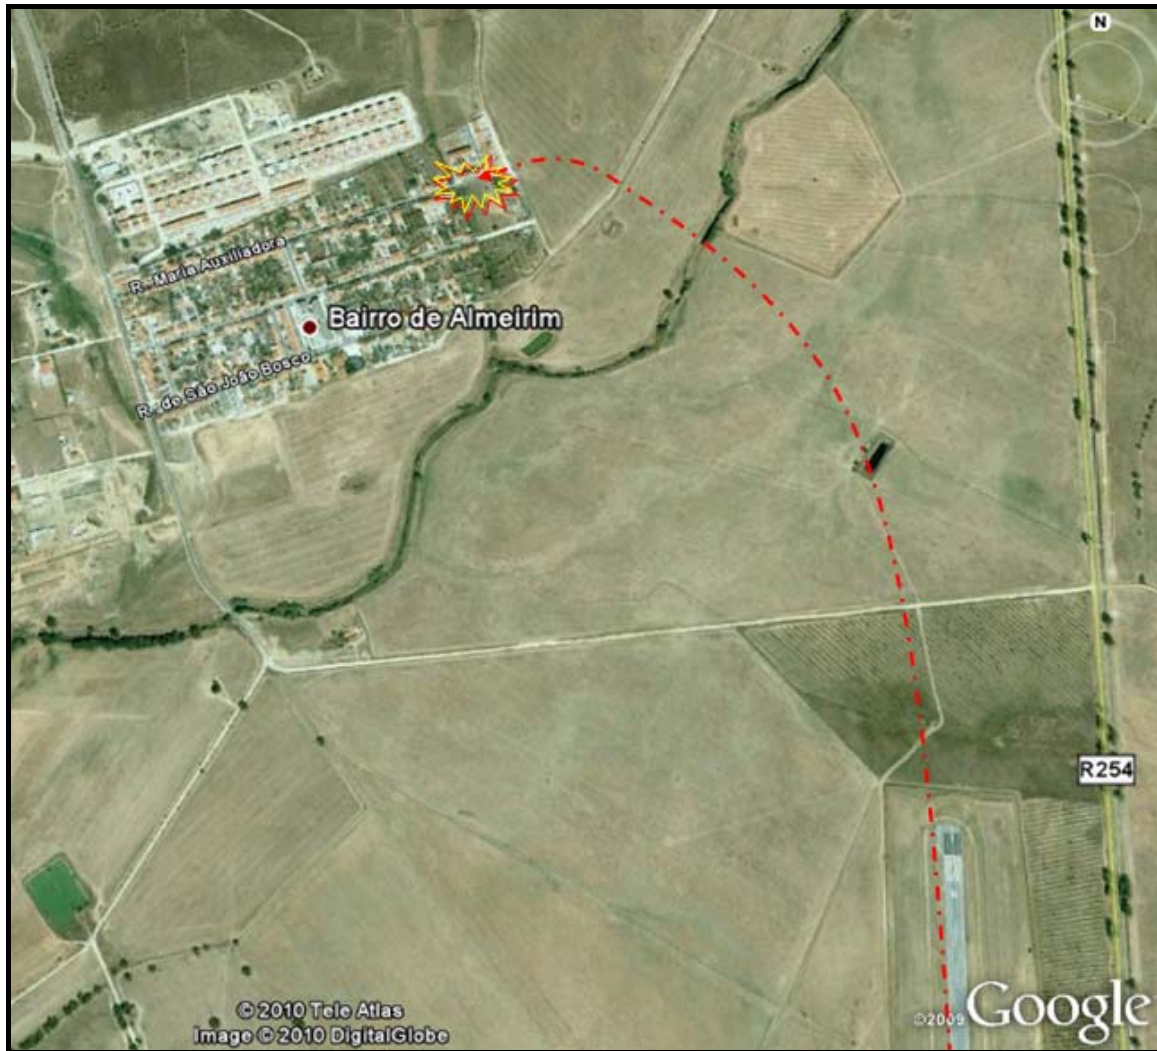
Picture Nr 1

The aircraft collided with a residential building, in Maria Auxiliadora street, Almeirim residential quarter, sited about 1160m far from runway end, on track 330° (*picture nr 1*). After the collision with the building, the aircraft fell to the ground, upside-down, a fire sparked immediately and the plane was engulfed by flames.

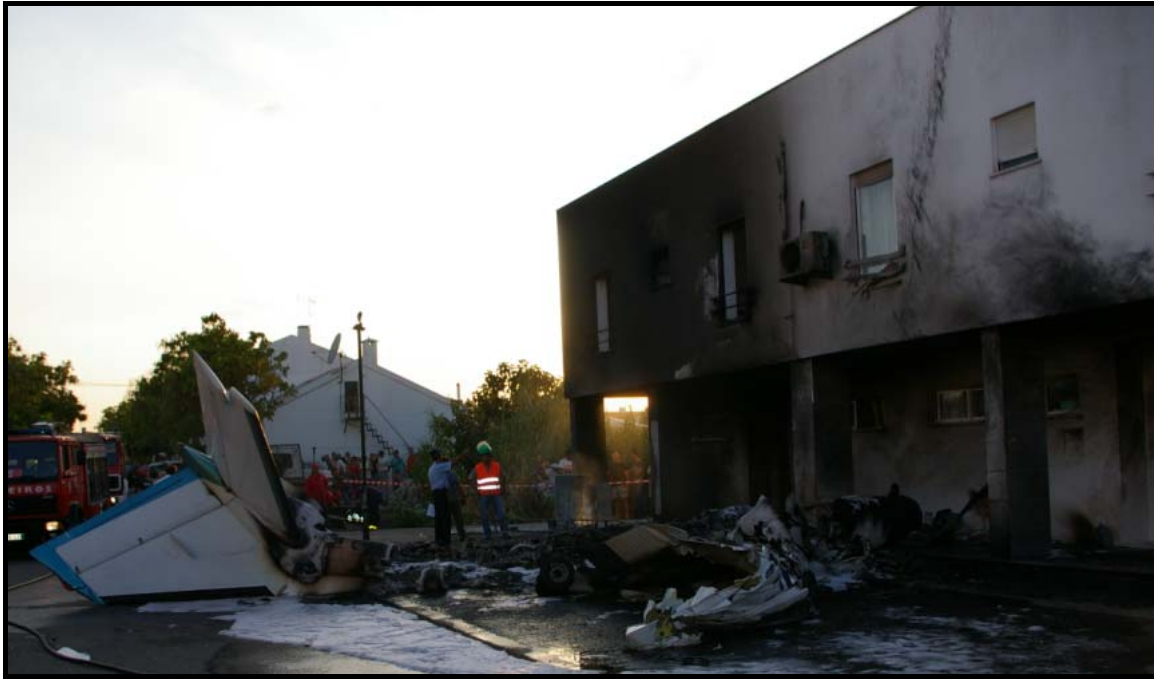
Picture Nr 2

The aircraft has been destroyed and consumed by fire (*picture nr 2*).

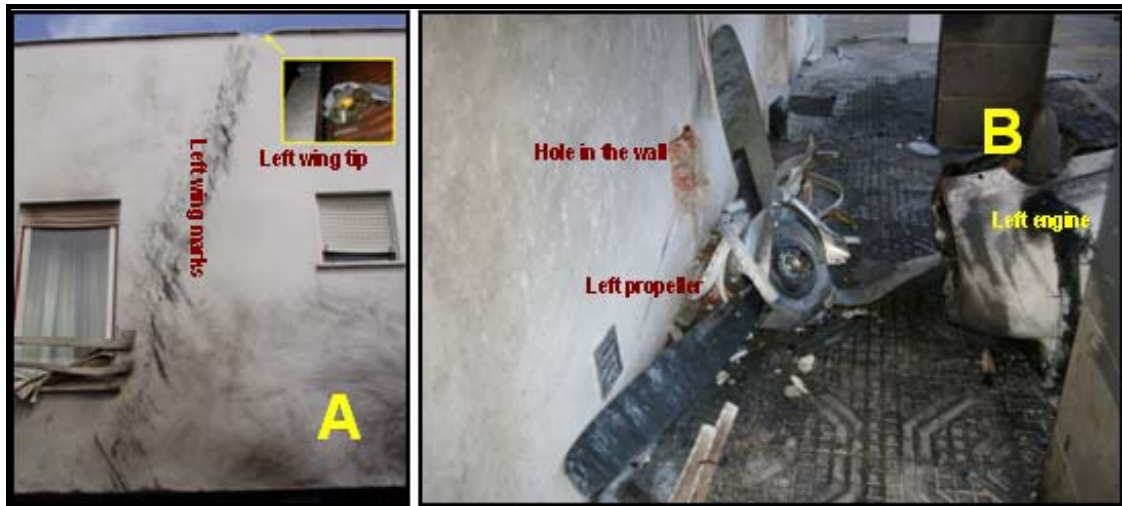
Figura Nº 9

Collision with the ground happened with aircraft upside down and nose slightly down, facing the building. Left engine separated from the wing and left propeller collided with a residence wall, due shaft fracture (*picture nr 9B*).

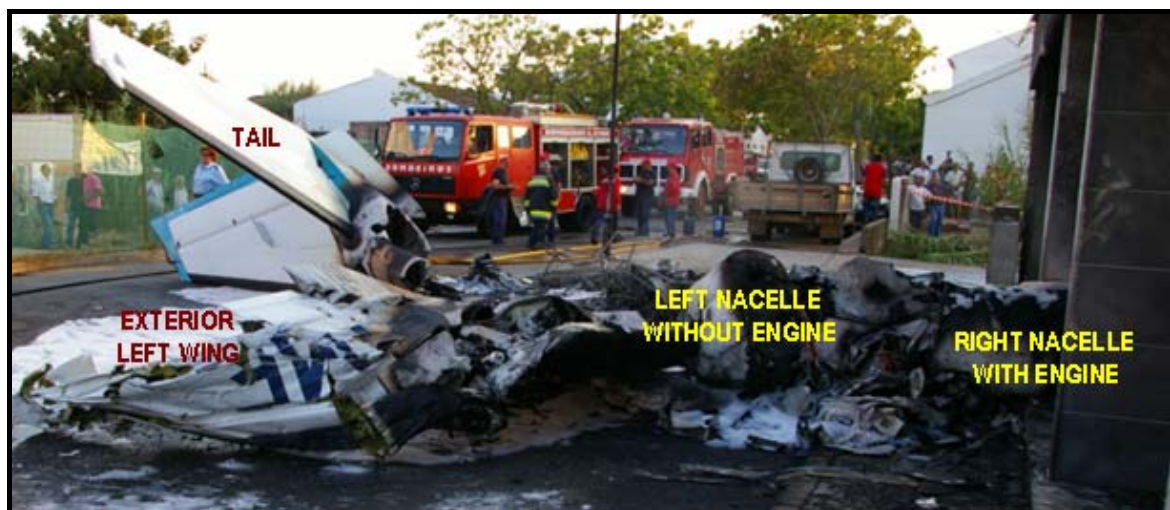
Figura Nº 10

Aircraft nose and right power plant impacted nearby, against a column, the propeller separated and rested under the wreckage, which was upside down, on the street (*picture nr 10*).

The fuselage, right wing and right engine nacelle were totally burnt by fire, becoming calcinated, while left inner wing and left engine nacelle were only partially burnt. The tail and left outer wing were spared from fire (*picture nr 10*).

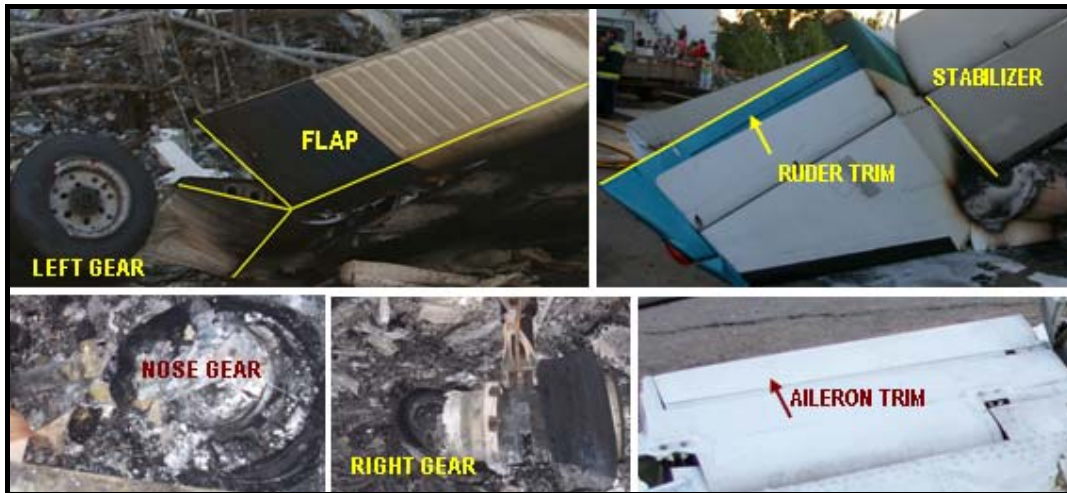
Picture Nr 11

Flaps were found selected to initial approach position ($\approx 13^\circ$). Ruder trim, stabilizer and aileron trim were found in neutral position. Landing gear was in extended position with pneumatics unpressurized, left main wheel apparently normal, right main wheel burnt and nose wheel calcinated by fire (*picture nr 11*).

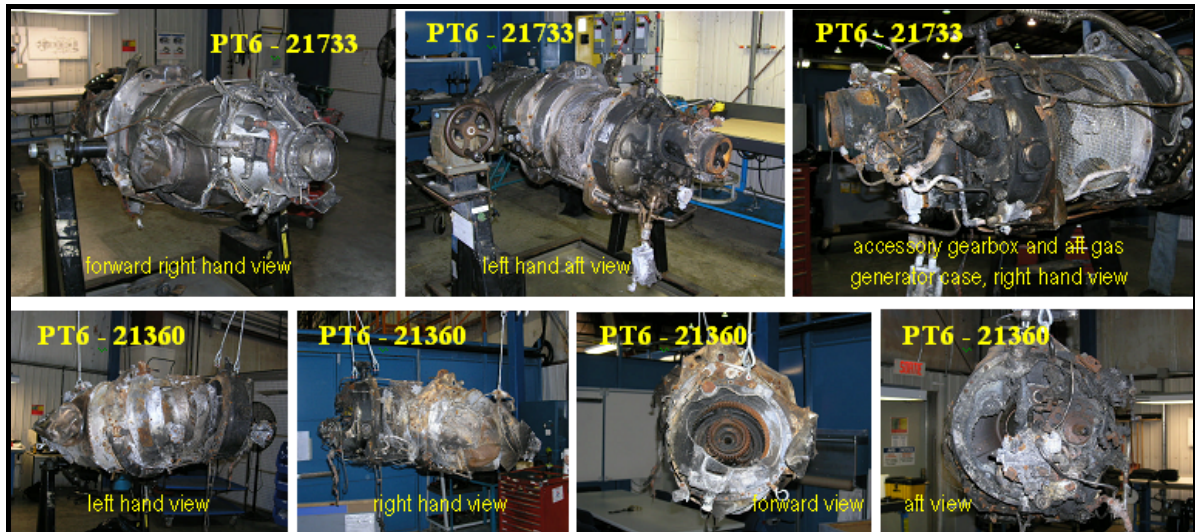
Picture Nr 12

Left engine (s/n 21733) separated from the wing, due impact forces, becoming partially burnt. Different happened to the right one (s/n 21360), which became almost calcinated by fire (*picture nr 12*).

- a) **Engine nr 1 (s/n 21733)** – *it “displayed contact signatures to its internal components characteristic of the engine being unpowered and rotating under air loads at the time of impact. The static contact signatures of the power section were characteristic of the propeller being most likely in feather at the time of impact. There were no indications of any pre-impact mechanical anomalies or dysfunction to any of the engine components observed that would have precluded normal engine operation and full power output”;*

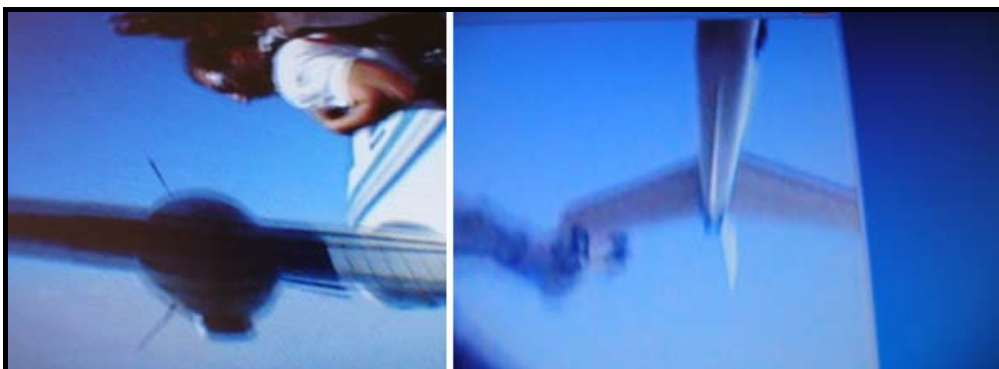
Picture Nr 22

Climbing through 9500ft, approximately, left engine (nr 1) flame-out and respective propeller automatically feathered (*picture nr 22*).

Pilot stopped climb at 10500ft, trying to control the aircraft with aileron (see *ruder deflection on opposite direction of expected*), informed the passengers there was an engine failure and they had to jump immediately, while he intended to continue flying the aircraft back for landing at departure airport.

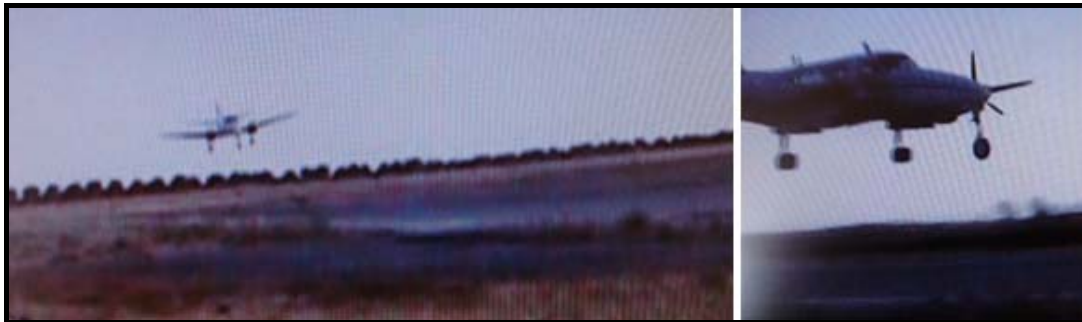
Picture Nr 23

A few minutes later, the aircraft was seen on final for RWY 01 (*picture nr 23*), at high speed and high descent rate, with gear down and left propeller in feather position.

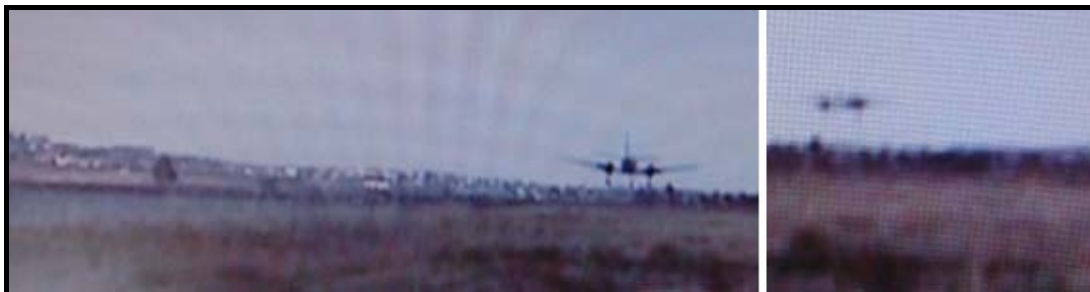
Picture Nr 24

NOTE 2 – *Aircraft was shown with right wing slightly lowered and some power on operating engine (engine noise was not compatible with idle throttle position). Being the airplane absolutely controllable there's no reason for such overspeed, which hinder the aircraft to touch the runway, while overflying it at all its length (picture nr 24).*

The aircraft made a low pass on all runway length, without touching the ground. Only after it passed the end, now at a lower speed, the pilot decided to reject landing and initiate a go-around.
