**Accident Investigation Board
Denmark**

Final Report
HCLJ510-2011-33
(HCLJ510-000704)

Accident to Piaggio Avanti P180
Registration N108GF
South of BGSF, Greenland
On 16 October 2009

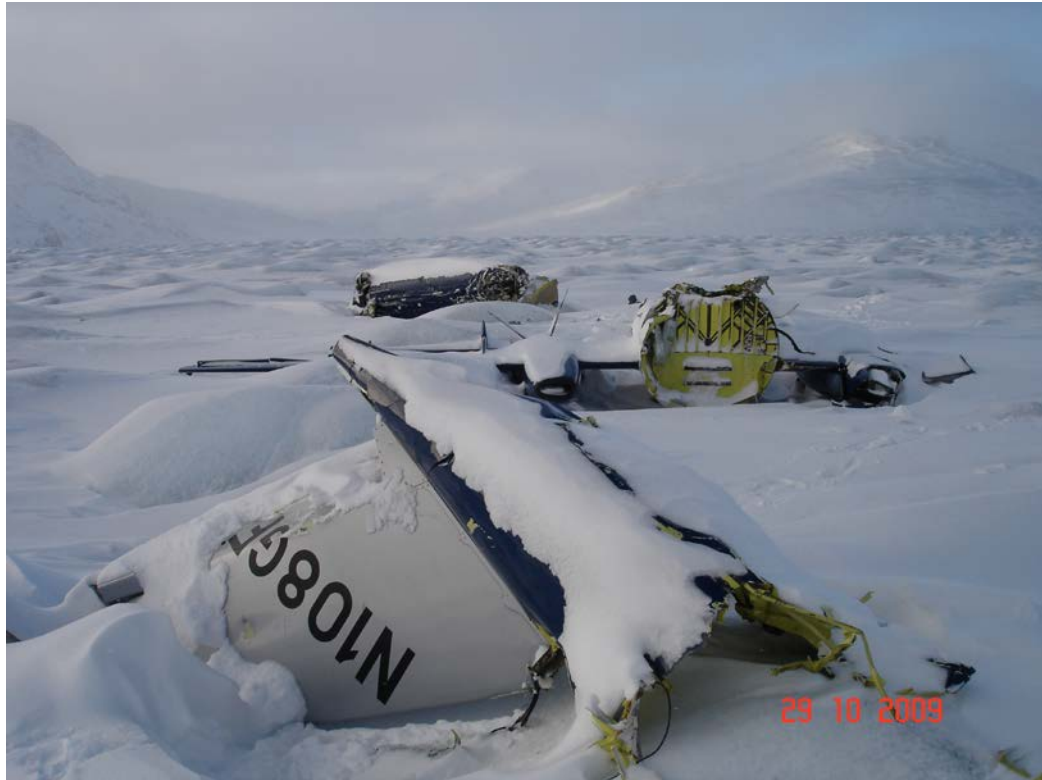
The aircraft was broken up into three major sections and numerous minor pieces. The major sections were the cockpit/cabin section, the wing/engine section and the tail section. The cockpit/cabin section was found approximately 50 meters from first impact. The wing/engine section was found approximately 40 meters from first impact. The tail section was found approximately 20 meters from first impact. There were numerous minor pieces from the aircraft at the accident site. Most of these were located along the track from first impact to the cockpit/cabin section.

The tail section, the wing/engine section and the cockpit/cabin section

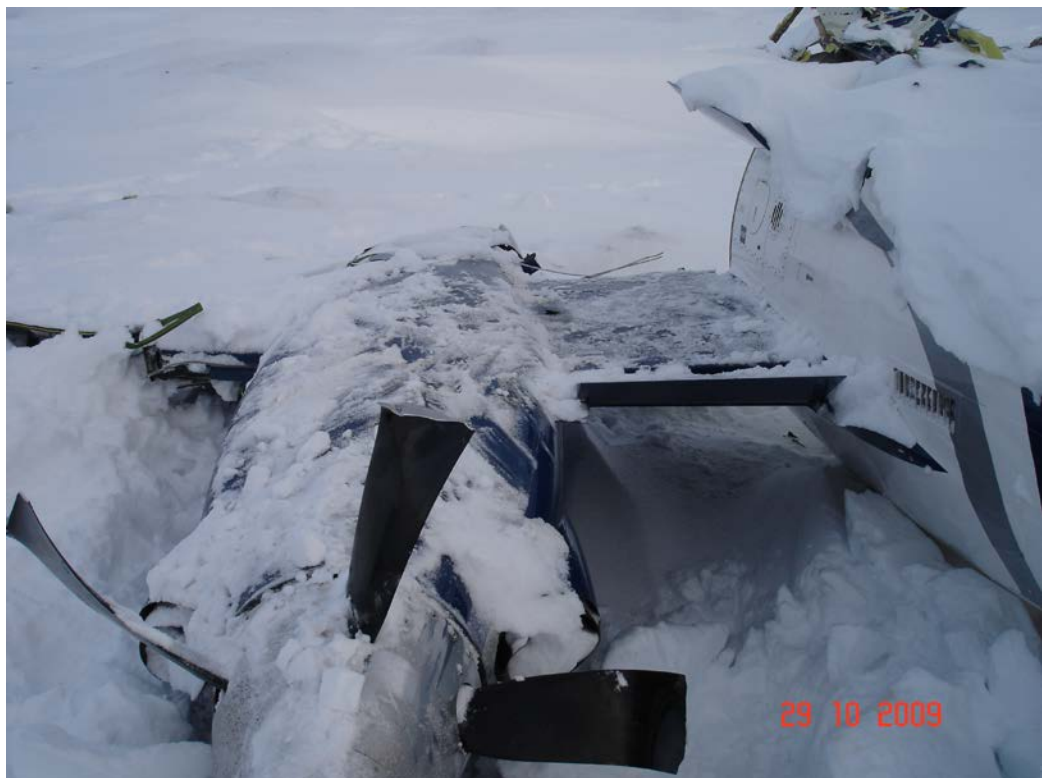
The right engine and the right propeller

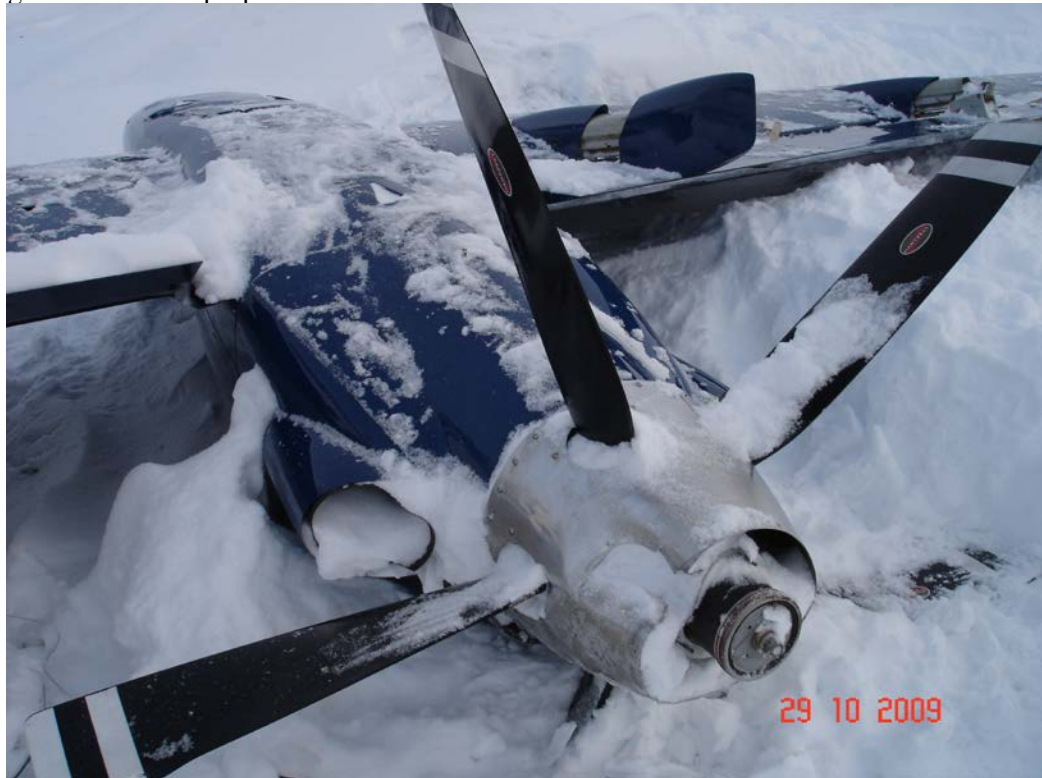
The left engine and the left propeller

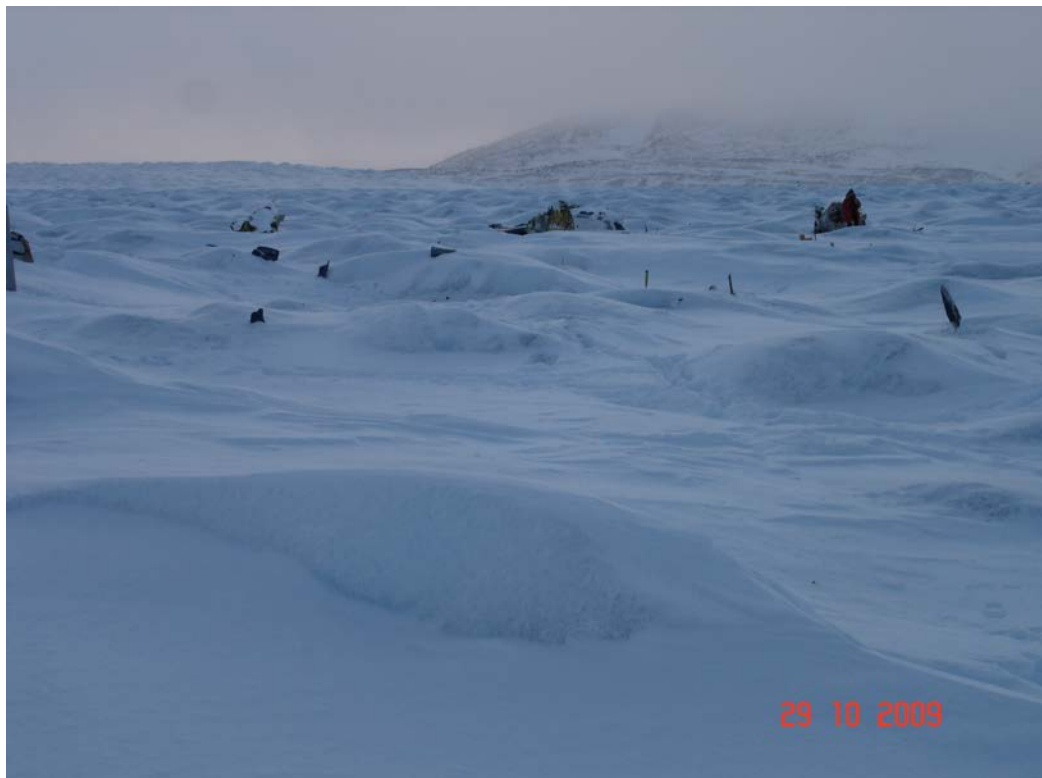
There were numerous of pieces from the aircraft. After being recovered the pieces were placed in the snow

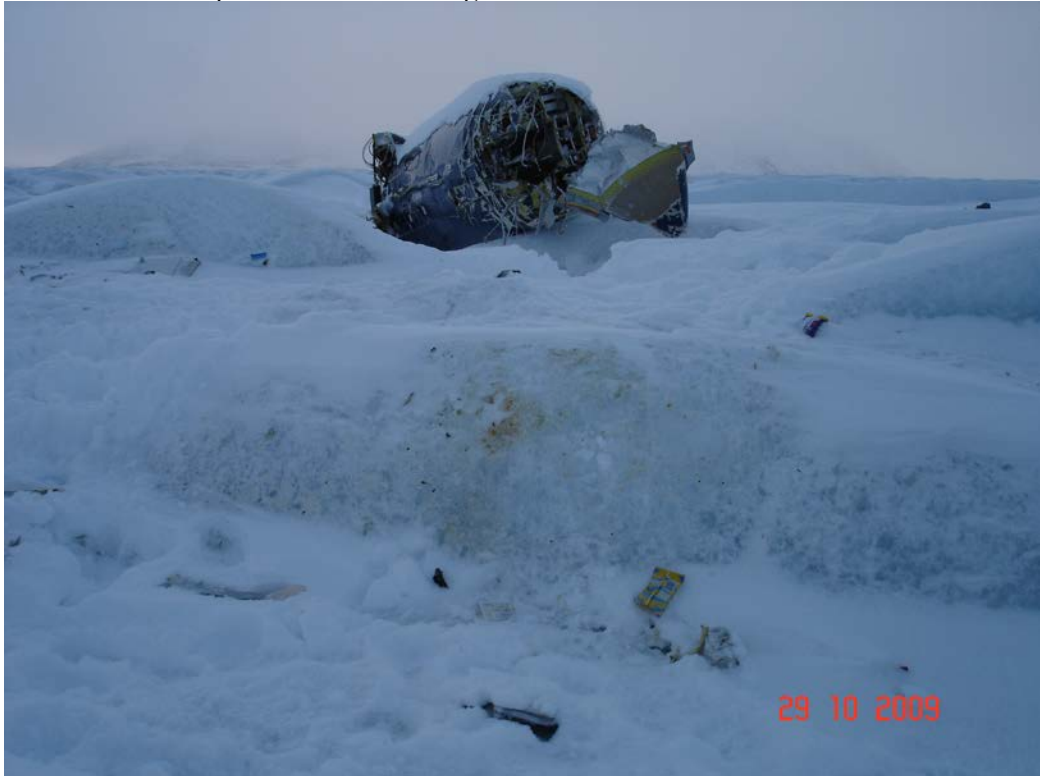
The cockpit/cabin section impacted a one meter high ice formation and turned over the nose

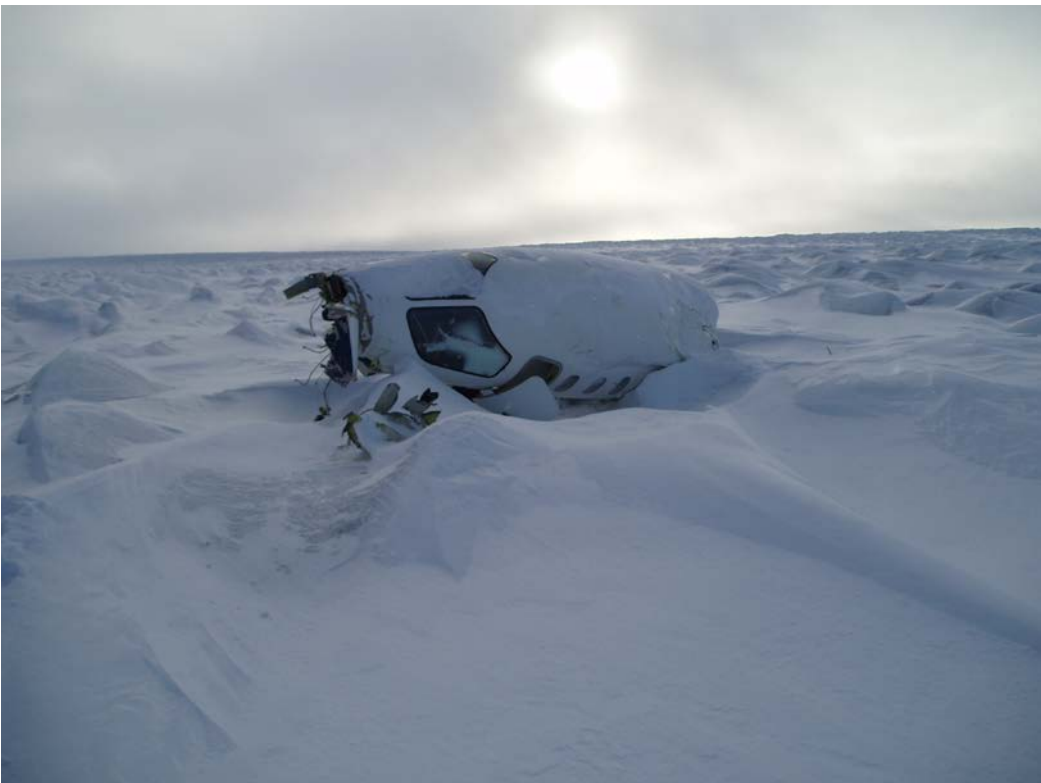
hang loose from the ceiling. The onboard toilet was broken up and the toilet fluid had left the toilet system. The cabin door located at the left forward part of the cabin could be operated. The landing gear was found retracted. The canards were torn off the cockpit/cabin section.

The cabin door could be operated but the access to the cabin was difficult

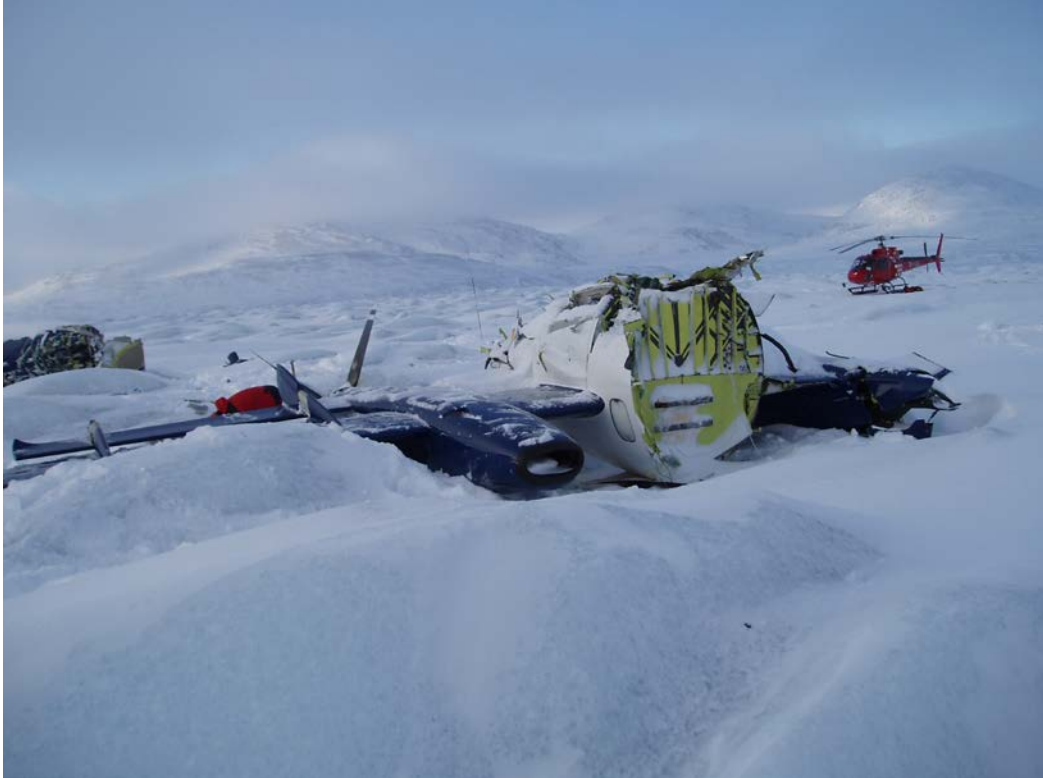
The wing/engine section was found upside down and pointing in the opposite direction of the track. The wing/engine section was torn open where the cockpit/cabin section and where the tail section had been attached. The left wing was substantially damaged. The right wing was destroyed. The outer part of the right wing – which was a part of the right wing fuel tank – was separated from the rest of the wing approximately one meter from the right engine. The remaining inner right wing tank next to the fuselage was opened and examined. The tank was found empty and dry. The left wing tank – which was almost intact – was opened and examined in two different areas. The tank was found empty and dry. It was not possible to examine neither the integral fuselage tanks nor the fuselage collector tanks, due to lack of lifting equipment at the accident site. The flaps were found in “MID” position. Both propellers were damaged. The left propeller suffered minor damage. The left propeller was found feathered and showed no signs of rotation. The right propeller was destroyed. All the right propeller blades were sheared off at the middle and showed signs of high power. All of the outer halves of the blades were missing and they were never found. The engines could not be inspected for damage. An investigation of the engine was not possible due to lack of lifting equipment.

The wing/engine section was found upside down and pointing in the opposite direction of the track

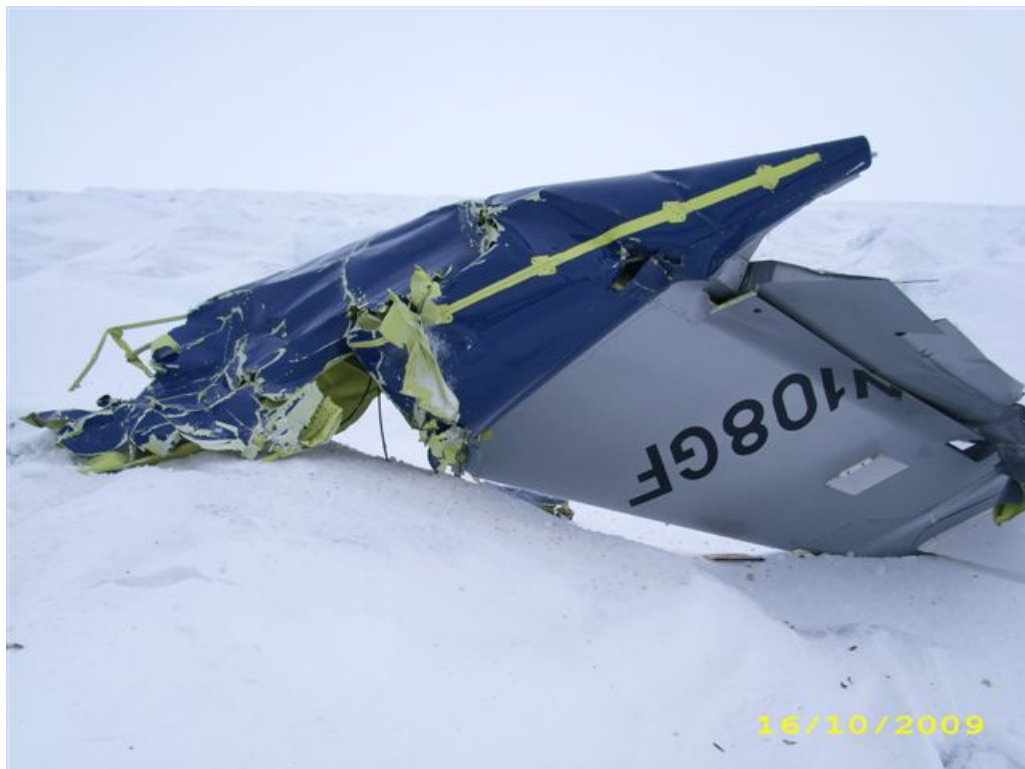
The tail section was found upside down. The tail section was torn open where it had been attached to the wing/engine section. The tail section was destroyed.

The tail section was found upside down

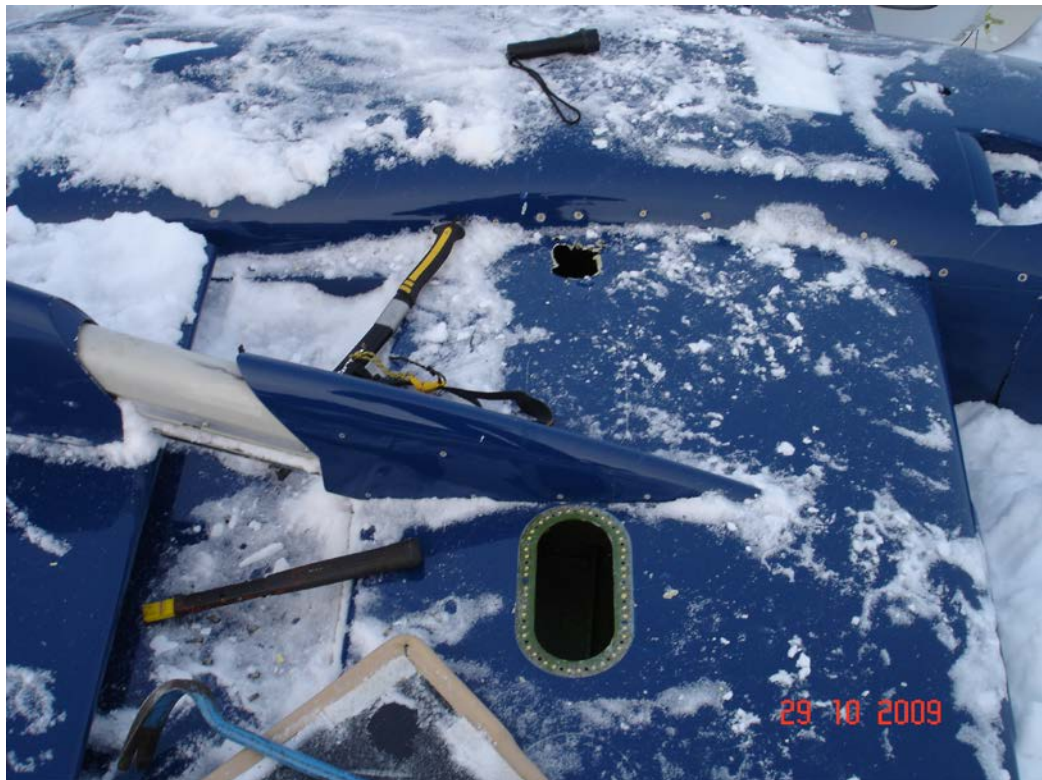
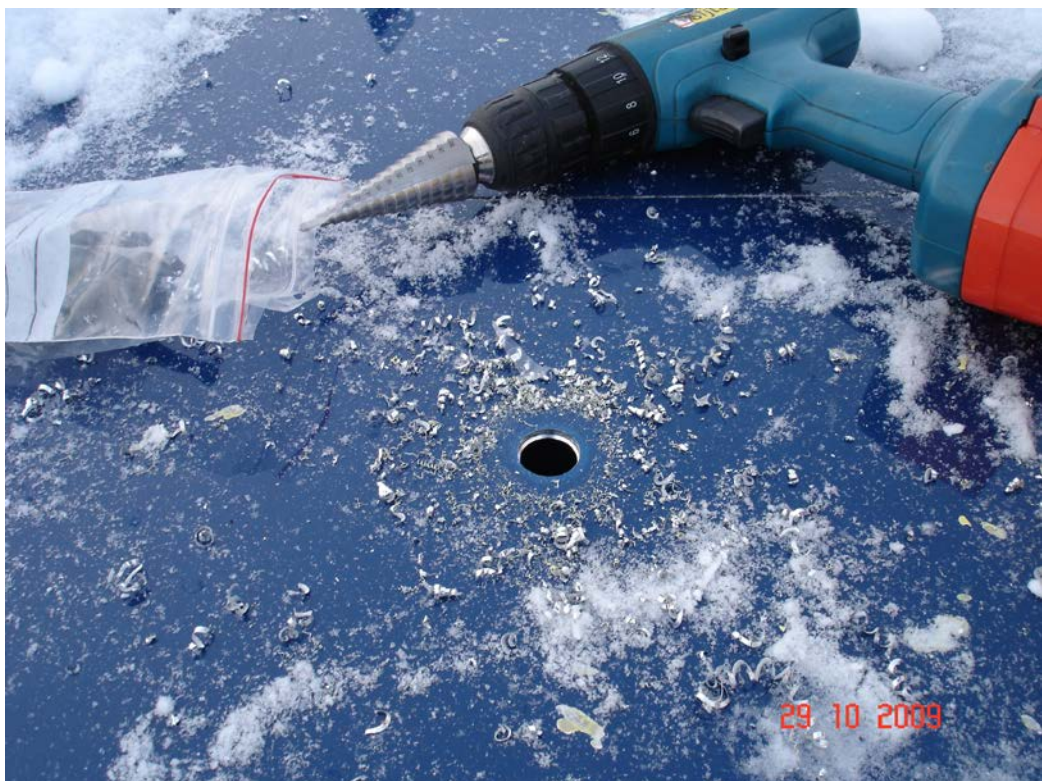
The wing fuel tanks were opened and no fuel were found

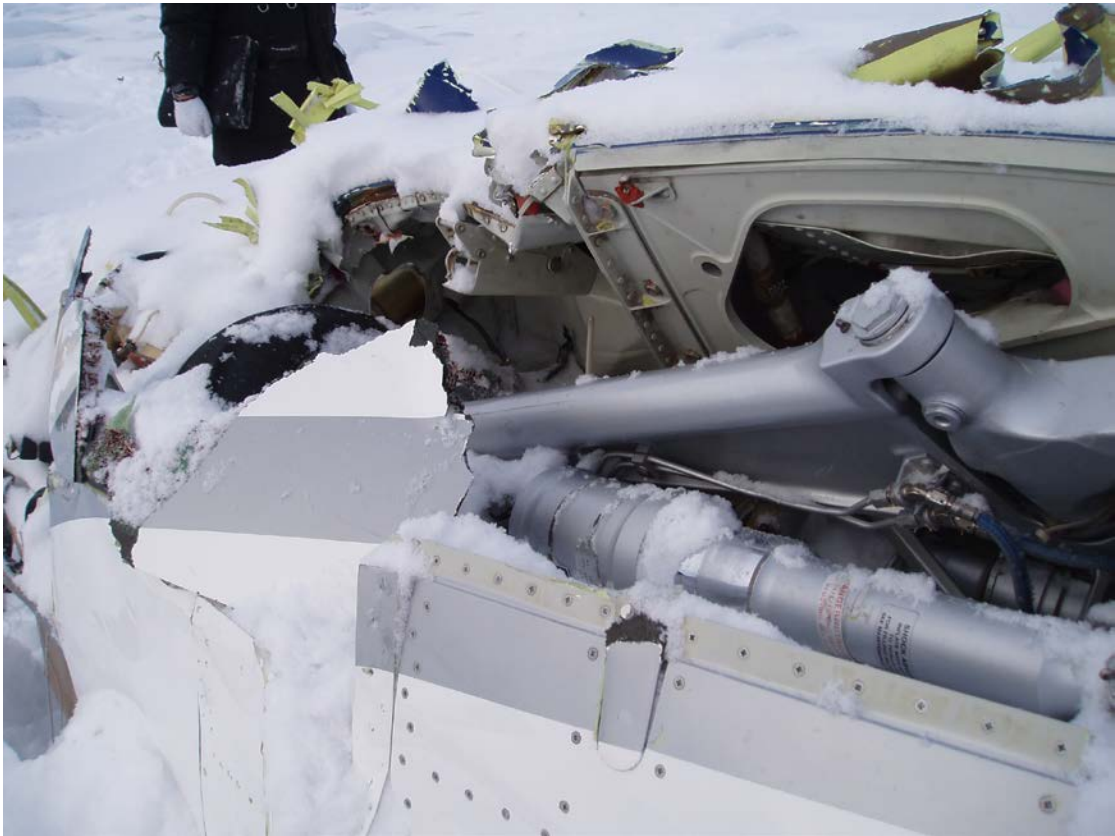
The Landing Gear was found retracted

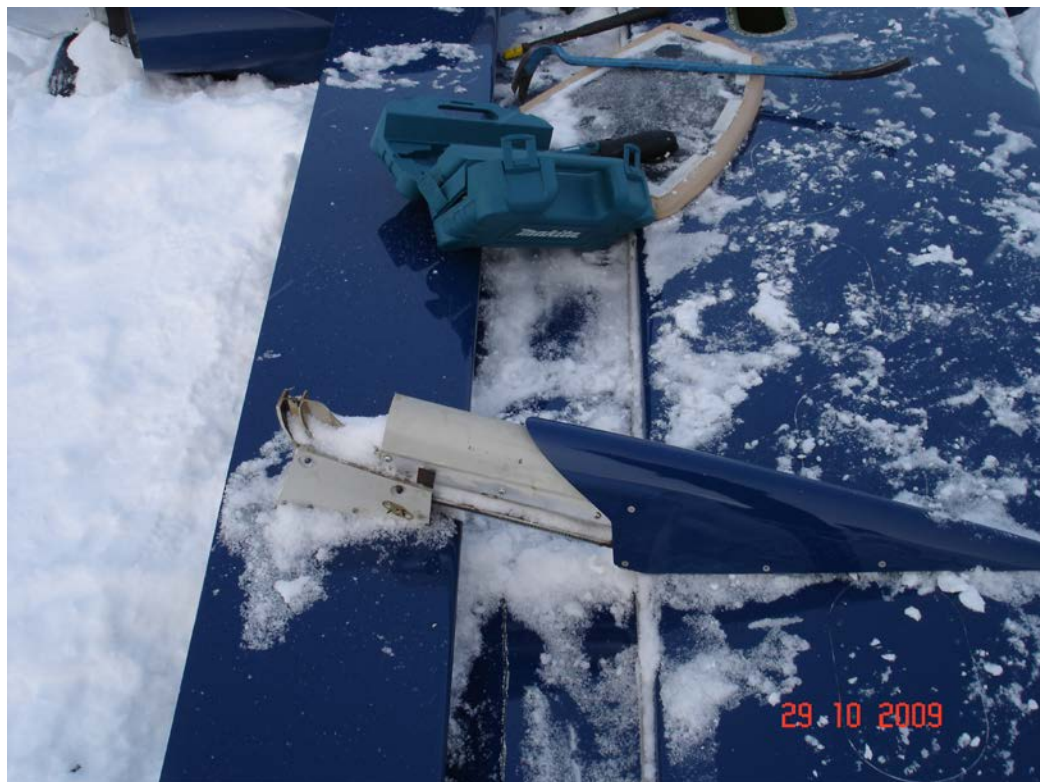
The wing flaps were found in the mid position

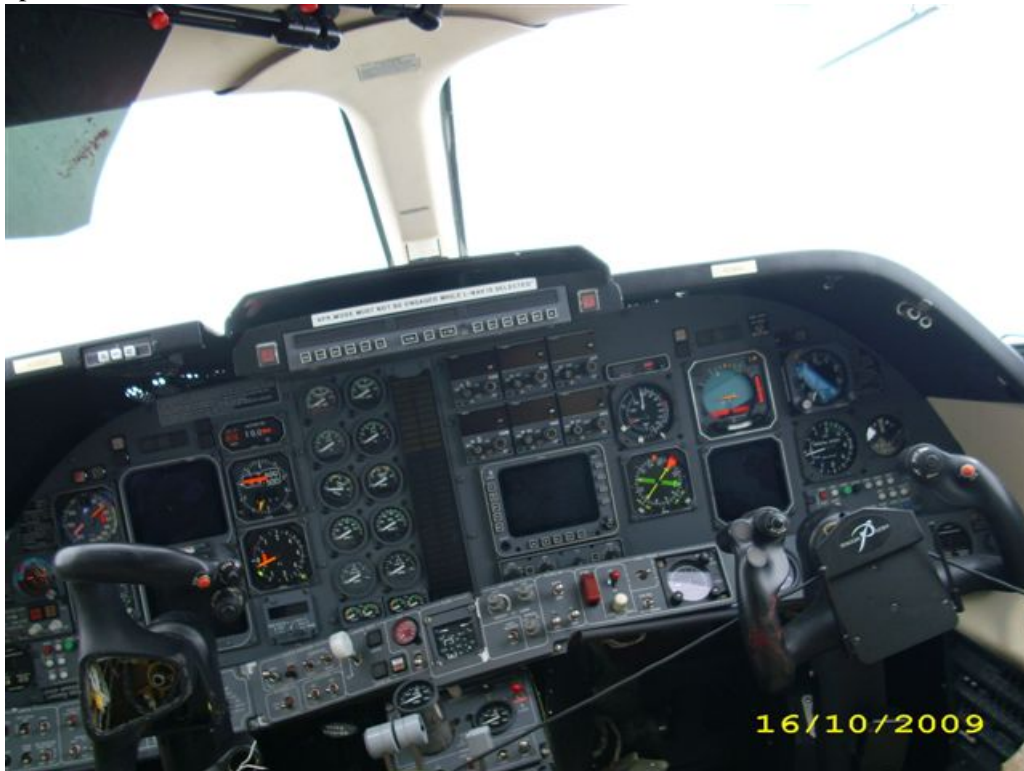
The cockpit/cabin section was severely damaged on the outside; but on the inside only minor damaged was observed in the cockpit and the forward part of the passenger cabin. The cockpit and the forward passenger cabin structure remained almost intact during the accident. The aft part of the passenger cabin was separated from the wing/engine section and did not remain intact.

The cockpit was almost intact

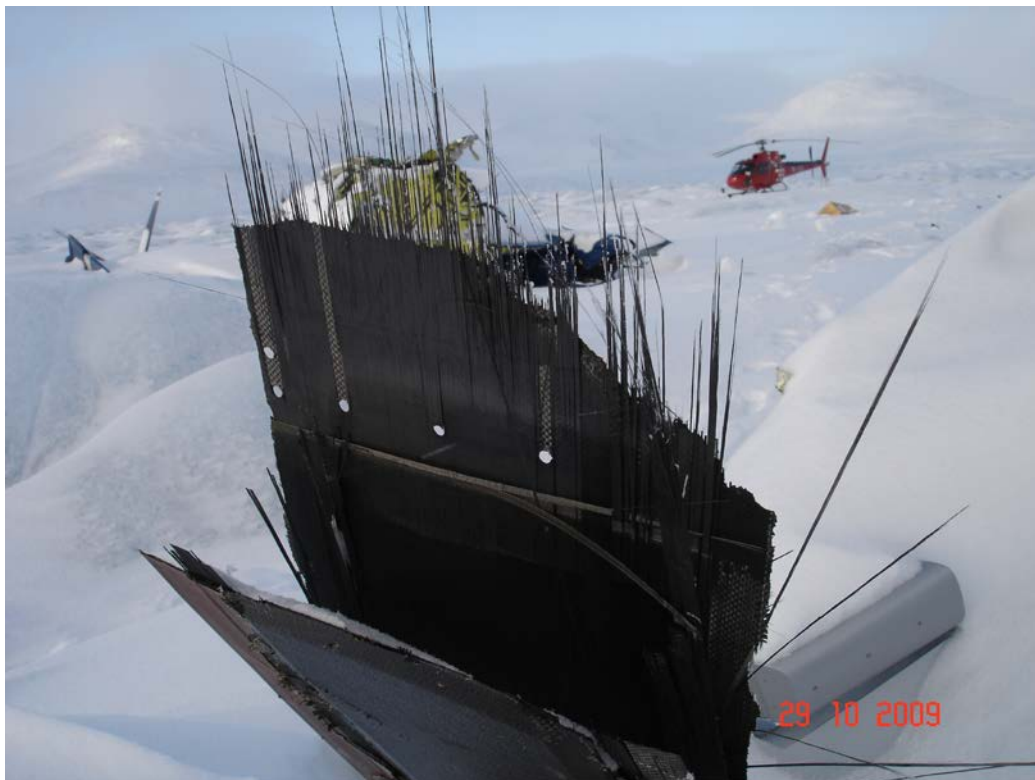
Broken carbon structure
