ACCIDENT INVESTIGATION FINAL REPORT

AN-26B, SP-FDO
Tallinn, Estonia
18. March 2010

Tallinn, 2012

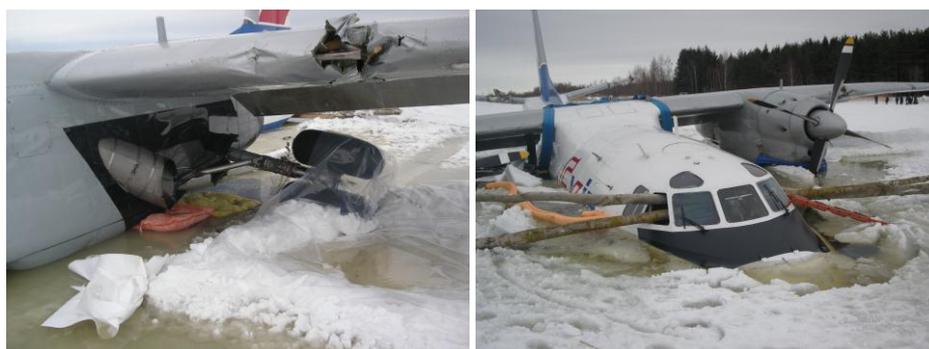
The aircraft landed on the snow-covered ice with its landing gear partly lowered and not locked. During the impact both left and right main gear and nose and gear bay doors were damaged and broken. From impact with the trees the leading edges of the wing and stabilizer sustained serious damages. One propeller blade on the RH engine was bent. The cockpit was filled with snow and ice coming in through nose gear bay and damaged cockpit floor.

The fuselage sustained skin damage from the impact and sliding on the ice. Initially the ice under the aircraft fuselage sustained the weight of the aircraft, but in ca 30 minutes it started to break and the aircraft started to sink. To avoid sinking trough the ice the aircraft was supported by wooden beams under the wing and through the cockpit side windows.

Ülemiste Lake is the drinking water source for Tallinn and to avoid fuel spill and water contamination the evacuation of the aircraft was of high priority. During evacuation the aircrafts wing and the fuselage sustained severe damages.

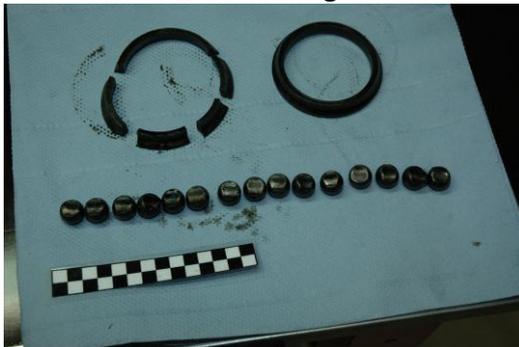
1. The main axial bearing (rear compressor bearing) was severely damaged. The inner forward race was fractured, broken and severely worn. The bearings cage was fractured. Balls were deformed and indicated signs of non-rolling movement of the bearing.

Rear compressor bearing

According to the engine examination data the engine failure was caused by failure of the compressor rear axial bearing. Broken breather duct and heat damaged pressure regulating washer caused improper ventilation of the bearing case and accumulation of the hot oil vapors to the bearing case. This led to temperature rise and coke formation in the bearing. Coke obstructed the scavenge oil channel and the oiling and cooling conditions of the bearing deteriorated even more. At some point the normal rolling was replaced by frictional movement of the bearing, which led to complete failure of the bearing.

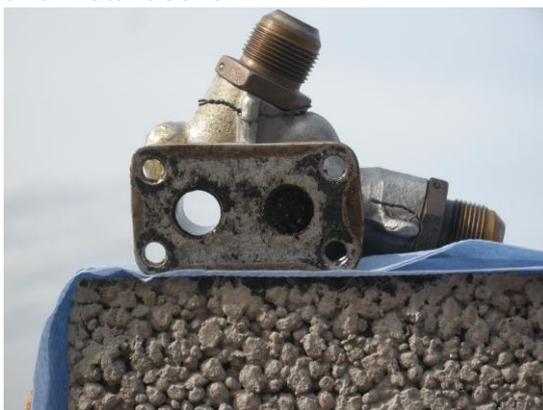
2. The oil scavenge duct for axial bearing was completely obstructed by coke and metal debris.

Obstructed oil scavenge duct

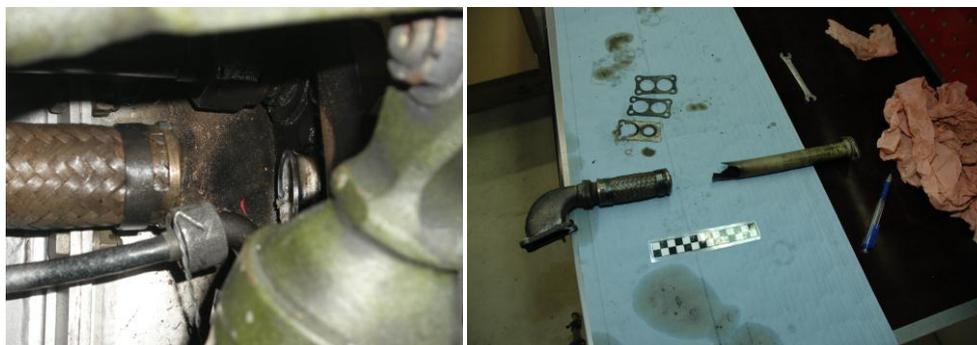
5. The breather duct for labyrinth cavities was broken and the part was missing on the outside of the engine and the surrounding area covered with oil and coke.

Failed breather duct

The broken breather duct is made of aluminum with the wall thickness of 0.8 mm. The cause and the time of the fracturing could not be determined, but the coke on fracture surfaces and around the broken pipe ending indicate, that it happened prior the engine failure and with high probability days to weeks prior the accident flight. The brake point of the duct was close to the section wall on the engine and difficult to spot during maintenance.

8. The process of recurrent training of maintenance personnel was changed particularly involved the maintenance of critical areas of plane;
9. Under supervision of CAA the verification of practical skills of 100% crew of the Exin Company was performed.

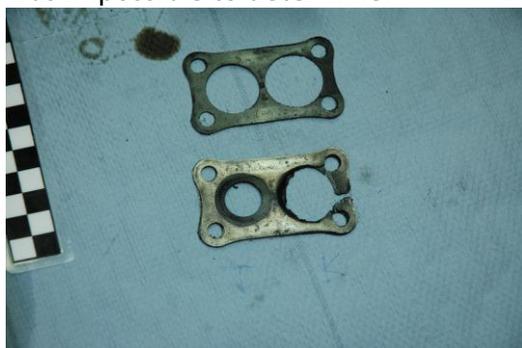
6. The liner (washer) for regulating the pressure in labyrinth cavities was heat damaged and the original diameter of the orifice to rear compressor bearing was impossible to determine.

Breather duct regulating liner
