AO-2010-003: VH-NTQ, In-flight engine shut down

Date and time:	14 January 2010, 0645 WST
Location:	Beagle Bay, Western Australia
Occurrence category:	Accident
Occurrence type:	Partial power loss (In-flight engine shutdown)
Aircraft registration:	VH-NTQ
Aircraft manufacturer and model:	Cessna Aircraft Co 208B Caravan
Type of operation:	Charter
Persons on board:	Crew – 1 Passengers – 0
Injuries:	Crew – 1 (Minor)
Damage to aircraft:	Seriously damaged

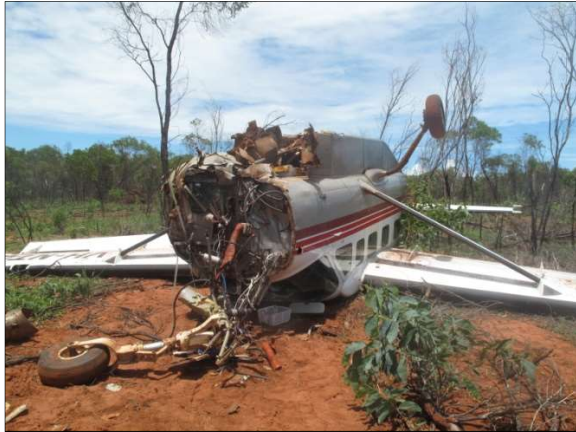
Figure 1: Accident site

The pilot diverted to the nearest airstrip, which was Beagle Bay, WA. He stated that the low oil pressure warning light illuminated so he shut the engine down and prepared for an emergency landing. The pilot reported that on the final approach to the airstrip he realised that the aircraft was too high and its airspeed was too fast. The aircraft touched down about mid way along the runway and overran the end of the runway by about 200 metres. The aircraft impacted a mound of dirt, coming to rest upside down (Figure 1).

The pilot, who was the only occupant sustained minor injuries. Examination of the aircraft by a third party and inspection of the photographs taken of the accident site, revealed that the engine, left main gear and nose gear had separated from the airframe during the accident sequence. There was a significant amount of oil present on the underside of the aircraft, indicating that the oil had leaked from the engine during operation. The engine was removed from the accident site as an assembly by a third party. The propeller was removed and the engine was shipped to an engine overhaul facility where a disassembly and examination was conducted under the supervision of the ATSB.

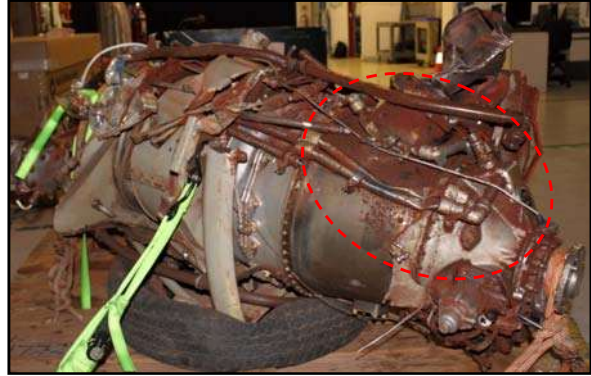
Figure 2: Engine assembly

External examination of the engine showed that red dust from the accident site had attached itself to the areas of the engine that had been contaminated with engine oil. It was apparent that there was a high concentration of oil on the outer surface of the reduction gear box between the 4 and 7 o'clock positions, the mid and rear sections of the engine were relatively oil free in comparison. Figure 2 shows the engine assembly as received at the engine overhaul facility, attached to a pallet with the bottom of the engine facing upwards; the highlighted area indicates a high concentration of oil contamination.

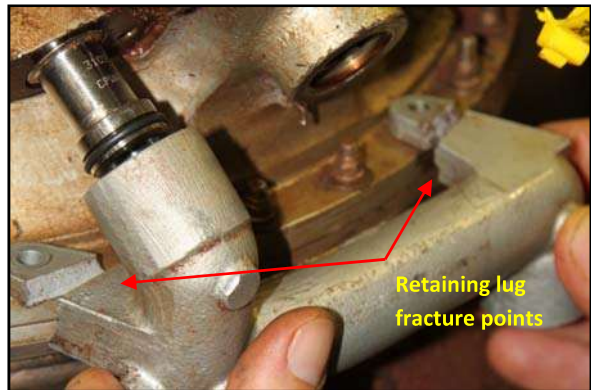
Figure 3: Oil transfer tube

The engine examination revealed accident damage to several components and oil lines. All of the engine's external oil seals were inspected with no pre-accident defects identified. The engine was disassembled at the hot section and accessory gear box, so an internal examination could be conducted. No pre-accident defects were noted during the internal examination. The accessory gear box chip detector, reduction gear box chip detector and the engine's main oil filter were inspected, with no foreign particles or debris noted in the oil system. Approximately 1 quart (0.92 L) of oil was drained from the engine, which had a normal operating capacity of 14 quarts (13.25 L). A sub section of oil pressure tube, that transferred oil from the oil pressure pump to the reduction gear box, was found to have fractured at both attachment lugs (Figure 3).

The factors that contributed to the oil transfer tube attachment lug failures could not be conclusively

identified during the detailed metallurgical examination. There was no evidence of fatigue cracking or a manufacturing defect that may have contributed to the failure.

The accident damage to the engine in the area of the apparent oil leak precluded a conclusive finding as to the source of the leak. Although the detailed examination of the oil tube attachment lug fracture surfaces was inconclusive, the oil tube remained the most likely source of the oil leak. Evidence from other oil tube failures indicated that significant vibratory loading can cause the oil tube attachment lugs to fracture in the manner observed in the oil tube fitted to VH-NTQ. There was

no evidence that the transfer tube was subjected to vibration from a compressor turbine or power turbine blade failure or of an incorrectly fitted engine mount. There was also no evidence of a pre-accident defect that would have caused a reduction in actual engine torque.

Following the accident, CASA issued an airworthiness bulletin, AWB 72-004 Issue 1, on 8 February 2010 to all Cessna 208 aircraft operators in Australia. The bulletin highlighted previous SDR failures and the possibility of the accident aircraft having experienced the same problem. The bulletin recommended the inspection of the engine oil transfer tube attachment lugs for cracks and the inspection of the engine vibration isolator mounts for correct installation. Any defects in the area of the vibration mounts and oil tubes were to be reported to CASA post inspection. At the time of writing this report one case of an oil tube with a loose fit and wear had been reported.
