**GUYANA CIVIL AVIATION AUTHORITY  
AIRCRAFT ACCIDENT INVESTIGATION REPORT  
RUNWAY EXCURSION ON LANDING**

**CARIBBEAN AIRLINES**

**BOEING 737-800**

**REPORT # GCAA: 2/5/1/63**

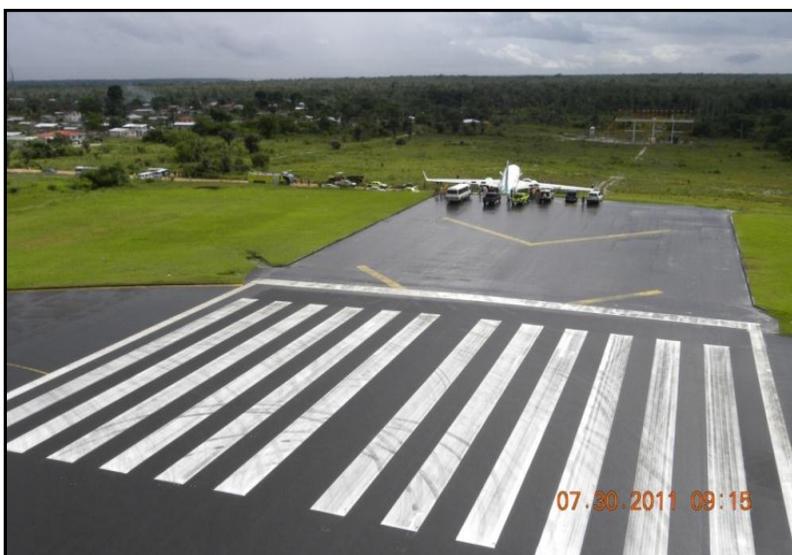
The aircraft came to rest approximately 130ft off the runway paved surface and 64ft left of the extended runway center line. The final aircraft heading was approximately 10° left of RWY06 center line. (Figs.5&6.)

**Fig.5: Location of Aircraft after accident**

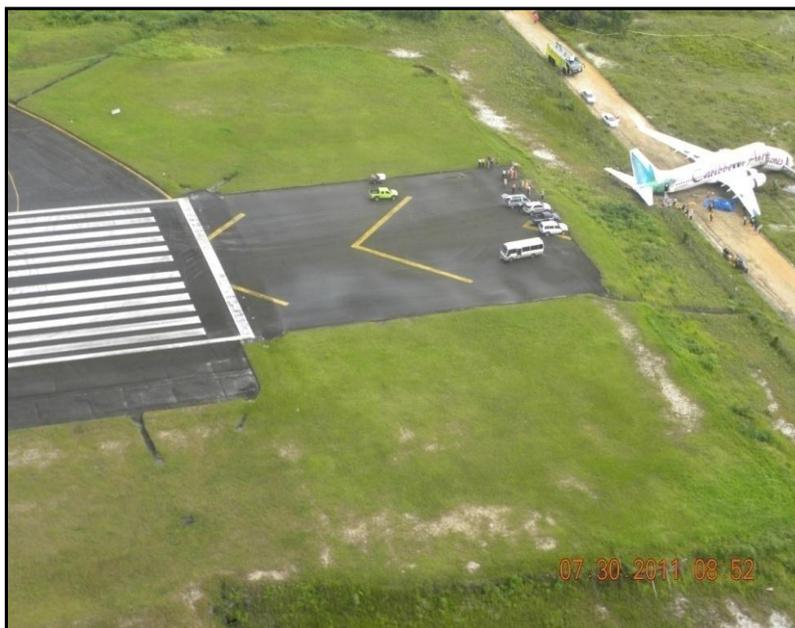
**Figure 6: The Aircraft's Final Heading was approximately 10° left of Runway 06**

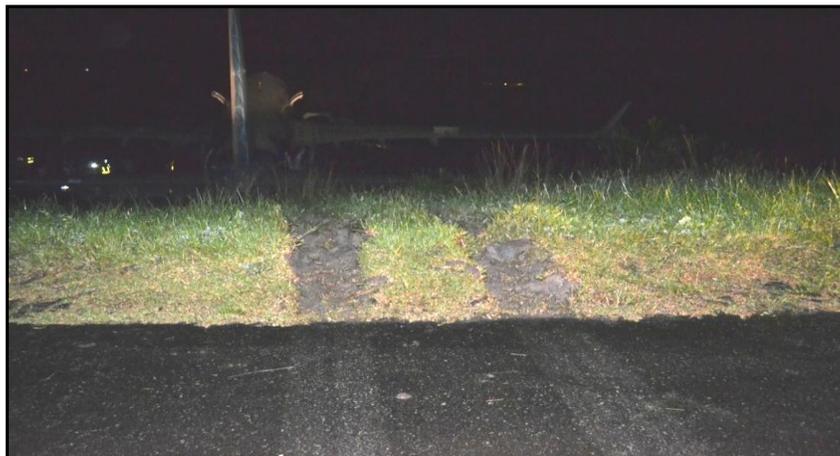
Main and nose gear tire marks were found in the dirt, immediately off of the asphalt (Fig.7). A set of main gear tire marks were found approximately 56ft off of the asphalt and down an embankment, 39ft in front of the airport perimeter fence, and then disappeared. These were approximately 8ft long and 2ft deep. Nose gear tire marks were not found at this location.

**Figure 7: Under carriage tire marks off the runway.**

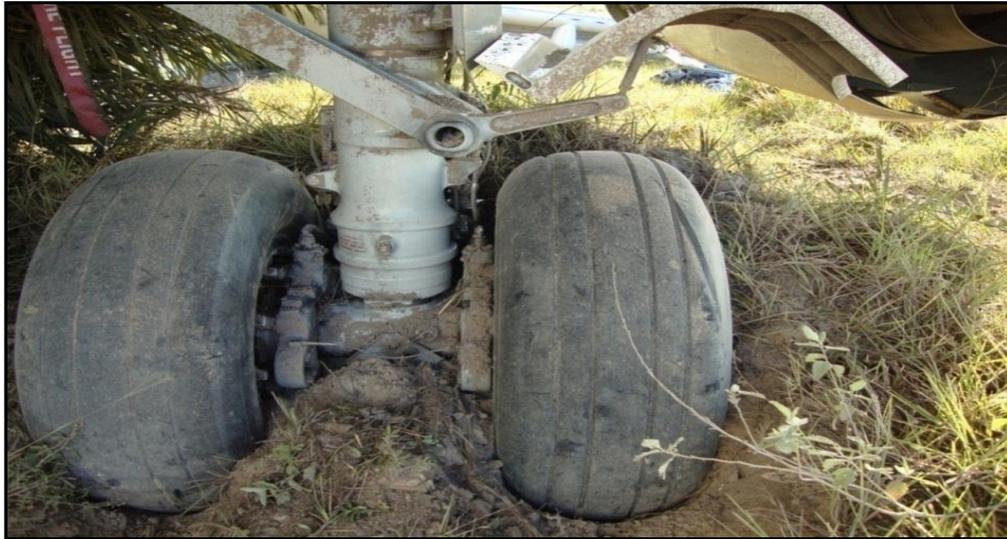
A 20ft wide dirt road located 15ft beyond the perimeter fence had no tire marks until its far side. A berm (i.e., dirt road shoulder) on the far side marked the final resting position of the main landing gear tires. The berm was located 74ft beyond the main gear tire marks found in the dirt. See Figures 8&9.

**Figure 8: A Dirt Berm Marked the Final Resting Position of the Main Gear Tires**

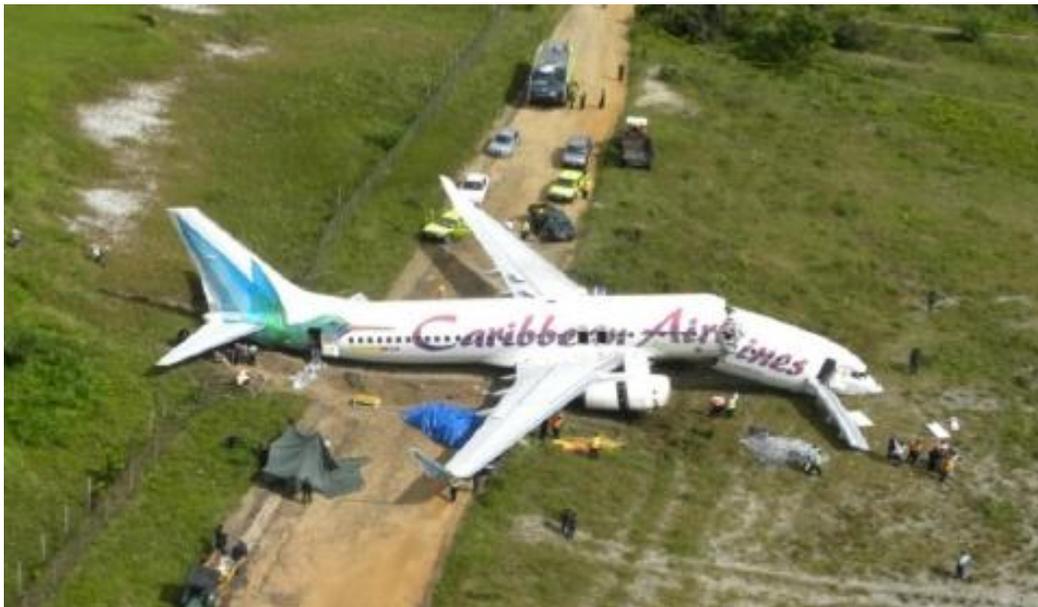
**Figure 9: Final position of aircraft across a 20ft Wide Dirt Road.**

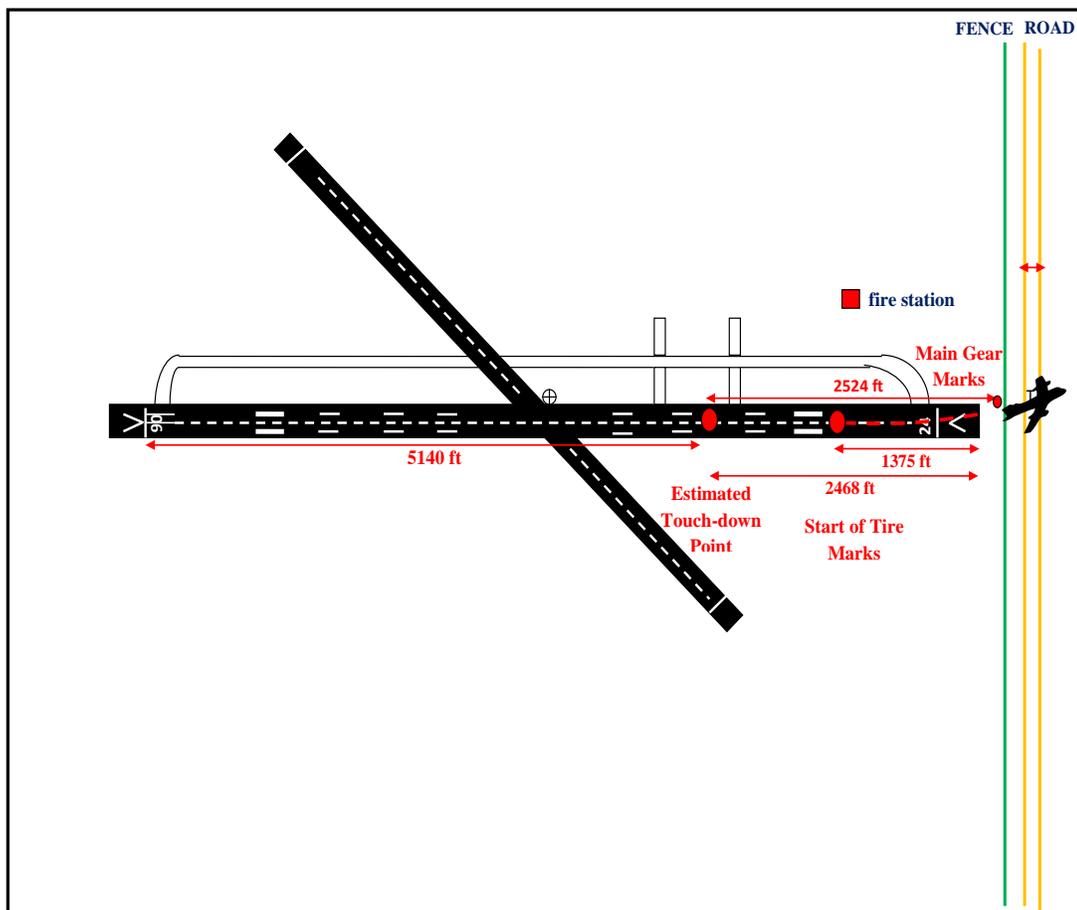
**Figure 10: Estimated Main Gear Touch-down Point**

Figure 10 highlights the estimated main gear touch-down point, the tire marks on the runway, and the final position of the aircraft. The figure shows

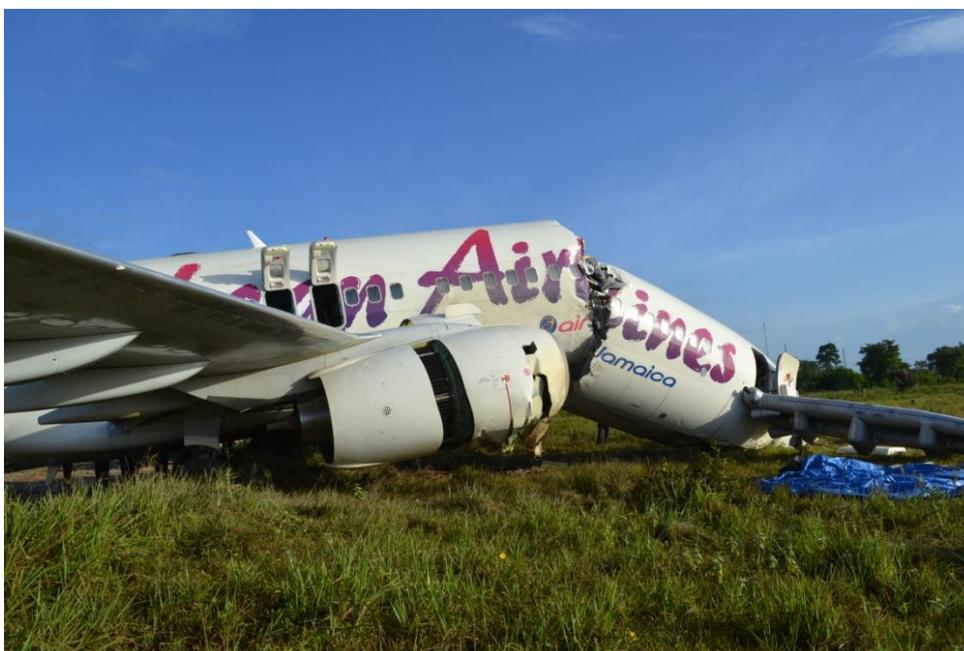
The forward fuselage partially broke aft of the first class cabin, and the nose was found resting on the ground. The aircraft flaps and slats were retracted. The nose wheel gear was pushed backwards (opposite the normal retraction direction) into the fuselage where avionics and electronics are housed. The thrust reverser doors were found partially extended on both engines.

**Figure 11: Showing break in first class cabin, deployed R1 slide, and open right over wing emergency exits and partially extended thrust reverser door**

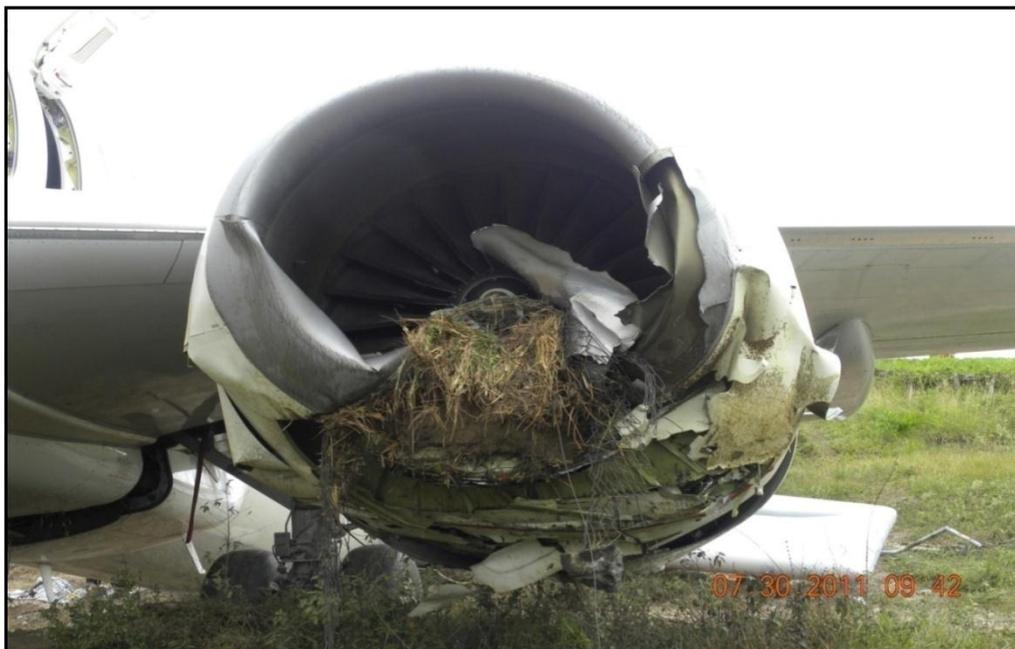
Barbed wire and airport perimeter fence mesh were found attached to the left engine nacelle. Mud and grass were found on both nacelles. See Figure 12. Figures 13&14 are included for additional perspective.

**Figure 12: Mud and Grass were found on Both Nacelles**

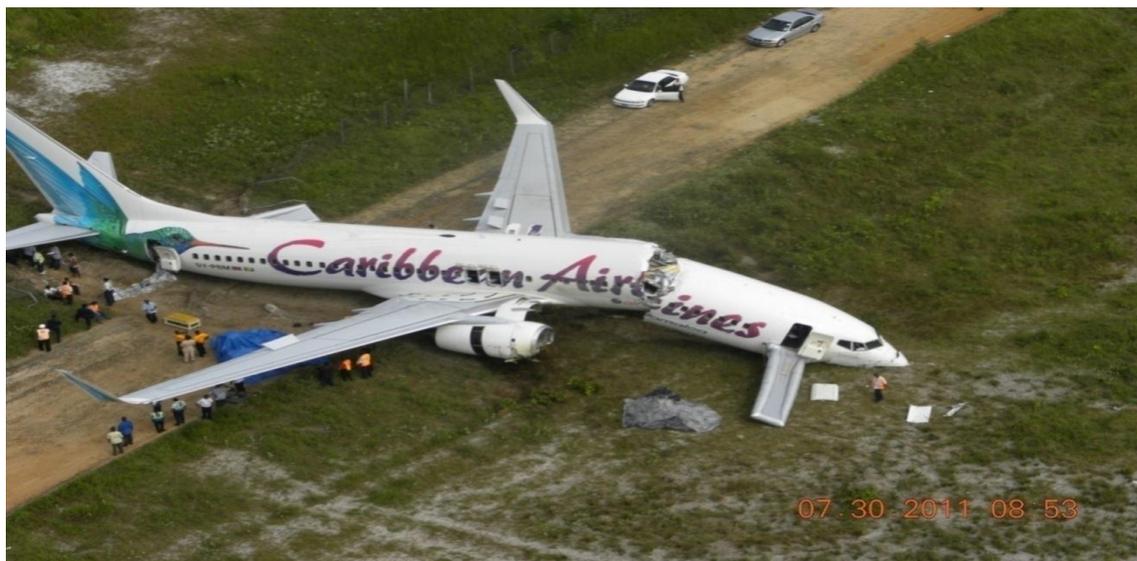
**Figure 13: Egress Slides on Right Side Deployed**

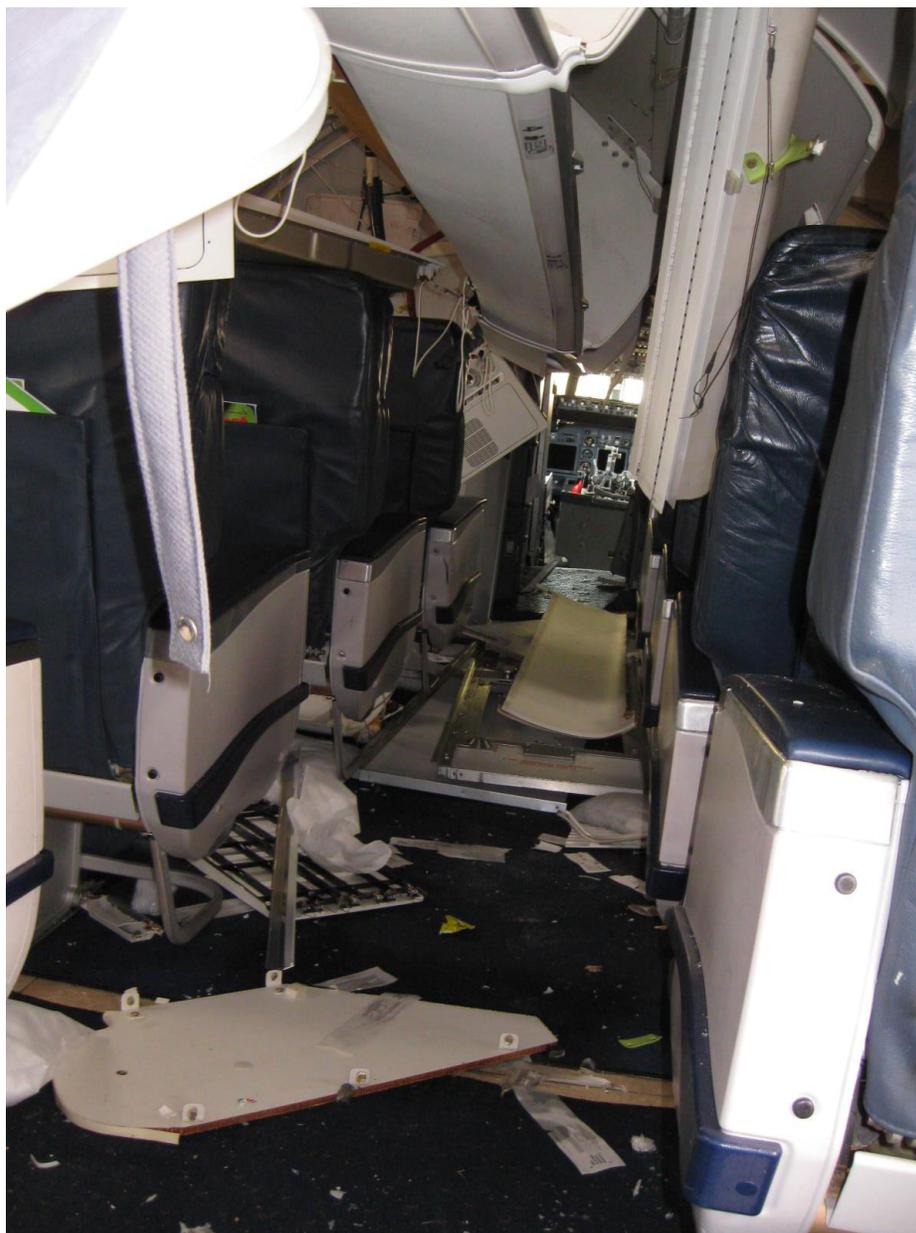
Damage to the support structure varied, and included torn metal brackets, snapped turnbuckles, and broken bushings. This damage was evident on both the stow bins and aircraft interfaces. The brackets and fasteners that attached the stow bins to one another were still intact, although, some showed evidence of bending stress in either the panels or the brackets.

The bins from the left side were resting over the aisle, supported by the open bin doors and passenger seats. The bins from the right side were resting on the seat backs on the right side of the cabin (Figure 15).

**Figure15: Cabin forward of the fuselage break; left stow bins resting over the aisle (looking forward).**

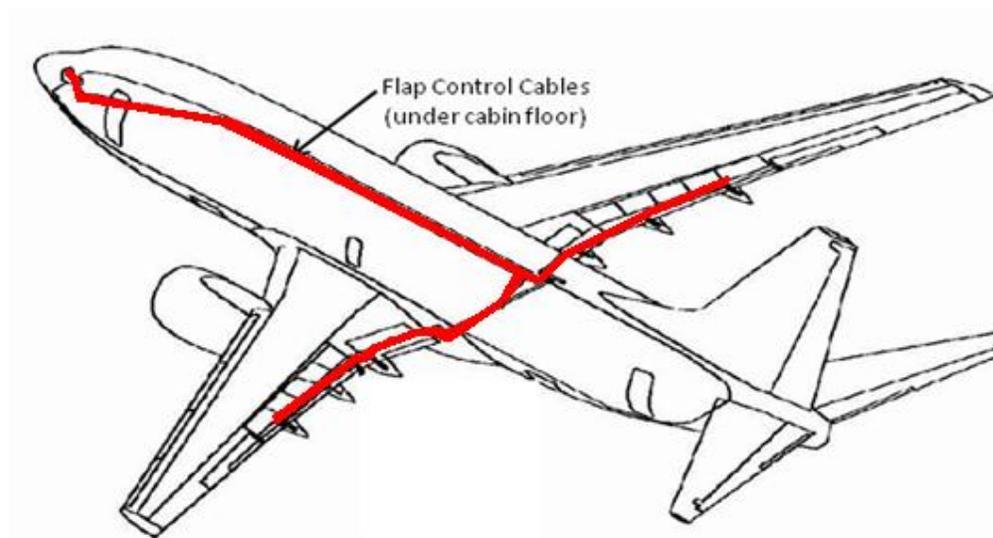
The flap control lever and flap position indicator in the cockpit indicated 30°. Further investigation revealed the cable operated by the flap control lever was moved due to the aircraft fracture, resetting the FCU to the 0° position.

**Figure16: Flap Control Cables in normal position**

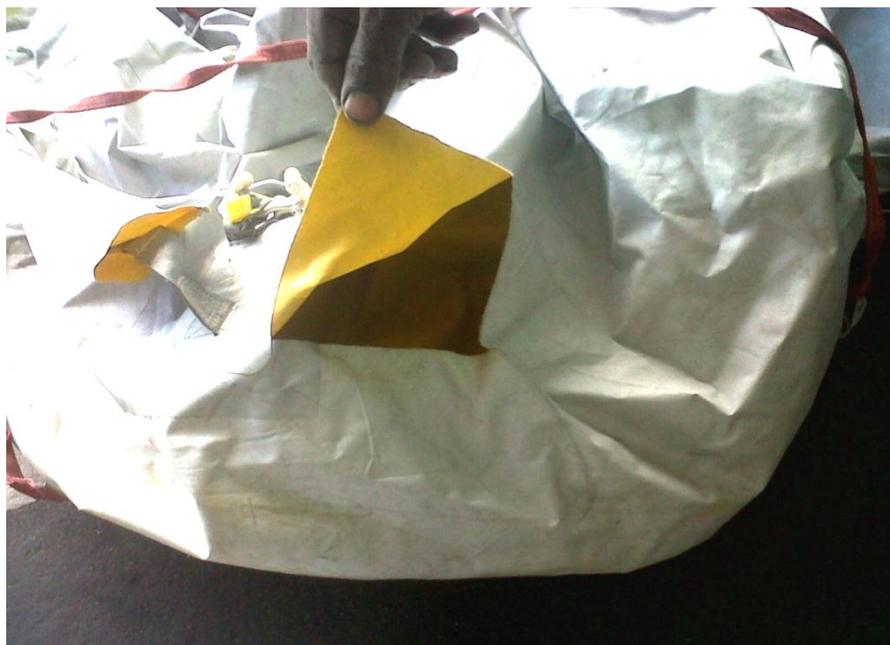
The R2 emergency slide which was partially deployed, and had a large fabric tear on the underside of the slide, was shipped to the manufacturer, Goodrich Service Centre in Phoenix Arizona for testing. It was concluded that the slide was damaged on deployment, after inflation had commenced. The damage prevented further inflation.

**Figure 17: Showing tear in R2 slide**

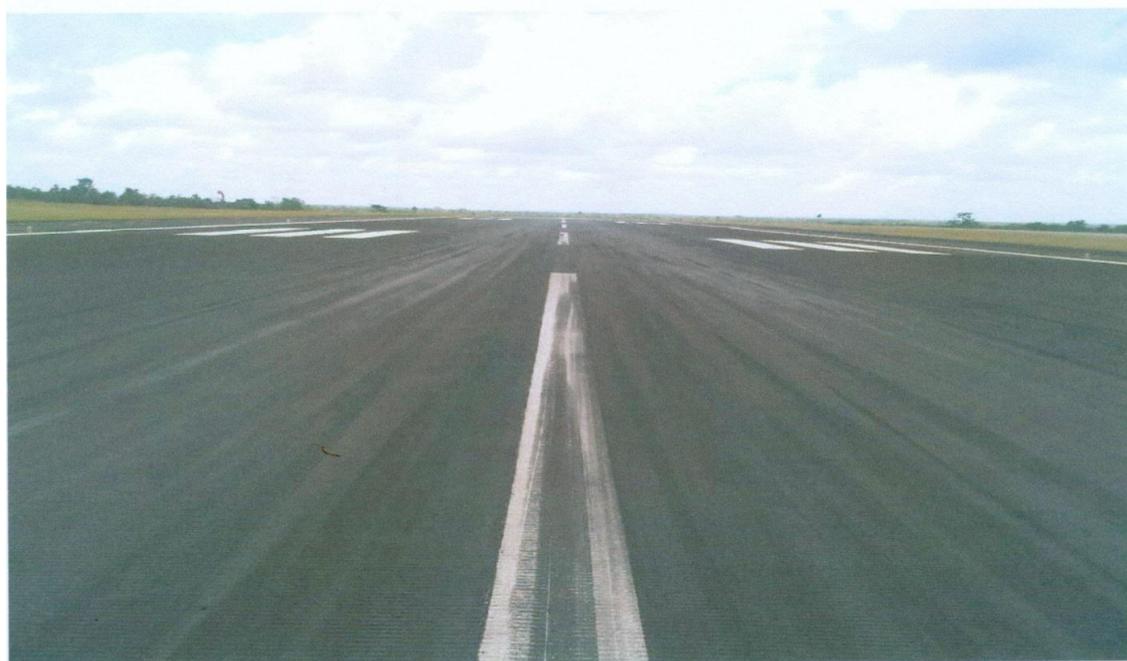
Photo No.2 shows runway 06 (Discoloration of paint markings)

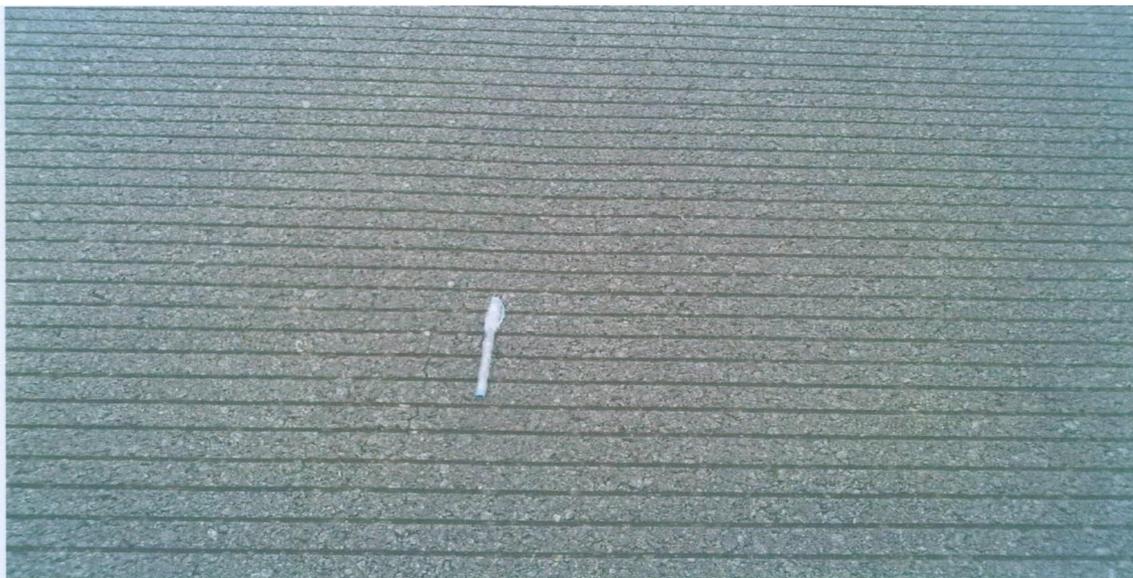
Photo No.3 Transverse grooving on the 06-24 runways (pen is to establish scale)
