AIRCRAFT ACCIDENT REPORT

SEIL/2011/05/24/F

**Report on the accident involving a Beechcraft C90
with nationality and registration marks N364UZ
operated by Shoreline Energy International Limited
which occurred at Barakallahu village near Old
Kaduna (Military) Airport, Kaduna State, Nigeria on
24th May, 2011.**

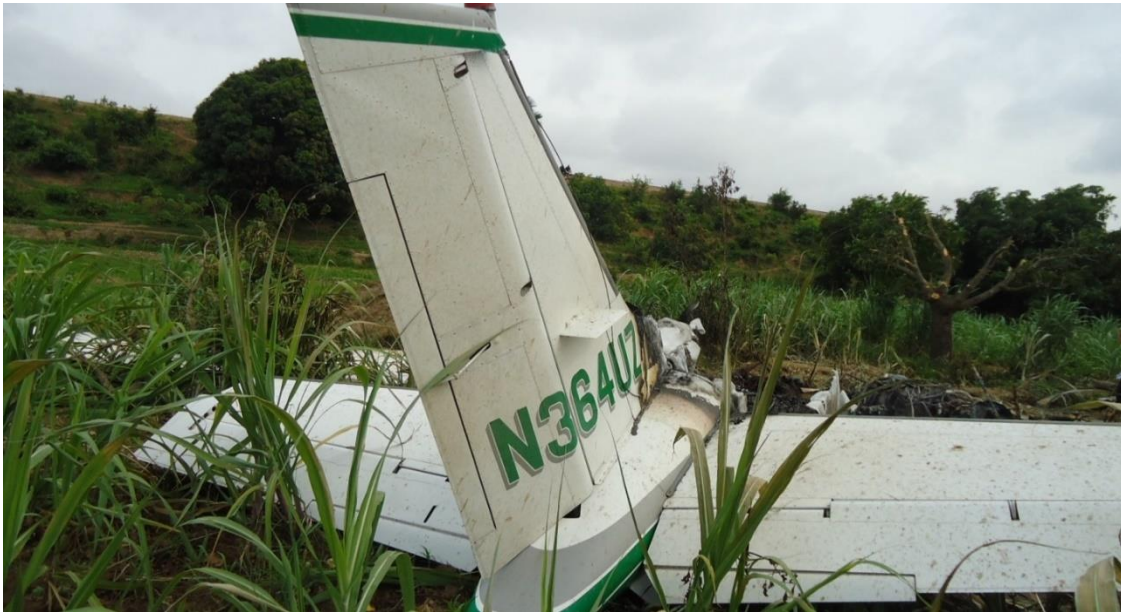
Figure 3: Aircraft wreckage in relation to mango tree

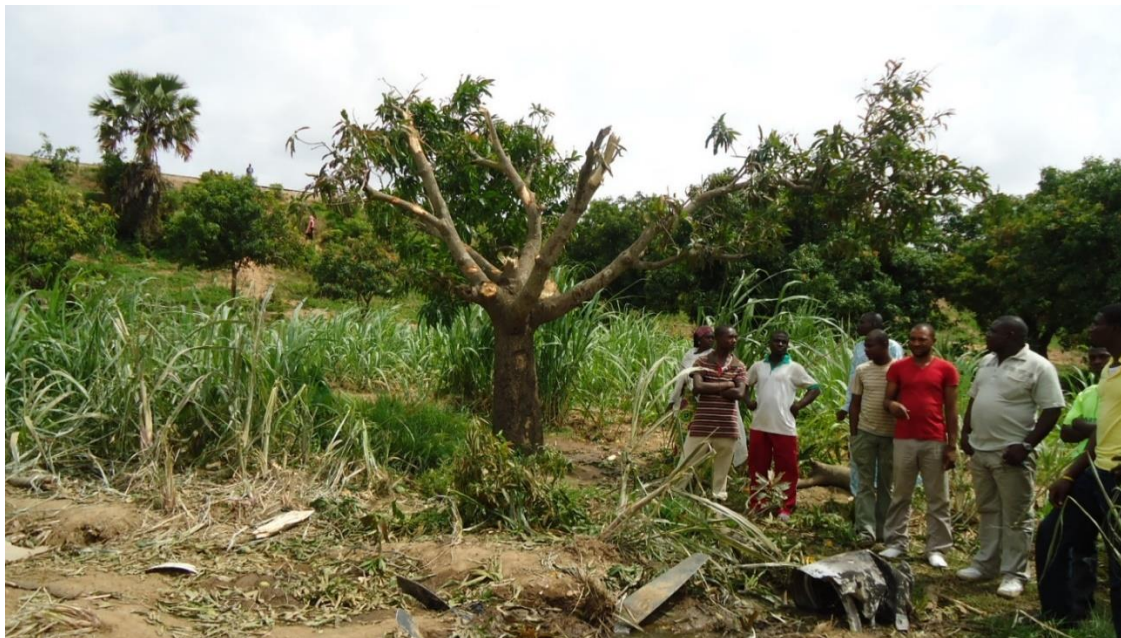
Figure 4: The Mango tree impacted by the aircraft before the crash

On finals the aircraft impacted a mango tree at a distance of about 878 m from the runway threshold. The right propeller assembly separated from the engine and was found partially embedded in the ground, while the left propeller remained attached to the engine. For the aircraft to be at a very low altitude to strike a mango tree at a distance of about 800 m to the runway threshold; it was an indication that either the aircraft was gliding or the engines were operating at very low rpm (revolution per

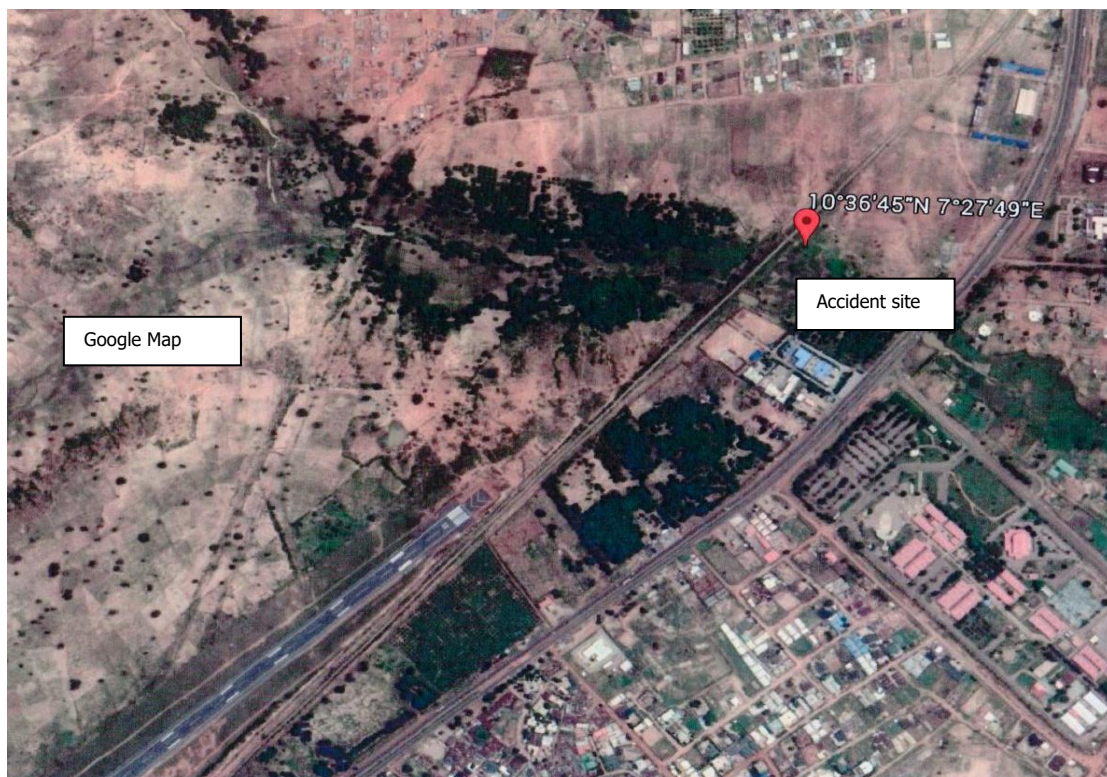
The aircraft was engulfed in flames after the crash which raged on for several minutes before the arrival of the rescue team thus consuming most of the aircraft as there was an existing rail track that obstruct the fire trucks from reaching the aircraft on time. However, Nig. CARs 12.6.15.2 stipulates that rescue and fire-fighting personnel should have access to areas that extend to 1000m beyond the ends of the runway and outside the aerodrome boundary.

Figure 7: Location of the accident site in relation to runway
