**COMMAND OF AERONAUTICS**  
**AERONAUTICAL ACCIDENT INVESTIGATION AND**  
**PREVENTION CENTER**

**FINAL REPORT**  
**A - 050/CENIPA/2014**

<b><u>OCCURRENCE:</u></b>	<b>ACCIDENT</b>
<b><u>AIRCRAFT:</u></b>	<b>PP-WCA</b>
<b><u>MODEL:</u></b>	<b>C-90 A</b>
<b><u>DATE:</u></b>	<b>20 April 2012</b>

This is the Final Report of the accident with the C-90A aircraft, registration PP-WCA, on 20 April 2012. The accident was classified as loss of control in flight.

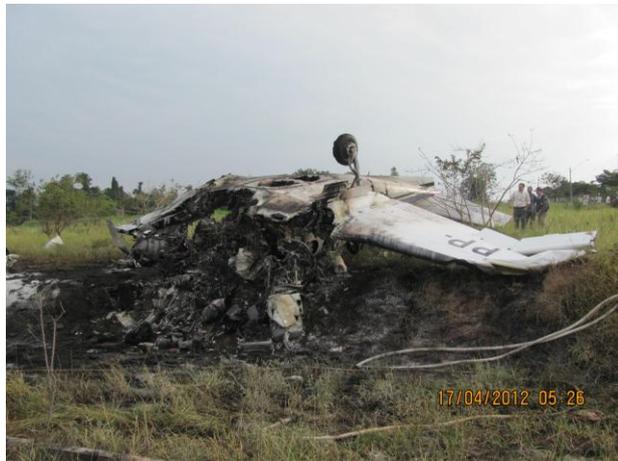
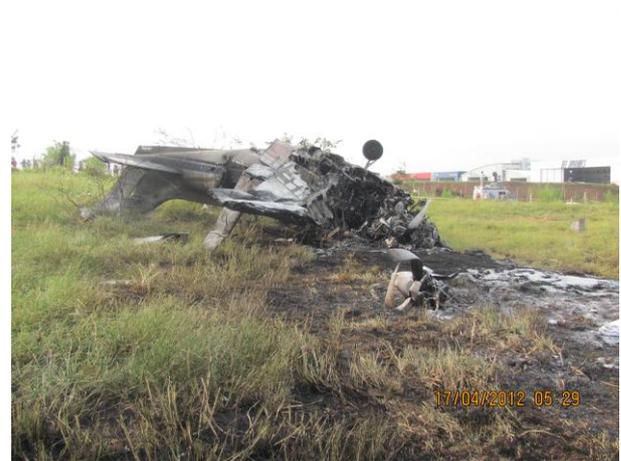
The aircraft crashed in an inverted position (upside-down), with the landing gear extended. A post-impact fire occurred.

Figures 1 and 2 – Situation of the aircraft after impact with the ground.

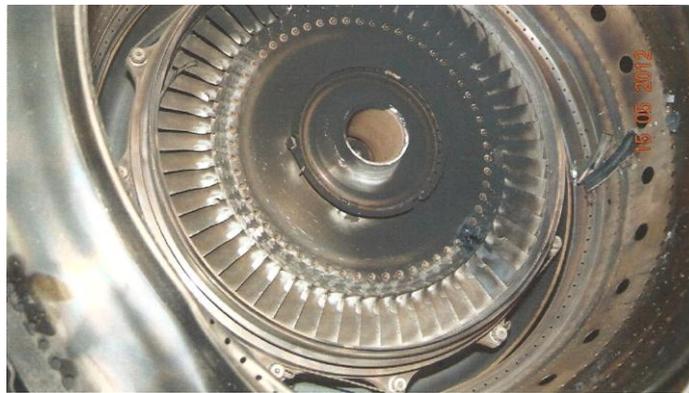
Marks of rubbing were identified in the root of the blades of the gas generator turbine rotor. In addition to the marks, small fractures could be observed in the tips of the blades.

Figure 3 – View of the right engine rotor.

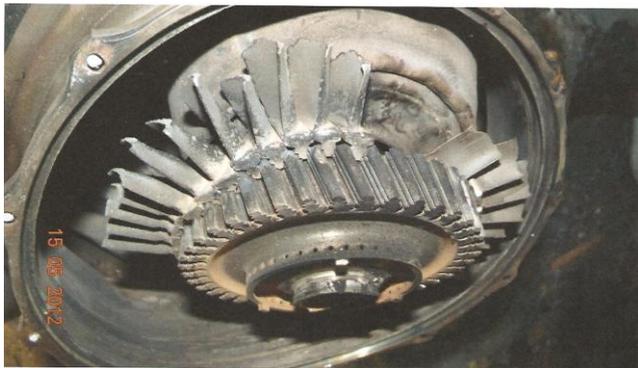
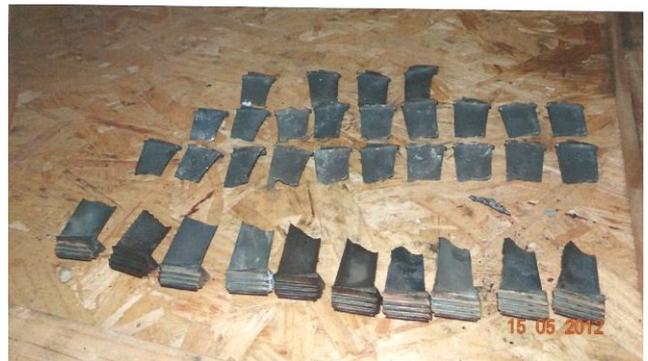
The power turbine rotor of this engine was found with all blades fractured in a mid-position relative to their length. Such signature is compatible with an engine that was not developing a high level of power upon impact, with a resulting abrupt stop.

It is possible to affirm that the right engine power level at the moment of the accident was between medium and low.

Figures 4 and 5 – General view of the power turbine rotor, and the fractured blades of this assembly.

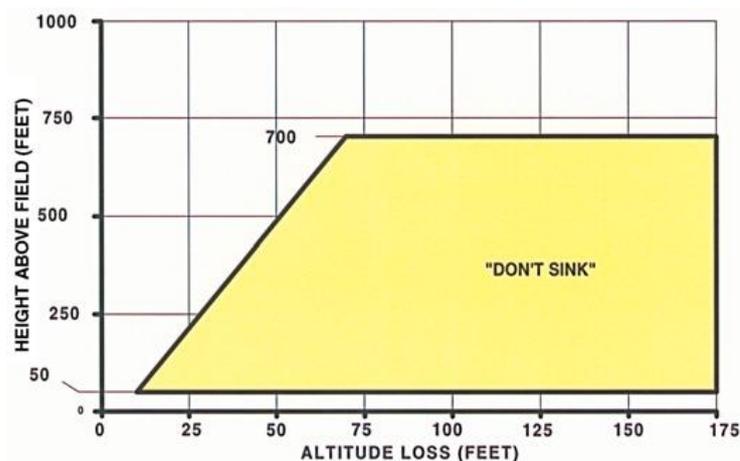
After departure, the pilot requested return to the airfield, declaring emergency on account of a possible failure of the landing gear. It was possible to verify, from the CVR recording, the activation of the EGPWS warning – *Don't Sink!*

Figure 6 – Graph of the EGPWS operation – *Don't Sink*.

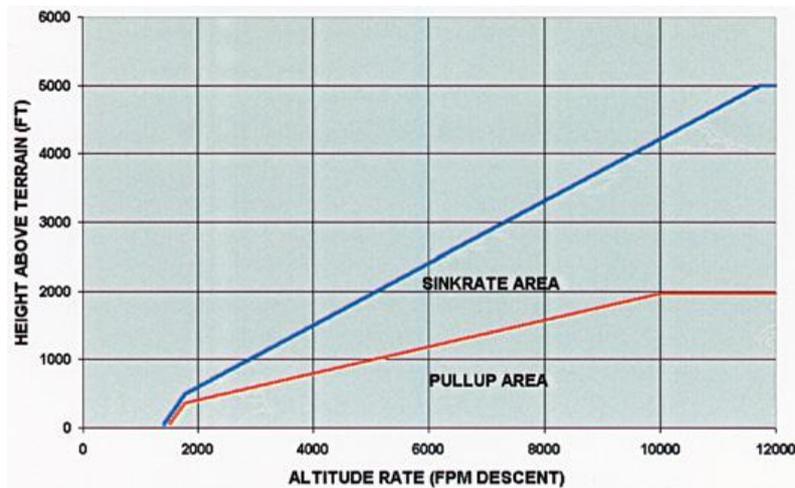
The pilot lowered the landing gear, and the Pull Up call-out became evident to him. This system is activated whenever an obstacle is detected at a distance corresponding to 30 seconds ahead of the aircraft.

Figure 7- Graph of the EGPWS operation – Pull Up.

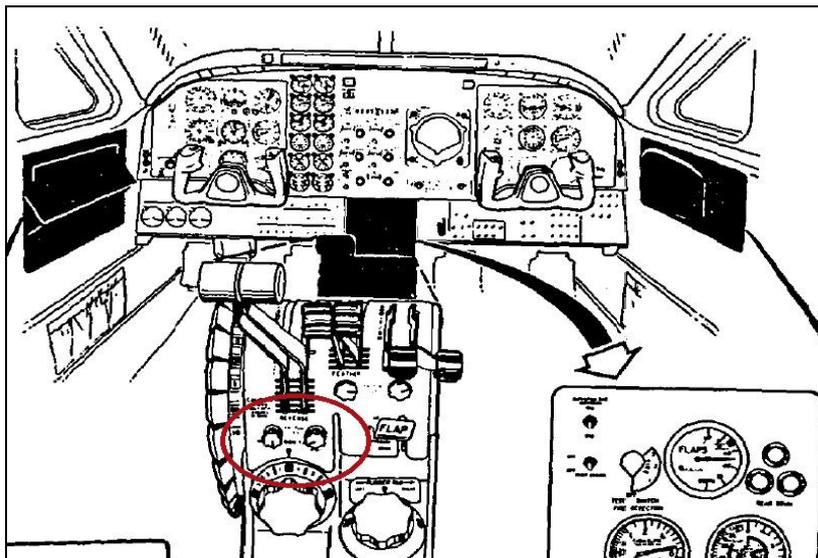
Figure 8 – View of the frictions of the power levers.

The power levers assembly of the aircraft had a double friction mechanism, allowing for an individual setting of the levers.

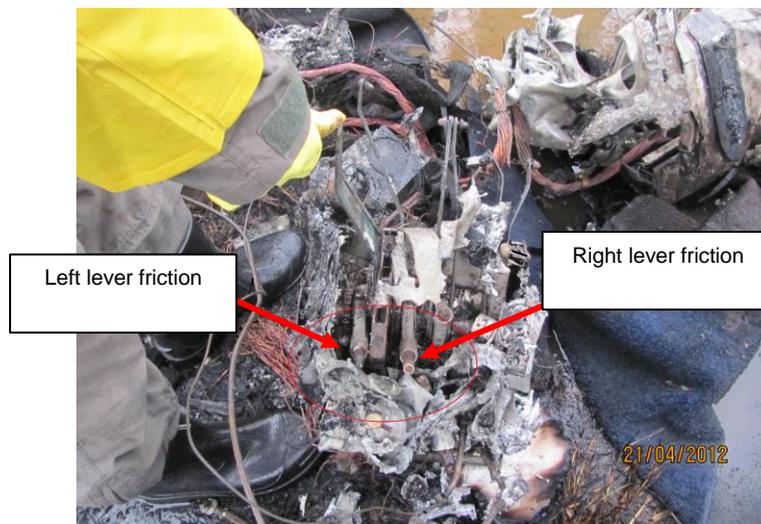
Figure 9 – In-detail view of the power lever frictions after the occurrence.

The power lever of the left engine was found with a maximum friction setting, where the power lever of the right engine was found with a minimum friction setting.

The friction of the left engine power lever was found with a minimum setting. The friction setting of the levers is part of the Before-Takeoff Checklist. This check may not have been done by the pilot, since he lacked adequate training for the operation of this type of aircraft and was, therefore, not qualified.
