**MINISTRY OF TRANSPORT,  
CONSTRUCTION AND MARITIME ECONOMY  
STATE COMMISSION ON AIRCRAFT ACCIDENT INVESTIGATION**

**FINAL REPORT**

**Occurrence No: 835/2011**

**Aircraft: ATR-72 airplane, registration marks: SP-LFH**

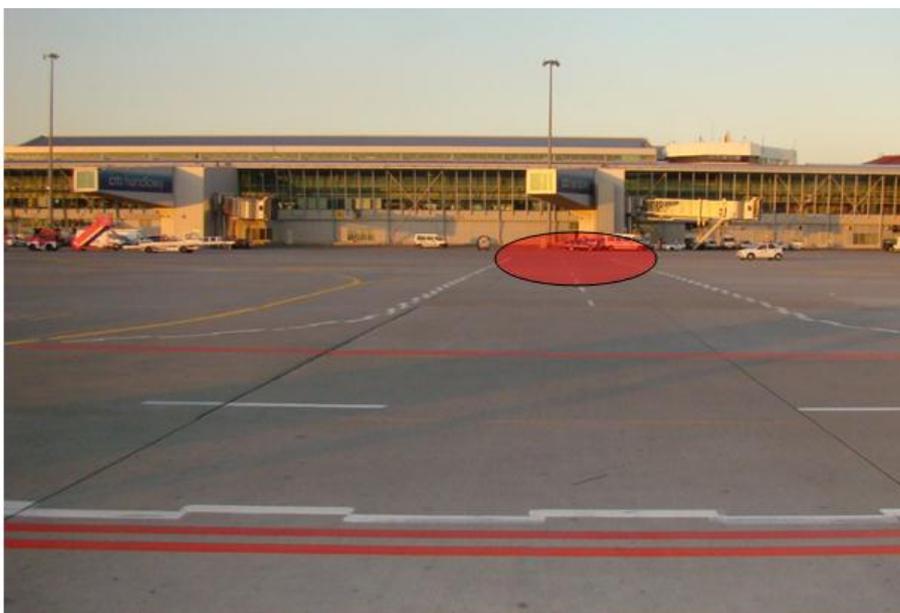
Photo No. 1 (SCAAI)

Collision site

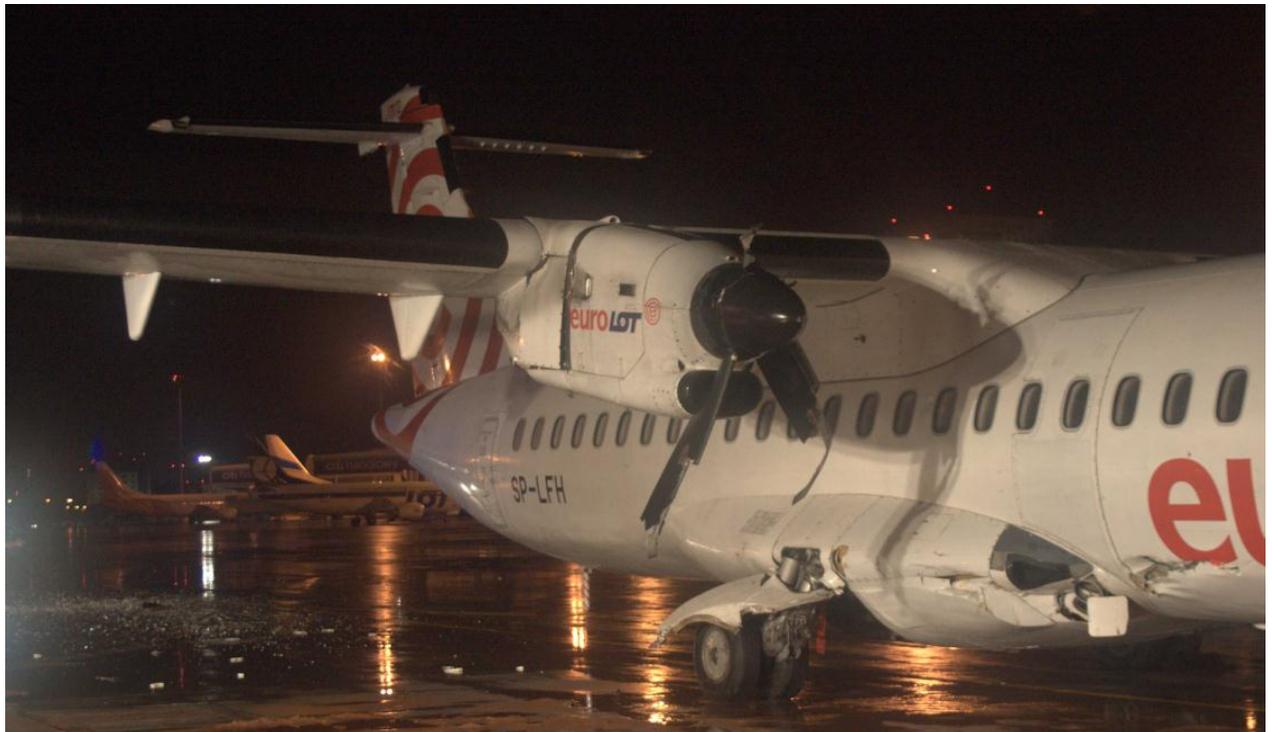
**Photo 2. Wreckage in the area of the occurrence site . (photo by “Polish Airports” State Enterprise)**

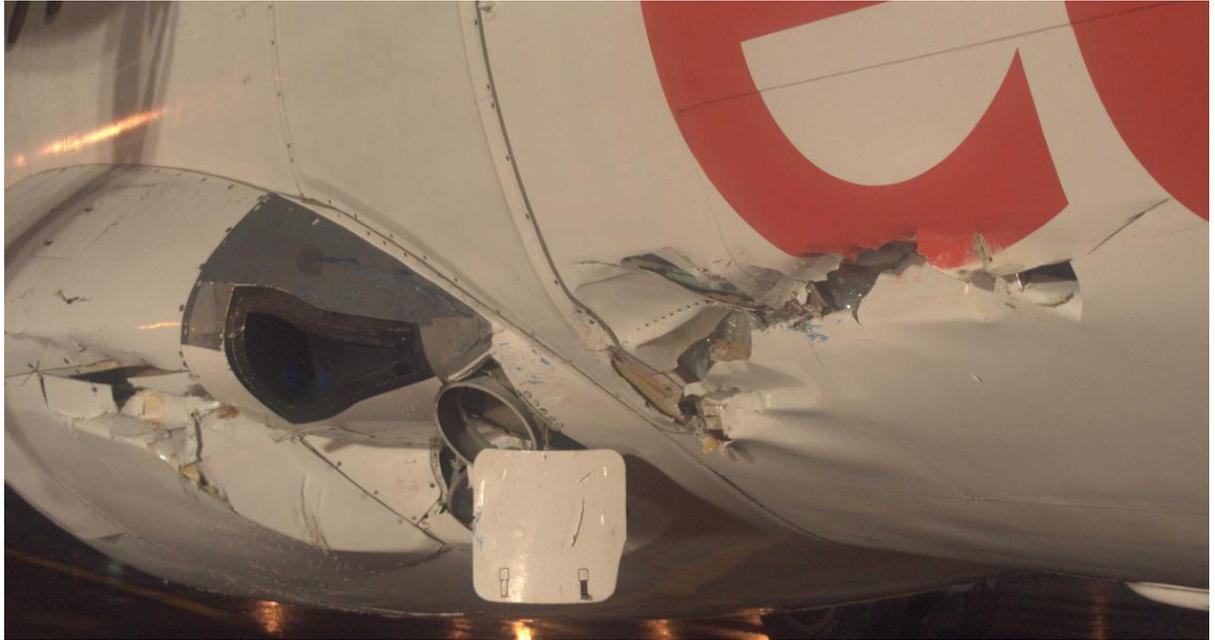
As a result of the collision the right engine of the aircraft with its 4-blade propeller, fuselage skin in the area of the right main landing gear gondola and the upper part of fuselage (hit by the propeller blade) were substantially damaged. The airplane was withdrawn from the further service.

**Photo 3. Damaged the landing gear gondola and the fuselage skin. (photo by LS Airport Service S.A.)**

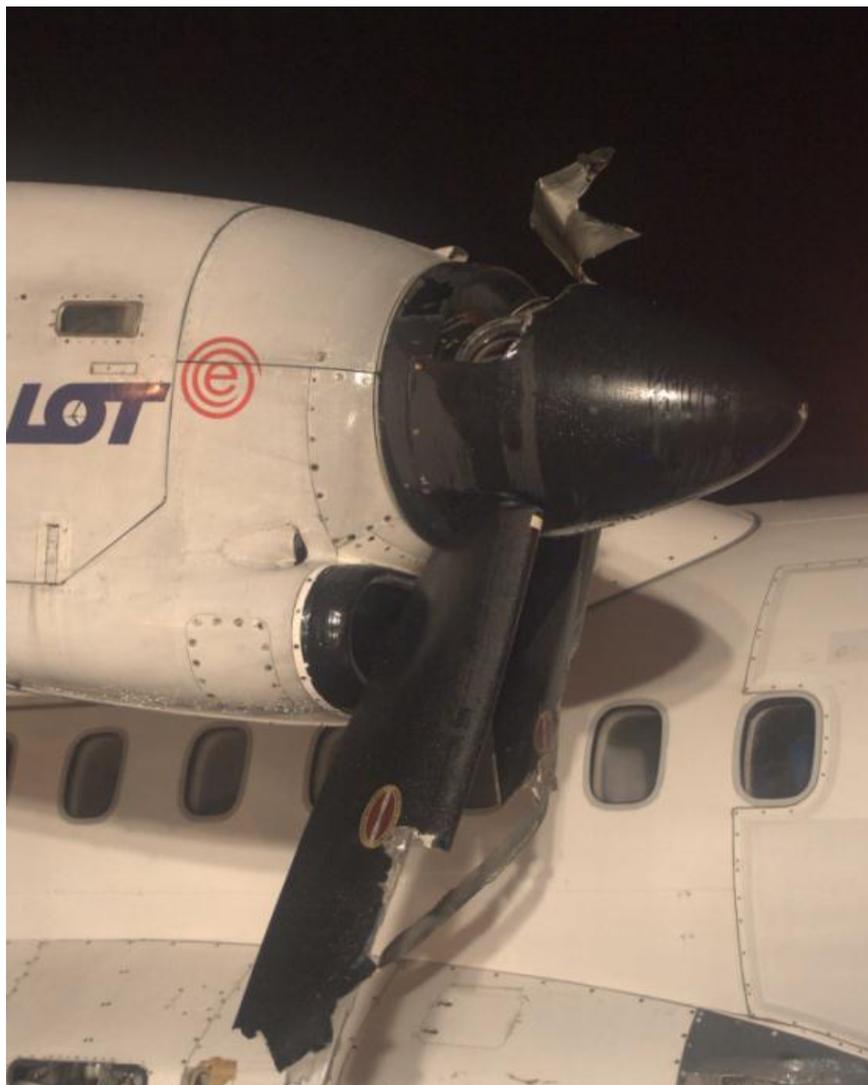
**Photo 4. Damaged propeller. (photo by LS Airport Service S.A.)**

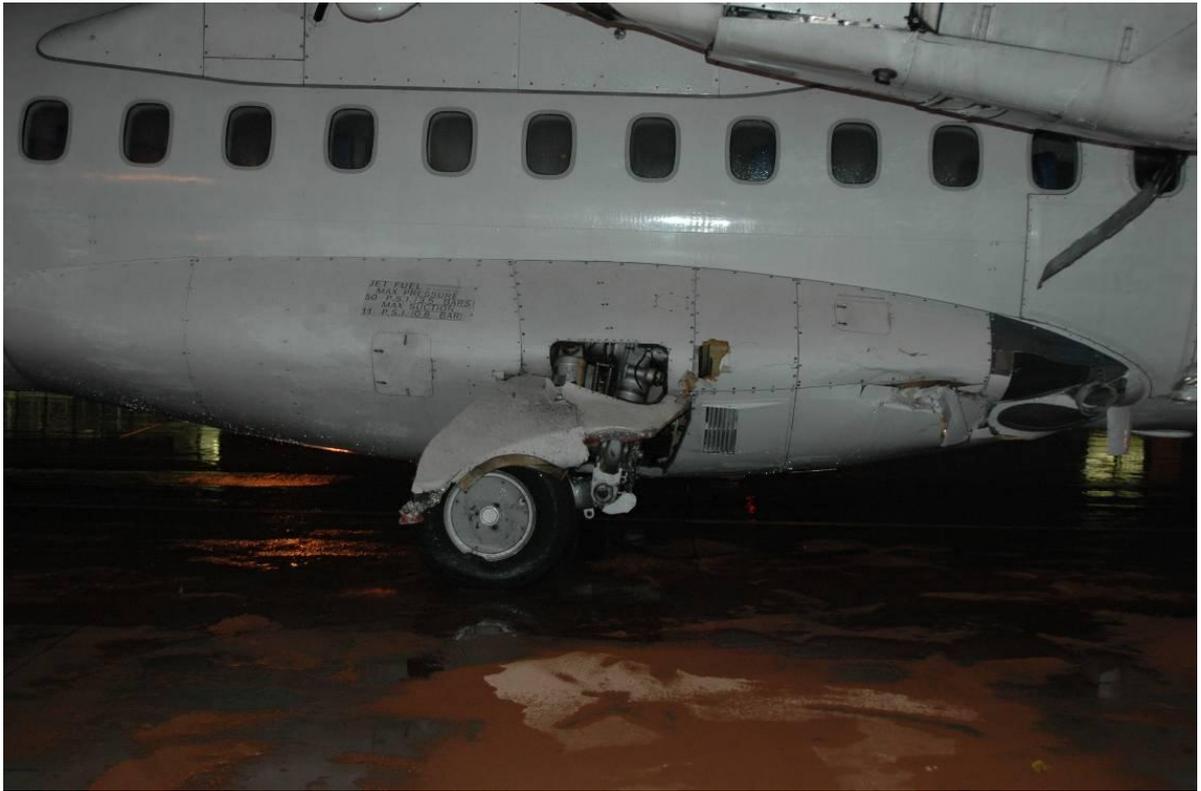
**Photo 5. Damaged gondola of the right main landing gear (photo by “Polish Airports” State Enterprise)**

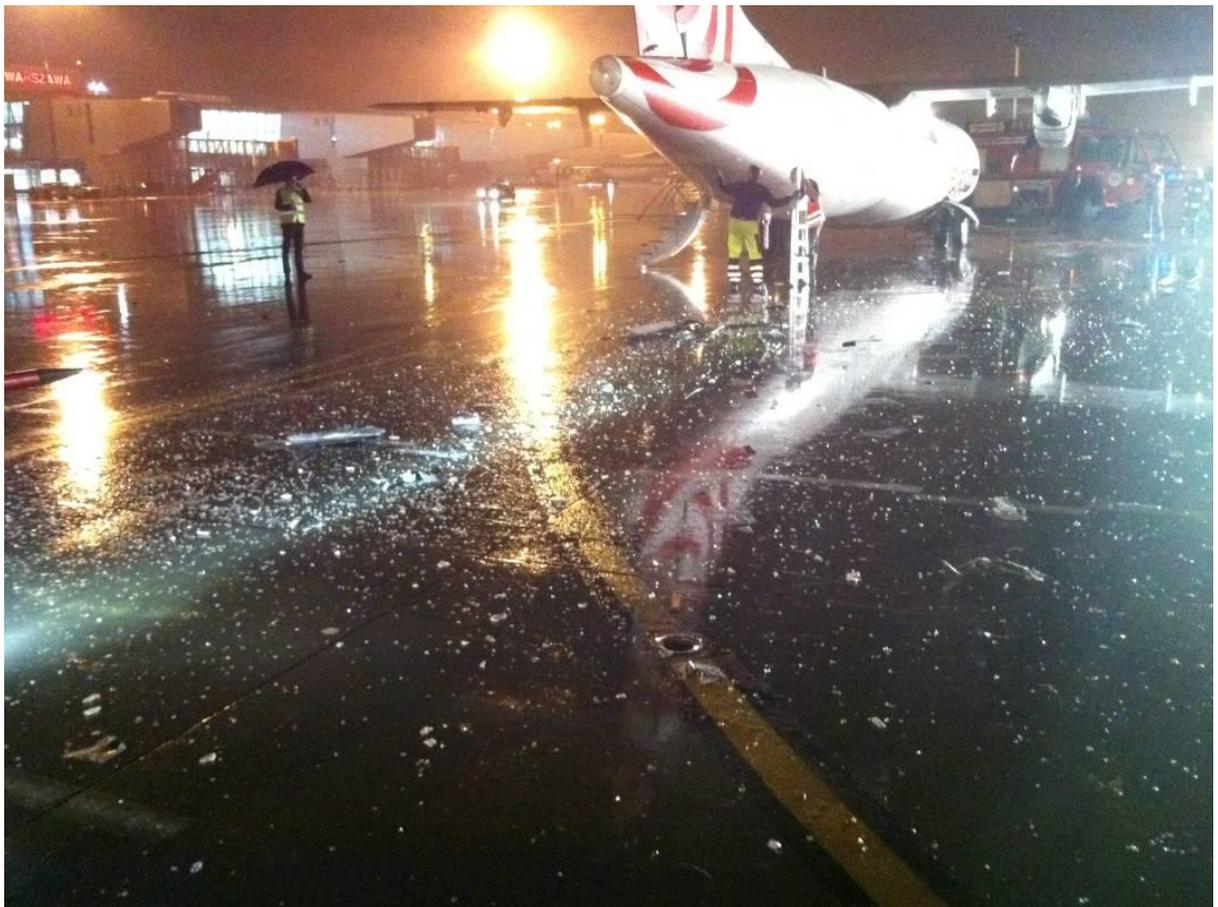
**Photo 6. Wreckage of the airplane and the tractor in the collision area (photo by “Polish Airports” State Enterprise)**

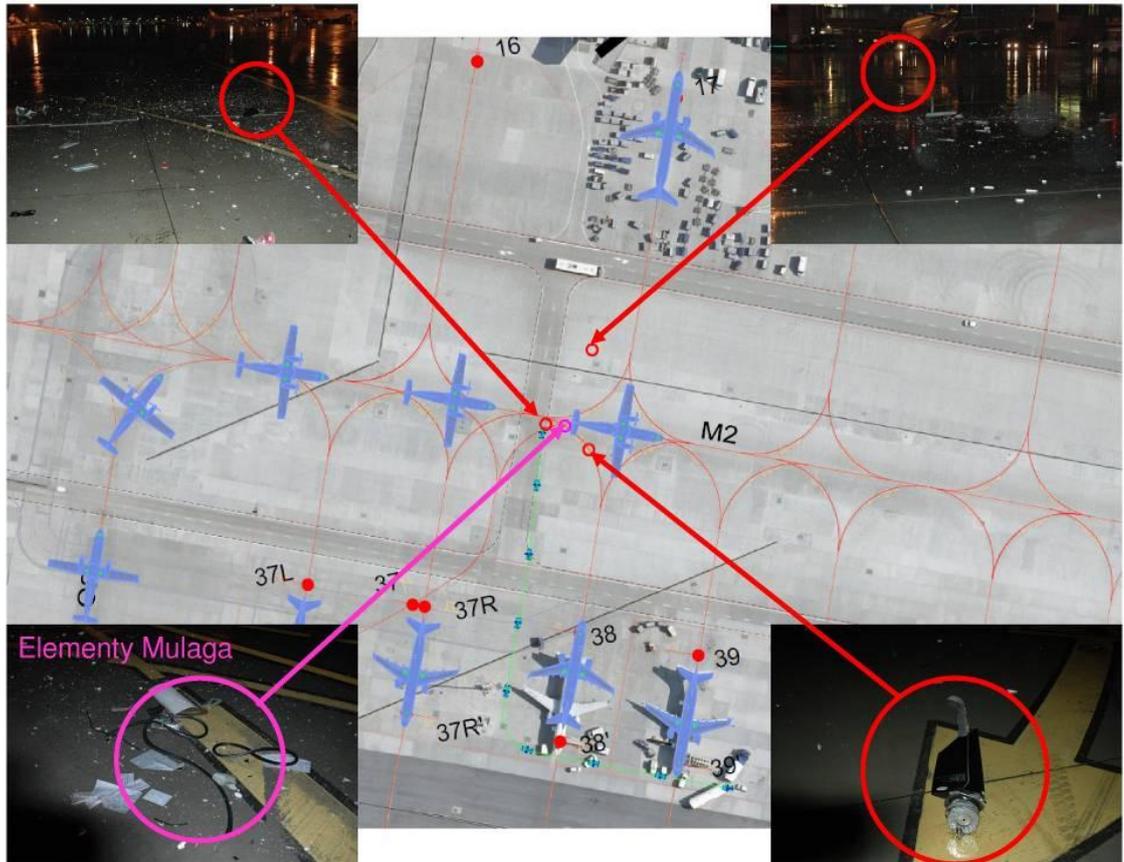
Sketch 1. Location of parts of the propeller blades and elements of the "Mulag" tractor (by "Polish Airports" State Enterprise)

To estimate the hazard of damage to other aircraft three concentric areas were marked around the occurrence site: I - with a radius of 50 m, II - 75 m, and III - 100 m (Sketch No 1). According to the available photographic documentation, the largest number of wreckage of large and medium size were found in area I. It should be assumed that a number of smaller elements could probably be found in the area II and perhaps also in the area III.

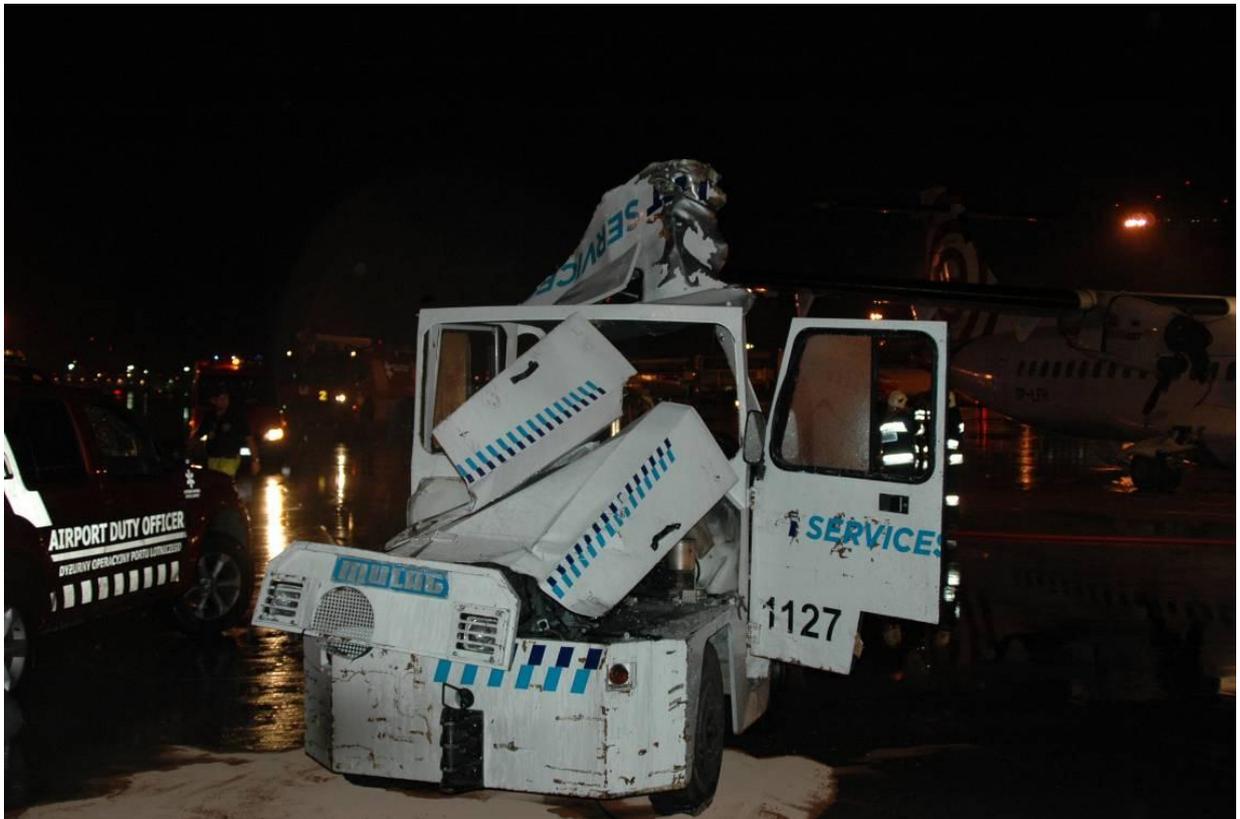
As a result of the collision the cab roof, engine cover and cab windows were substantially damaged. The tractor was withdrawn from the further service.

Photo 7. Damaged "Mulag" tractor . (photo by "Polish Airports" State Enterprise)

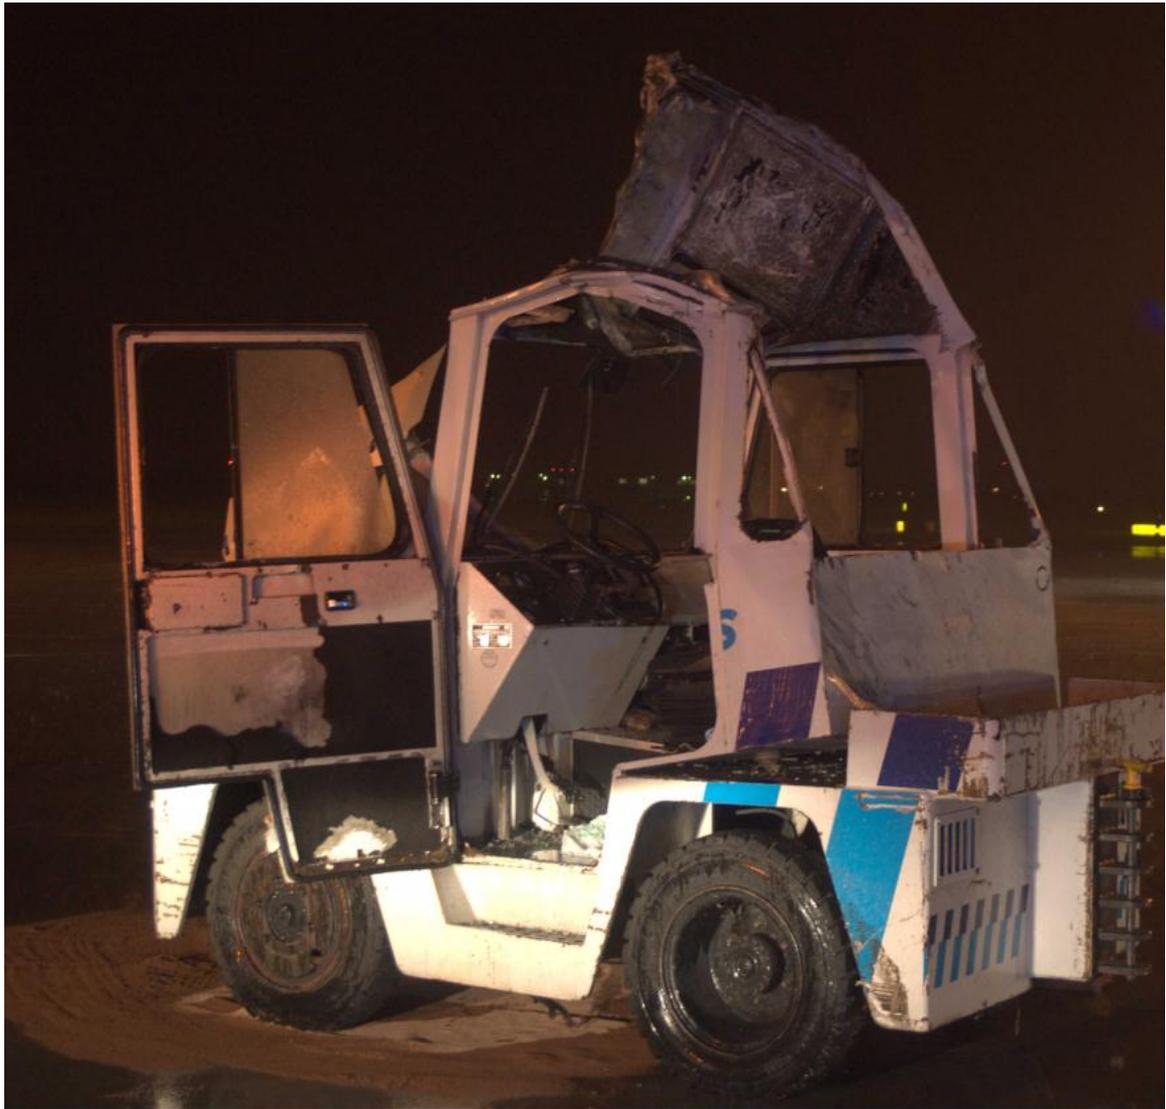
**Photo 8. Rear cover damaged by the propeller (photo by LS Airport Service S.A.)**

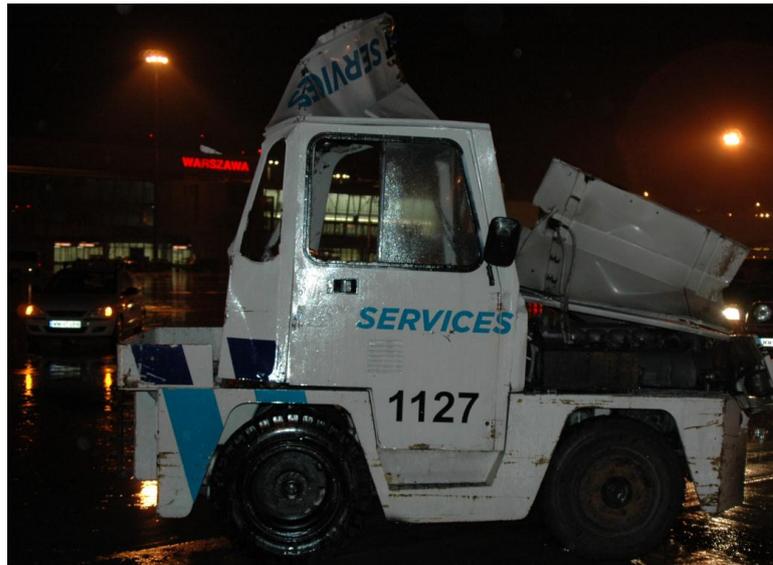
Collision with the airplane ATR 72 occurred at the intersection of the service road with taxiway "M2". During the accident there was heavy rain and lightning at the aerodrome. Despite the rain in the course of driving the tractor operator kept the side window in the left door opened in order to improve visibility. This is documented in Photo No 9 made shortly after the accident.

Photo 9. Damaged Mulag tractor with the side window opened. (photo by “Polish Airports” State Enterprise)

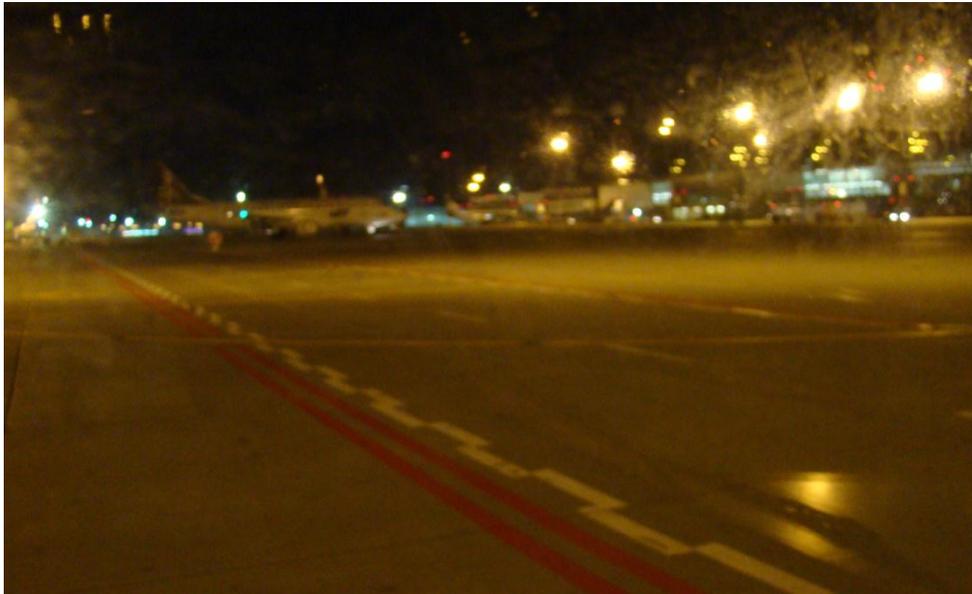
Photo No 10 shows the position of Embraer airplane beginning a turn from taxiway "O2" in taxiway "M2". Based on recording from CCTV camera No 1, when the ATR was approximately at Embraer place, the "Mulag" slowed down approaching the safety line on the parking apron at stand 38 (Recording No 1). Probably at this time, the tractor operator looked to the right at the service road parallel to taxiway "M2", which he wanted to take following the service road

Photo 10. A plane taxiing by taxiway „O”. (photo by SCAAI)

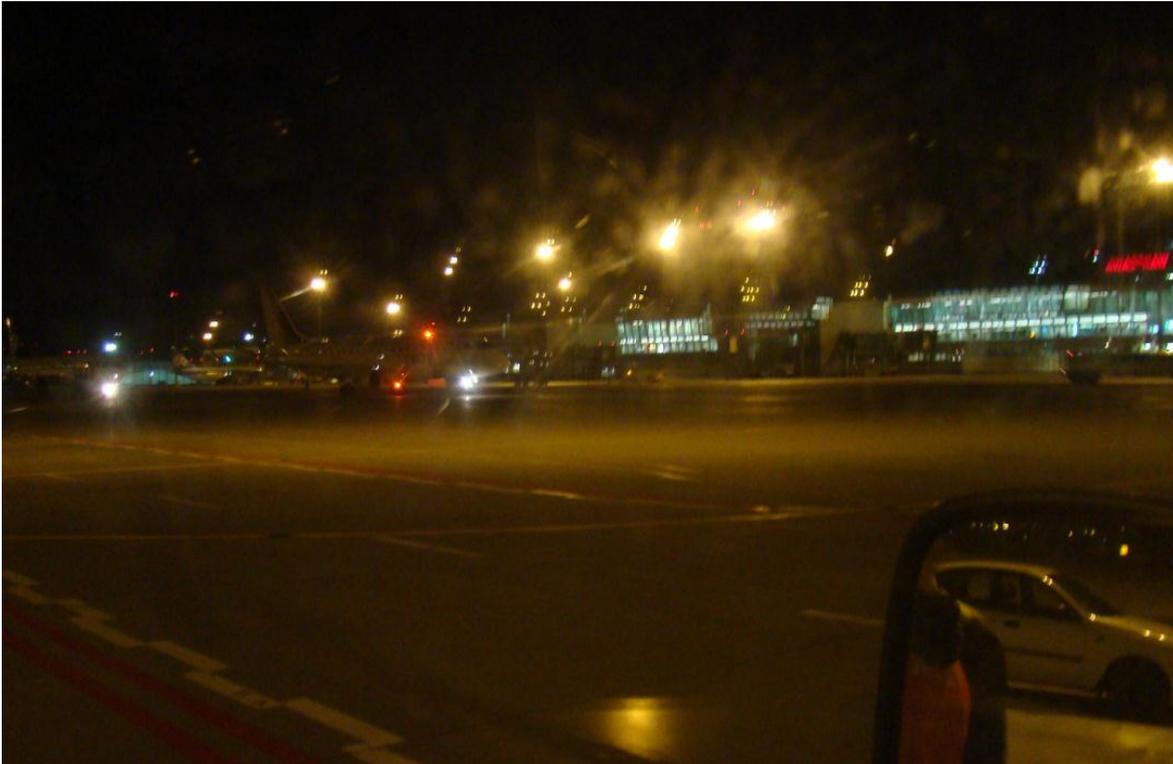
Photo No 11 shows Embraer airplane (as seen from the "Mulag" cab) commencing taxiing by taxiway "M2" after the right turn from taxiway "O2".

Photo 11. Embraer taxiing by taxiway „M2” (photo by SCAAI)

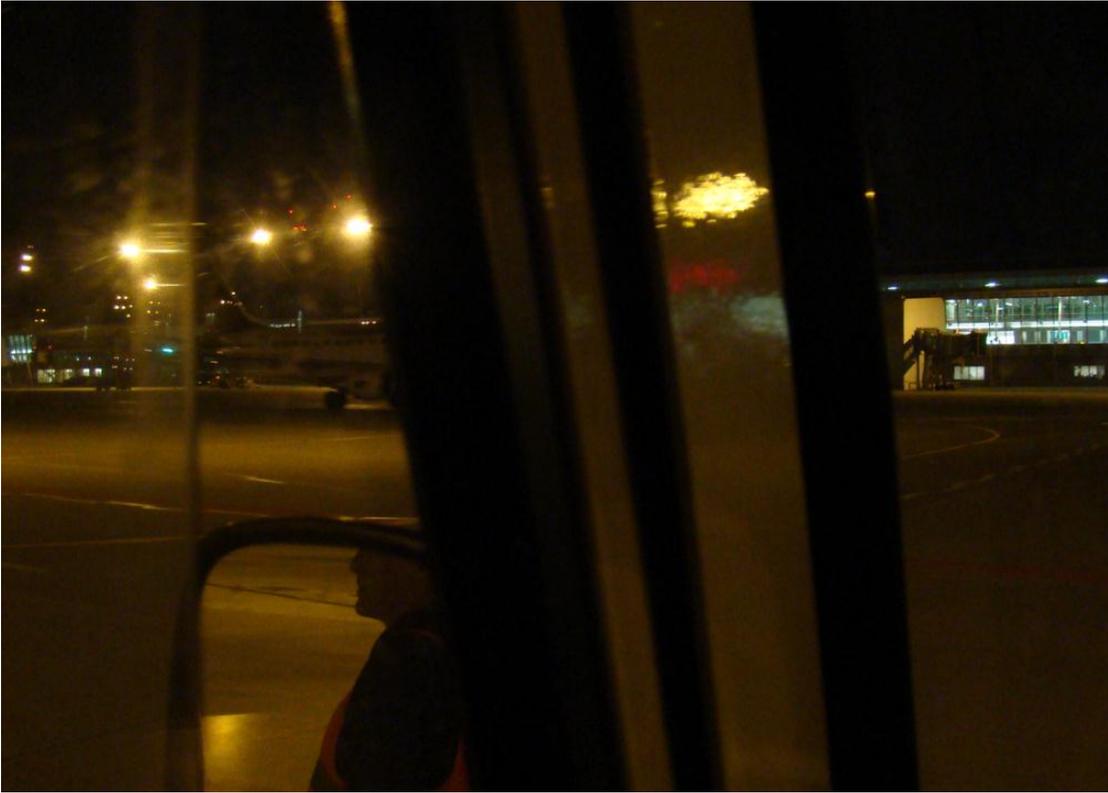
Recording No 4 from CCTV camera shows that "Mulag" was already on the service road perpendicular to taxiway "M2", when ATR 72 was passing stand 16. Probably at that time the silhouette of the airplane could have been partially or completely obscured for "Mulag" driver. It could have been obscured by the left window post or as a result of light reflections from the wet apron and therefore the driver did not notice the airplane (photo No: 12-13)

**Photo 12. Partially obscured Embraer airplane taxiing by taxiway „M2” (photo by SCAAI)**

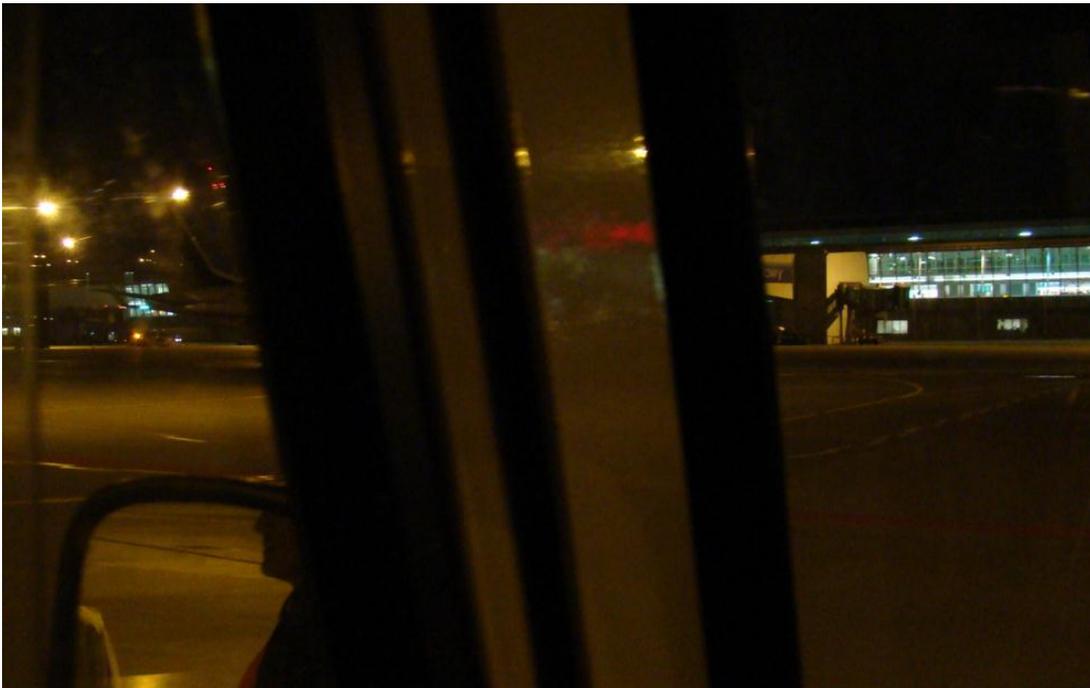
**Photo 13. Partially obscured Embraer airplane taxiing by taxiway „M2” (photo SCAAI)**

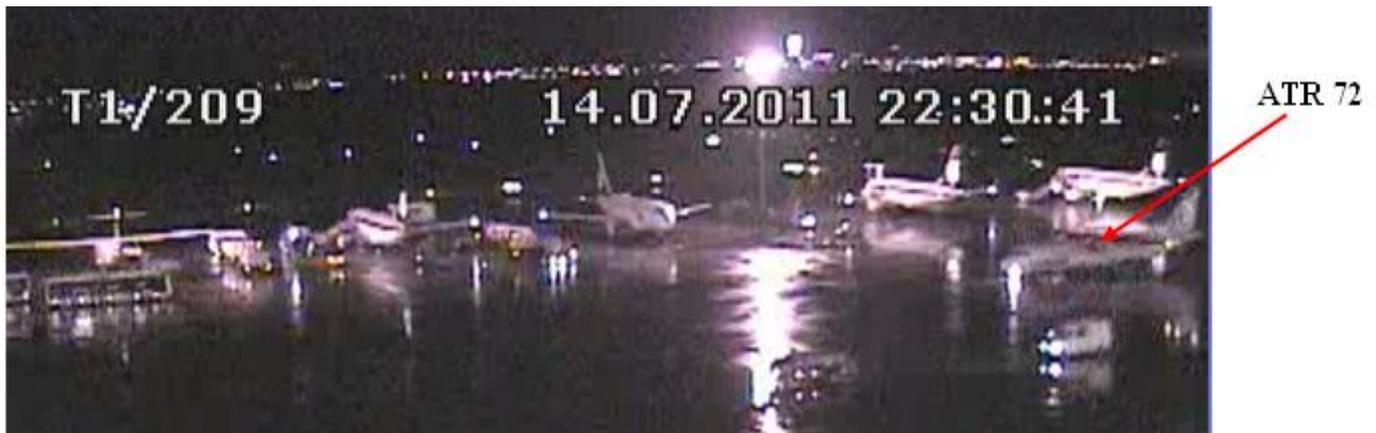
**Recording No 9 from CCTV camera No 209.**

Recording No 9 shows the collision moment. the "Mulag" tractor is obscured by ATR 72 fuselage. After the collision the airplane fuel system was unsealed and rapid leakage of the fuel occurred, which is clearly visible on the recordings from CCTV cameras.

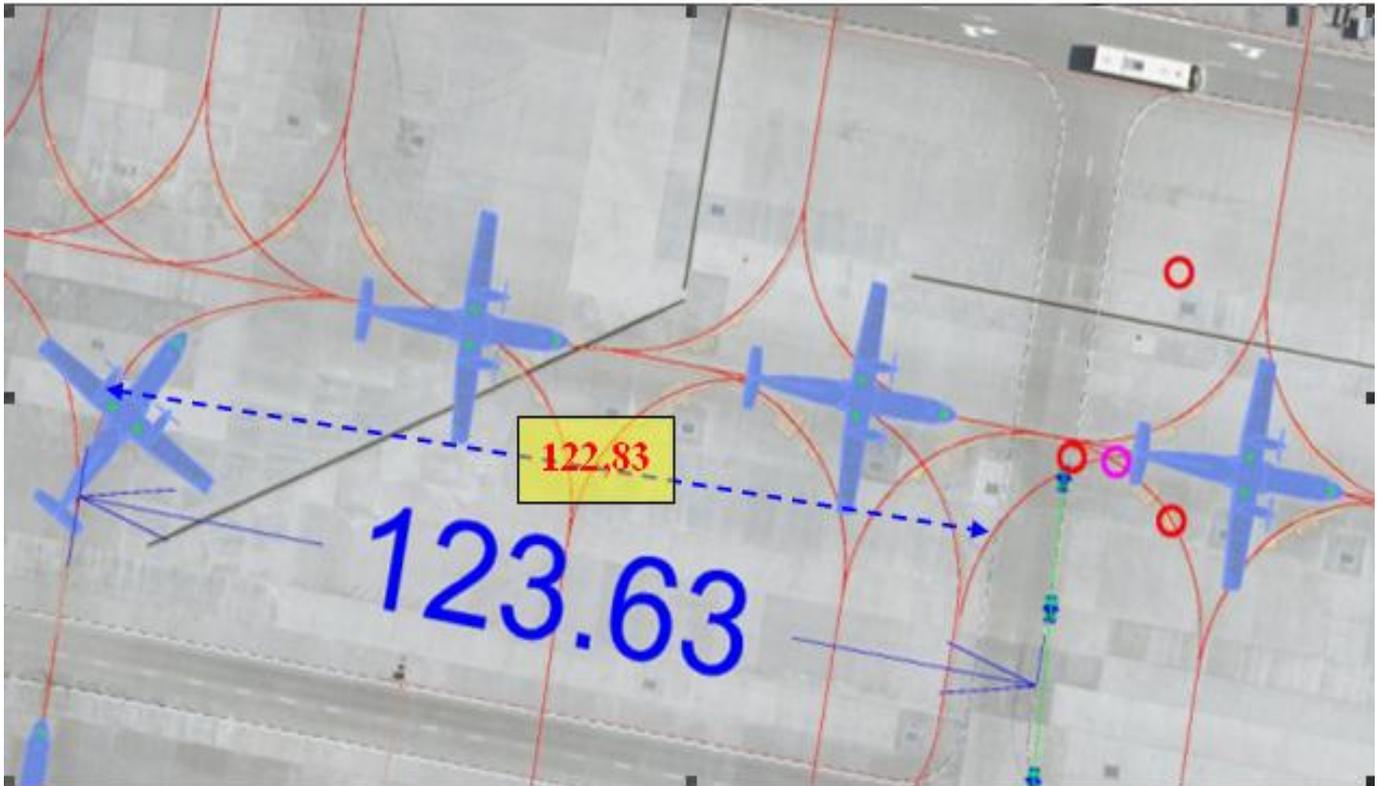
- weather conditions during the event - heavy rain with lightning;
- light reflections in the area of taxiway "O" and "M2", which, in particular on the wet surface of the aerodrome ground movement area hampered observation of the moving vehicles and airplanes.
- the construction of the "Mulag" cab, which could probably obscure the aircraft taxiing by taxiway M2;
- small distance - 122,83 m - between the service road and taxiway "O2" center line. (picture below).

Sketch 2. Taxiway „O” and the service road with the distances marked. (by “Polish Airports” State Enterprise and SCAAI)

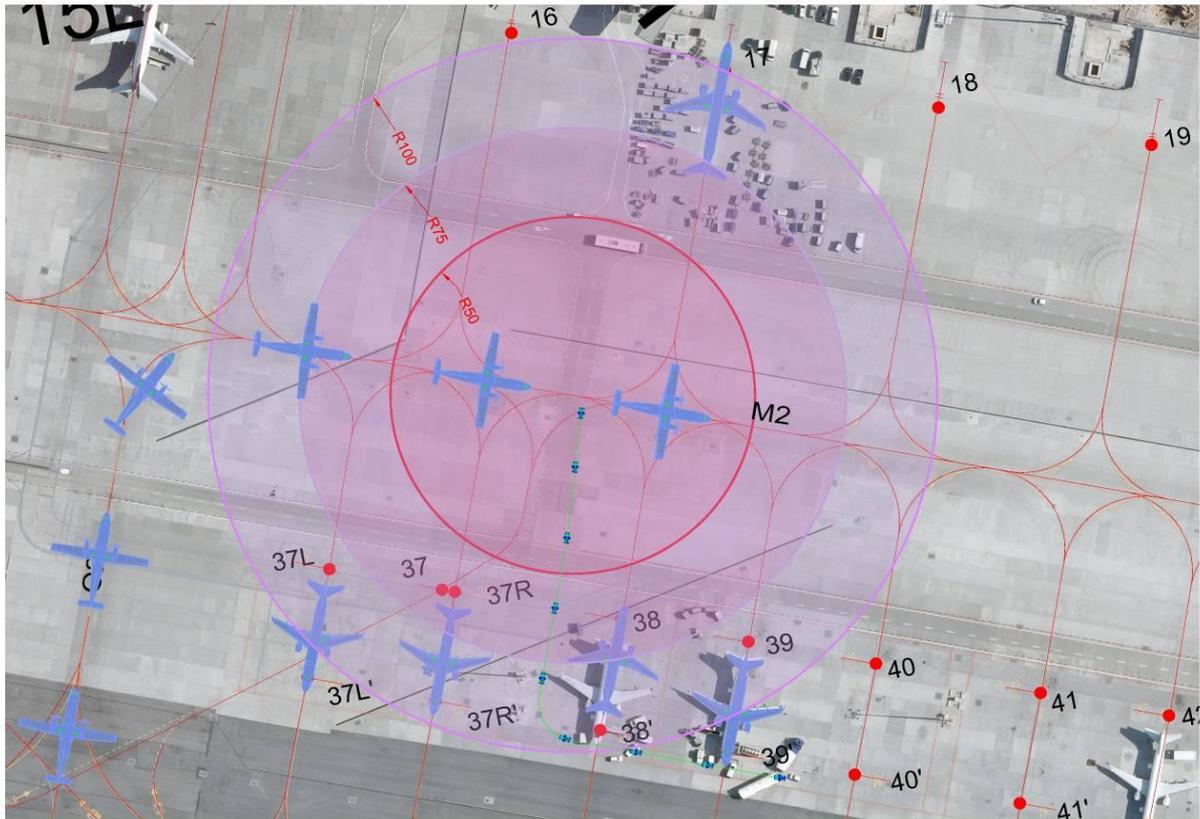
The collision resulted in separation of the airplane right engine propeller blades and the "Mulag" tractor parts which were scattered around aerodrome maneuvering area. Following the accident it would be appropriate to suspend air operations in order to check the airplanes for Foreign Object Damage (FOD) and the parking stands for the presence of Foreign Objects.

Sketch 3. Place of the occurrence with the three marked areas. (by "Polish Airports" State Enterprise)
