FINAL REPORT

ACCIDENT

Occurrence No.: 1400/11

Aircraft: B767-300ER, SP-LPC

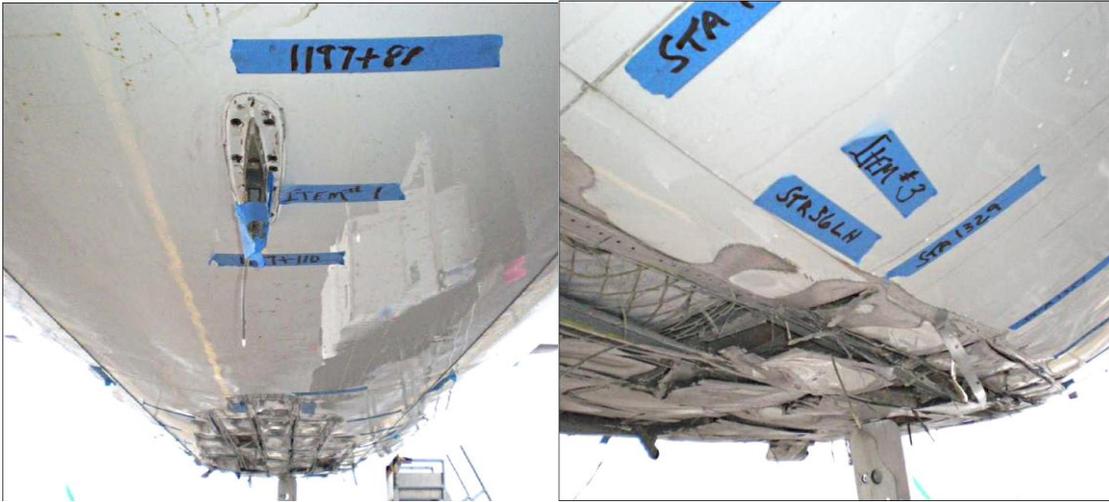
- Fuselage - local deformation preventing opening of the right aft cargo hold, damage to skin and elements of frames and stringers in the area of section 46, damage to the water tank service door, drain mast destroyed (Figure 1).
- Left wing - flap bracket fairing tip broken, cracked edges of the landing gear shock absorber hatch door, damaged brackets of the hatch door, damaged inboard flap skin in the area of the trailing edge.
- Right wing - flap bracket fairing tip broken, support points covers were cut out.
- Left main landing gear - strut of the main landing gear hatch door damaged (damaged joints of elements - Figure 2).
- Right main landing gear - strut of the main landing gear hatch door damaged (Figure 2).

Figure 1. Damage to the lower part of the fuselage in the area of section 46 – front view and close up.
(Source: Boeing)

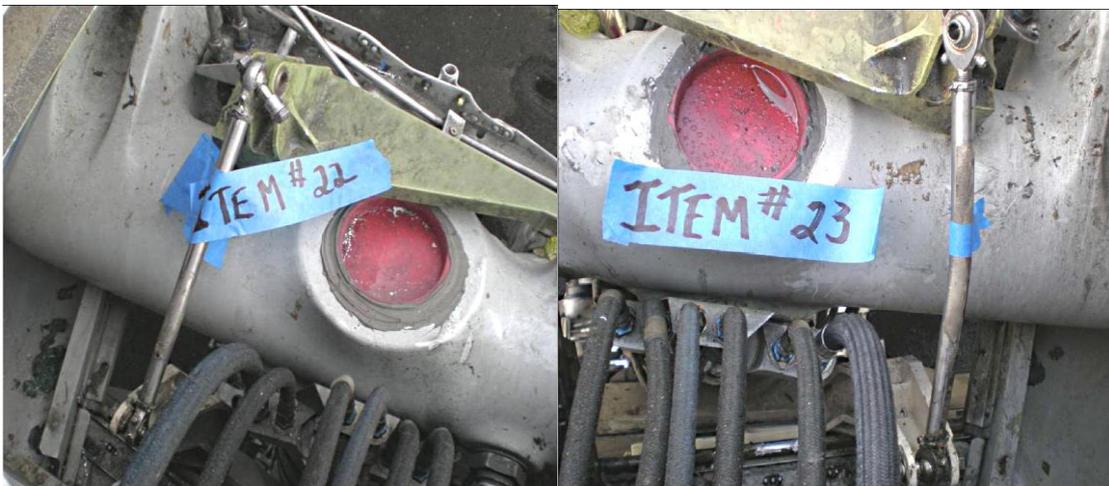
Figure 2. Damaged struts of the main landing gear hatch door (left and right).
(Source: Boeing)

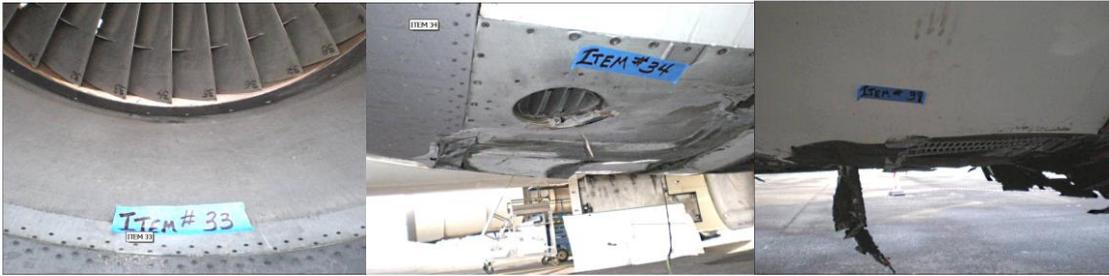
- Left nacelle – fan casing deformed and damaged inside due to contact with the rotating fan blades and abraded outside due to contact with the ground. Thrust reverser damaged (elements partially abraded, partially detached, fixings of same elements bent), some elements fell off from the airplane (Figure 3).
- Right nacelle – fan casing deformed and damaged inside due to contact with the rotating fan blades and abraded outside due to contact with the ground. Thrust reverser damaged (elements partially abraded, partially detached, fixings of some elements bent - Figure 4).

Figure 3. Damage to the left engine nacelle – from the left: fan inlet inside, bottom part, thrust reverser.
(Source: Boeing)

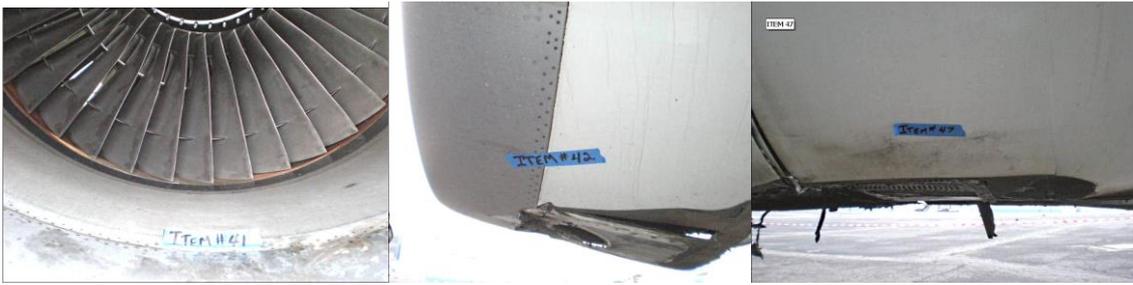
Figure 4. Damage to the right engine nacelle – from the left: fan inlet inside, bottom part, thrust reverser.
(Source: Boeing)

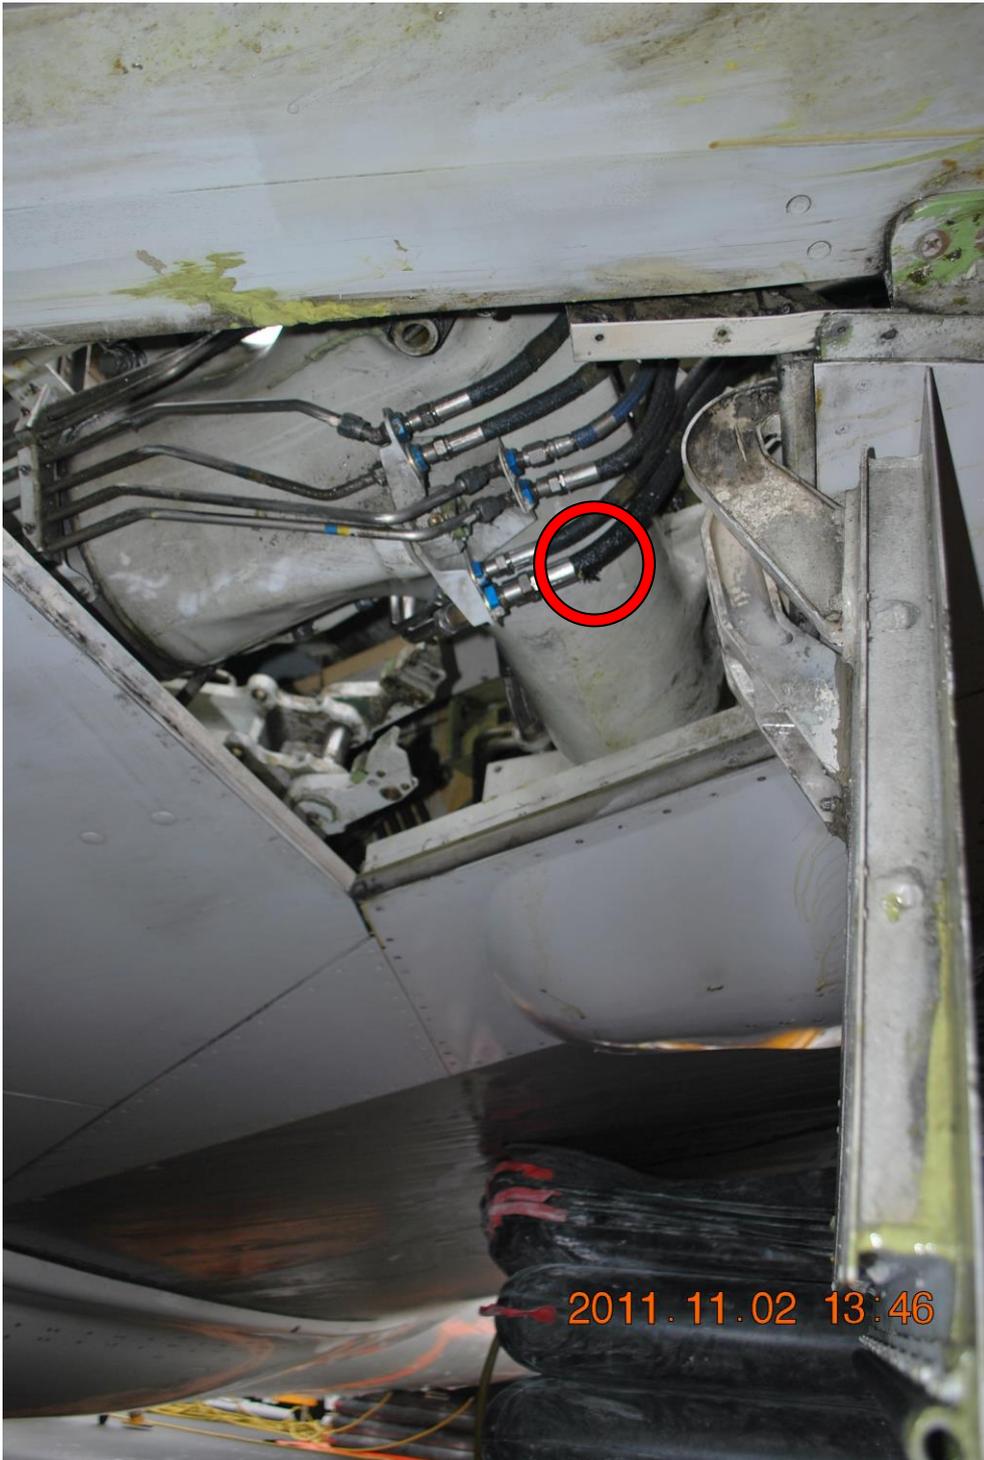
1. Failure of the hydraulic hose connecting the hydraulic system on the right leg of the main landing gear with the center hydraulic system, which initiated the occurrence.
2. Open C829 BAT BUS DISTR circuit breaker in the power supply circuit of the alternate landing gear extension system in the situation when the center hydraulic system was inoperative.

Figure 22. Damaged hydraulic hose (marked with red circle) on SP-LPC right main gear.
(Source – SCAAI)

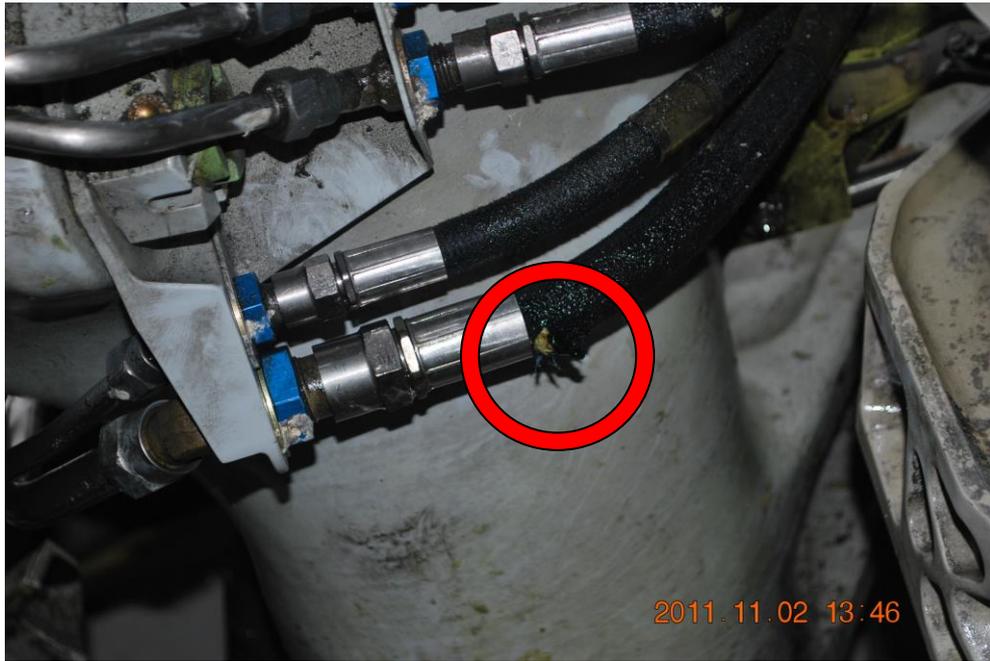
Figure 23. Close-up of the damage to the hydraulic hose (marked with red circle) on SP-LPC right main gear. (Source – SCAAI)

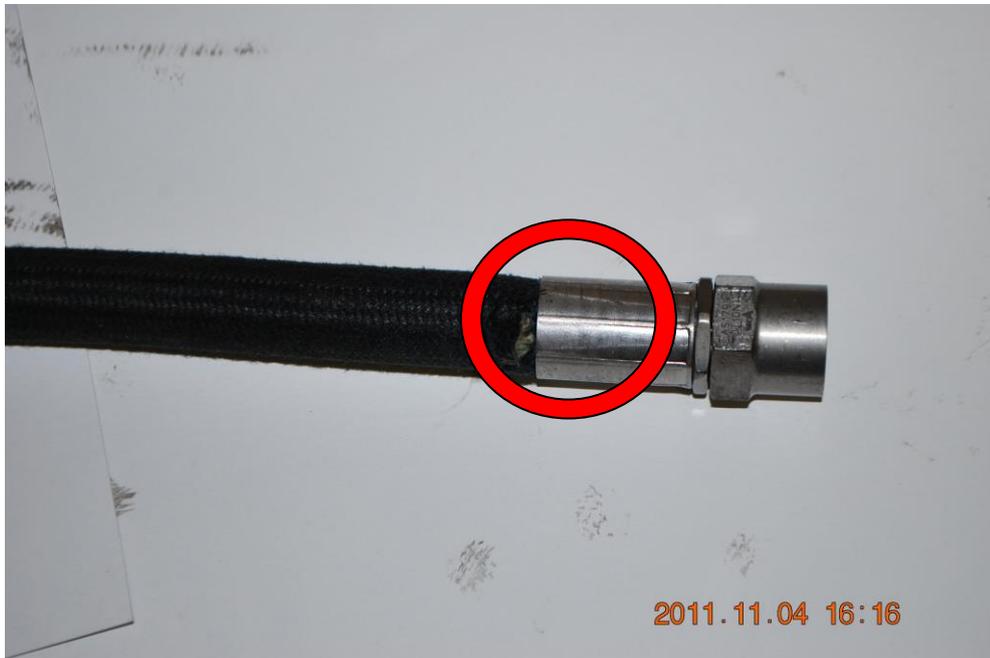
Figure 24. Damage to the hose from hydraulic system of SP-LPC airplane. (Source – SCAAI)

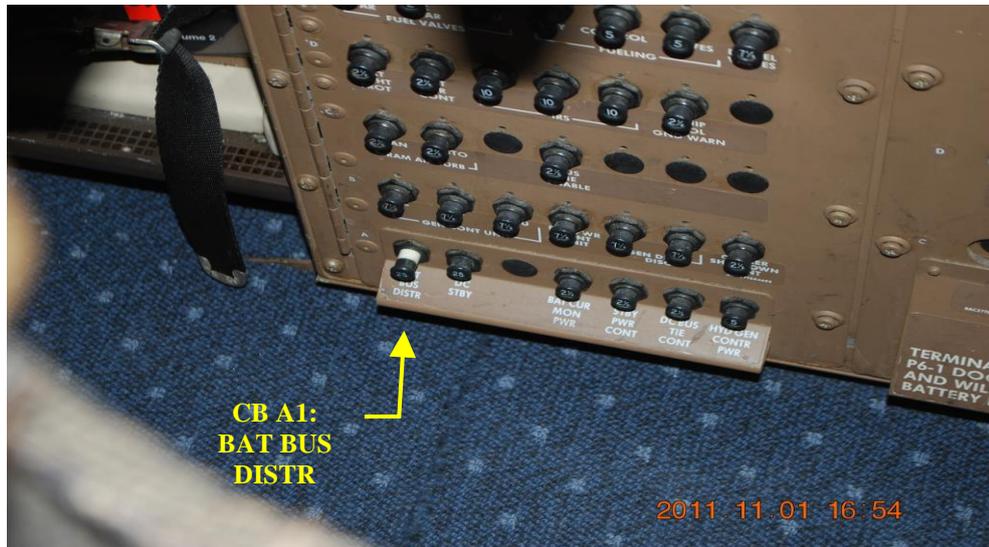
Due to the above the airplane documentation was analyzed to determine the role of C829 circuit breaker. Documentation showed that C829 protected 13 circuits including the alternate landing gear extension system. OFF setting of the circuit breaker caused, among others, that the actuator of the alternate landing gear extension system could not be powered when needed (normal extension of the landing gear was not possible due to failure of the center hydraulic system).

Figure 25. P6-1 panel in the cockpit (section with C829 circuit breaker).
(Source – SCAAI)

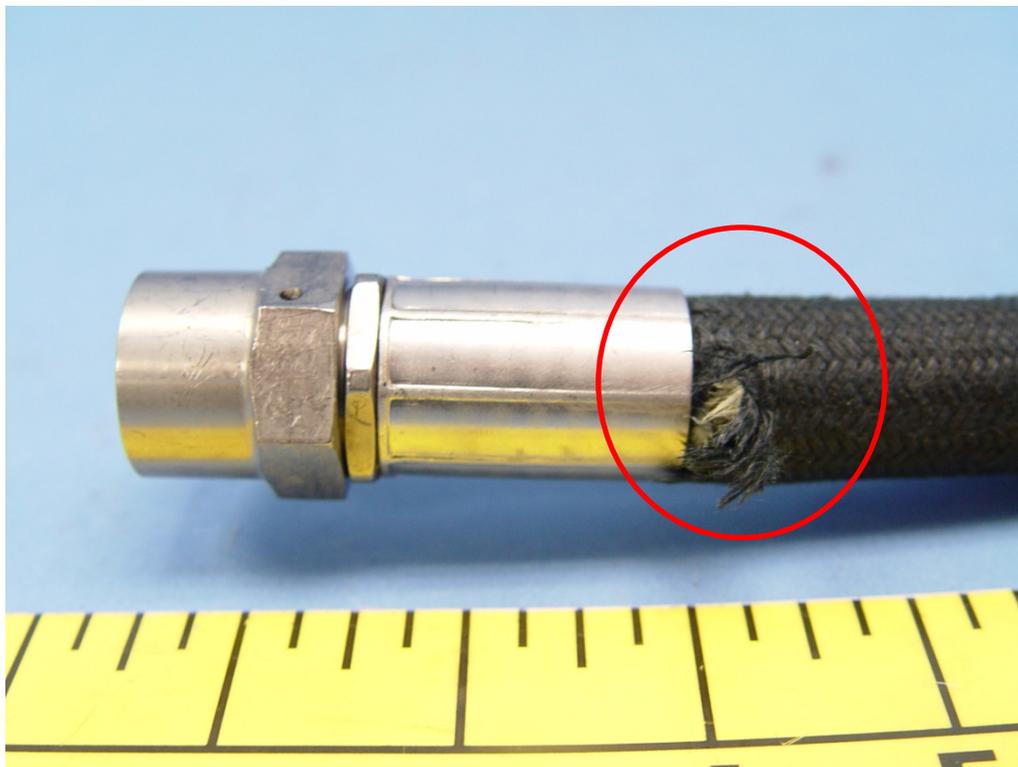
Figure 2. Close-up photograph of damage to hydraulic hose (area highlighted in red circle).

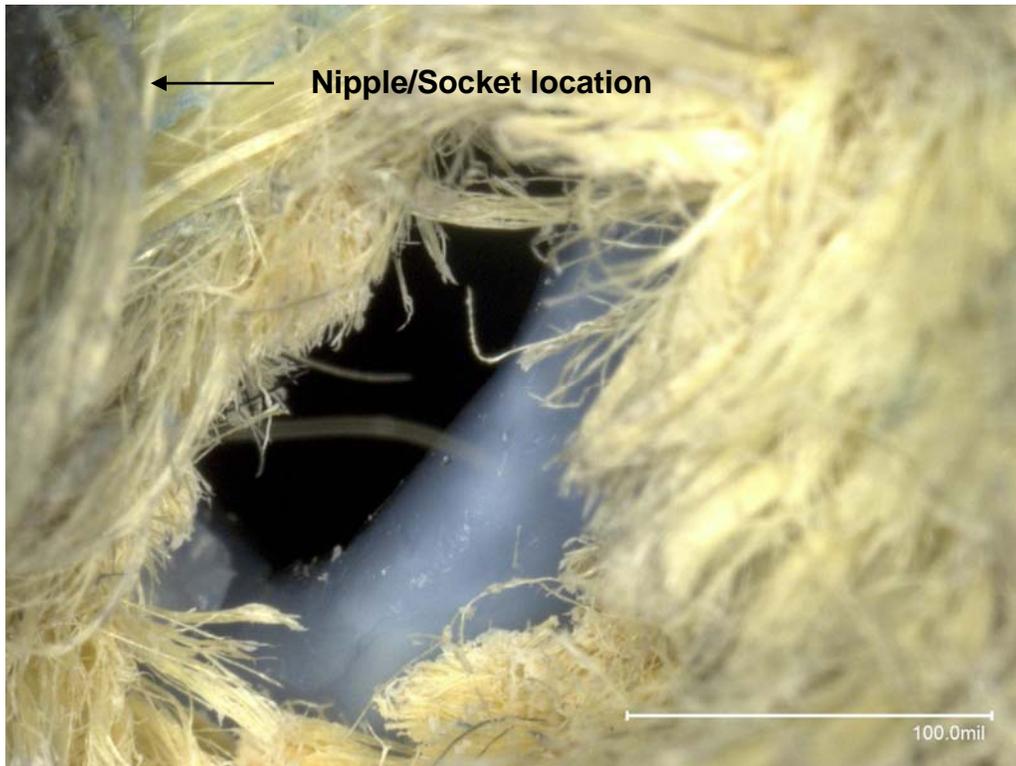
Figure 3. Close-up photograph of hole.

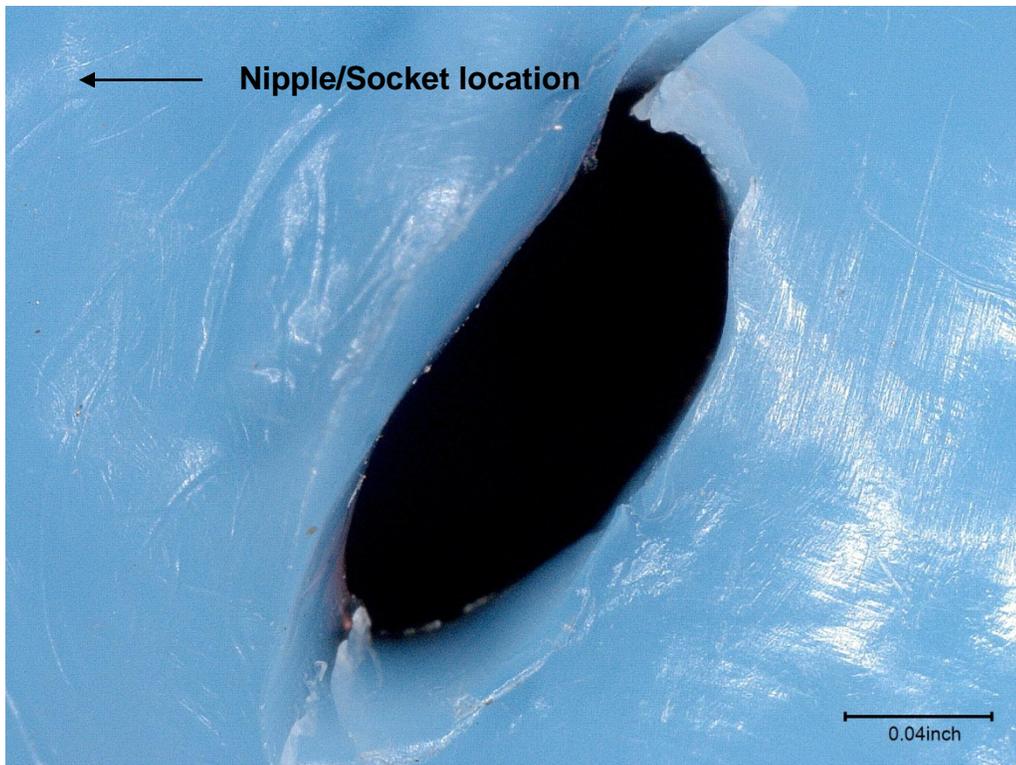
Figure 4. Close-up photograph of crack in hose sidewall.

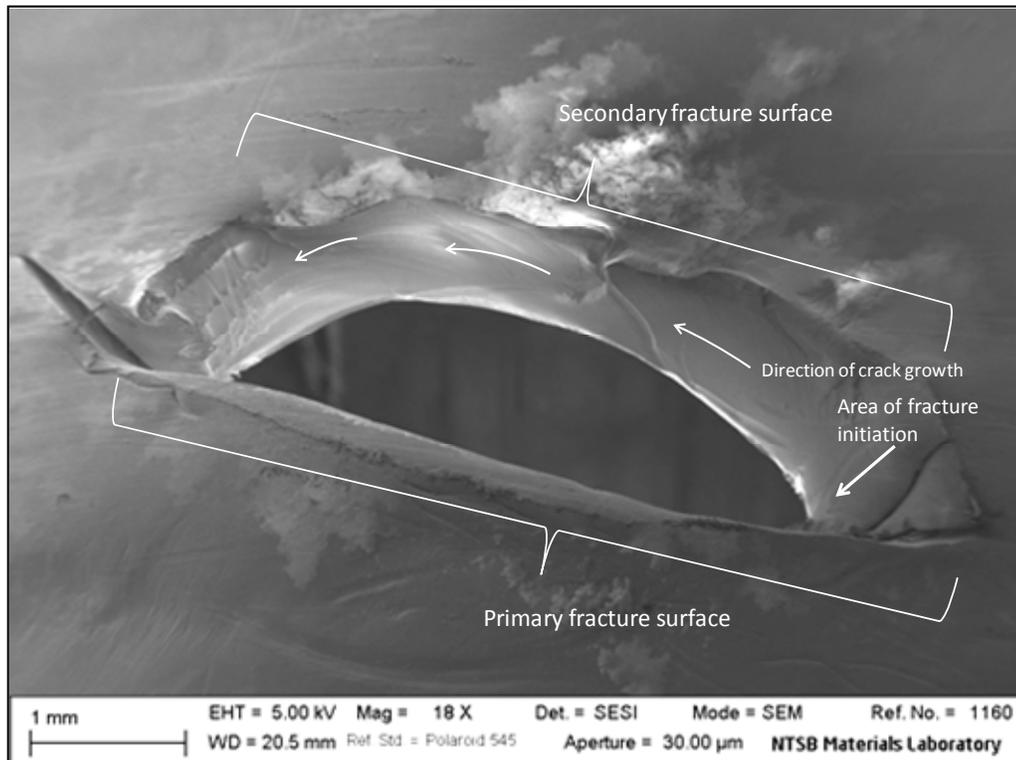
Figure 6. SEM image of crack with fracture features annotated.

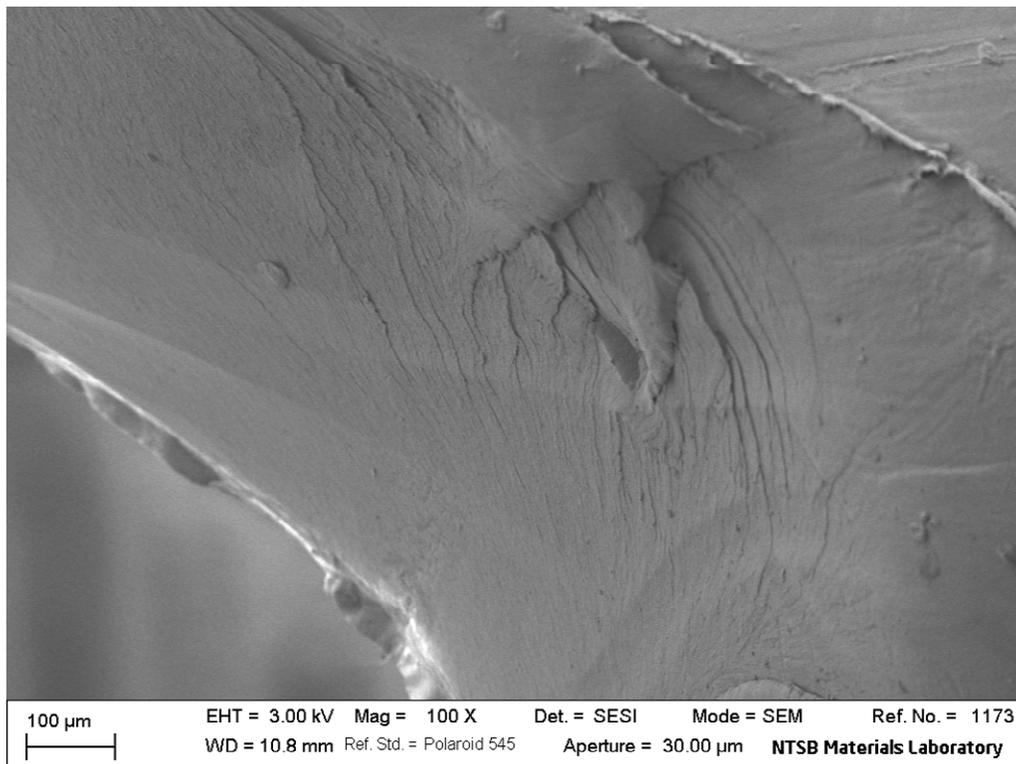
Figure 10. Close-up SEM image of branch cracking and directional crack markings.

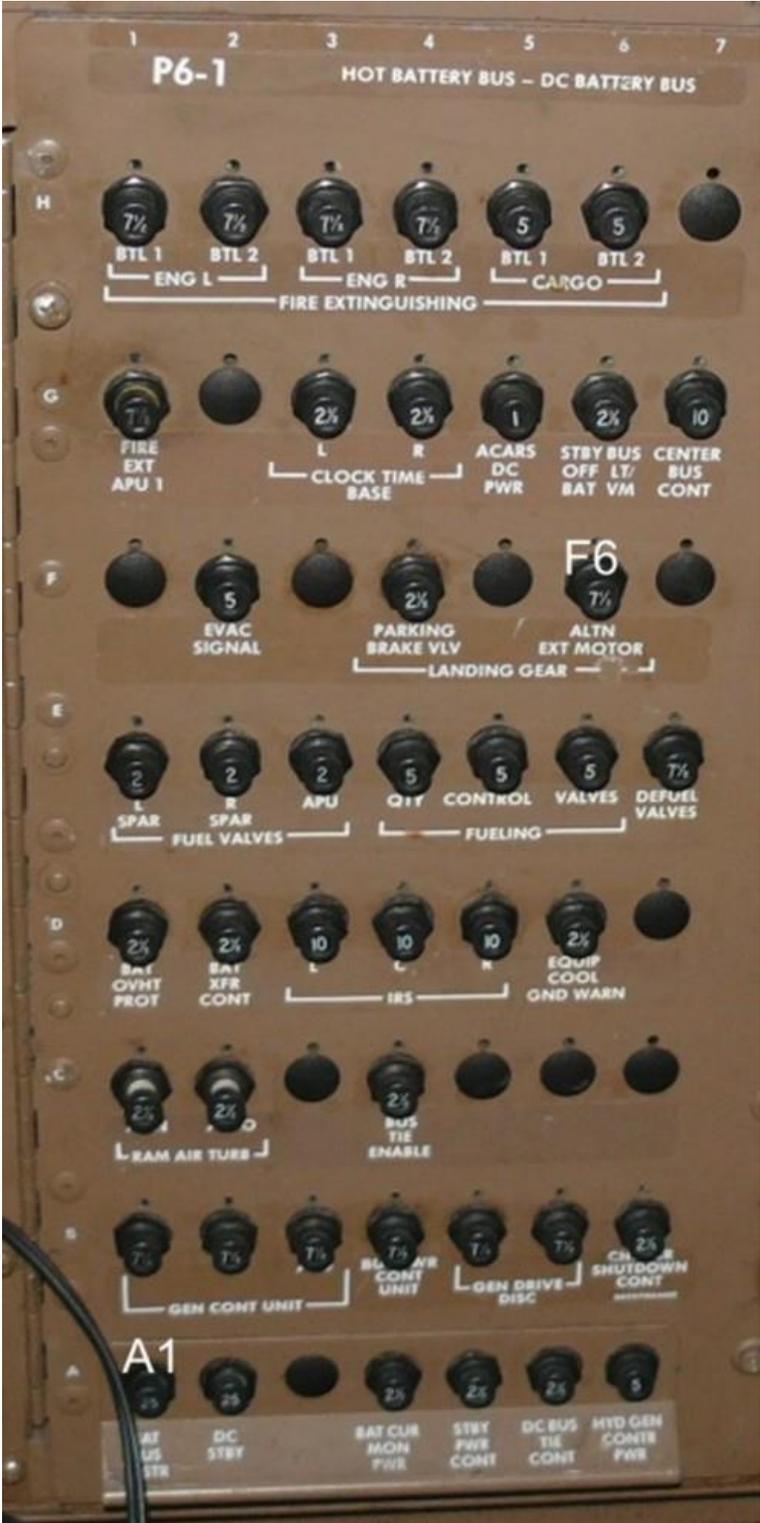
After LO16 flight it was found that C829 BAT BUS DISTR circuit breaker on A1 position on P6-1 panel was in OFF setting.

Fig. 1. P6-1 panel. C829 BAT BUS DISTR on A1 position

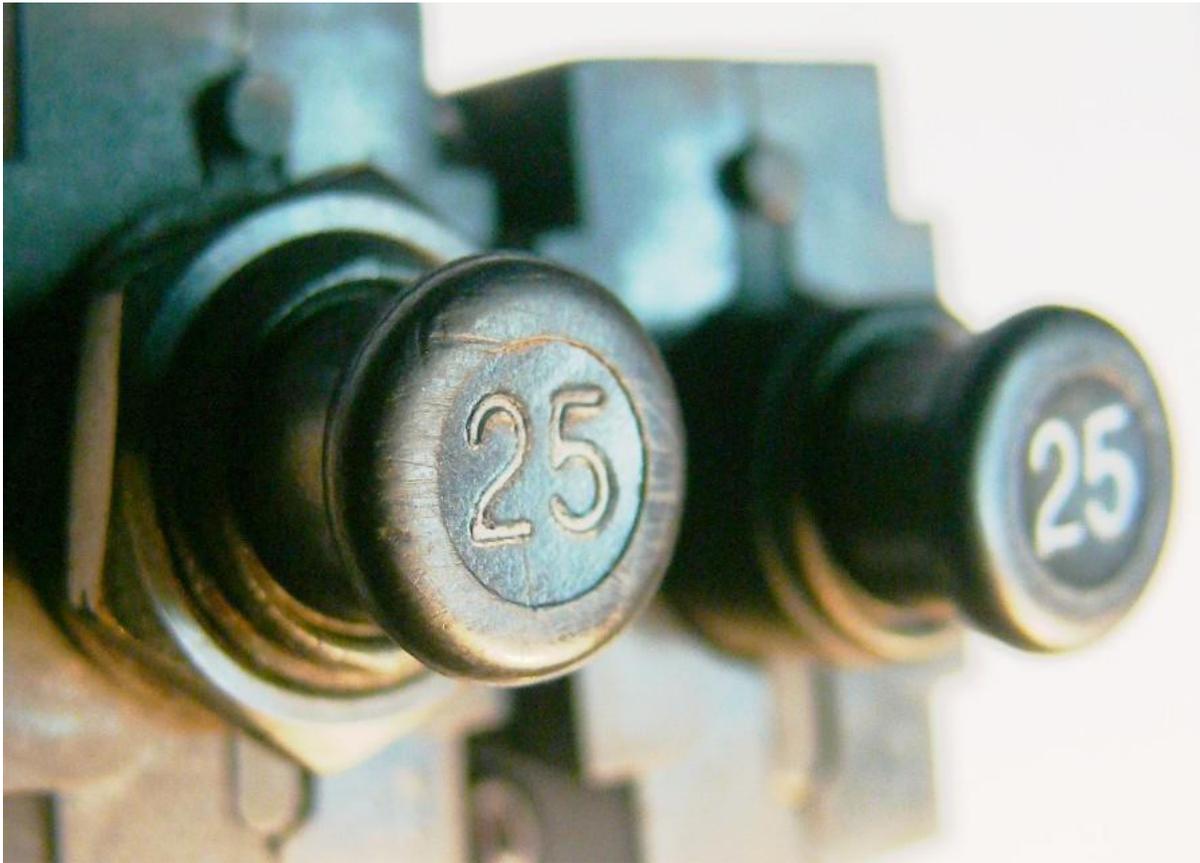
It should be noted that the button of C829 circuit breaker showed many traces of scratches and abrasions (Fig. 9 and Fig. 10).

Fig. 9. Buttons of C829 circuit breakers (left – from SP-LPC, right – a new one)

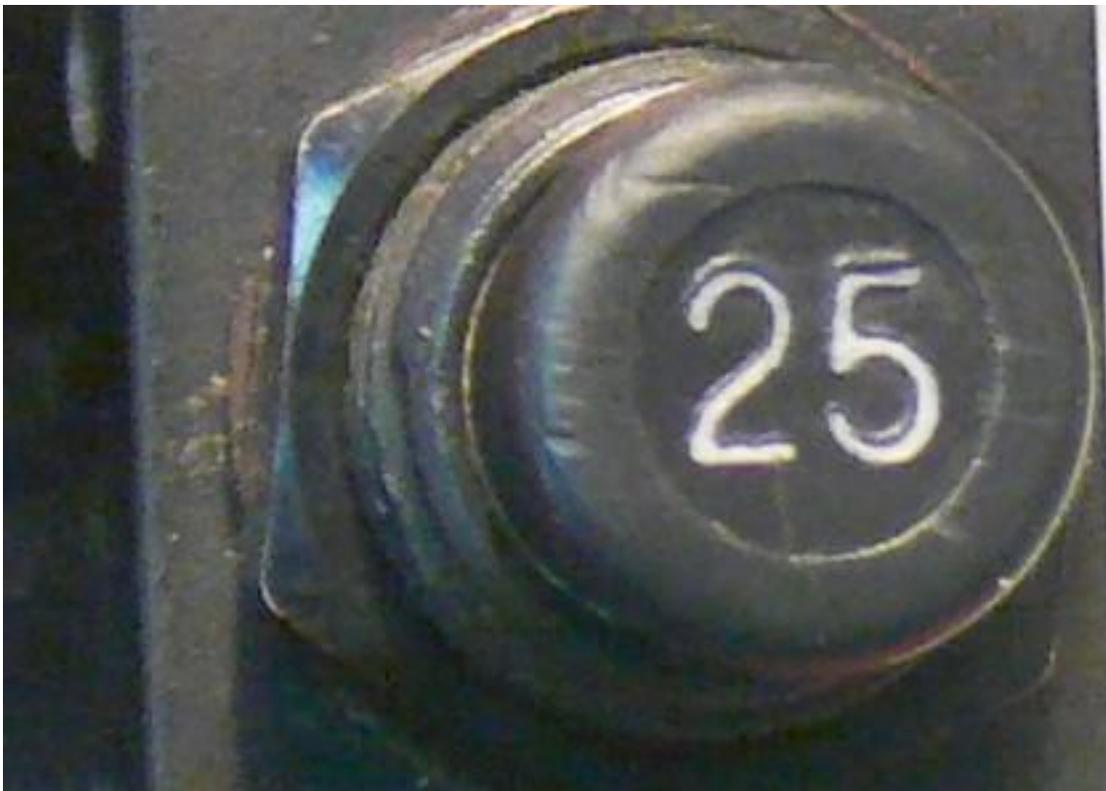
Fig. 10. Button of C829 circuit breaker from SP-LPC airplane

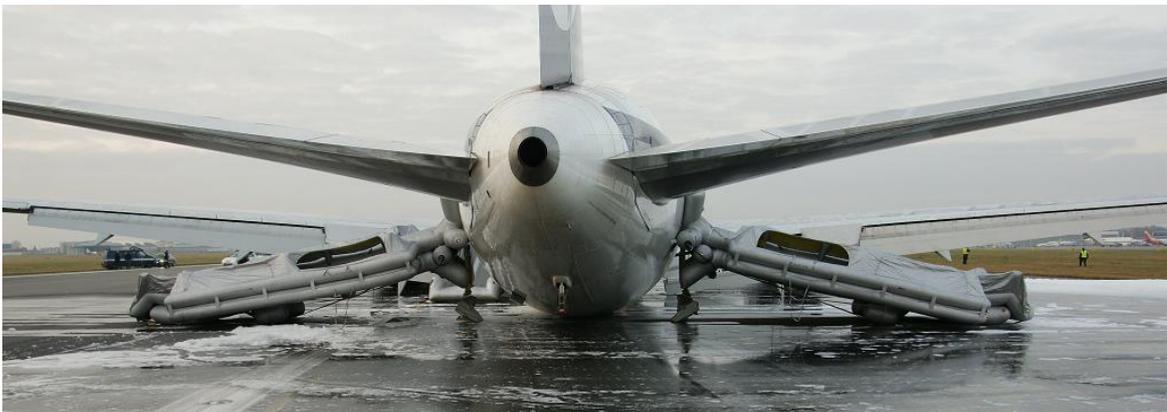
Figure 4. Position of the aft slides of SP-LPC airplane after gear up landing.

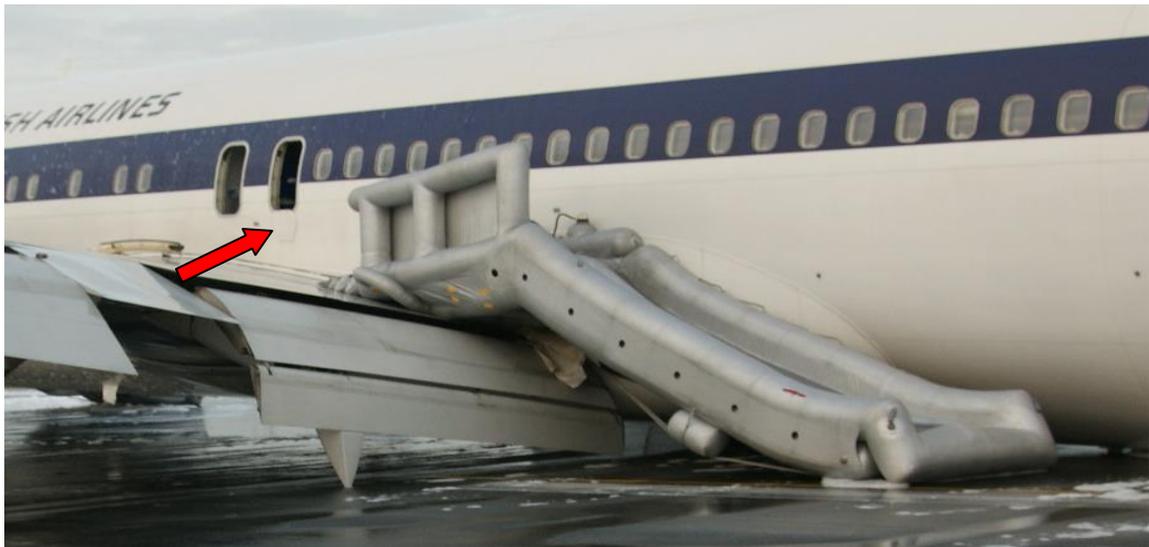
Over-wing emergency exits on the right side of the airplane (2R1 and 2R2) were not opened because after assessing the situation outside the airplane CC3 stated smoke hazard. After the touchdown engine No. 2 rubbed against dry surface of the runway leaving a plume of fire. The over-wing emergency exits on the left side of the airplane (2L1, 2L2) were opened, but nobody was evacuated this way. That was due to the fact that all passengers, directed by CC7 and CC6, very quickly moved towards the aft exits. Door 2L1 was thrown out of the airplane while door 2L2 remained inside. The wing slide was inflated, but the drop step under over-wing exit 2L2 did not open.

Figure 5. Evacuation slide on the left wing and locked drop step.
