# Loss of control and collision with terrain involving Angel Aircraft Corporation 44, VH-IAZ

near Mareeba Airport, Queensland, on 14 December 2019

## **ATSB Transport Safety Report**

AO-2019-072

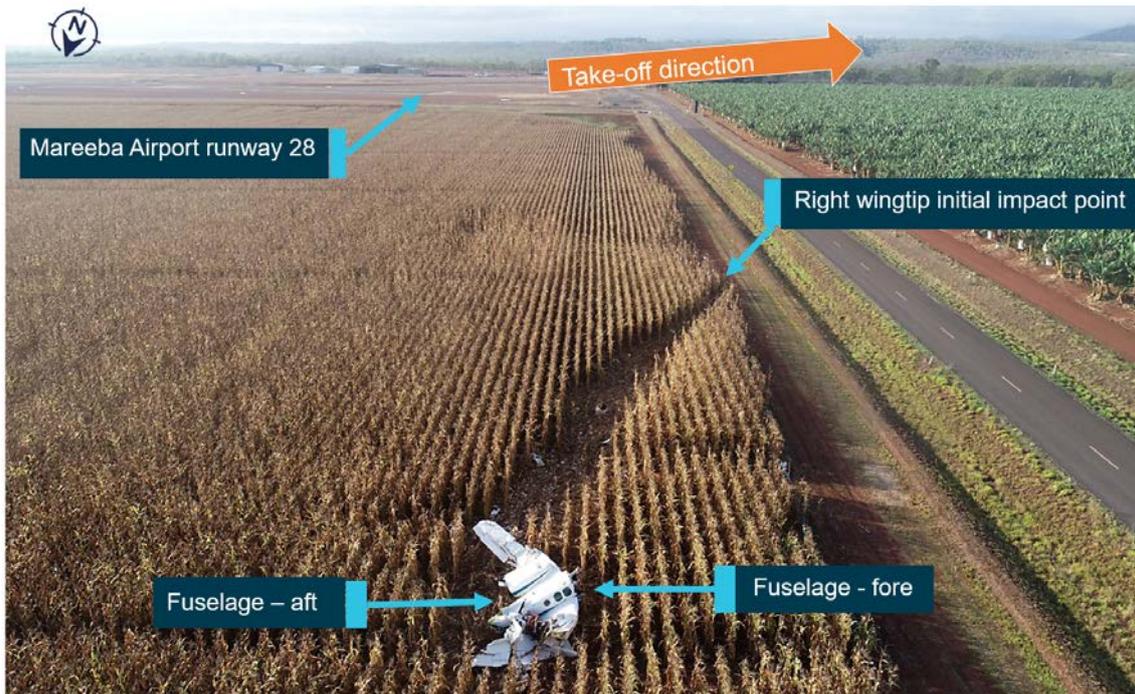
**Figure 2: Accident site showing the take-off direction, initial impact point and fuselage resting position**

Witnesses then saw the aircraft touch down on the runway and continue to take off again, consistent with a ‘touch-and-go’ manoeuvre, and heard one engine ‘splutter’ as the aircraft climbed to an estimated 100–150 ft above ground level. At about 1115, the aircraft was observed overhead a banana plantation beyond the end of the runway, banked to the right in a descending turn, before it suddenly rolled right. Witnesses observed the right wing drop to near vertical and the aircraft impacted terrain in a cornfield. Both pilots were fatally injured and the aircraft was destroyed (Figure 2).

The accident site was located in a cornfield about 475 m north of the runway at Mareeba Airport. Based on an analysis of the wreckage and ground marks, it was evident that the aircraft impacted terrain right wingtip first, while travelling in a northerly direction. The nose landing gear impacted the ground about 33 m beyond the initial impact point, after the right wing had fractured and collapsed under the weight of the aircraft. At that point, the fuselage was at, or slightly over, vertical, and the cockpit folded under and to the left.

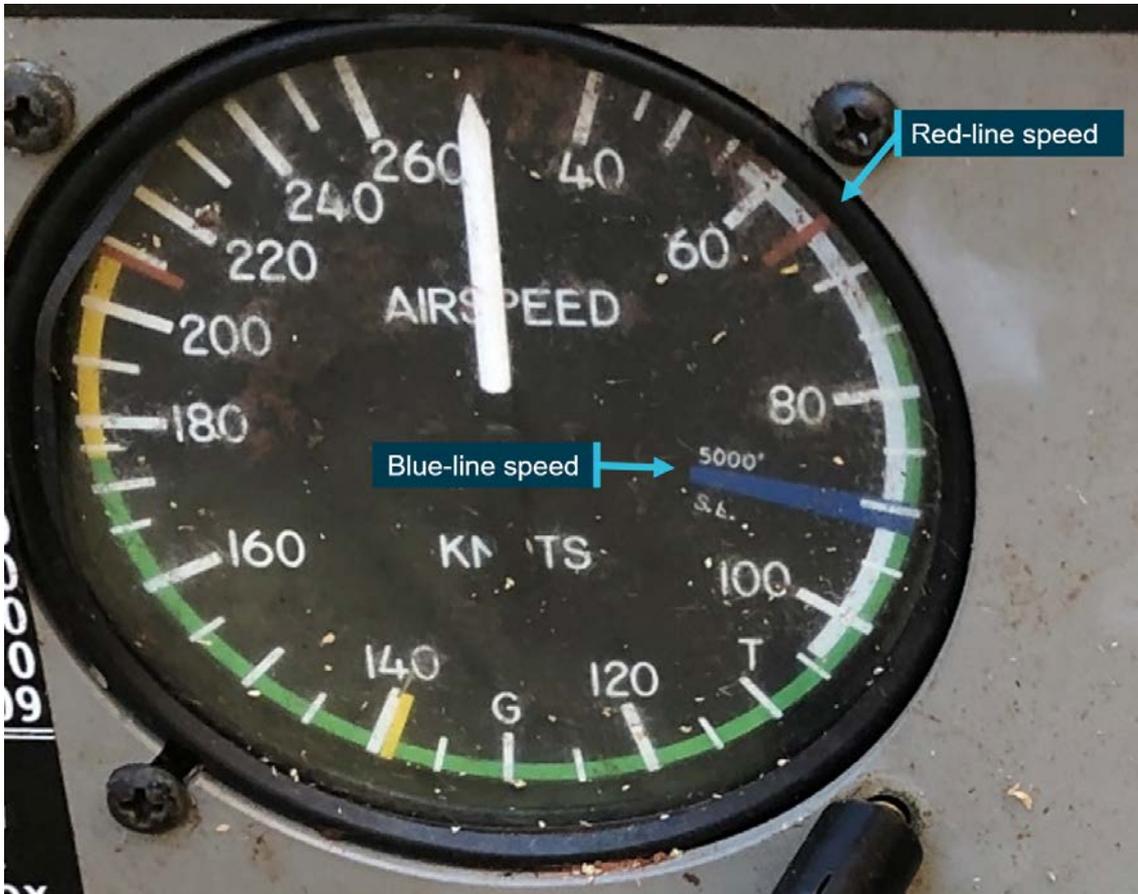
**Figure 3: Airspeed indicator from VH-IAZ showing red-line ( $V_{MC}$ ) and blue-line ( $V_{YSE}$ ) speeds**

In the accident flight, banking towards the inoperative engine significantly increased the actual  $V_{MC}$  to the extent that it probably exceeded the  $V_{YSE}$  (blue-line) speed (90-92 KIAS). This is important as pilots often use blue-line speed as a safety margin above  $V_{MC}$  for initiating a simulated engine failure, and assume that if blue-line speed is maintained, there is sufficient margin above red-line speed (published  $V_{MC}$ ) to prevent an asymmetric loss of control.
