Aircraft Accident Report

Operator: Sita Air Pvt. Ltd.

Aircraft Type and Model: Dornier 228-202(K)

Registration: 9N-AHA

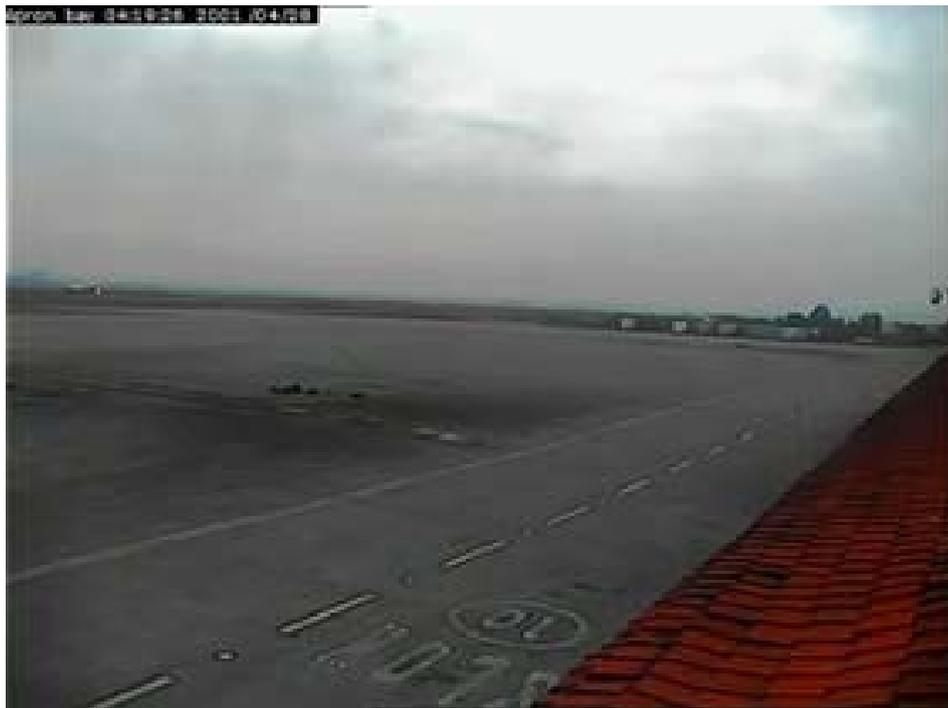
A CCTV camera on an airport building recorded the flight from approximately 10 seconds before the aircraft left the ground until impact. Approximately 5 seconds before the aircraft left the ground, what appeared to be a flash appeared in the region of the right engine for one frame of video³. Following analysis, the flash was considered to represent a real event rather than being an artefact of the recording process (Figures 1.1-1 and 1.1-2).

Figure 1.1-1
CCTV image five seconds before the aircraft left the ground

CCTV image five seconds before the aircraft left the ground –zoomed in

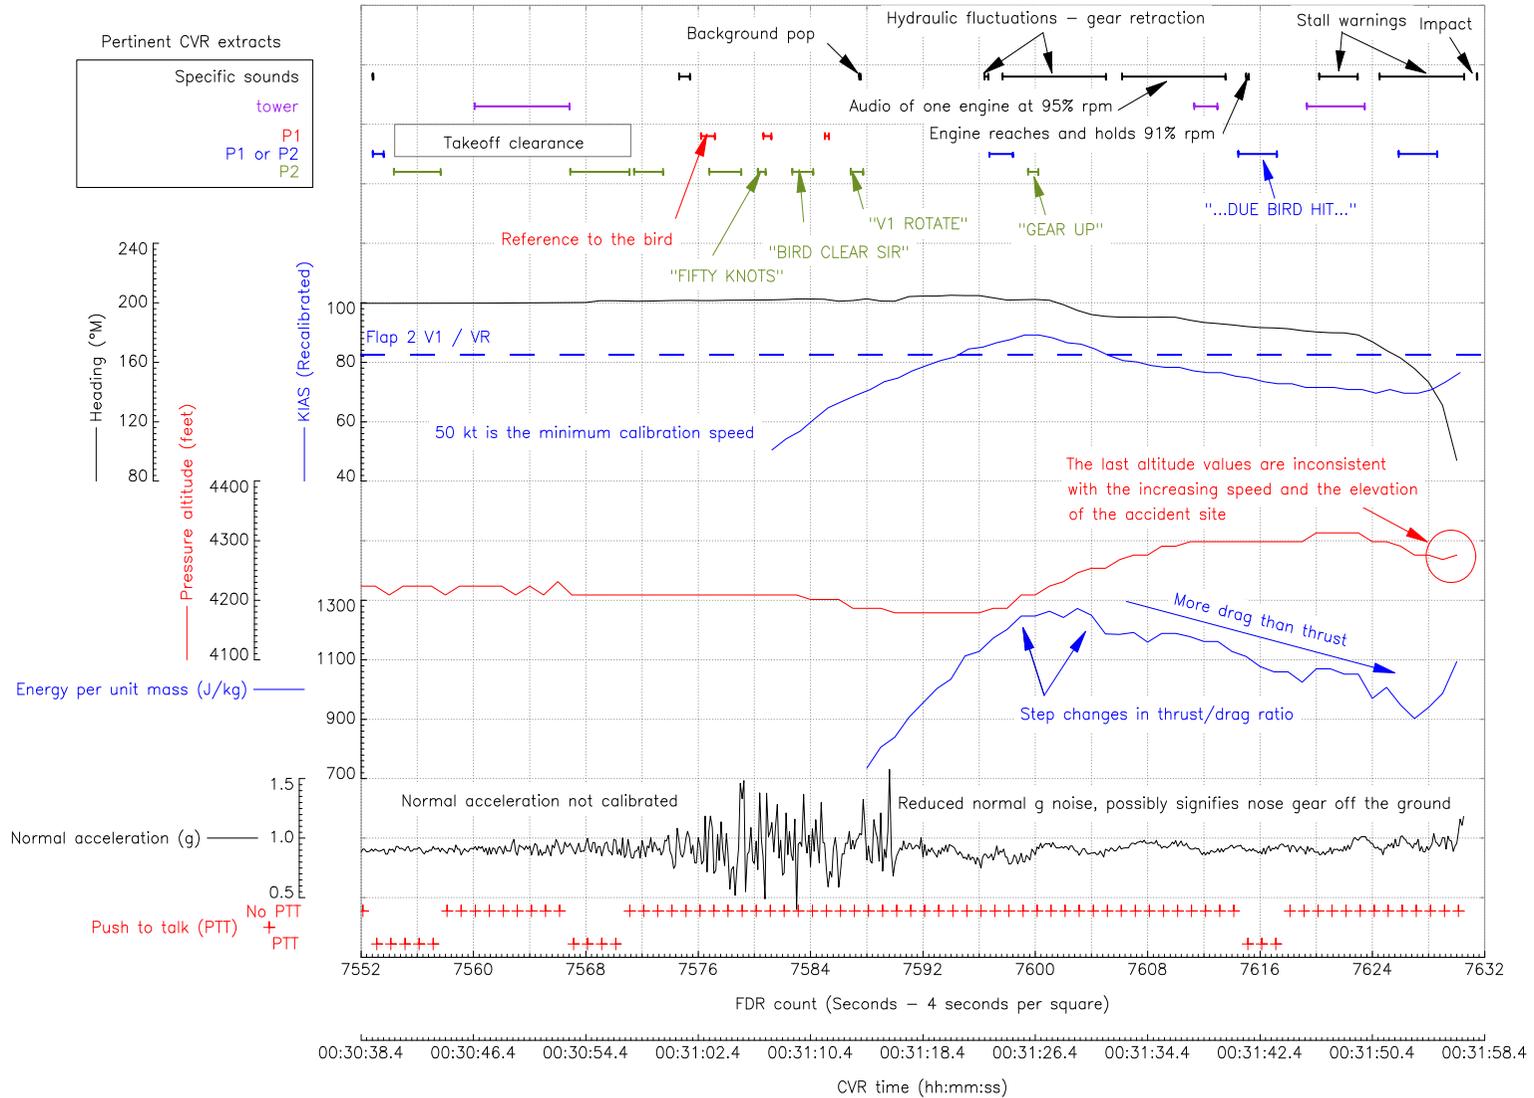
Figure 1.11-1 Pertinent extracts from recordings and calculated total energy per unit mass, zeroed at the airfield elevation.

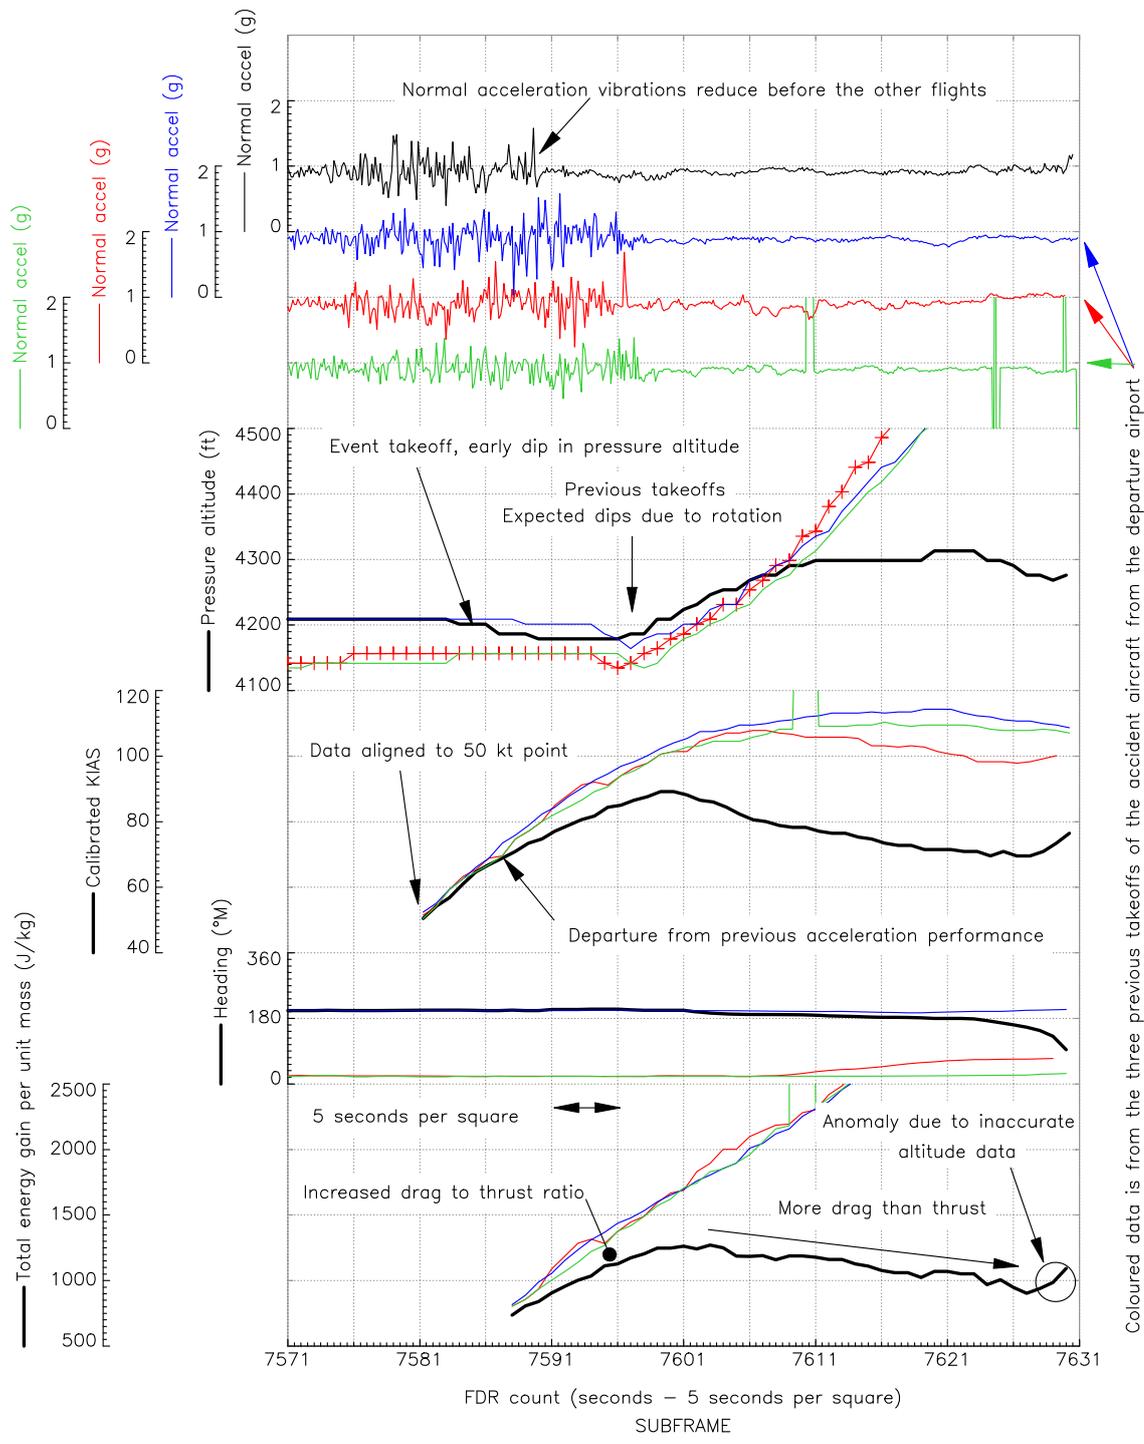
Figure 1.11-2

Comparison of the accident flight (black lines) with the previous take offs from the same airfield.

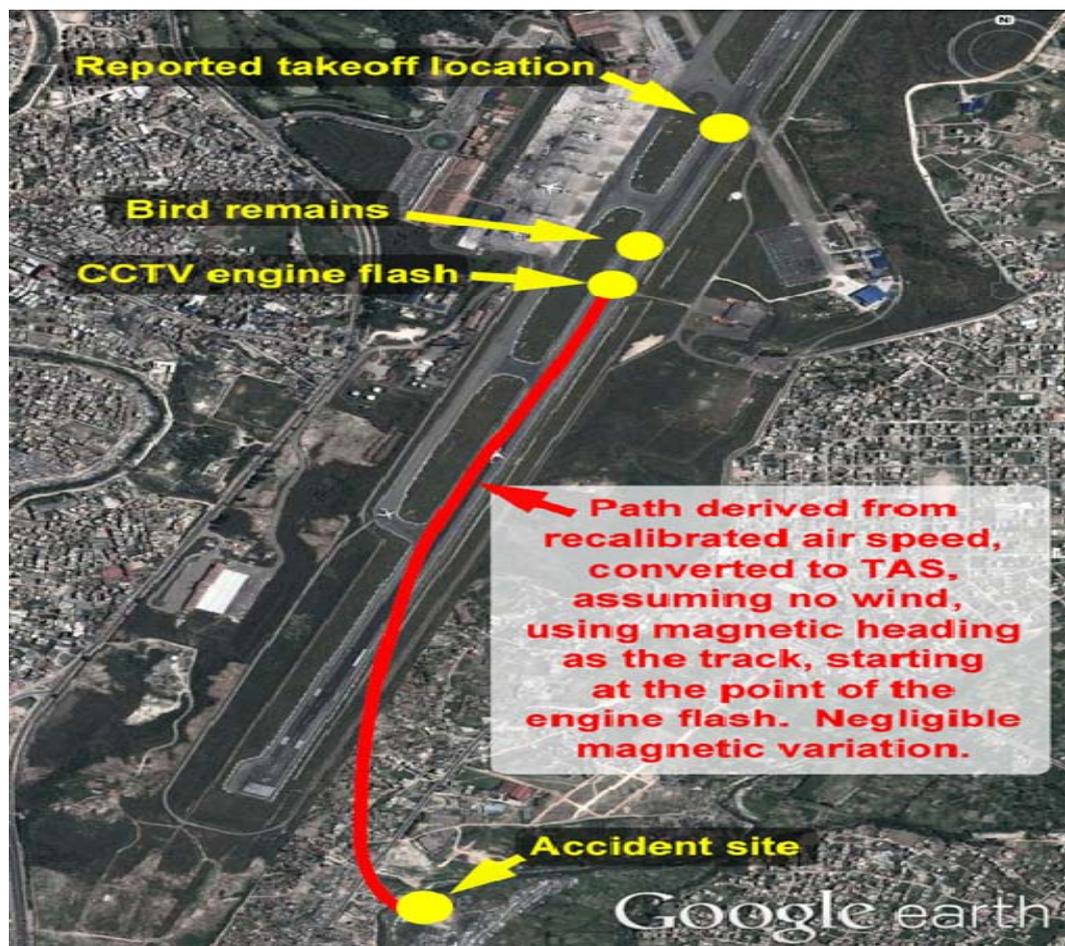
The CCTV recording was analysed to determine the location of the aircraft when the flash occurred. This position was aligned in time with the CVR sound assumed to be associated with the flash and with the recorded data to synchronise all recorded data. Using the recorded data, and making estimated altitude corrections for the last two recorded seconds, a flight path was derived from the position on the runway where the flash occurred to the point on the ground where this process estimated the accident should have occurred. The results, shown in Figure 1.11-4, show that the derived position of the accident site was very close to the actual accident site and the final track was consistent with the direction of ground markings. This process provided confidence that the parameter values being used by the investigation were reasonable.

Figure 1.11-4
Derived flight path

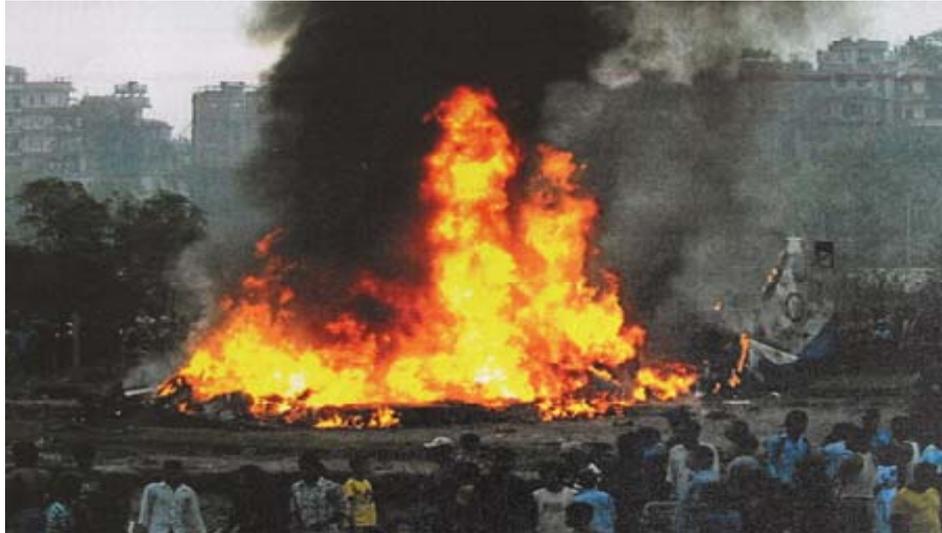
Figure 1.12-2
Post-impact fire showing tail section remains pointing towards north-west
(Copyright AFP/GETTY)

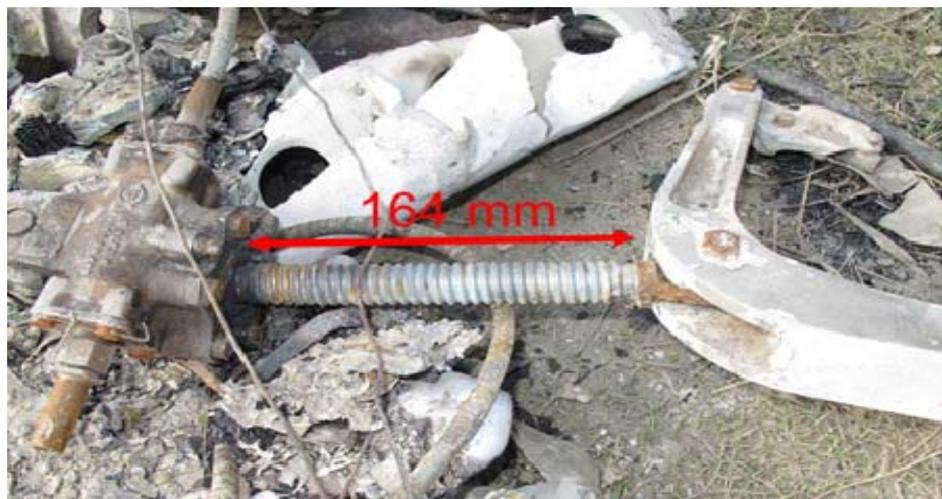
A preliminary examination of the wreckage was carried out onsite. The wings, cabin and cockpit had been severely consumed by fire but parts remained recognisable. Three flap jack actuators were identified and their extension was measured at 164 mm which corresponded to a flap position of 20° which is 'Flaps 2' (Figure 1.12-3). The main landing gear was found to be in the retracted position.

Figure 1.12-3
One of the flap jack actuators

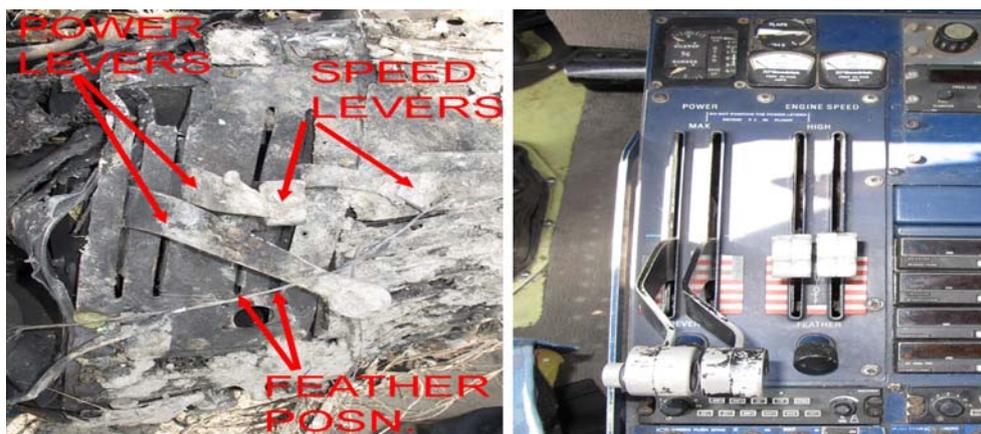
Figure 1.12-4

The left engine power lever was found in the approximate flight idle position but was bent to the side (Figure 1.12-4). The right engine power lever was slightly forwards of the flight idle position. Due to the separation of the engines from the wing and the impact forces within the cockpit, the power levers could have moved during the impact sequence. The left speed lever was in a mid position, the right speed lever was slightly forward of a mid position and both levers were bent sideways. Both levers could have moved during the impact sequence, but if they had been in the gated feather position prior to impact then it is unlikely that they would have moved. Both engine fire levers were in the unselected position. The flap lever was in the Flaps 1 position.

Power and speed (rpm) levers – accident aircraft 9N-AHA (left); another Dornier 228 (right) with power levers in ground idle position and speed levers in fuel shutoff position

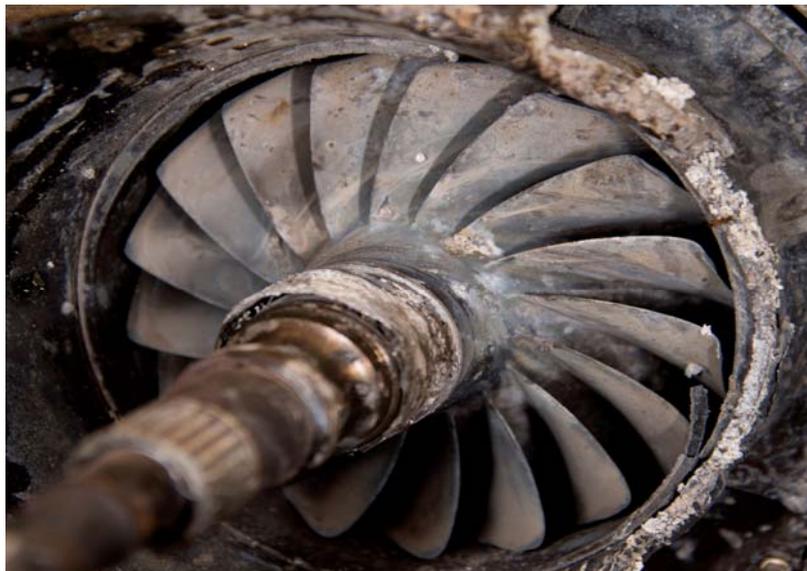
Figure 1.12-5

The left engine had separated into two main sections, the gear case and the power sections. Both had suffered fire and impact damage. The first stage compressor impeller blades were bent back opposite to the direction of rotation (Figure 1.12-5) and there was corresponding rotational scoring through 360° on the surrounding shroud. There was no impact damage to the leading edges of the first stage compressor blades. There was scoring on the tips of the second stage compressor blades and corresponding rotational scoring on the surrounding shroud, and there was also rotational scoring in the turbine section of the engine. This evidence indicated that the engine was rotating at impact. The combustion chamber and plenum were undamaged and the fuel nozzles were in place with no blockages. The three stages of the turbine section were undamaged apart from rotational scoring, but the test result did not confirm the metal spray in the form of aluminum deposits on the suction (back) faces of the turbine rotors and stators of all three stages. These metal spray deposits were determined to be material from the compressor shroud which has an aluminium coating. The rotational scoring of the shroud which occurred during impact would have released aluminium particles into the combustion chamber, where they melted and then re-solidified when they struck the turbine stators and rotors. This evidence indicated that the combustion chamber was lit at impact and therefore the engine was operating at impact. The engine manufacturer could not determine a power setting at impact – the evidence was consistent with idle power, full power, or any power in between.

There was no evidence of bird remains inside the engine and a black ultra-violet light was also used to identify any protein remains inside the power section of the engine which could be indicative of bird remains, but none were found. There was also no odour of bird remains inside the engine.

Left engine first stage compressor impeller – blades bent back opposite to the direction of rotation

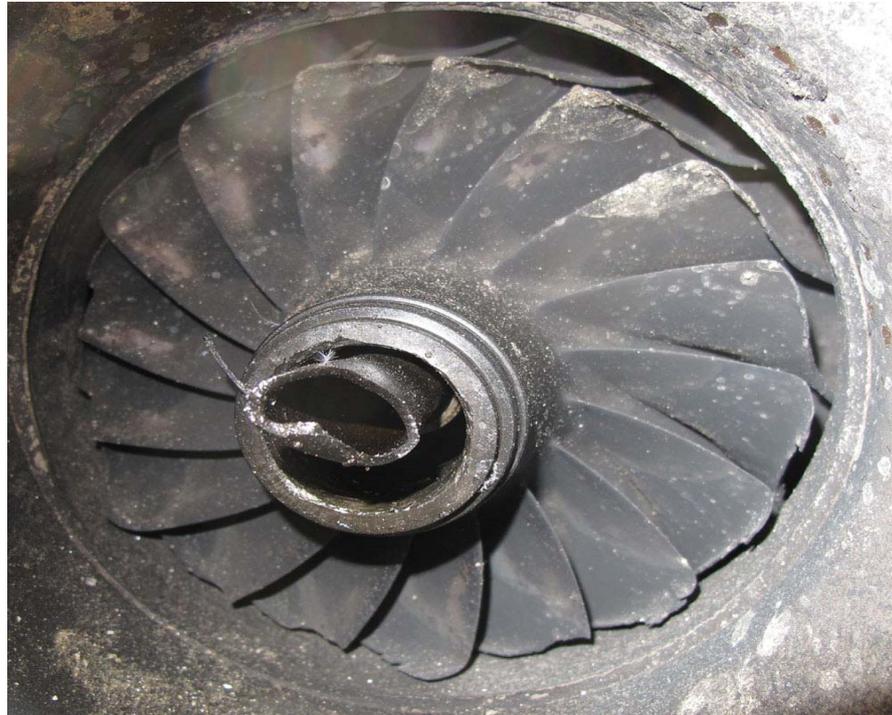
Figure 1.12-6

The right engine had separated into two main sections, the gear case and the power sections. Both had suffered fire and impact damage. The first stage compressor impeller blades were bent back opposite to the direction of rotation and there was corresponding rotational scoring through 360° on the surrounding shroud. Some parts of the impeller blade tips were missing and had a jagged appearance (Figure 1.12-6). One of the first stage compressor blades had leading edge damage near the tip. There was scoring on the tips of the second stage compressor blades and corresponding rotational scoring on the surrounding shroud, and there was also rotational scoring in the turbine section of the engine. This evidence indicated that the engine was rotating at impact. The combustion chamber and plenum were undamaged and the fuel nozzles were in place with no blockages. The three stages of the turbine section were undamaged apart from rotational scoring, but there were metal spray deposits on the suction (back) faces of the turbine rotors and stators of all three stages. There were also metal deposits on the leading edge and pressure (front) side of the first stage turbine rotor blades. These metal deposits were determined to be material from the compressor shroud. This evidence indicated that the combustion chamber was lit at impact and therefore the engine was operating at impact. The engine manufacturer could not determine a power setting at impact – the evidence was consistent with idle power, full power, or any power in between.

There was no evidence of bird remains inside the engine and a black ultra-violet light was also used to identify any protein remains inside the power section of the engine which could be indicative of bird remains, but none were found. There was also no odour of bird remains inside the engine.

Right engine first stage compressor impeller – blades bent back opposite to the direction of rotation

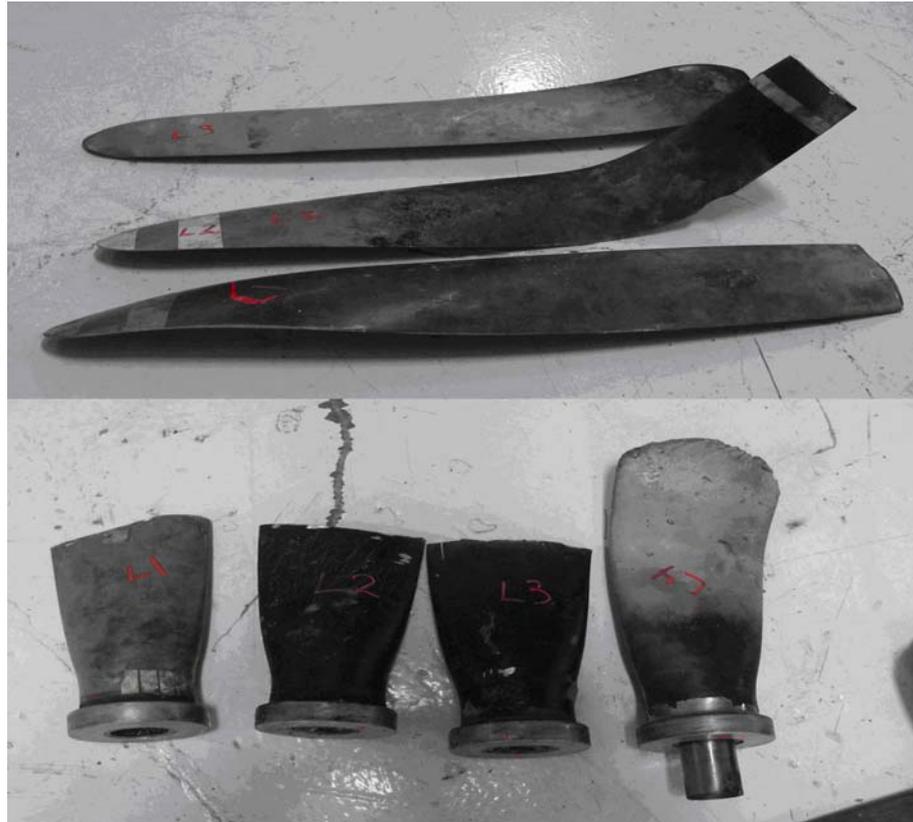
Figure 1.12-7

Examination of the hub unit revealed that the L3 hub arm had three adjacent blade butt impact marks caused by contact with the blade butt. These three marks suggested multiple impacts while the blade was changing pitch during the ground impact sequence. The location of the marks indicated that the blade had been in a normal operating position and then moved towards reverse pitch. The L2 blade butt had 1 mark indicating reverse pitch. The internal surface of the piston had an impact mark indicative of the piston being in a reverse pitch position. According to the propeller manufacturer it is common to see propeller blades being driven towards reverse pitch in an impact sequence. Compressive bending in the link arms and gouging of link screws that had made contact with the guide collar were also evidence of the propeller having been driven towards the low/reverse pitch position. It could be concluded that the left propeller was at a normal positive blade pitch angle at the time of impact – not feathered or in reverse pitch.

Based on the very mild damage to the propeller blades and the lack of significant twisting, tearing, or leading edge damage in the tip area, the propeller manufacturer concluded that the propeller was operating at low or no power at the time of impact. This evidence combined with the evidence of a normal positive blade pitch angle indicated that the engine was probably at low power and not ‘no power’, because a functioning NTS system would have driven the blade angle to a very high, near feather, pitch angle.

Left propeller blades – three blades cut near the butt to facilitate shipment

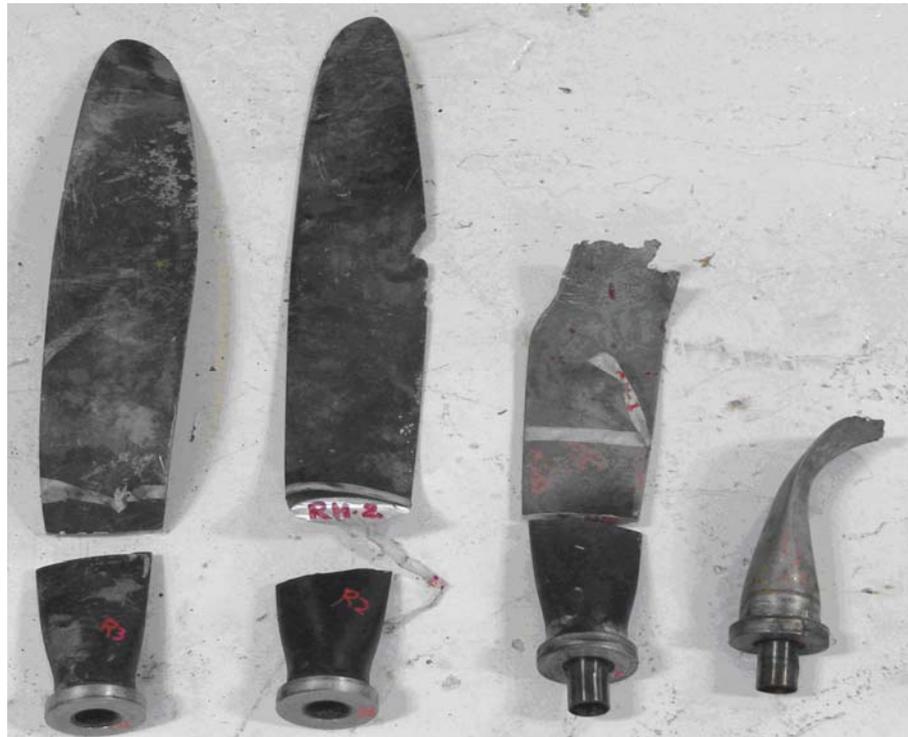
Figure 1.12-8

The right propeller blades were numbered R1 to R4. Blade R1 was missing its outer third where it had melted, and it could not be matched with any of the three separated tips. The blade was not bent or twisted and had no leading or trailing edge damage (Figure 1.12-8). Blade R2 was intact and had a 45° aft bend at $\frac{1}{4}$ radius and no twist. Its leading edge was undamaged and its trailing edge contained a large gouge at mid-blade. Blade R3 was intact and had a 45° aft bend at $\frac{1}{4}$ radius and slight additional forward bending at the outer $\frac{1}{3}$ of the blade. Its leading edge had mild gouges at $\frac{1}{3}$ blade and no trailing edge damage. Blade R4 was missing its outer two-thirds and could not be matched with any of the three separated tips. The blade was bent 45° forward at about 10 inches from the butt end. Its remaining leading edge and trailing edge were undamaged.

Examination of the hub unit did not reveal any hub arm impact marks and there were no marks on the propeller butts either to determine a blade angle. However, a fragment of the damaged spinner was deformed over the piston which provided an indication of piston position. This fragment was 4 inches from the guide collar which indicated that the piston was in a position representative of a blade angle of approximately 20° at the time the spinner was crushed. The low pitch stop is 15° and a typical blade angle at takeoff power is approximately 35°. The blade angle at feather is 76°. This evidence combined with the lack of significant blade twisting, tearing, or leading edge damage in the tip area, indicated that the engine was at low power.

Right propeller blades – three blades cut near the butt to facilitate shipment

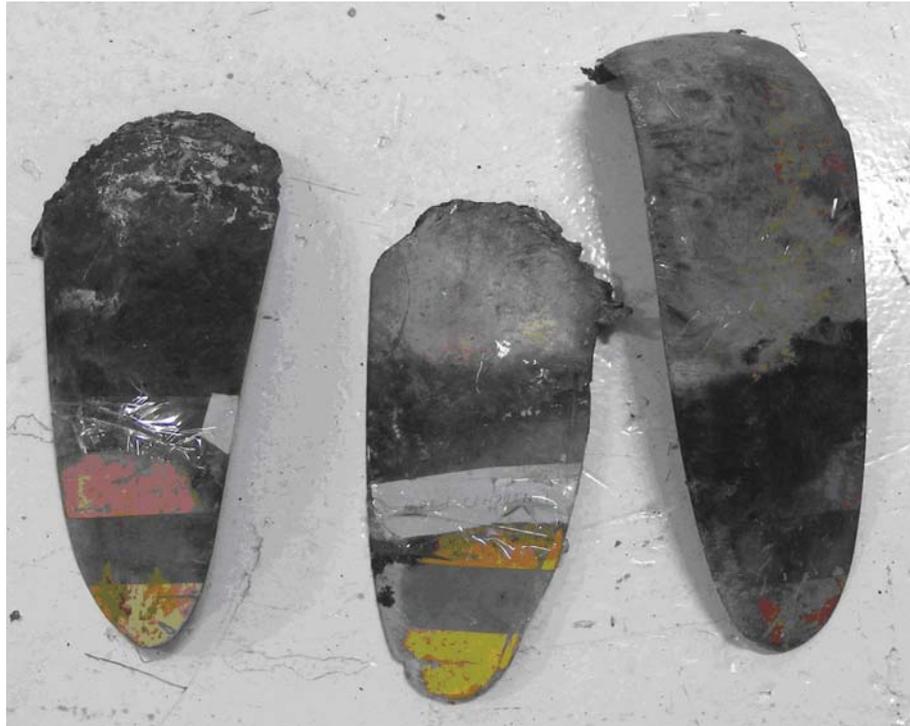
The three separated blade tips that could not be matched up are shown in Figure 1.12-9 - two of these were from the right propeller. There was no significant leading edge or trailing edge damage to any of these blade tips, but one blade tip had a leading edge nick and one had chordwise scratches.

Separated propeller blade tips that could not be matched to the separated blade ends, although two of these are from the right propeller

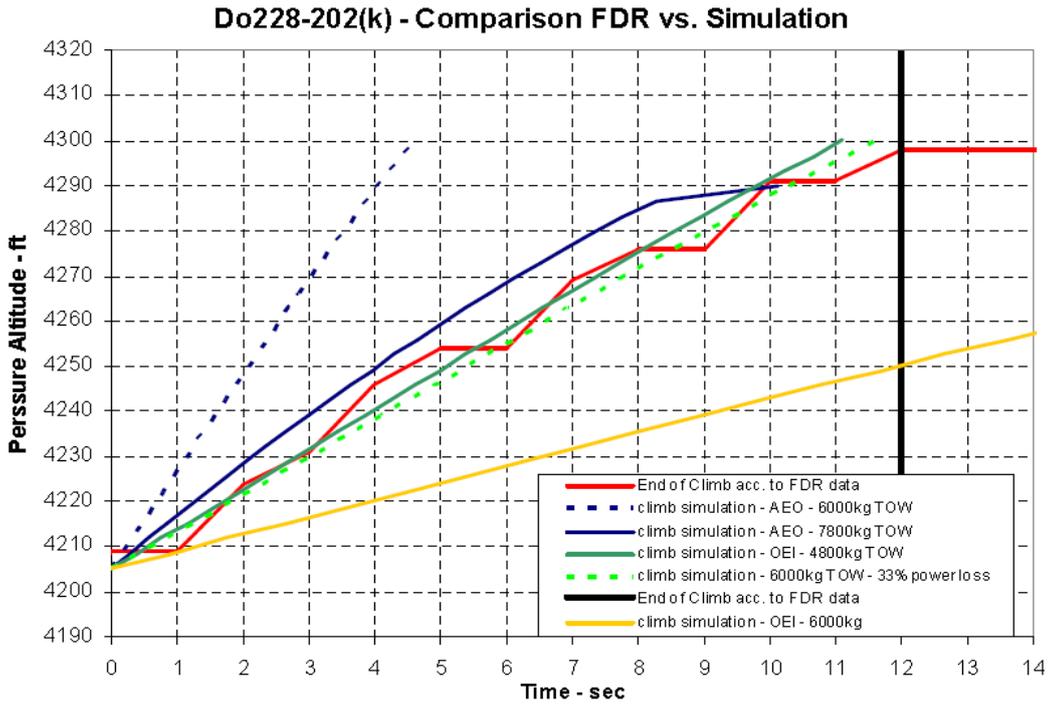
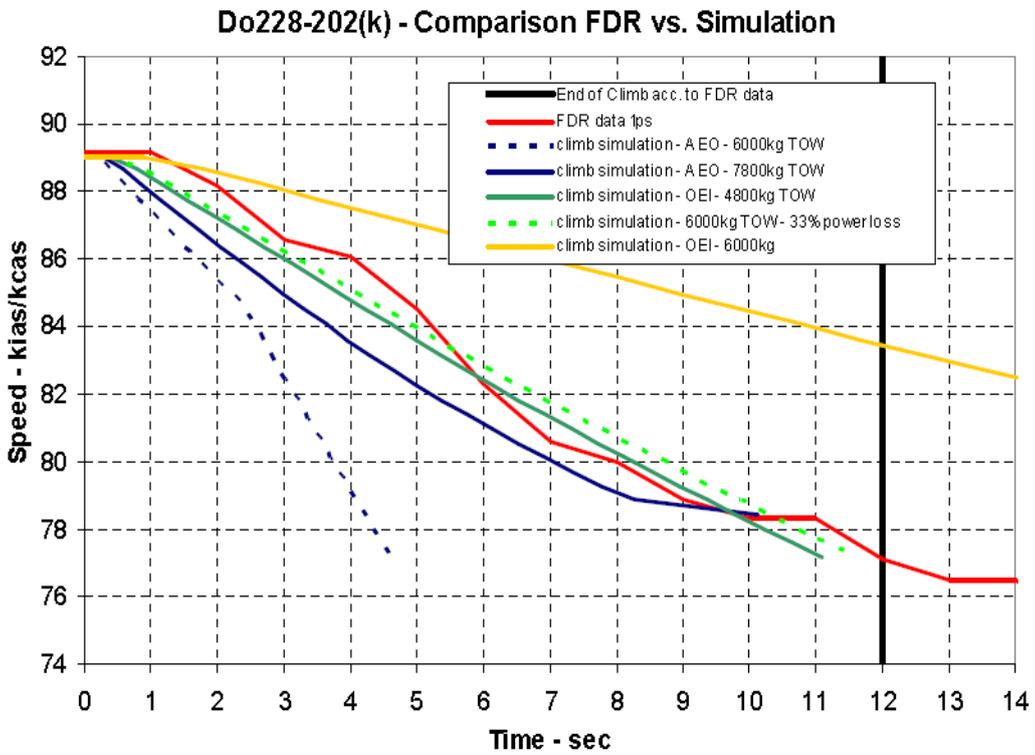
The results of the calculations are shown in Figures 1.16-1 and 1.16-2. The red line in each graph represents the actual performance of the aircraft. The calculations were made using a pressure altitude of 4,250 feet and a temperature of 19 °C.

Figure 1.16-1
Climb situation considering altitude (red line is the actual performance of the aircraft)

Figure 1.16-2
Climb simulation considering speed (red line is the actual performance of the aircraft)

Following a single engine failure, an aircraft would be expected to maintain a speed of V_2 and follow a lower climb rate than the one observed. The yellow lines in Figures 1.16-1 and 1.16-2 show the expected climb profile of an aircraft at 6,000 kg OEI. The lines show that the simulated aircraft would have reached a given altitude at a later time than the actual aircraft while matching the speed profile, and would have reached a given speed at a later time than the actual aircraft while matching the altitude profile. The solid green lines show that the takeoff weight of the simulated aircraft had to be reduced to 4,800 kg before it had the power available OEI to match the observed speed-altitude profile of the accident aircraft. Given the assumed takeoff weight of between 5,800 and 6,100 kg, this shows that the aircraft had more power during the climb phase than would have been the case under OEI conditions.

The broken green lines in the graphs show that a simulated aircraft with a takeoff weight of 6,000 kg would have matched the observed speed-altitude profile had it suffered an average 33% power loss during the climb phase. An average total power loss of 33% from two engines each capable of producing 715 SHP equates

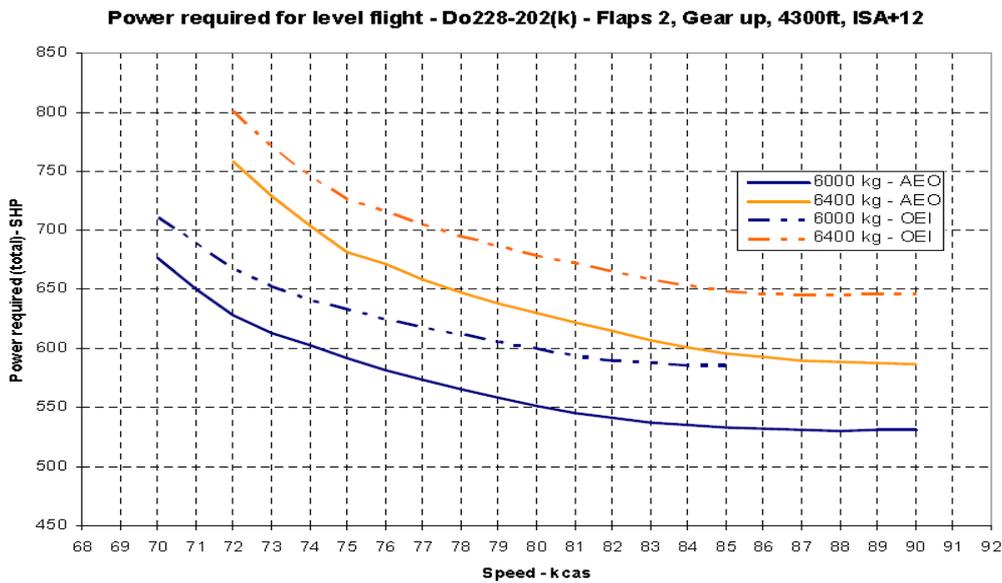
The TC holder was unable to model the level-flight deceleration phase of the aircraft after it reached 100 ft AAL, so it calculated the steady-state power required to maintain level flight at different weights and the results are shown in Figure 1.16-3.

Figure 1.16-3
Power required curve for level flight at different weights

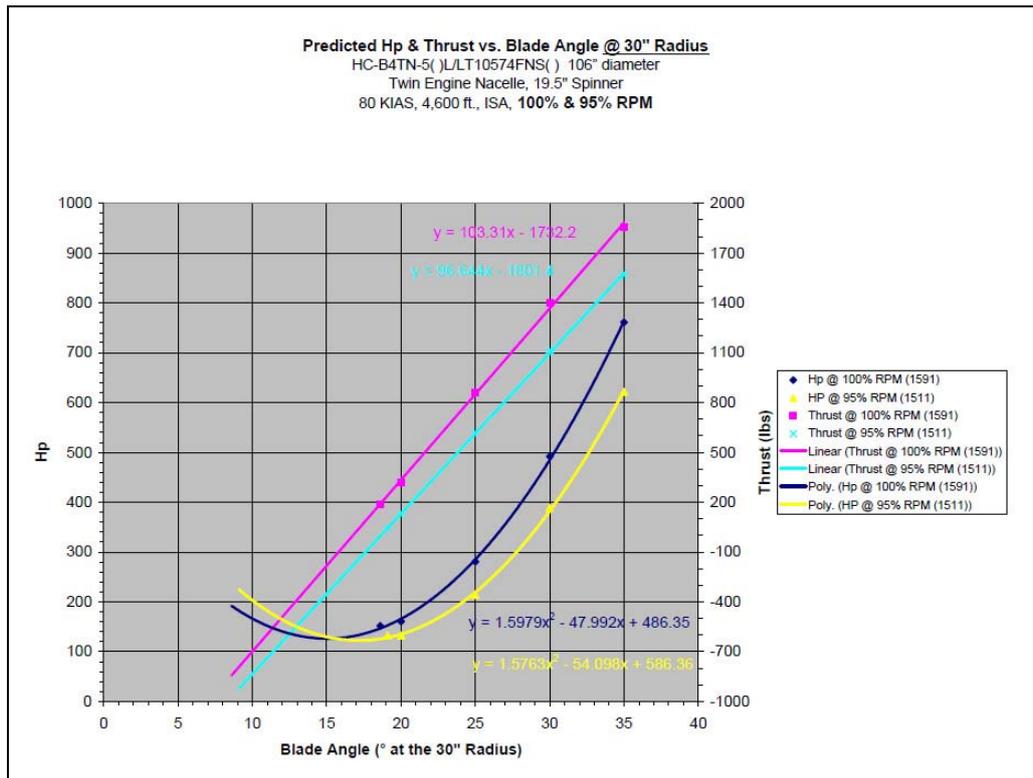
The propeller manufacturer was asked to calculate how much power was required to turn the propeller at 100% rpm and 95% rpm in the same conditions. The propeller manufacturer's calculations are shown in Figure 1.16-4. Hp is the power required to turn the propeller. Thrust is the thrust delivered by the propeller and negative values of thrust mean that drag is being produced. Propeller blade angle is presented on the x-axis and the minimum in-flight blade angle is 15°.

The results show that at 100% rpm and a blade angle of 15° the power required to turn the propeller is 125 hp and the net result is a drag of about 180 lb (-180 lb thrust). Because only 6 hp is available at flight idle in this condition it means that 100% rpm would not be maintained.

The results show that because of the low idle fuel flow setting on 9N-AHA, if flight idle had been selected at airspeed of 80 kt, the rpm would have reduced below 95% rpm and the drag produced by the propeller would have been greater than 350 lb.

Figure 1.16-4
 Hartzell predicted Hp and Thrust Vs Blade Angle and rpm

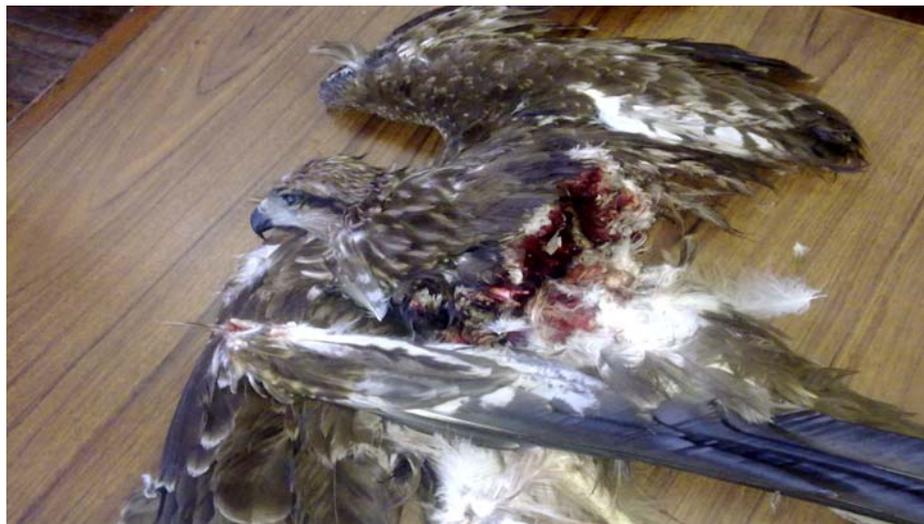
Figure 1.18-2

The total weight of the carcass was 695 g. There were no missing parts but the carcass body was broken into three parts: the largest part, weighing 460 g, included the head, body and right wing; the pelvic part, weighing (185 g) included the two legs; and the right wing, weighing 50 g. The bird appeared to have been cut or sliced through the propeller tips was examined in the national zoo laboratory.

The remains of the bird found on the runway were examined in national zoo lab
