**AVIATION INVESTIGATION REPORT
A12C0154**

LOSS OF CONTROL AND COLLISION WITH TERRAIN

**GOGAL AIR SERVICES LIMITED
CESSNA 208B, C-GAGP
SNOW LAKE, MANITOBA
18 NOVEMBER 2012**

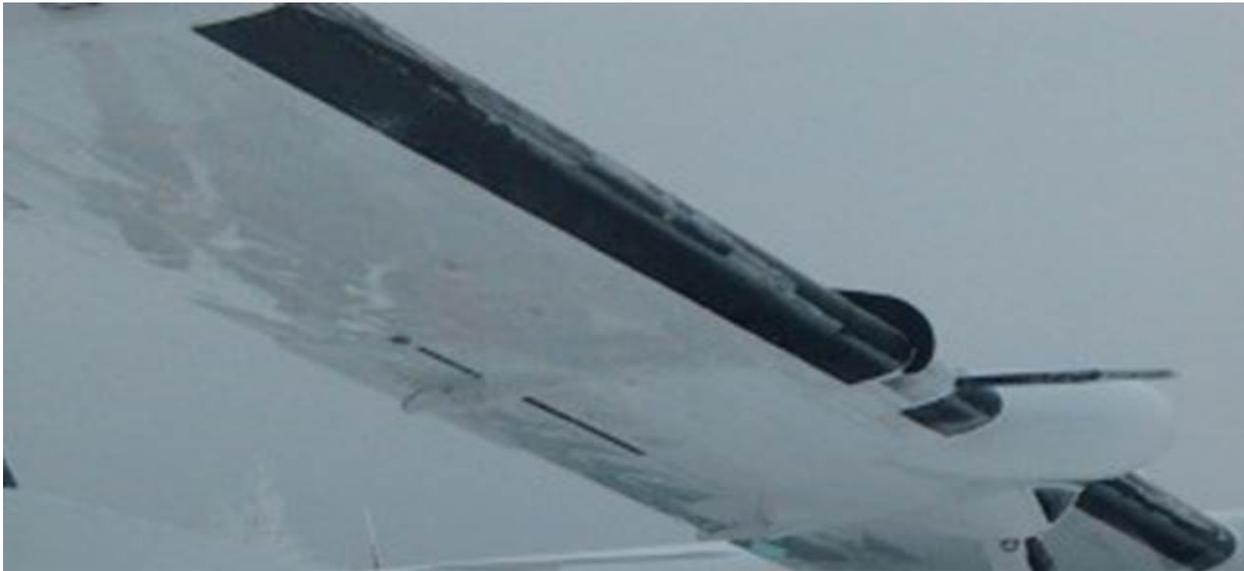
The Caravan had accumulated some rime ice on the leading edges of the wings (Photo 1) and the horizontal stabilizer from the flight into Snow Lake on the previous day. During the pre-flight inspection, the pilot tapped the leading edges of the wings with a broom handle in an attempt to remove the ice, but did not do this on the horizontal stabilizer of the aircraft. Ice remained on the leading edges of the wings and tail before the flight. No de-icing or anti-icing

fluids were applied to the wing or horizontal stabilizer, and no tactile inspection of the upper wing or tail surfaces was observed.

Photo 1. Ice on leading edge of wing before the accident flight

The weather conditions on the day before the accident were conducive to the accumulation of rime ice in cloud. The aircraft had an accumulation of rime ice on its wing and tail leading edges, left from the incoming flight to Snow Lake on the day before the accident. The ice had most likely accumulated during the previous day's flight in icing conditions. Although the pilot made an attempt to remove the ice before flight, a significant amount of it remained on the aircraft. The aircraft's gross weight at take-off exceeded the aircraft's allowable gross weight in icing conditions of 8550 pounds by about 1100 pounds.

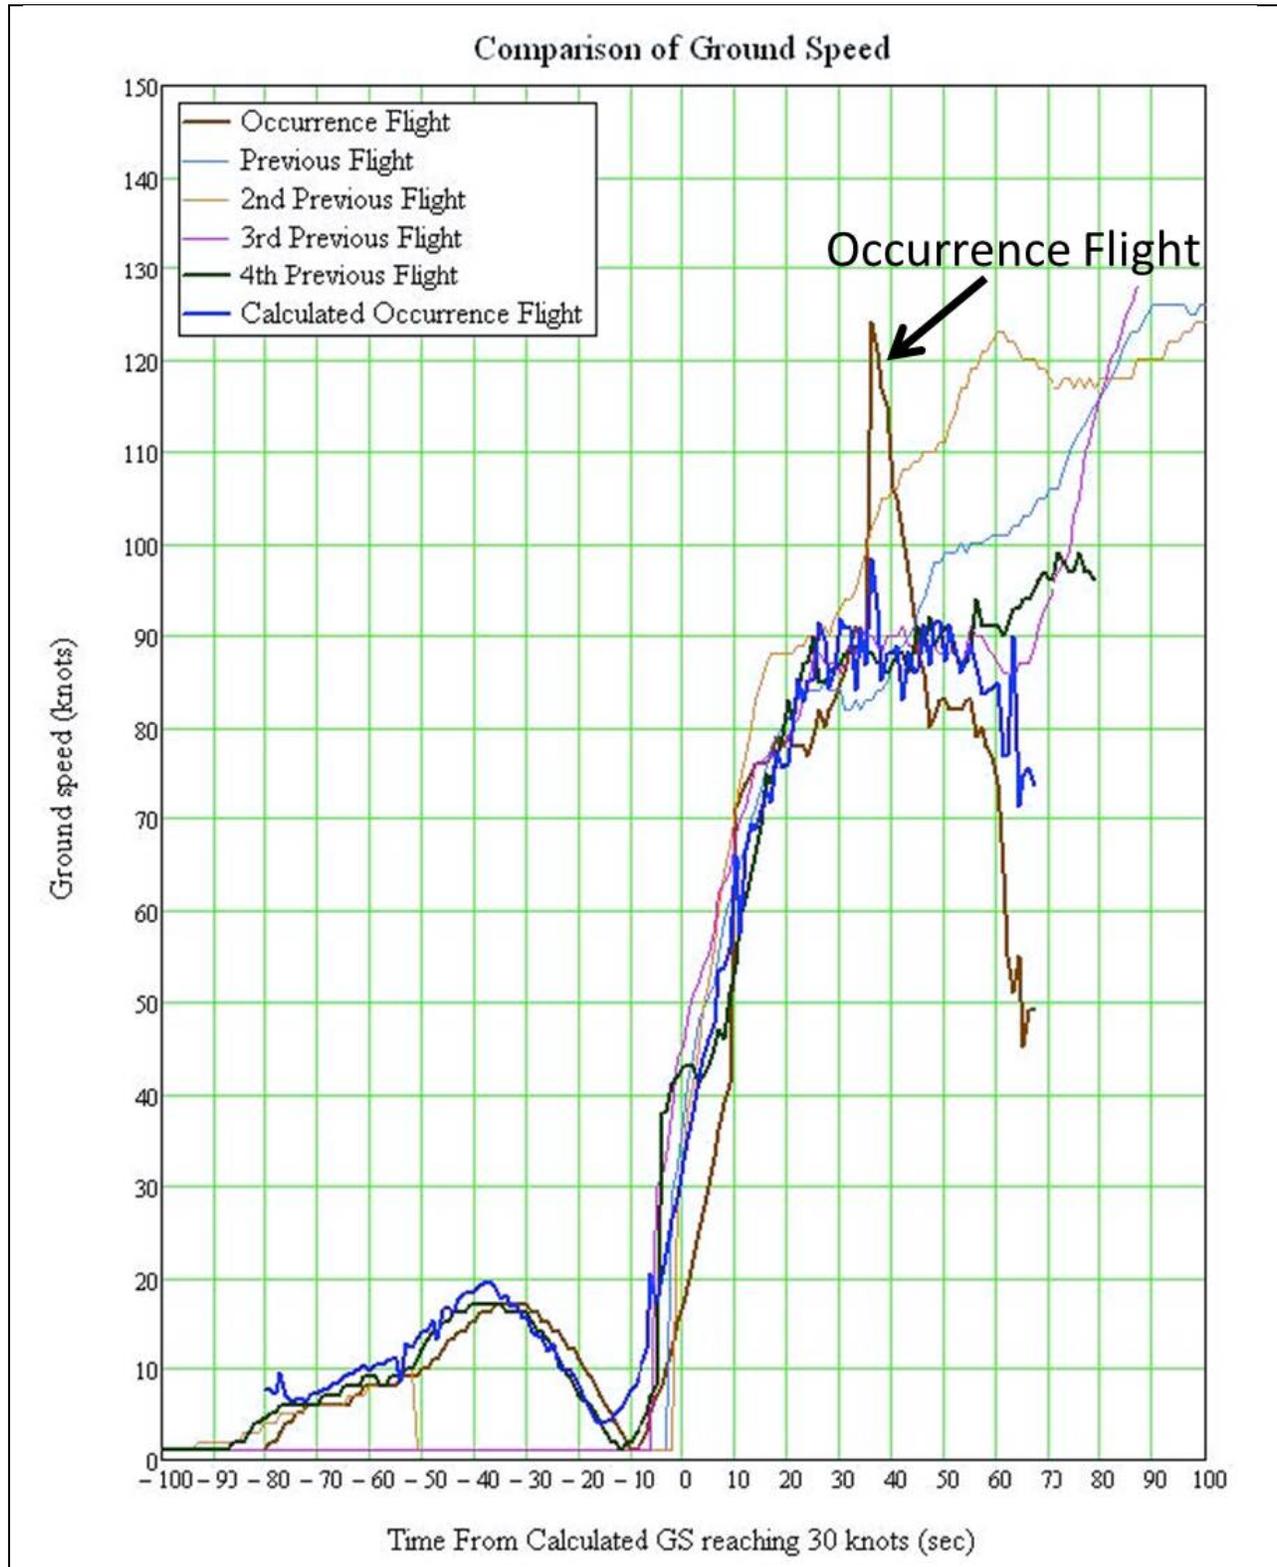
Appendix F – Comparison of ground speed on the accident flight and four previous flights

The spike in the Chelton-calculated aircraft ground speed, noted toward the end of the flight, could have resulted from a change in wind speed or direction aloft, from a retraction of the flaps in flight, or from global positioning system (GPS) anomalies. If the pilot departed with flaps configured to 0°, the spike in the aircraft ground speed likely resulted from a change in wind speed or direction aloft, and would have temporarily reduced the aircraft's airspeed. The target climb CAS of 104 knots in 0° flap configuration, however, was never reached. If the pilot departed with flaps at 20°, then at some point after departure, the flaps were retracted to 0°. The normal procedure is to select 10° flap upon reaching 85 knots, and not to retract the flaps fully until reaching 95 knots. The maximum CAS the aircraft reached was 90 knots, which would indicate that the flaps should have been at the 10° position. The flaps at 0° in this scenario would indicate that the flaps had been selected fully up either prematurely or inadvertently upon reaching 85 knots. In either case, the sudden change in wind speed, direction aloft, or flap position would have reduced the available lift, likely to the point of wing stall. The aircraft's performance was reduced, and its stall speed was increased, by its overweight condition and by ice contamination on its wing and tail leading edge surfaces, and it likely stalled with little warning to the pilot.

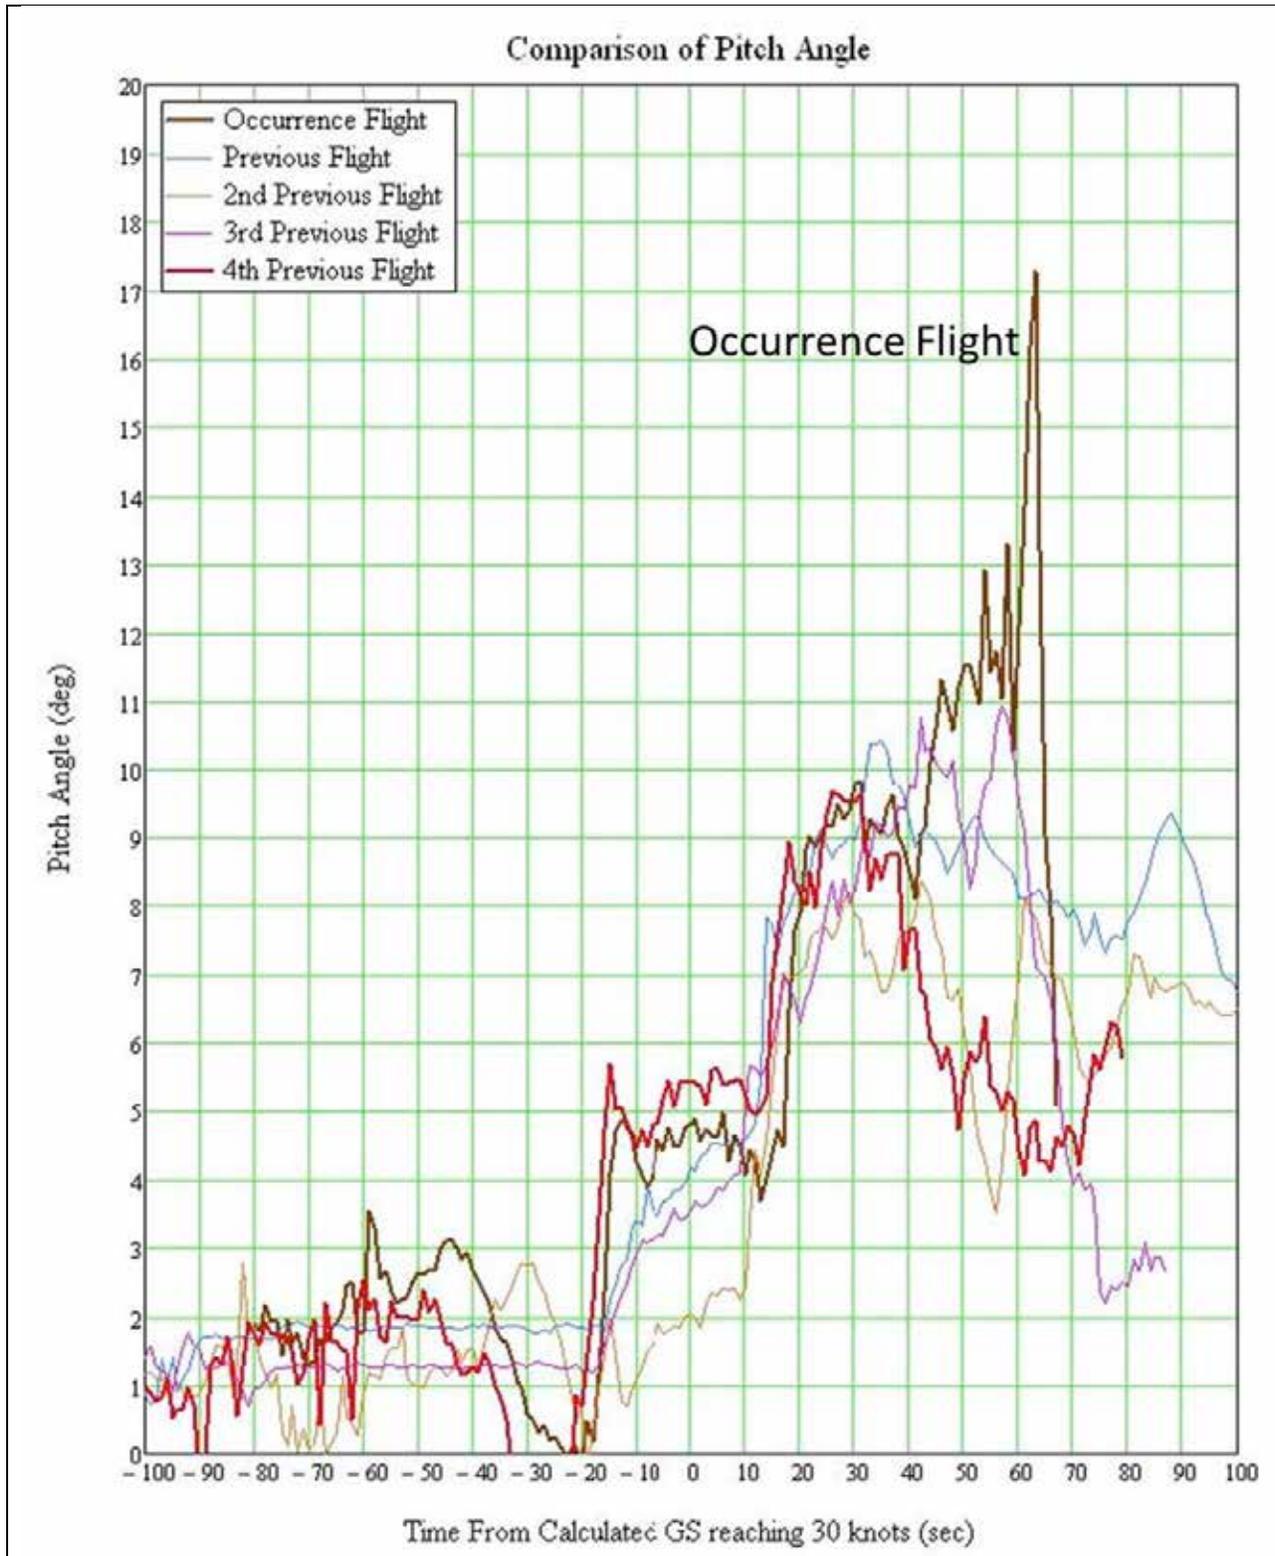
Appendix G – Comparison of pitch angle

about 10 knots in the ground speed. The spike is followed by oscillations in the aircraft's pitch angles continuing to the end of the data, as noted in the aircraft's calculated pitch angles (Appendix G). No change in the engine parameters were noted at that time. A ground speed spike can result from a shift in wind speed or direction aloft, or from retraction of the aircraft's wing flaps, or from global positioning system (GPS) anomalies. About 10 seconds after the spike in ground speed, there is an increase in aircraft pitch angle and several subsequent oscillations in pitch, and a decrease in speed and altitude consistent with an aircraft stall.

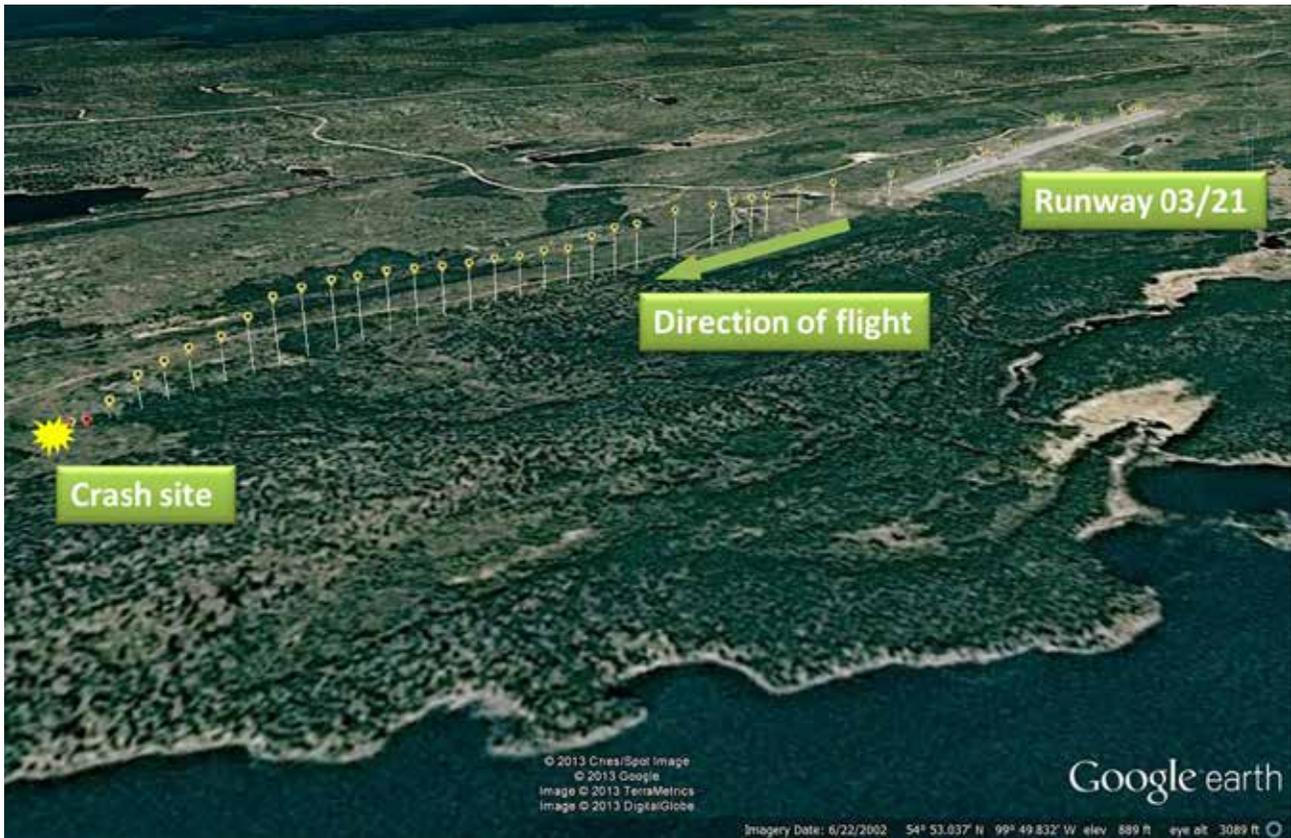
Appendix H – Flight path of accident flight

The aircraft struck the ground on a heading of 210°, approximately 0.9 nm off the end and approximately 70 meters to the right of an extended centreline of Runway 21. The aircraft descended through approximately 30-foot trees in a slight nose-down attitude. The wings were damaged from tree contact, and the outboard portion of the right horizontal stabilizer and elevator were torn off and remained in the trees. The aircraft struck the ground on a gentle up-slope, causing a sudden stoppage. The aircraft's nosewheel and belly pod were torn off, the main landing gear was splayed outwards, and the aircraft's nose and floor structure were buckled. All of these factors helped reduce the impact loading to the occupants. The aircraft yawed to the right and slid approximately 30 feet before coming to rest. The aircraft's descent angle and short ground slide were consistent with a low-air-speed stall condition before tree contact.
