**AVIATION INVESTIGATION REPORT
A12Q0216**

**LOW-ENERGY REJECTED LANDING AND
COLLISION WITH TERRAIN**

**PERIMETER AVIATION LP
FAIRCHILD SA227-AC METRO III, C-GFWX
SANIKILUAQ, NUNAVUT
22 DECEMBER 2012**

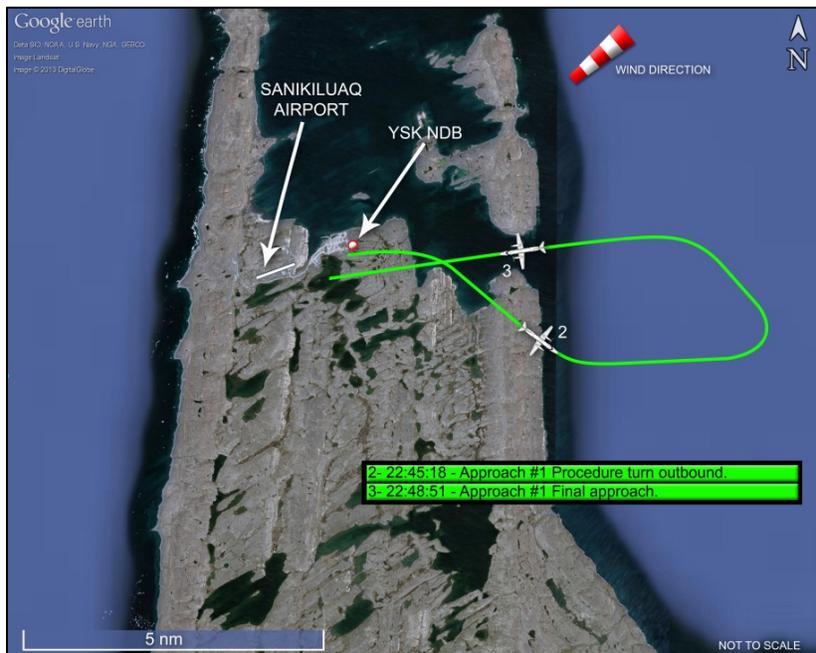
Figure 2. Approximate trajectory of the first approach (Source: Google Earth, with TSB annotations)

The lights of the town, situated just over 0.6 nm east of the airport, were observed while the aircraft was on final approach; the crew could not see the runway environment. Visual contact with the runway environment was made approximately 0.6 nm from the threshold of Runway 27 at an indicated altitude¹⁴ of 600 feet. The published MDA¹⁵ is 560 feet asl; the published minimum circling altitude of 620 feet asl had not been obtained and therefore not used. A left-hand circling for Runway 09 was initiated. The aircraft descended to an indicated altitude of approximately 500 feet. Thirty seconds later, at 2251 UTC, visual contact with the ground was lost, and the circling manoeuvre¹⁶ was continued in instrument meteorological conditions (IMC). A go-around¹⁷ was not called or initiated, and the published missed approach procedure was not followed.

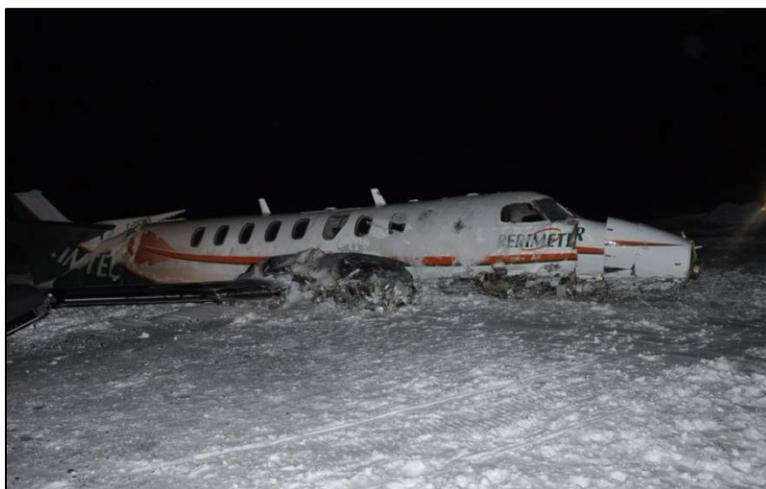
Photo 1. Aircraft wreckage (Source: Royal Canadian Mounted Police)

The doors of all 3 landing gear bays were open on impact and were torn away, indicating that the gear was in transition when the aircraft struck the ground, but not yet fully up and locked. The right main gear and the nose landing gear were torn away on impact with the ground. The left main gear was found retracted into the gear well; however, the tires were cut and bruised; the left main gear retracts slightly ahead of the right gear in normal operation. The landing gear selector in the cockpit was found in the UP position.

Both propellers had broken away from the engine propeller shafts close to the initial impact point. The propeller blades were severely distorted and several had separated from the propeller hubs. The damage sustained by the propellers indicated that both engines were producing significant power at the time of impact.

The fuselage belly skin and underside of the engines were cut and ripped open while sliding across the sharp, rocky terrain, exposing wire bundles, hoses, insulation, lines, and buckling the floor. The fuselage fractured at the forward pressure bulkhead and in the rear baggage compartment area below the dorsal fin. Snow and gravel entered the cockpit floor areas via the openings

in the floor and fuselage. Both wings remained attached to the fuselage, but were substantially damaged. There was no post-impact fire (Photo 1).

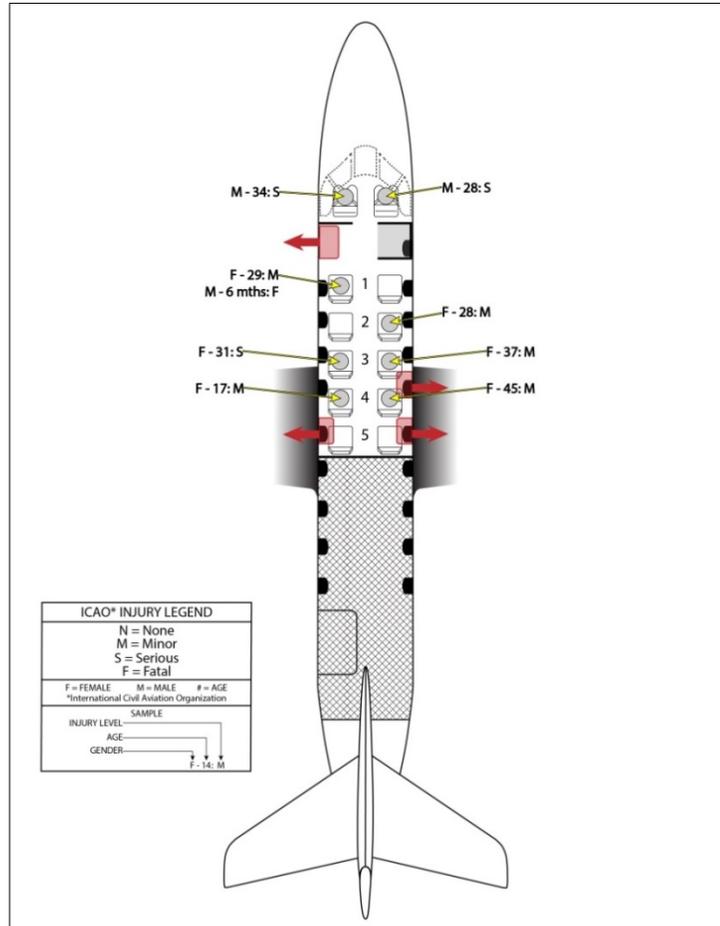
Figure 8. Seating depiction

Cabin seat legs and floor attachment points were broken for seats 2L, 3L, 3R, 4L and 4R.⁴⁵ All adult passengers received minor injuries except for the adult passenger seated in 3L, who

received a fractured ankle. Seat support and attachment failures can subject occupants to unfavourable positions that greatly reduce tolerance to injury. When a seat does not remain securely attached to the floor, occupant injury protection offered either by the seat or by the safety belt and shoulder harness is considerably reduced.

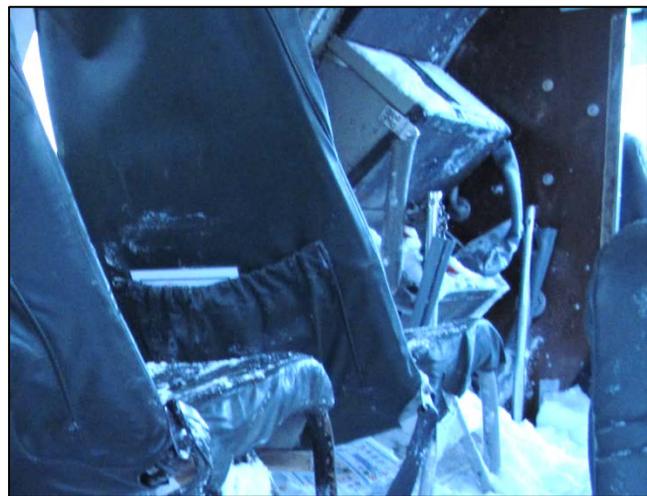
Photo 2. Door stair in front of seat 1L

The belly of the aircraft was compressed, and the deflection had been transmitted to the passenger cabin floor during the impact and subsequent travel across the ground. This damage also deformed the hinge structure of the forward main cabin door and placed abnormal loads on the door latching mechanism. The main cabin door, located on the left side aft of the cockpit bulkhead, was hinged on the bottom with steps and a hinged handrail incorporated into the door construction. When the cabin door is closed, the steps and handrail are immediately forward of the first seat on the left (seat 1L), where the mother and infant were seated. After impact, the orientation of the fuselage and proximity to the ground prevented the door from opening fully.

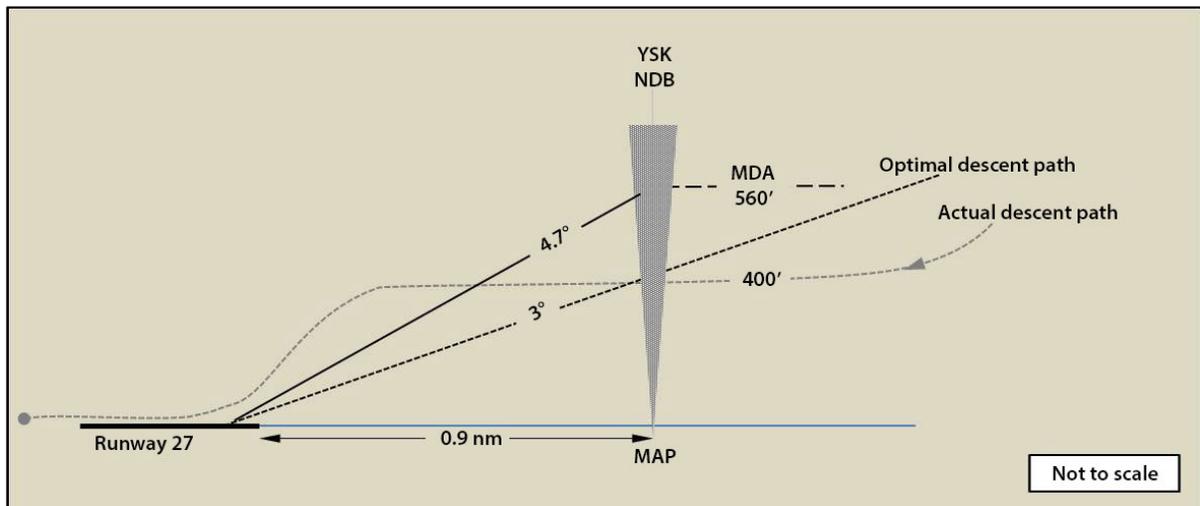
Figure 12. Actual descent path versus optimal descent path

In the case of the CYSK NDB Runway 27 approach, the NDB is the MAP and is located 0.9 nm from the threshold of Runway 27 (Figure 12). Using a threshold crossing height of 40 feet, the descent angle from the MDA of 560 feet, is 4.7 degrees.¹¹³ If flight crews choose to land when they reach the MAP, at MDA, the resulting descent path would be steep and lead to a rate of descent of approximately 1240 fpm. Under industry accepted stable approach criteria, this would be considered unstable, as it is greater than 1000 fpm. Therefore, any decision to land should be made prior to the MAP in order to maintain an approximate 3-degree approach path and remain on a stable approach.
