**AVIATION INVESTIGATION REPORT  
A13P0166**

**CONTROLLED FLIGHT INTO TERRAIN**

**AIR NOOTKA LTD.  
DE HAVILLAND DHC-2 (FLOATPLANE) C-GPVB  
HESQUIAT LAKE, BRITISH COLUMBIA 3 NM W  
16 AUGUST 2013**

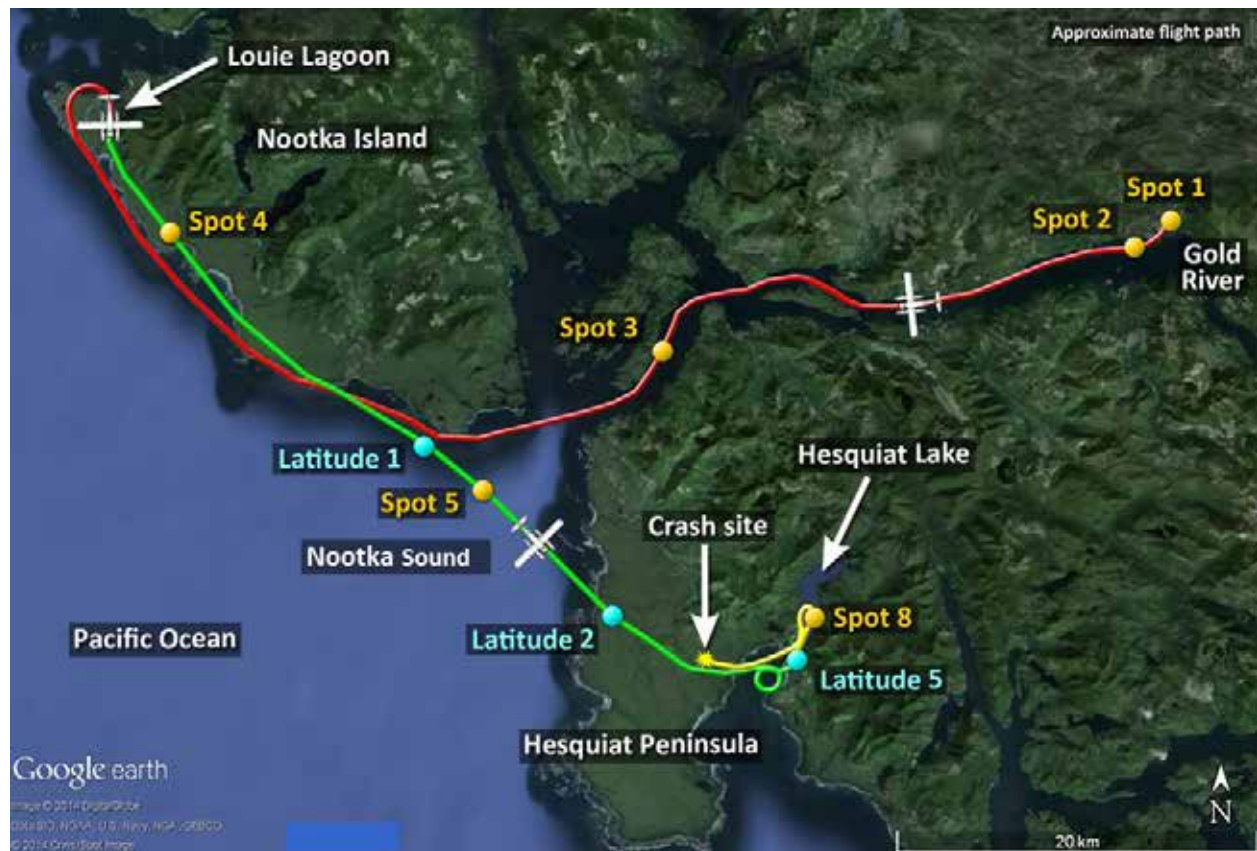
Figure 1. Route of flight (Source: Google Earth, with TSB annotations)

While flying over Nootka Sound, British Columbia, at just under 300 feet above sea level (asl), en route from Louie Lagoon to Hesquiat Lake, the pilot radioed Air Nootka's base to report that the weather was good enough for 2 company aircraft to depart the company's base for Hesquiat Lake to pick up 9 additional hikers at the Hesquiat Lake dock.

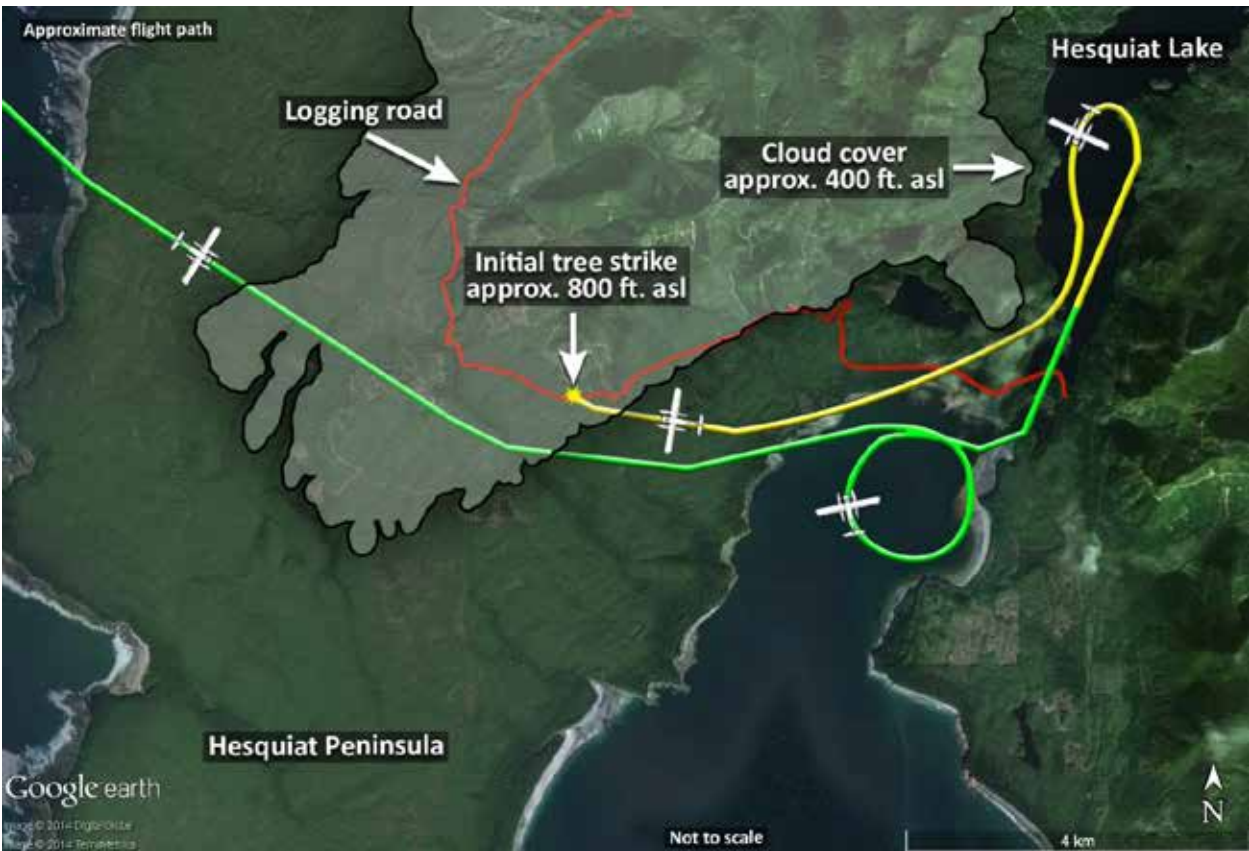
Figure 2. Arrival and departure from Hesquiat Lake (Source: Google Earth, with TSB annotations)

About 6 minutes later, C-GPVB crossed over the west shore of Hesquiatic Peninsula while flying at about 400 feet asl. It continued east across the peninsula, arriving at the dock on Hesquiatic Lake at about 1004. The weather there included rain, wind from the southeast, visibility about 2 ½ nm, and a ceiling of about 400 feet asl.

The pilots of the other 2 Air Nootka aircraft inbound to Hesquiatic Lake elected to stay over the shoreline of Hesquiatic Peninsula for its entire periphery rather than cross the peninsula. The inbound pilots reported their locations and the weather along their route several times to C-GPVB's pilot as they approached. At about 1023, the pilot of C-GPVB radioed the 2 inbound aircraft that he was off the lake and was going to take a look at crossing the peninsula westbound. C-GPVB flew westbound for about 2 minutes, climbing into cloud while staying just above tree-top level, until it struck a tree at about 800 feet asl. The pilots of the 2 inbound aircraft heard a brief "Mayday" on the radio, but were unable to contact C-GPVB afterward. C-GPVB came to rest in forest about 600 feet west of the initial tree strike. All 6 occupants survived the crash, but a short time later a post-crash fire ignited. Four passengers were able to exit the aircraft, but the pilot and 1 passenger remained in the aircraft, which was subsequently consumed by the fire. The 406 megahertz (MHz) emergency locator transmitter (ELT) transmitted a signal for a short period before it was destroyed by the fire.

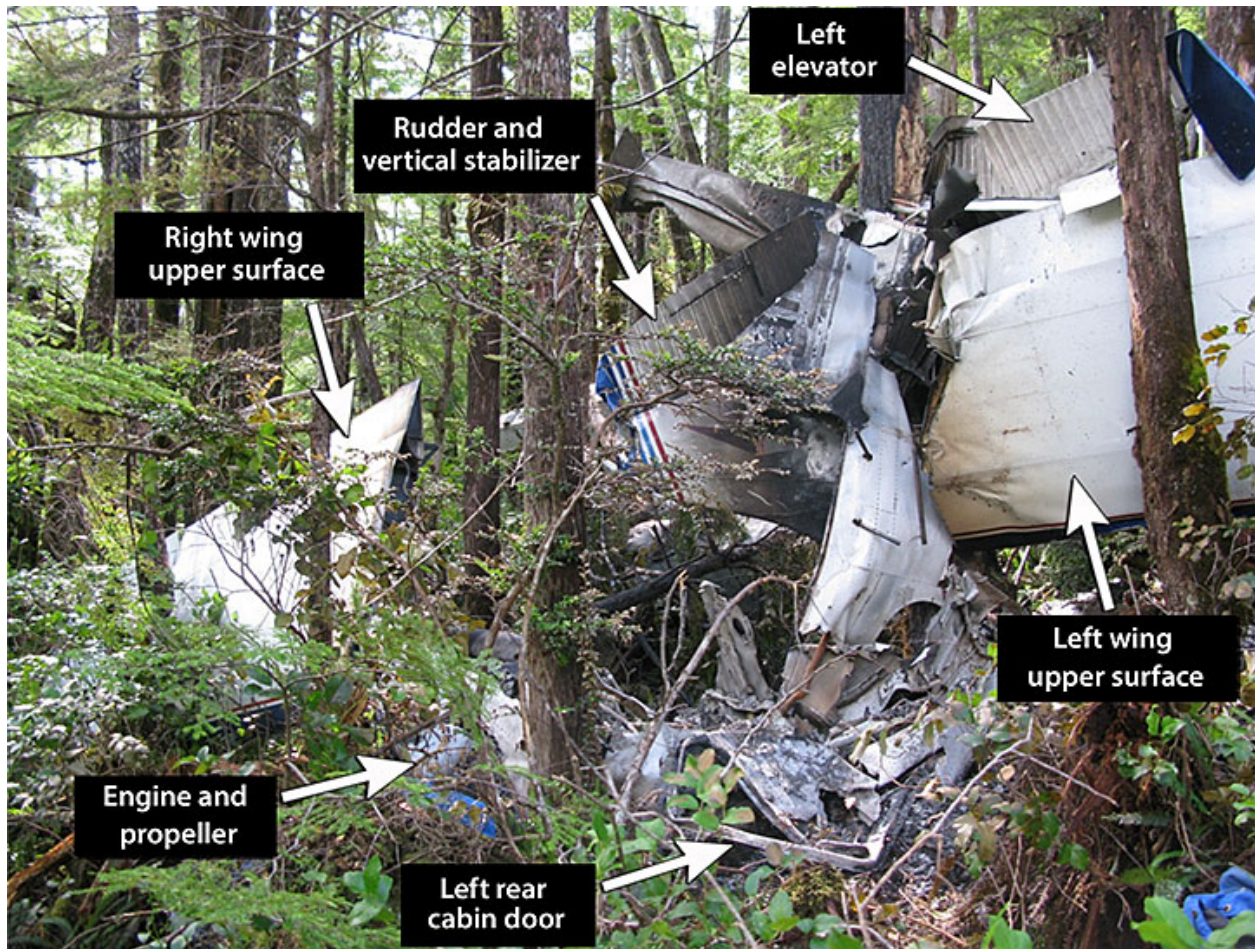
Photo 1. Accident site

The accident occurred about 3 nm west of Hesquiat Lake in mountainous terrain in the northern portion of Hesquiat Peninsula. The terrain from the southern tip of Hesquiat Peninsula to about 1 mile south of the accident site (about the southern 2/3 of the peninsula) is relatively level ground less than 200 feet asl. The tree that was hit was about 140 feet tall, significantly taller than the trees surrounding it. The aircraft struck the tree about 20 feet below its top and came to rest nose-down in forest about 600 feet further west. The tree is about 400 feet north (uphill) of a logging road running across the hillside in the same direction the aircraft was flying. It is not known if the pilot was using the road as a navigation aid.

The floats detached at final impact, but otherwise the aircraft remained largely intact until consumed in the post-crash fire (Photo 1).
