Final Report No. 2205 by the Swiss Accident Investigation Board SAIB

concerning the accident involving the
Embraer EMB-505 aircraft, CN-MBR

on 6 August 2012

St. Gallen-Altenrhein (LSZR) regional
aerodrome, Thal/SG municipality

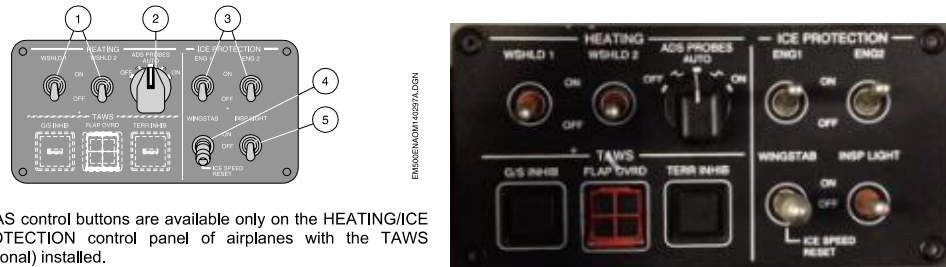
Separate TAWS control buttons are optionally available on the Phenom 300 aircraft. The function of these control buttons and their corresponding use is not described in the POH. Aircraft CN-MBR was equipped with this option.

Figure 10: HEATING/ICE PROTECTION control panel
(left: POH 2908, 6-11-05; right: in aircraft CN-MBR)

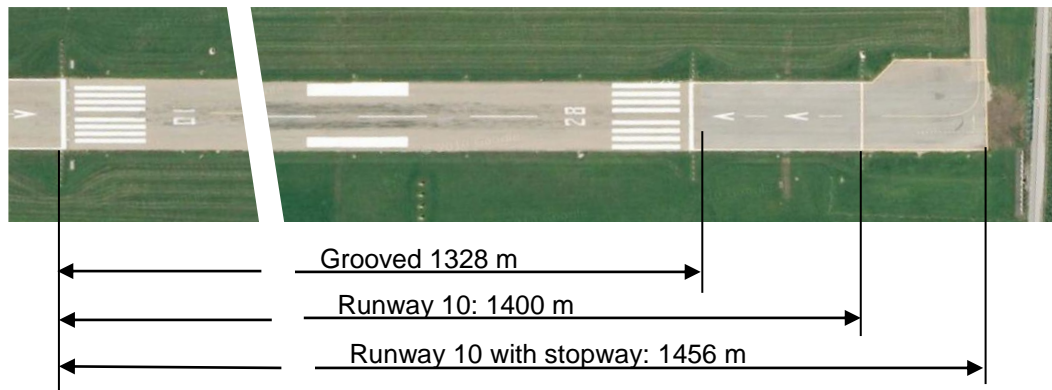
The runway length available on runway 10 was 1400 metres, plus a further 56 metres of hard surface (stopway). The first 1328 metres of runway 10 were grooved.

Figure 18: Longitudinal dimensions of runway 10

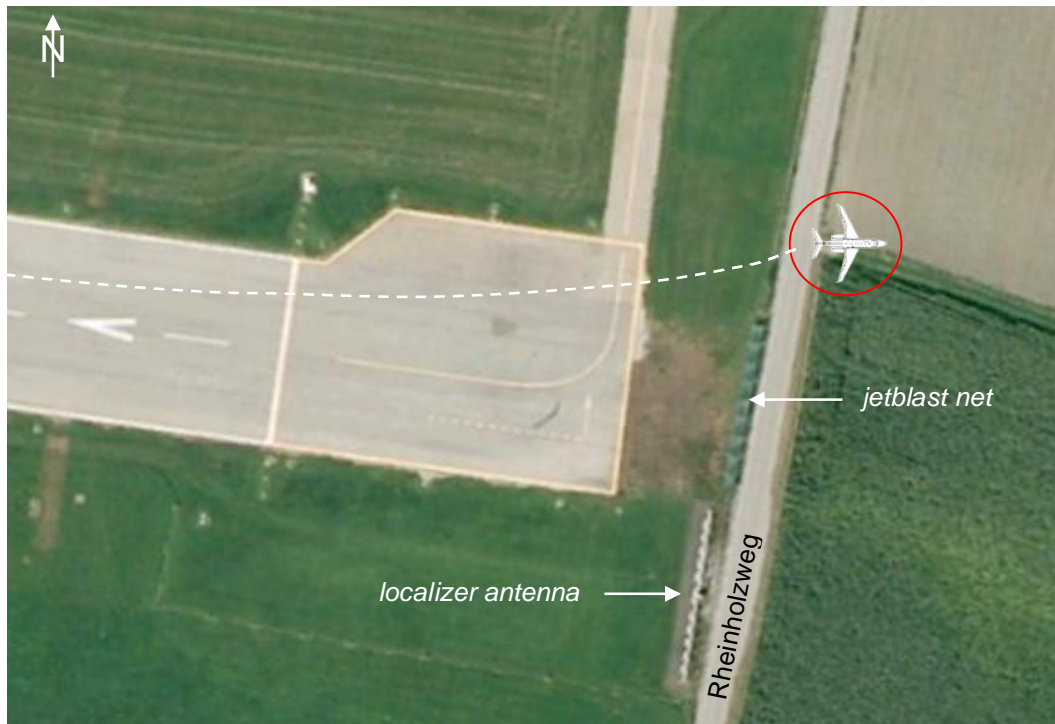
The site of the accident is the eastern side of the road (Rheinholzweg) running perpendicular to the runway at a distance of 20 metres from the end of the runway, just 30 m from the end of runway 10.

Figure 19: End of runway 10 with the road (Rheinholzweg) running perpendicular to it. Site of the accident marked in red on the edge of a maize field

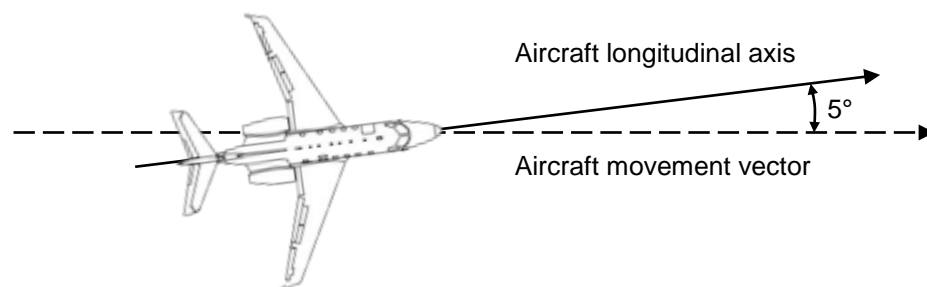
The longitudinal axis of the aircraft was not parallel to the aircraft's vector of movement; it was rotated approximately 5 degrees to the left.

Figure 20: The longitudinal axis was rotated in relation to the movement vector

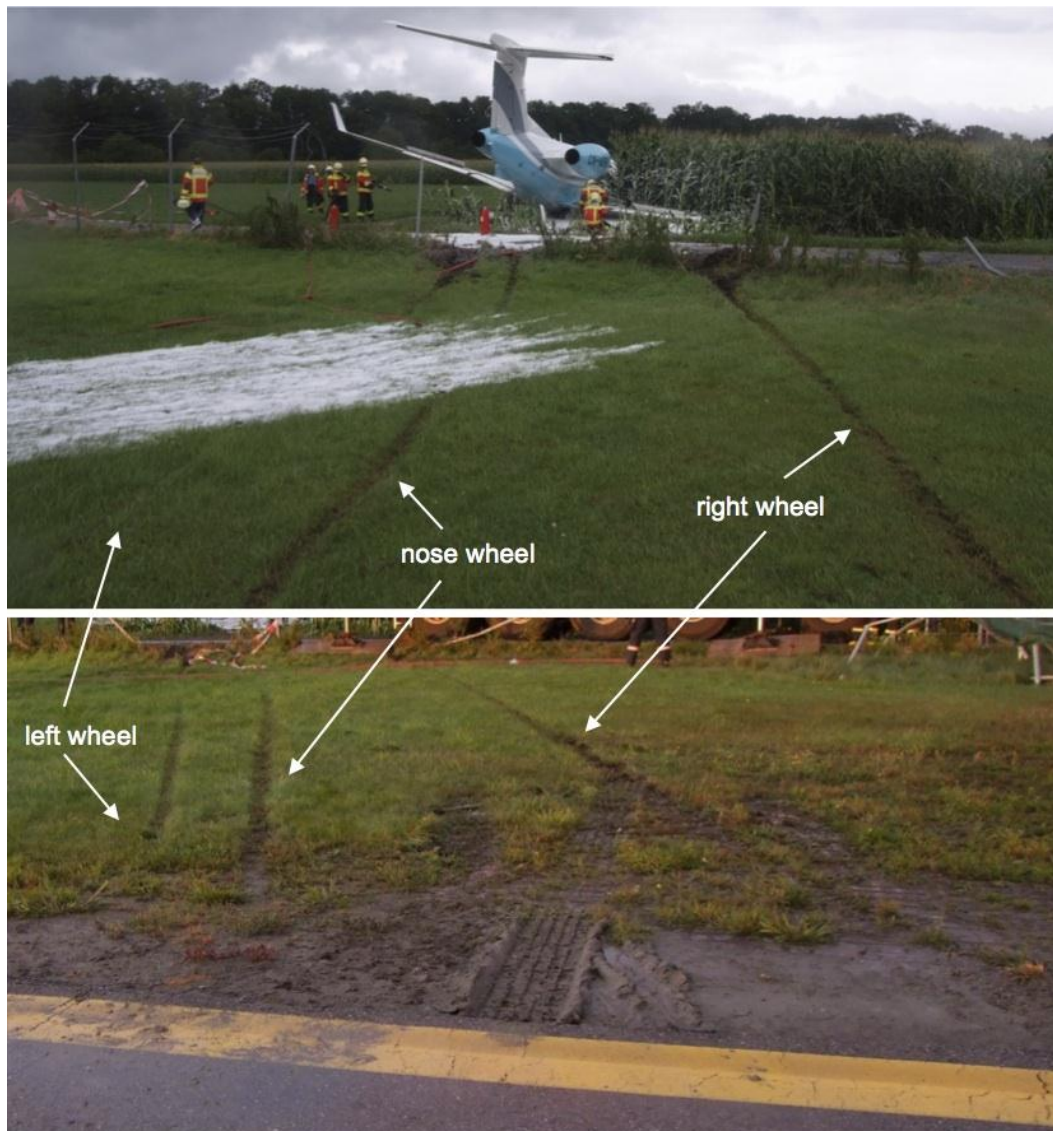
No real impact occurred, as the aircraft was negatively accelerating, or braking, only in the horizontal direction. The speed of the aircraft when it rolled over the end of the runway was 44 kt, according to the CVDR recordings. The subsequent slow deceleration caused by the roll over the soft ground, the breaching of the perimeter fence and the crossing of the adjacent road took place over a distance of approximately 30 m and was marginal.

Figure 21: Aircraft wheel marks after it rolled beyond the end of the runway

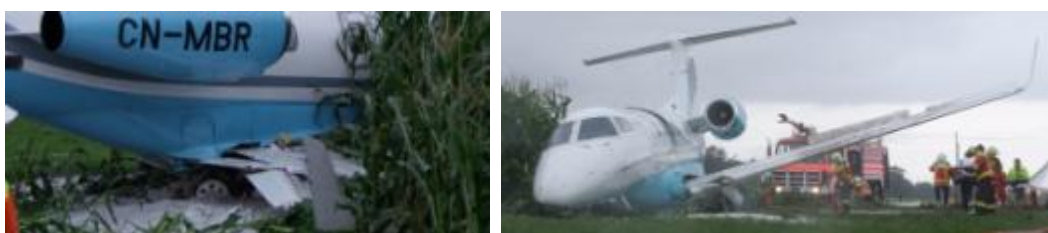
The lower part of the fuselage and the right wing, including the fuselage-wing panels, was severely damaged.

Figures 22 and 23: Right main landing gear and left wing

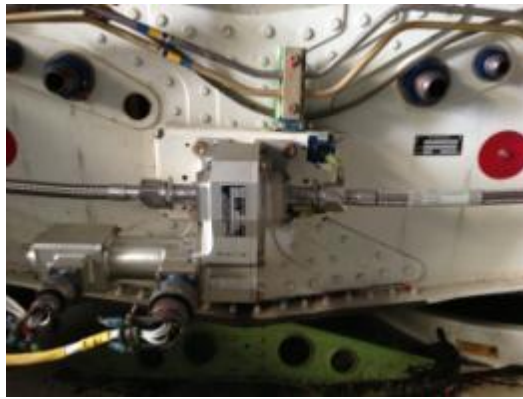
Figure 24: Flap drive system

The flap selector lever (FSL) was found in position 3. In this position the flaps would have had to extend to 26°. However, they were in a position between 9 and 10°. This corresponded to the recorded values. In view of the general condition of the aircraft, no mechanical functional check of the flap system could be carried out. However, a visual inspection produced no evidence of any pre-existing defects.

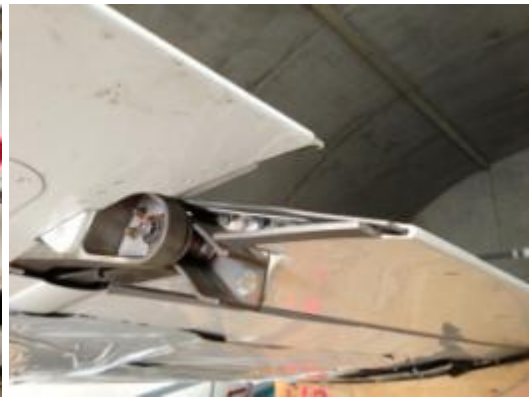
Figure 25: Flaps on left wing, 9.49° extended

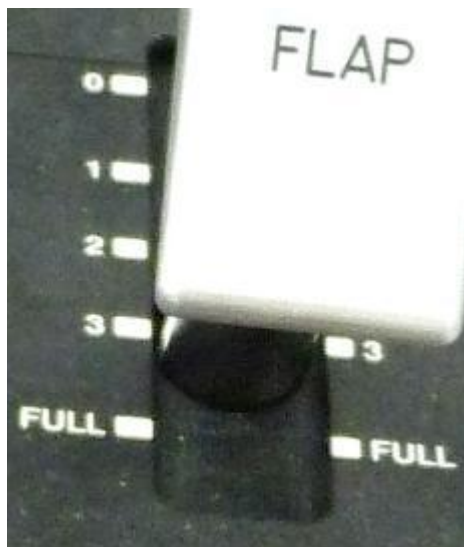
In CN-MBR an FSL P/N 780501-7 was installed (cf. chapter 1.16.2.5).

Figure 26: FSL in CN-MBR

During which of these three FSL replacements the stopper fitted on delivery was lost is not apparent from the available documentation.
