Investigation report

L2014-02

Aircraft Accident Resulting in the Death of Eight Skydivers at Jämijärvi on 20 April 2014

OH-XDZ

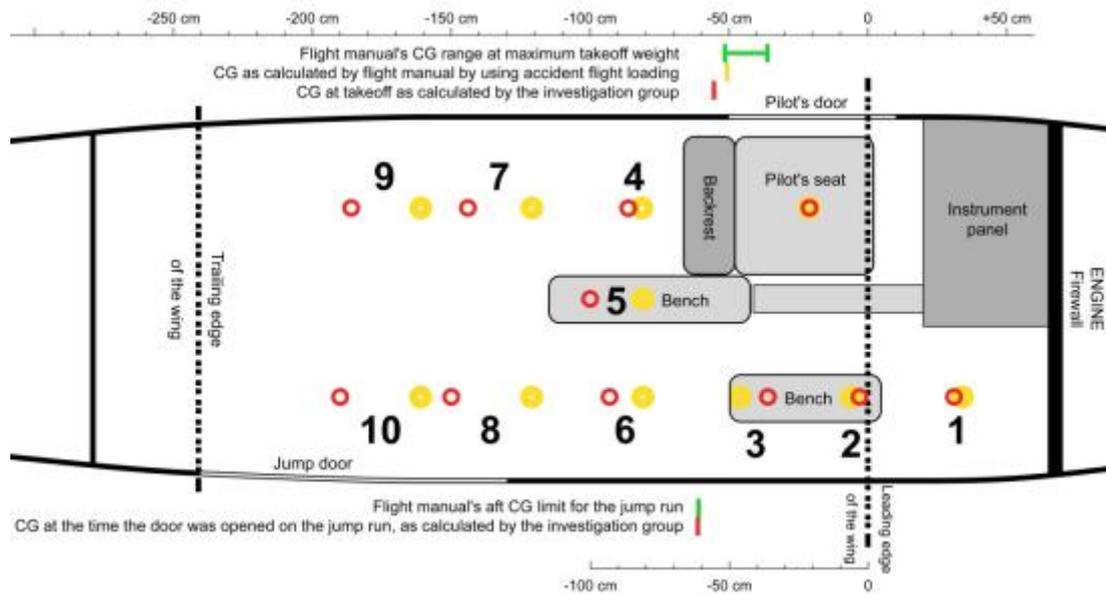
Figure 5. The positioning of skydivers in the aircraft as per the flight manual (yellow markings), and that in accordance to the investigation group's measurements (red markings).

The table below presents a comparison between the flight manual-specified values and those achieved through measurements when skydivers are seated as tightly as possible, facing rearwards. As per the measurements the persons in positions 7-10, wearing full parachuting gear, sat at least 23-29 cm further back compared to the values given by the flight manual.

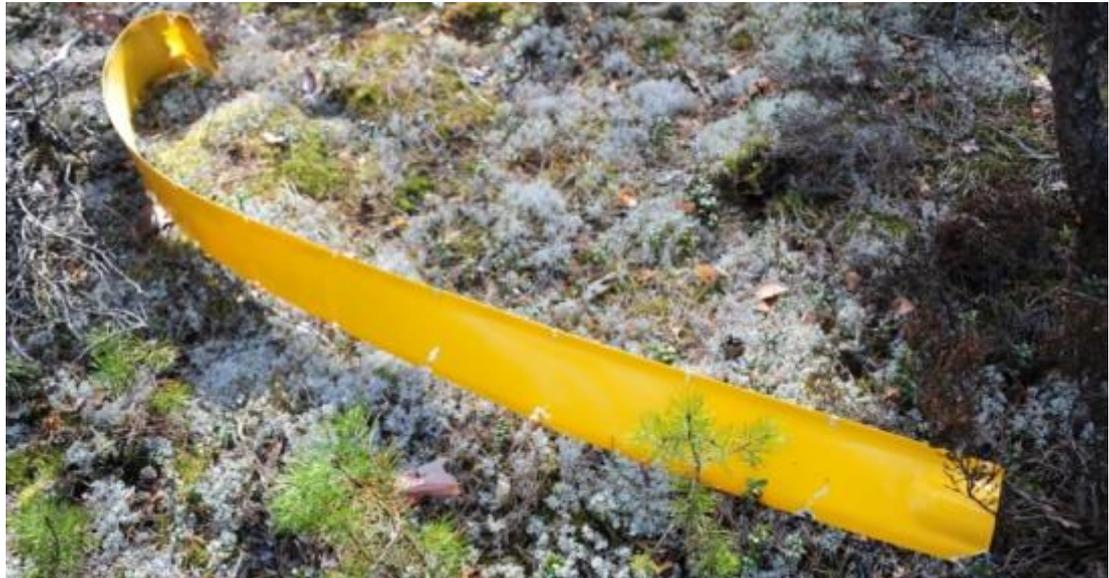
Figure 7. The upper fillet between the right wing and the fuselage, found in the terrain.

Judging by the location where the fillet between the right wing and the fuselage was found it was determined that it came loose at altitude. The fracture marks on the fillet indicated that the right wing had folded downwards around its root mountings. The root spar of the wing broke when the wing folded. Fuel streamed from between the wing and the fuselage during the nosedive. The eyewitnesses said that the aircraft left a vapour trail. They made their observations after the wing had already folded.

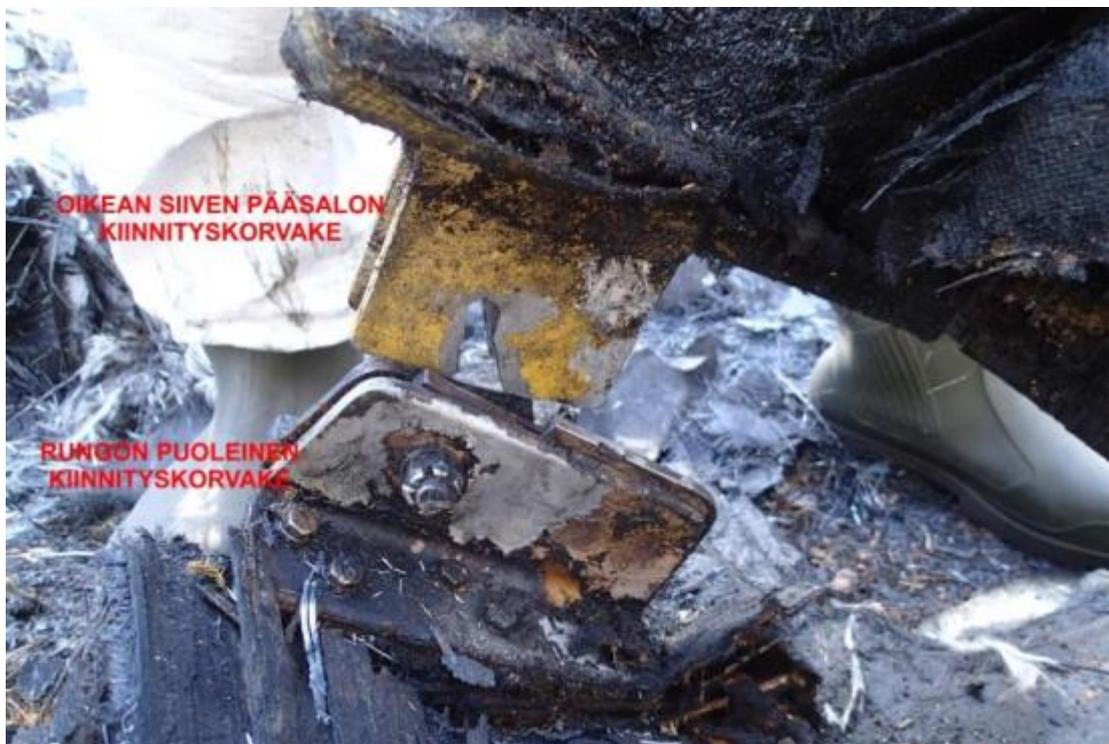
Figure 8. The right wing's main spar fitting and the fuselage-side fitting.

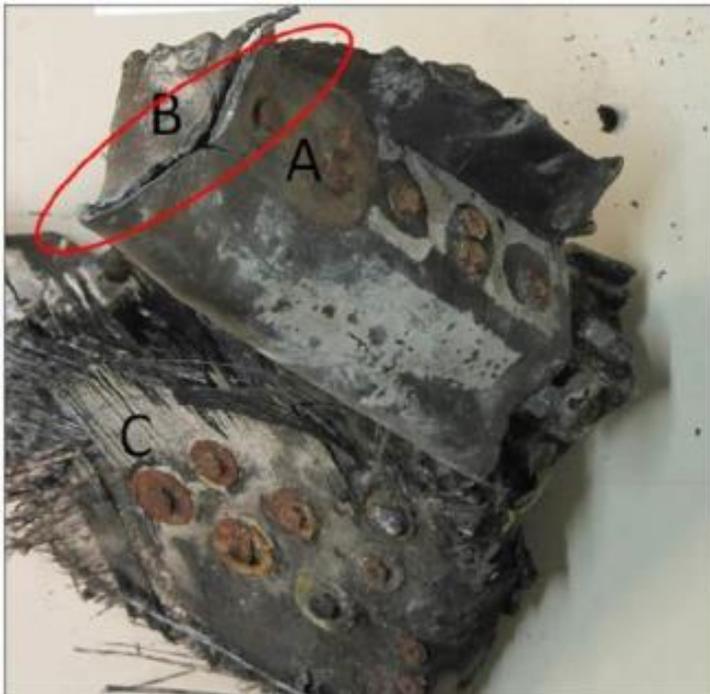
Figure 13. The lower part of the right wing strut found at the accident site. "A" indicates the upper surface of the strut. "B" indicates the upwards bent lower surface and "C" shows the burnt lower surface of the fuselage.

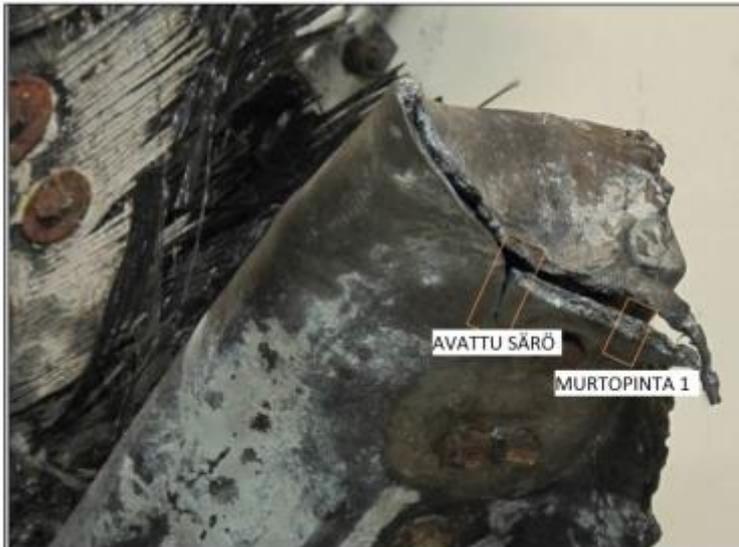
Figure 14. During the material analysis samples were cut from the fracture surface and the crack itself. (Photo: VTT)

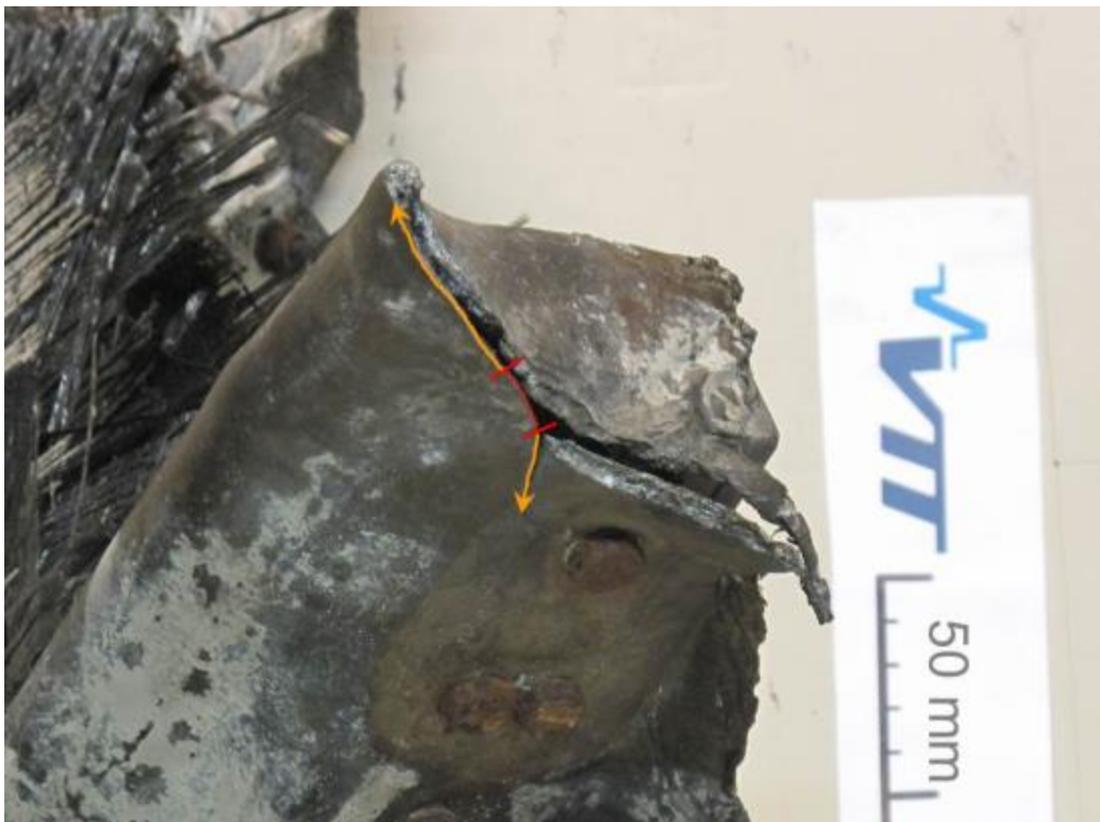
The crack originated behind the leading edge of the profile, at the top, and propagated in both directions transversely in relation to the profile. At the level spot in the middle of the profile the fatigue crack turned lengthwise, towards the edge of the fastening inside the profile. The red colour in figure 15 illustrates the area where the crack started and the yellow colour the areas to which it continued.

Figure 15. Propagation of the crack in the wing strut (Photo VTT.).

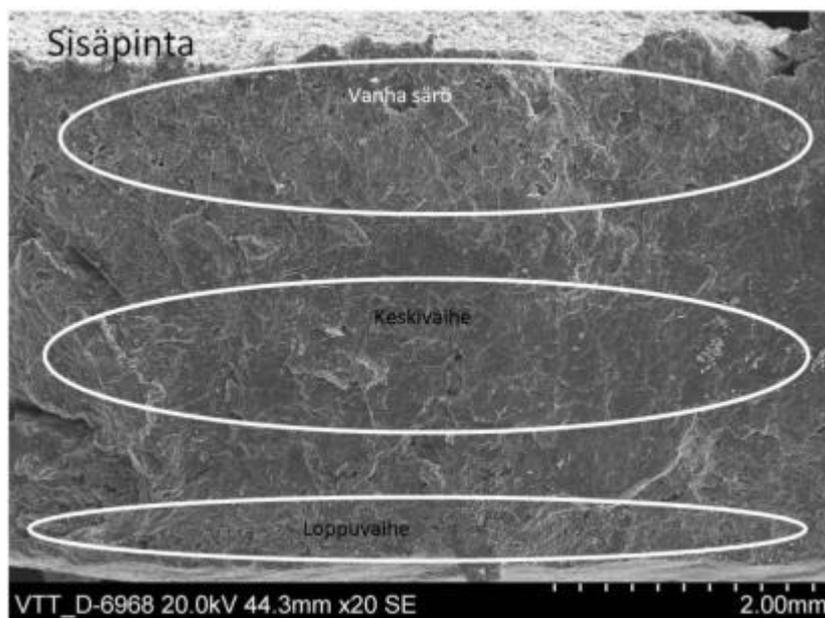
The SE micrograph of the opened crack is shown in Figure 16. The ovals in the image mark the areas of the old crack as well as the intermediate and final stages.

Figure 16. An SE image of the fracture surface of the opened crack. (Photo: VTT)

An older crack was discovered on the fracture surface of the opened crack which began on the strut's inner surface. The crack has propagated from the inner surface of the strut towards the outer surface.

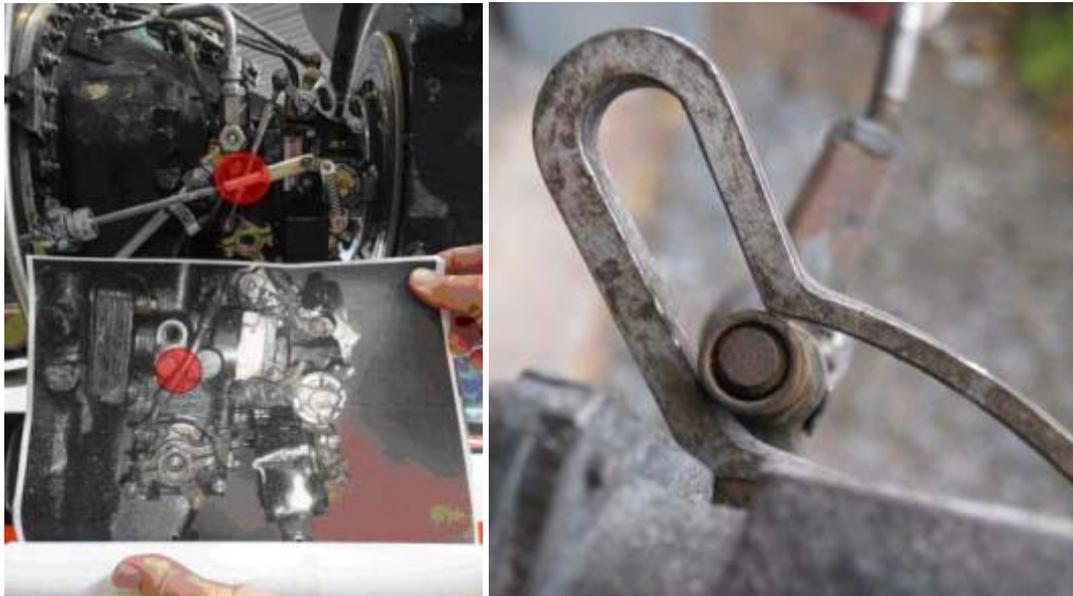
On the right side at the front of the engine there was a governor which was badly broken in the crash. Some of the lever tie-rods were crushed and pressed against the side of the governor. The beta light microswitch's actuating cam was in the "beta light on" position. The beta light turns on when propeller blade angles are at 8 degrees (Figure 4). The microswitch and the mechanism of its actuating cam had broken off from the governor housing.

The positions of the rods were compared with those on a fully functioning engine. Judging by their positions the governor had been in the beta range.

Figure 19. The photo on the left shows governor rod comparisons – a functioning engine above and a photo displaying the OH-XDZ's rod arrangement below. The photo on the right shows the guide which is operated by the engine's fuel control lever.

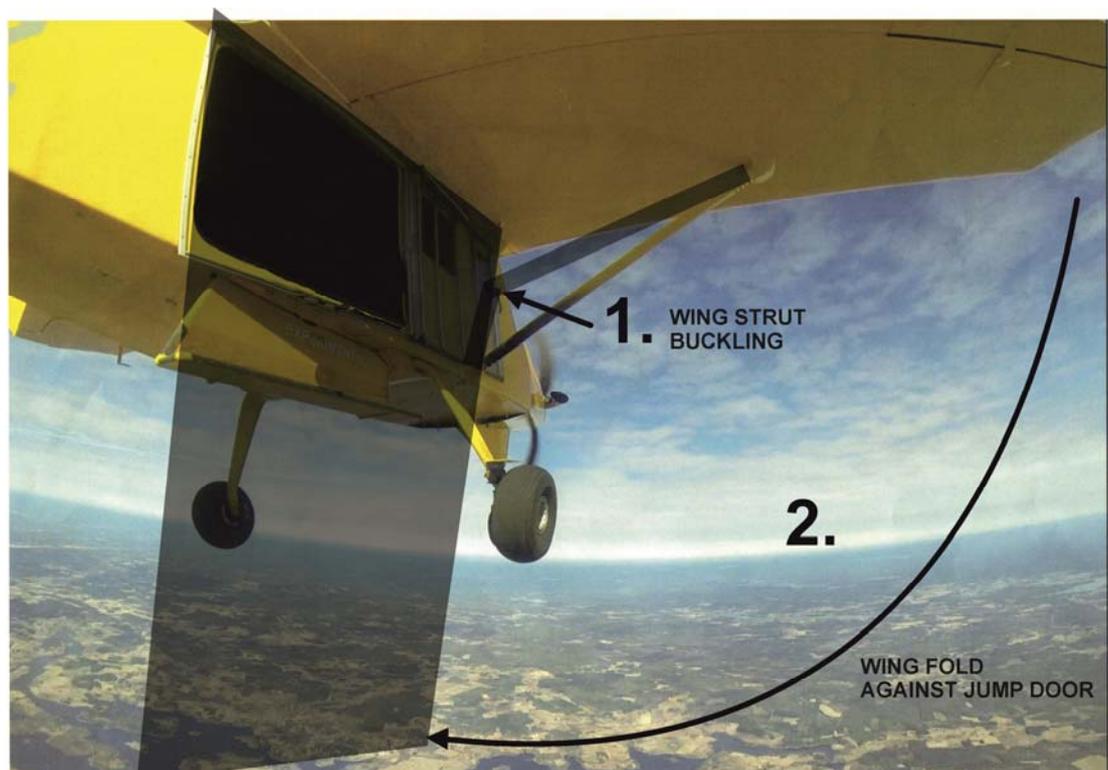
The folding of the right wing was caused by the buckling of the wing strut due to a downward force.

Figure 22. *The wing's folding against the jump door.*
