**Havarikommisjonen**  
Accident Investigation Board Denmark

# **FINAL REPORT**

**29-1-2014**

**BOMBARDIER INC. DHC-8-202**

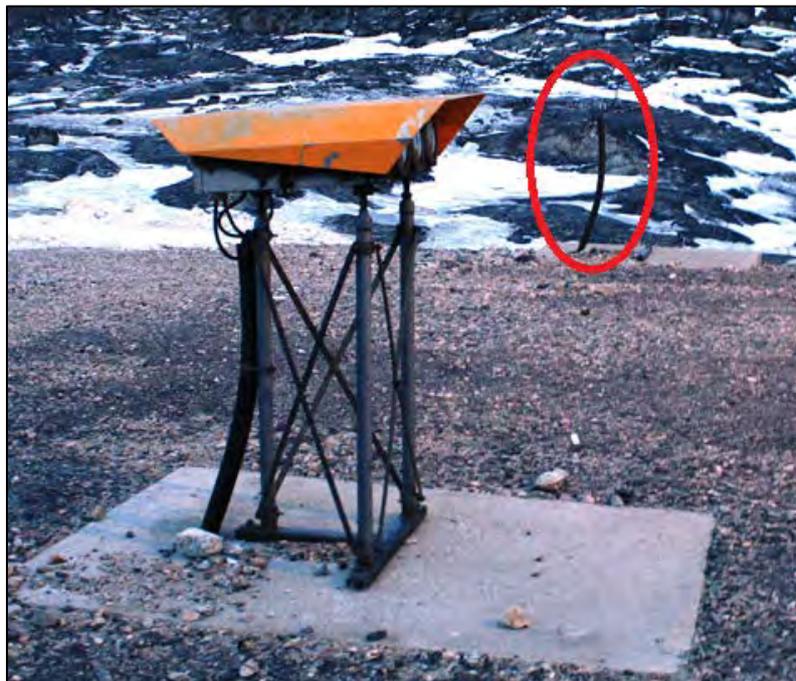
One runway edge light was destroyed.

One PAPI light to runway 25 was destroyed - see below in the red marking.

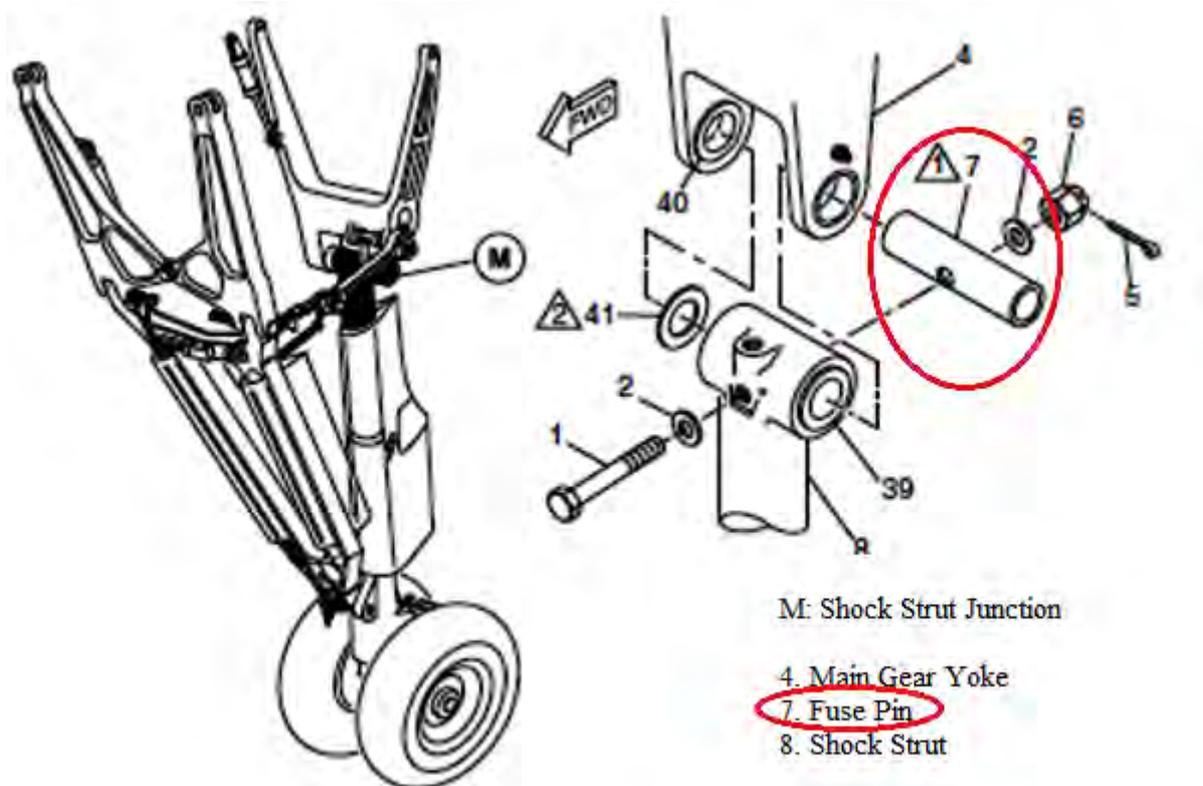
A draft of the main landing gear and the structural fuse pin

*In the level attitude the shear pin will fail at a rate of descent between 14.9 (894 feet/minute) and 15.7 ft/sec (942 feet/minute). In the tail down attitude the shear pin will fail at a rate of descent between 16.6 (996 feet/minute) and 17.15 ft/sec (1029 feet/minute). In both cases, at the instant of pin failure the horizontal ground load will be small.*

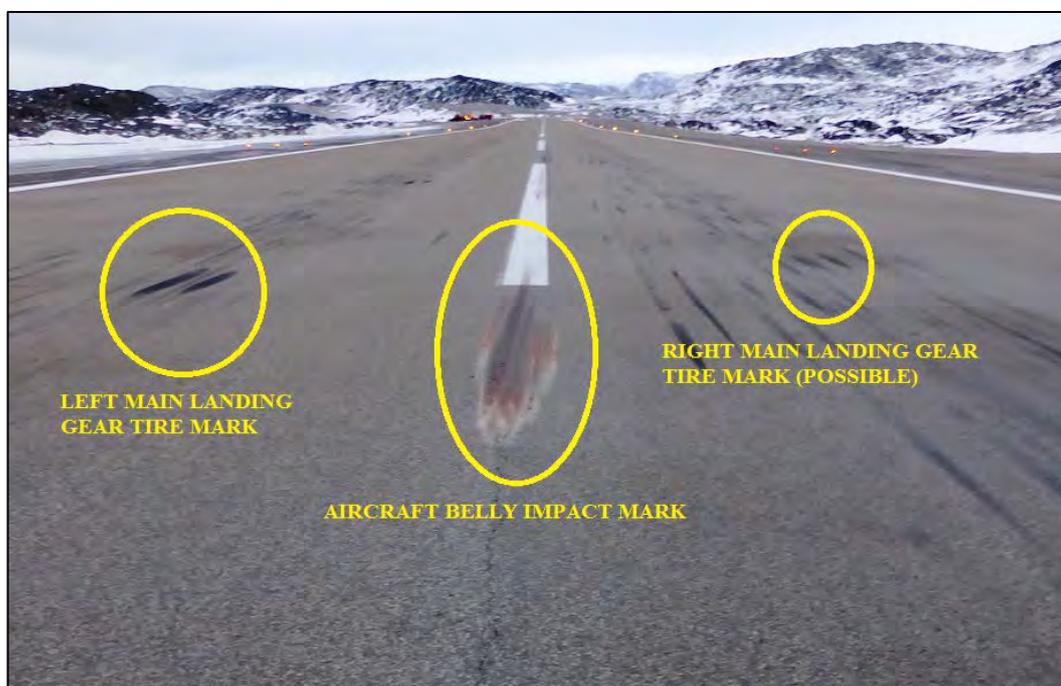
<u>Number</u>	<u>Distance from threshold (runway 07)</u>	<u>Events</u>
1.	173 meters	Touchdown on the runway centerline See picture below

2.		Shearing of the left main landing gear structural fuse pin
3.		Collapse of the left main landing gear
4.	180 meters	Aircraft 2nd belly impact mark after which continuous belly marks

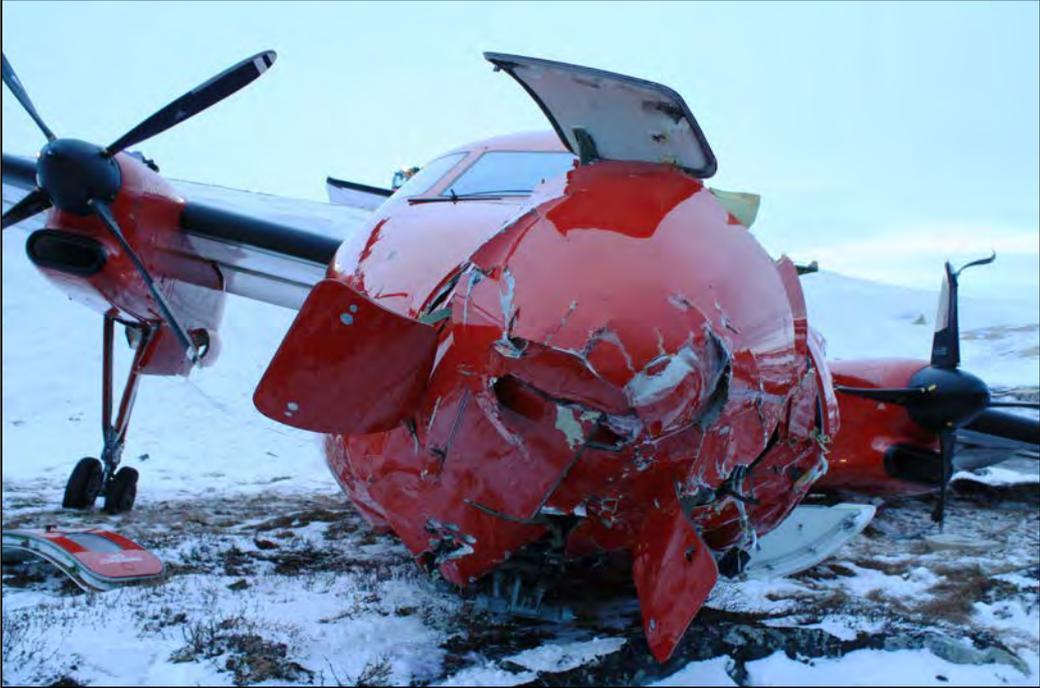
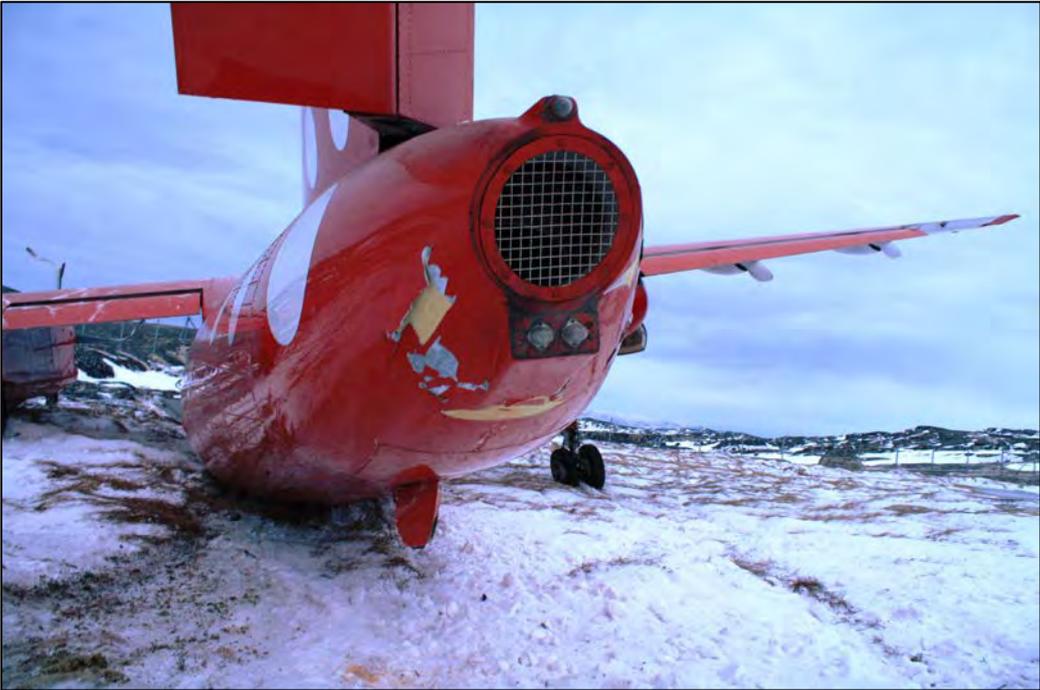
1.12.3 Exterior damage to the aircraft

As a result of impacting rocks, the wing structure, the fuselage, the left propeller and the left main landing gear were destroyed.

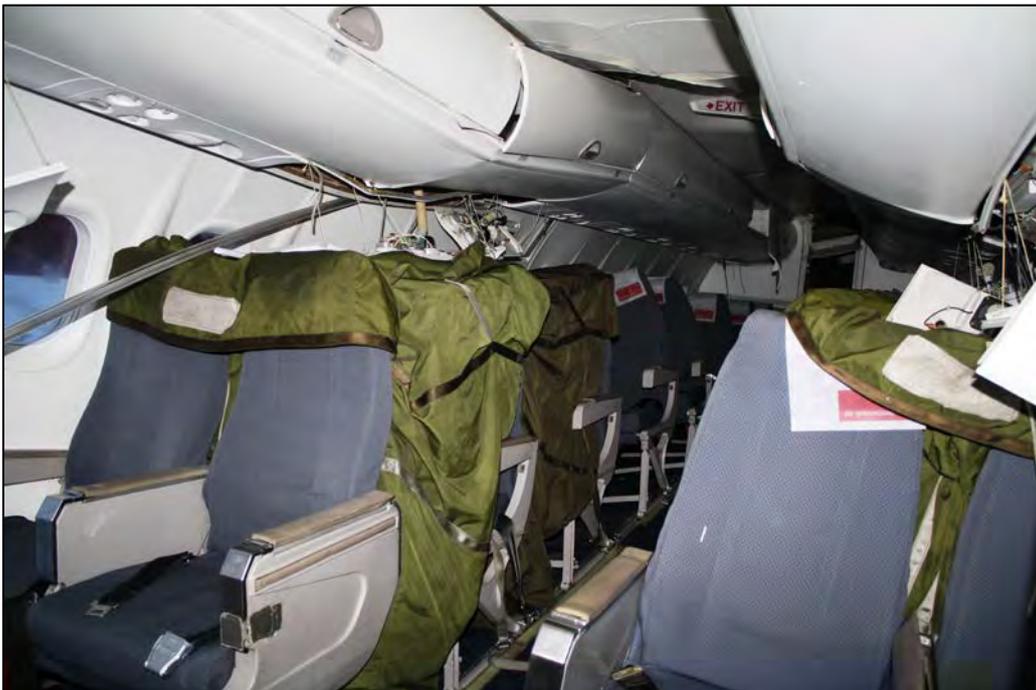
#### 1.12.5 Interior damage to the passenger cabin

The passenger cabin was substantially damaged.

However, obstructions did not hinder free movement of the passengers during the evacuation.

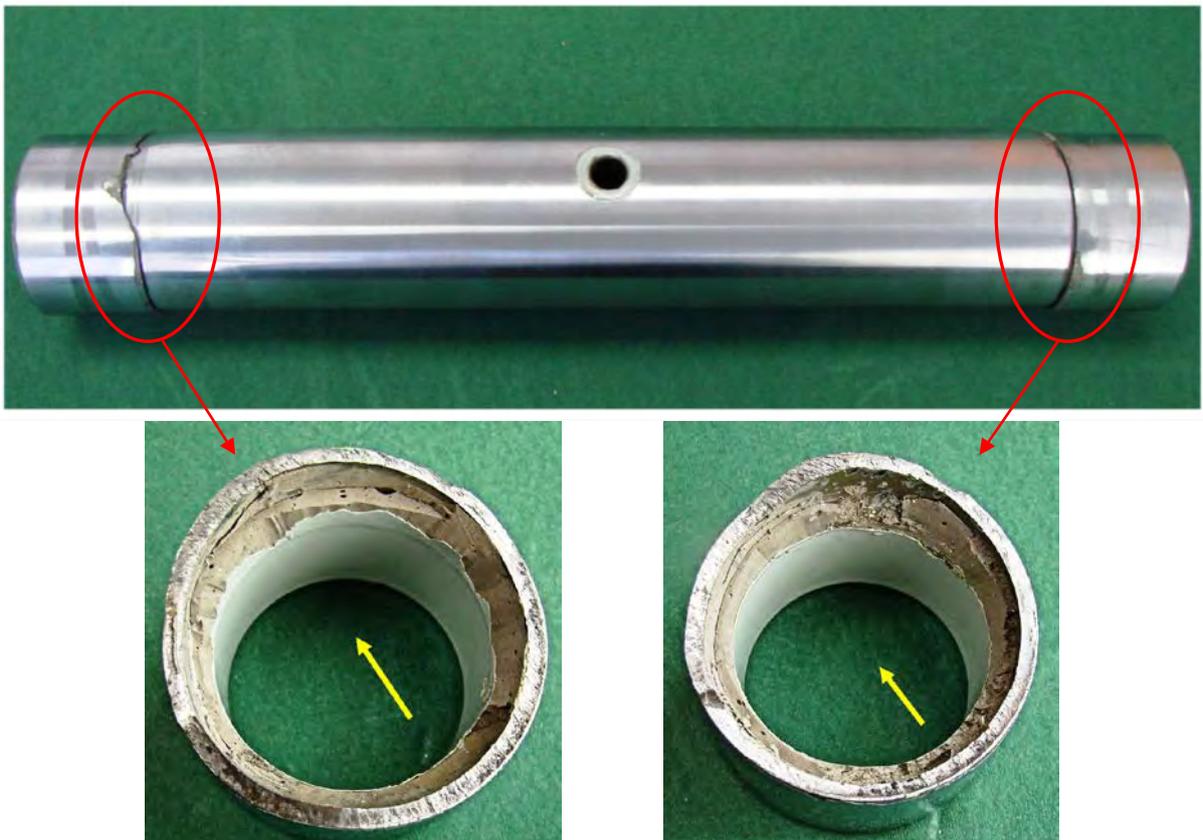
- The left main landing gear structural fuse pin (part number: 10150-5 and serial number: 11EXC5958) sheared at two places - see below in red markings. The yellow arrows indicate the direction of shearing

- A laboratory analysis of the left main landing gear structural fuse pin concluded shearing as a result of lateral and vertical overload stress

- The laboratory analysis of the left main landing gear structural fuse pin did not reveal manufacturing imperfection

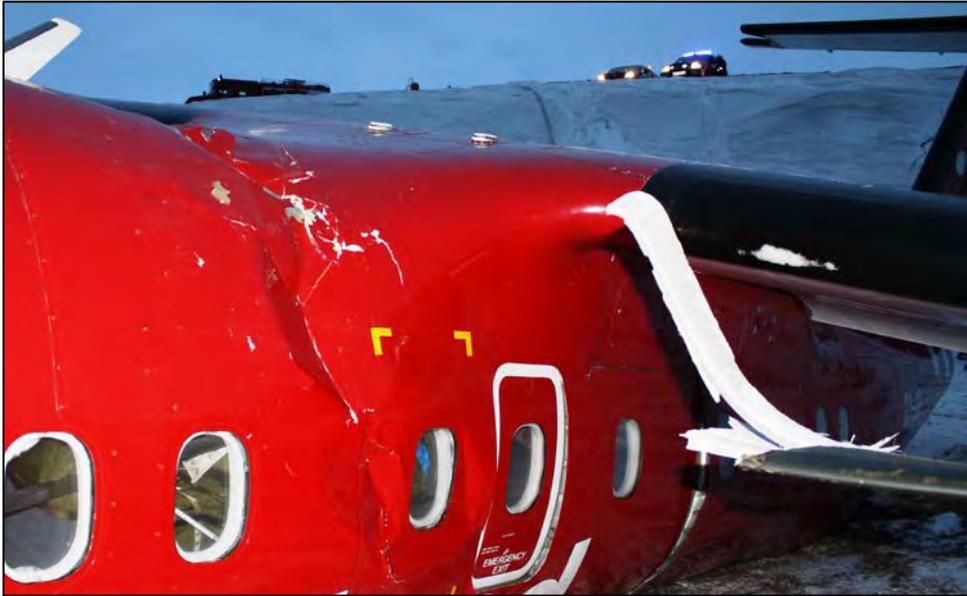
The left mid passenger cabin emergency exit:

The impact sequence caused aircraft structural deformations leading to jammed and partly jammed emergency exits.

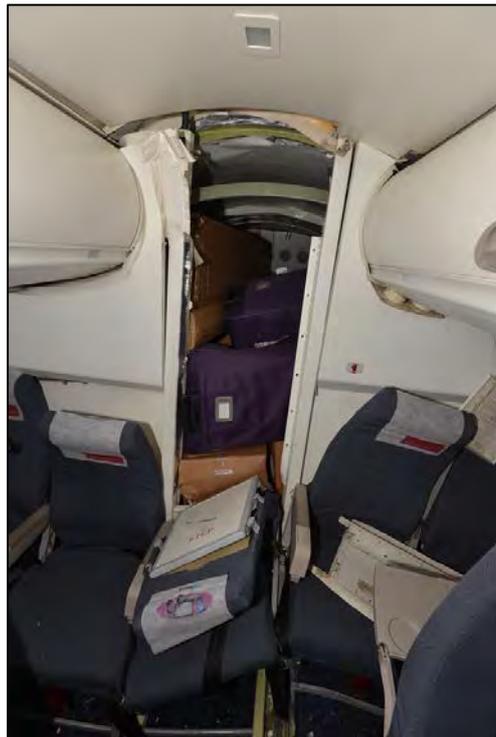
At impact, forward moving cargo destroyed the mid passenger seat in front of the baggage compartment internal access door.
