FINAL  
KNKT.13.05.18.04

Aircraft Accident Investigation Report

**PT. Deraya  
BAe ATP Freighter; PK -DGI  
Wamena Airport, Wamena, Papua  
Republic of Indonesia  
31 May 2013**

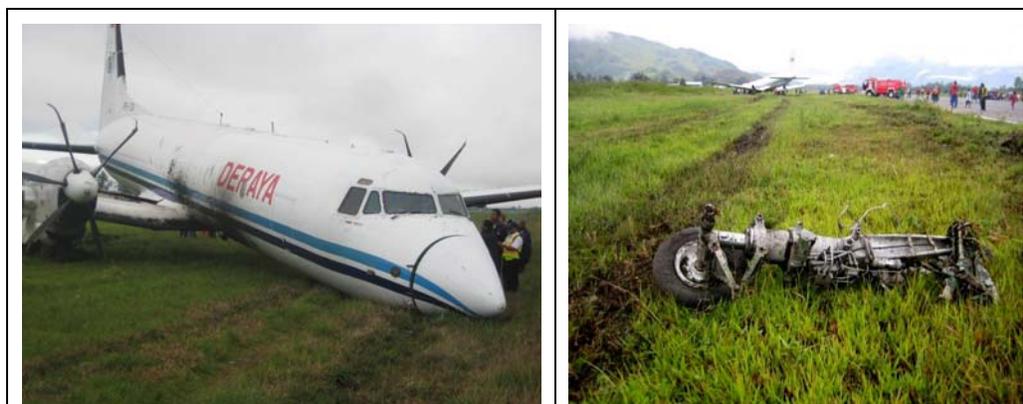
The nose landing gear detached and found on the shoulder at about 250 meter from the aircraft final position. The main landing gears broken and all the propellers bent.

The damage of the aircraft were the nose and main landing gear broken, all the propeller blades bend.

Figure 2: The aircraft final position and the nose landing gear detached

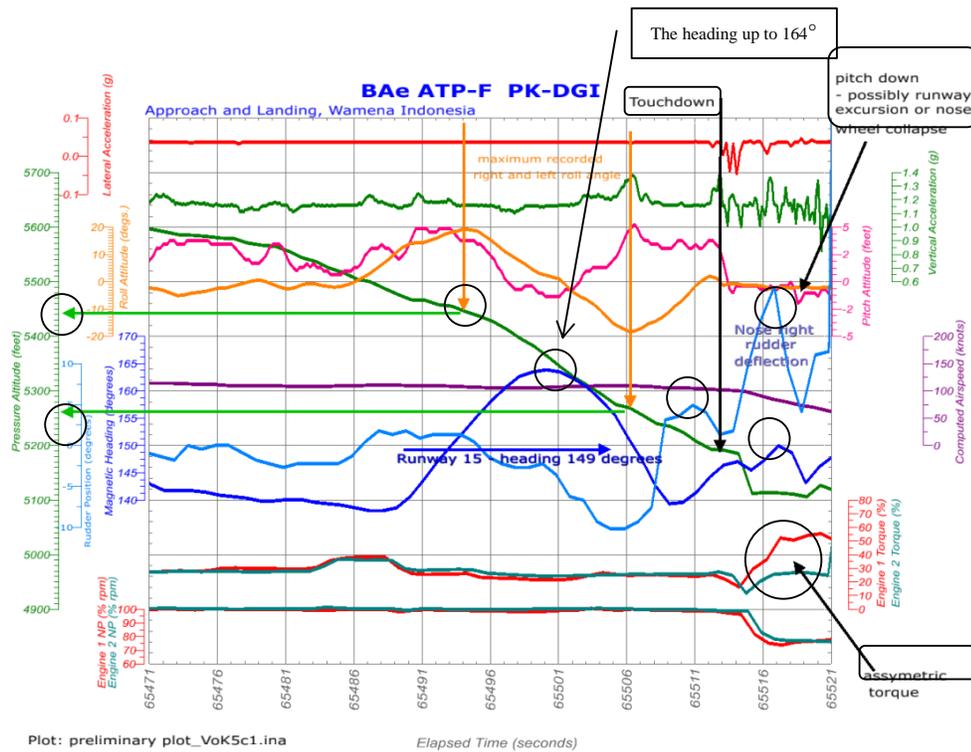
**Figure 4: The FDR graph data for several significant parameters**

- When at approximate 5,450 feet ( $\pm 400$  feet AGL) and 5,260 feet ( $\pm 200$  feet AGL) the pitch varied from  $1^\circ$  down to  $5^\circ$  up and the aircraft rolled to the right up to  $20^\circ$  and at aircraft heading  $164^\circ$  the aircraft rolled to the left up to  $20^\circ$ .
- The aircraft speed relatively constant from 105 kts until touchdown.
- The aircraft touchdown with roll angle approximately  $2^\circ$  to the left and heading of  $147^\circ$  while the runway heading was  $149^\circ$ .
- After touchdown the NP indicated drop from 100% to approximately 70% and maintained.
- The engine torques was asymmetric; it shows that the left engine torque was approximate 55% while the right engine torque was approximate 25%.

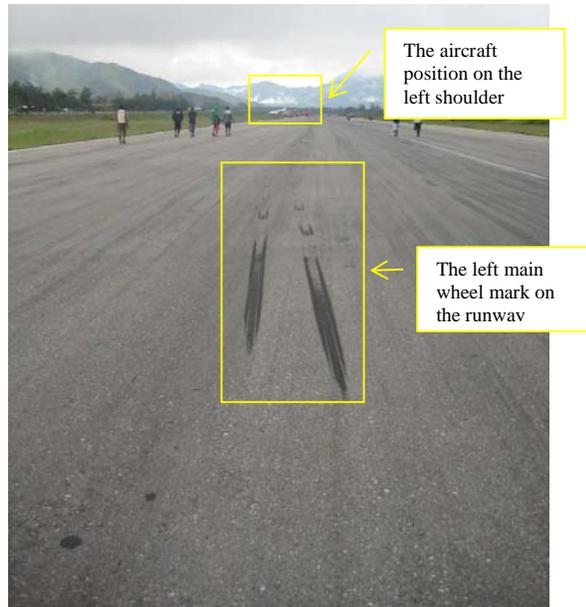
- The touchdown marks indicated that the aircraft movement misalign with the runway centerline
- The initial left main wheel out of the runway pavement found at 750 meters from the beginning runway 15.
- The aircraft travelled on the left runway shoulder parallel with the runway 15.
- The nose landing gear was detached and the aircraft last position was 1,073 meters from the beginning and 10 meters left side of runway 15.

**Figure 5: The mark of first touchdown found on the runway**

The FDR revealed that the aircraft touchdown with roll angle approximately  $2^\circ$  to the left and heading of 147 while the runway heading was  $149^\circ$ , this was confirmed by the evidence of touch down mark found on the runway.

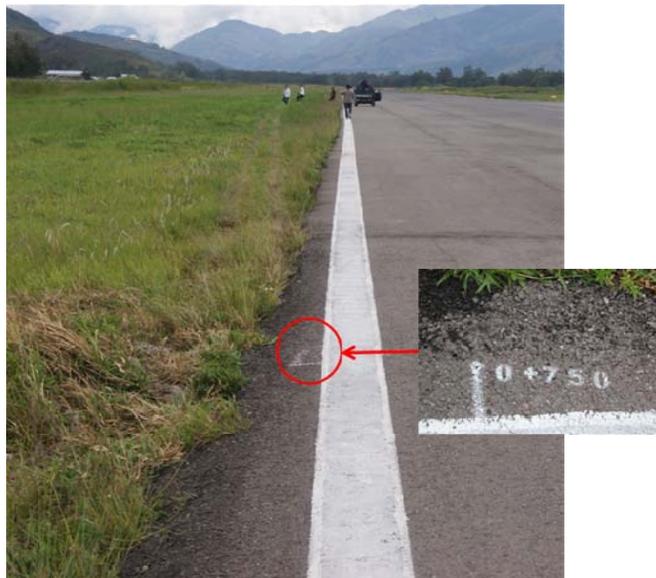
**Figure 6: The mark of left main wheel off the runway**

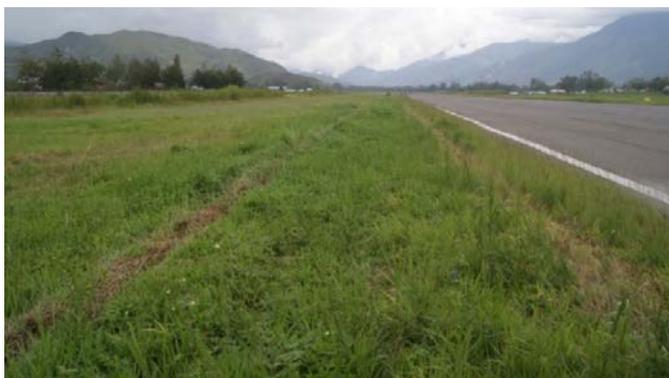
**Figure 7: The mark of both main wheels off the runway**

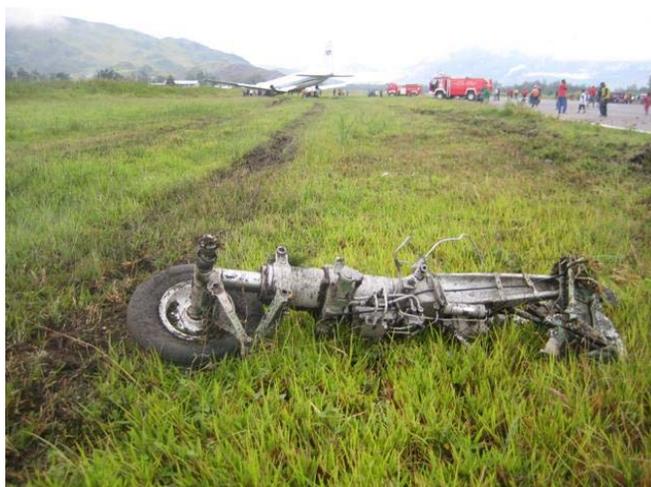
**Figure 8: The aircraft final position and the nose wheel detached**
