FINAL
KNKT.13.06.19.04

Aircraft Accident Investigation Report

**Merpati Nusantara Airlines
Xi 'An Aircraft Industry MA60; PK-MZO
El Tari Airport, Kupang
Republic of Indonesia
10 June 2013**

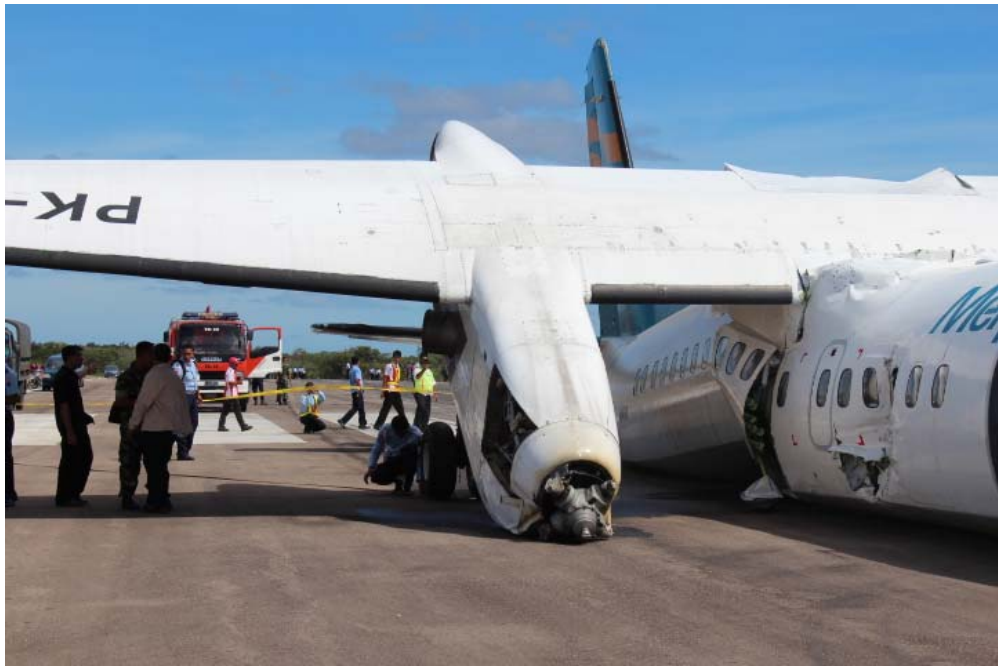
The aircraft was substantially damaged.

Figure 2: Damage on the right side of the aircraft

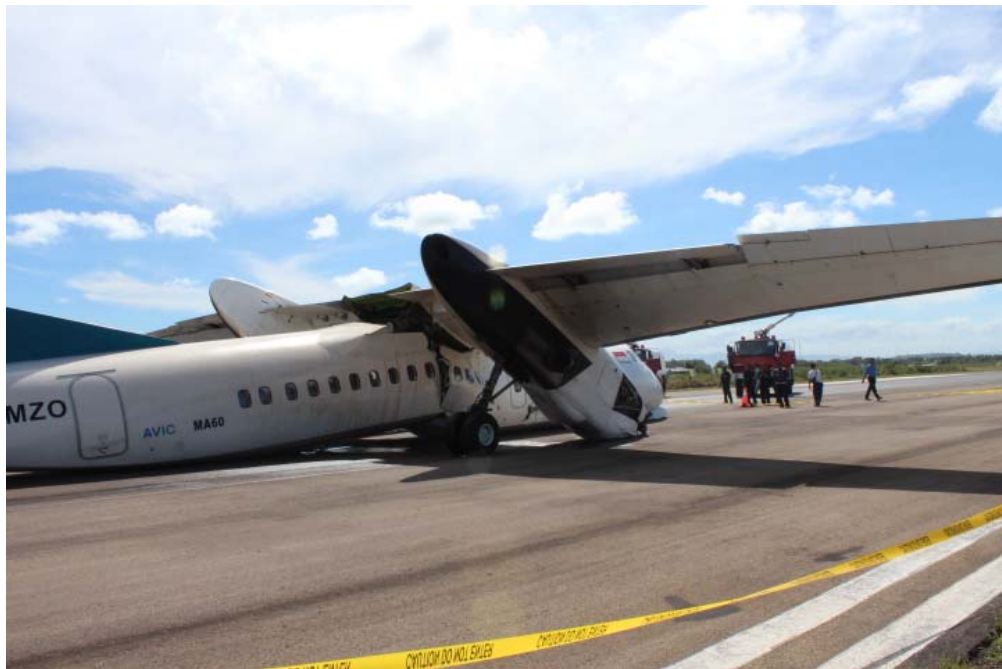
Figure 3: The rear right view of the aircraft

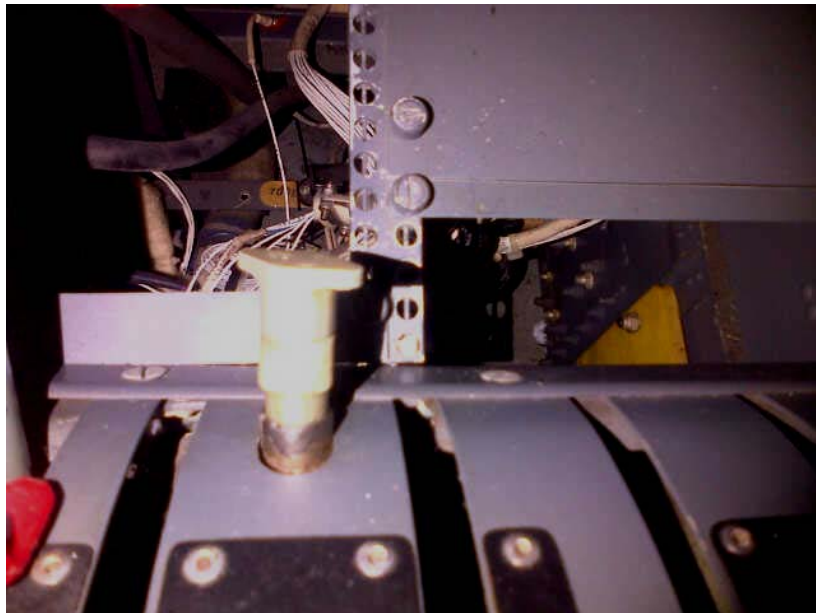
Figure 5: The electric magnetic stop found on “OPEN” position

On the accident aircraft, the electric magnetic stop was found in OPEN position. This situation was consistent to the operator approach check list which stated “PL LOCK – OPEN”.

The power levers prevented to move from flight idle to ground idle during flight by the function of Electric Magnetic Lock Systems and Mechanical Power Lever Stop Slot. At the accident aircraft was found that the electric magnetic lock system (Power Lever lock) was on open position.

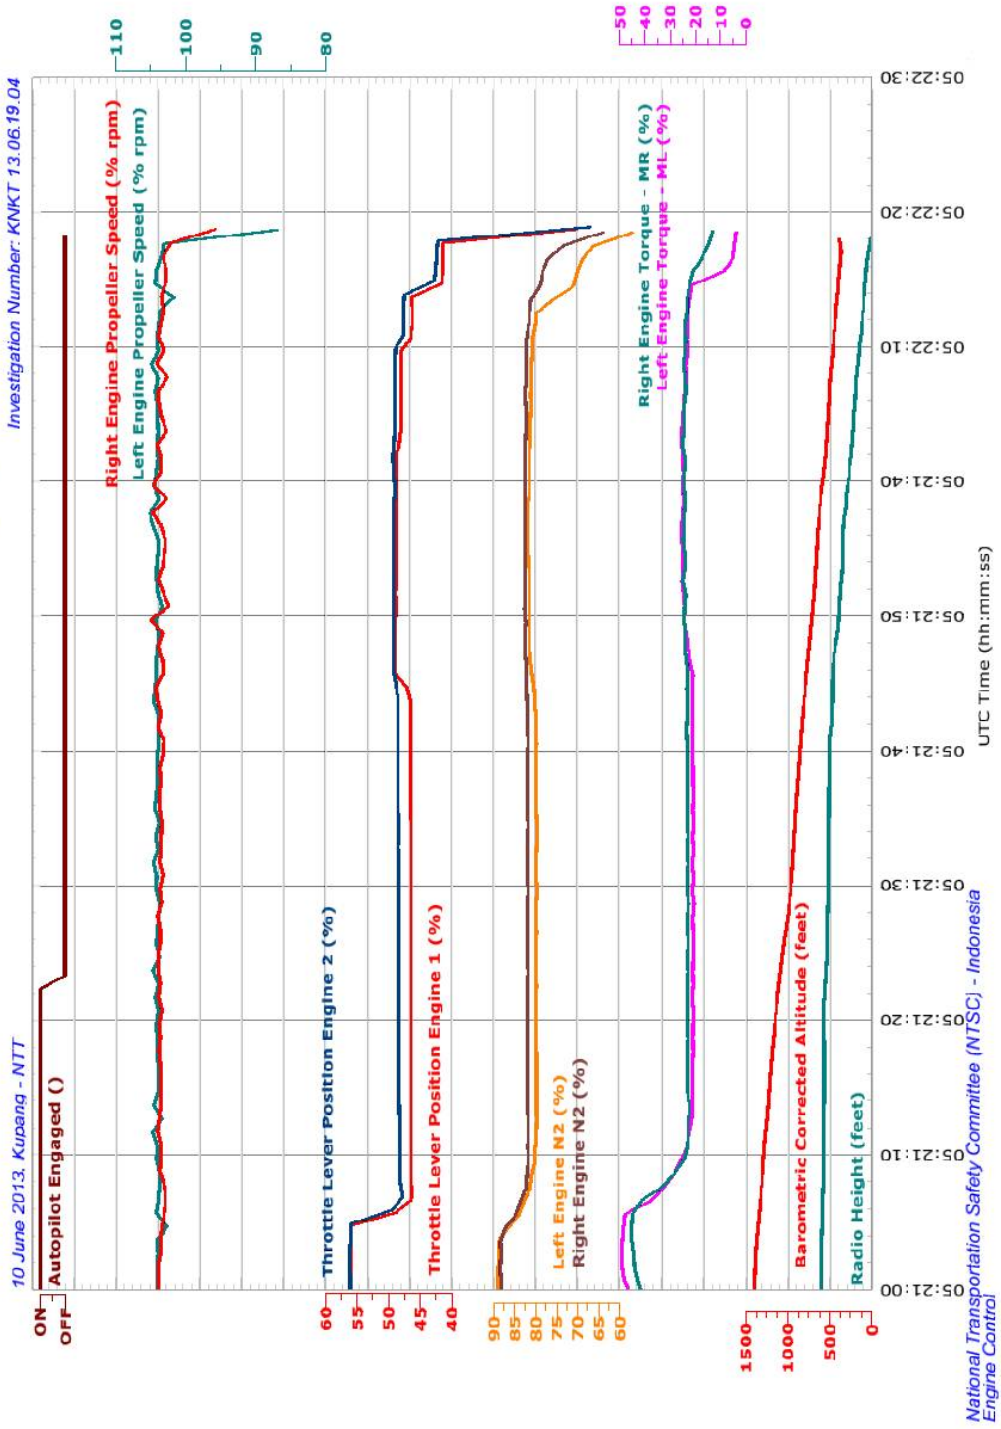
Further analysis of the FDR data was performed at NTSC facility in Jakarta, where the corrupted data of the last 8 seconds of the flight was successfully retrieved (figure 9).

Figure 9: FDR plot of main engine parameters

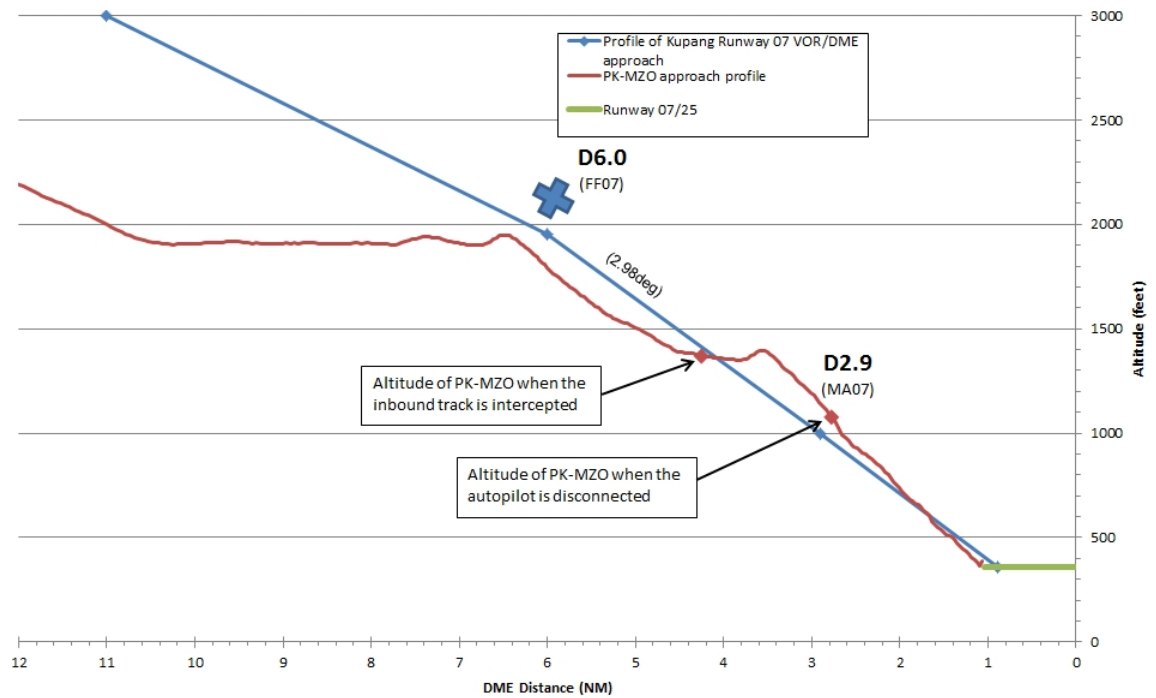
Figure 10: Comparison of published approach and actual profile based on FDR

Figure 10 indicates that based on the FDR data, the approach was not on profile as published for runway 07, while the approach angle greater than 2.9°.

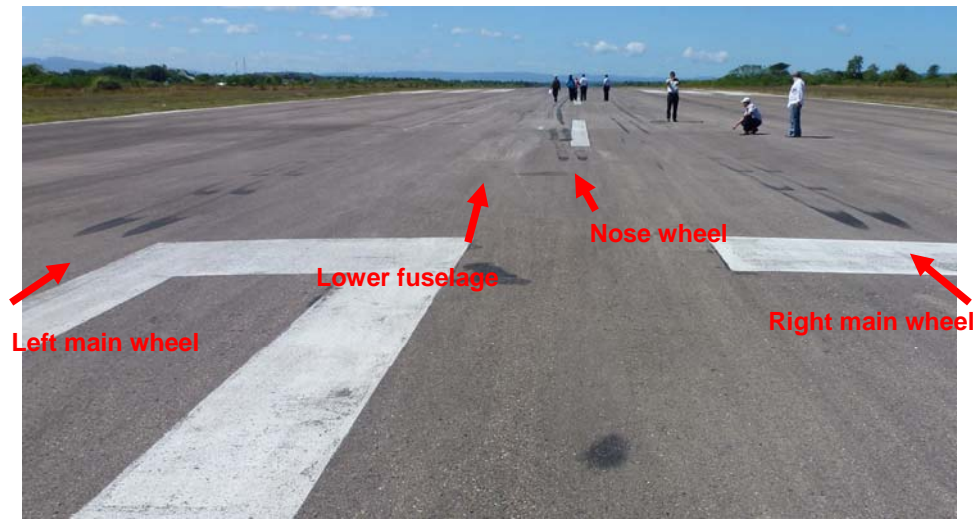
The marks on the initial touchdown showed that the lower fuselage impacted to the runway between the first marks of the main wheels and nose wheels (figure 13). The distance between the main wheels and the nose wheels marks was 7.5 meters while the normal distance was 9.5 meters.

Figure 12: The marks of the initial touch down

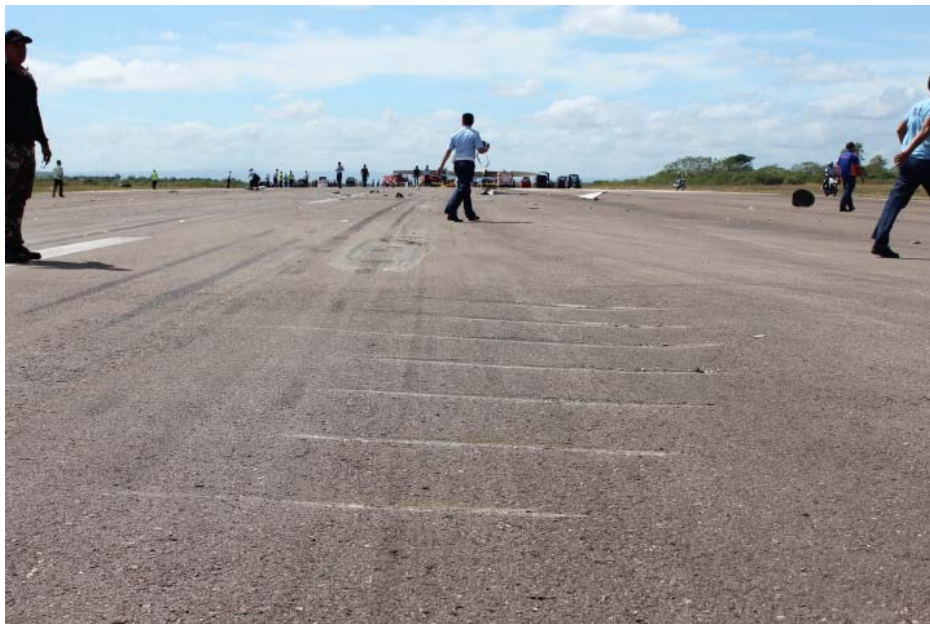
The propeller scratch marks were found on left and right side 13 meters of the main wheels marks.

Figure 13: The propeller scratch marks
