**KOMITE NASIONAL KESELAMATAN TRANSPORTASI
REPUBLIC OF INDONESIA**

KNKT.12.10.19.04

Aircraft Accident Investigation Report

PAC 750 XL; PK-RWT

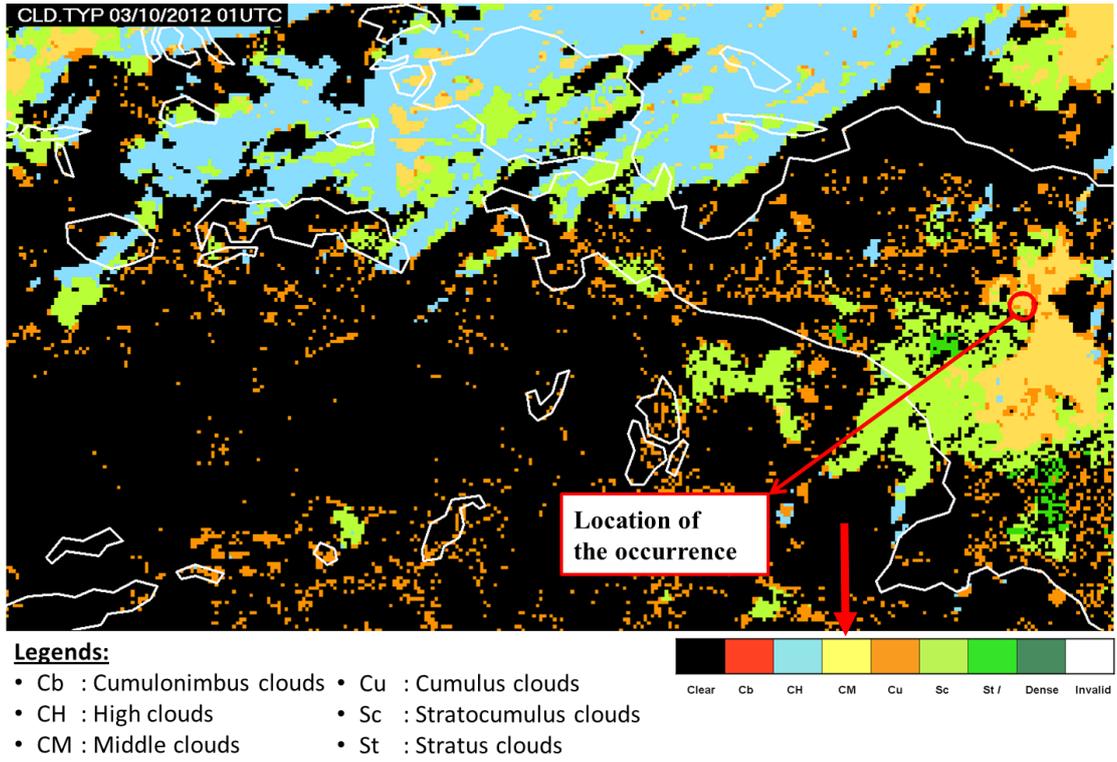
Figure 2: Satellite weather image at 0100 UTC

The satellite weather image indicated that there were middle clouds and cumulus clouds surround the occurrence area. According to International Cloud Atlas Volume I³, the altitude ranges of middle clouds in the tropical area are between altitudes of 6,500 up to 25,000 feet and the cumulus usually have their bases in the low altitude from the earth surface up to 6,500 feet, however their vertical extent is often that their tops may reach into the middle and high clouds.

The satellite weather image between 0100 and 0200 UTC showed the middle cloud of cumulus formation surround the Koropun aerodrome. The height ranges of the middle cloud of cumulus in tropical could extend up to 25000 feet.

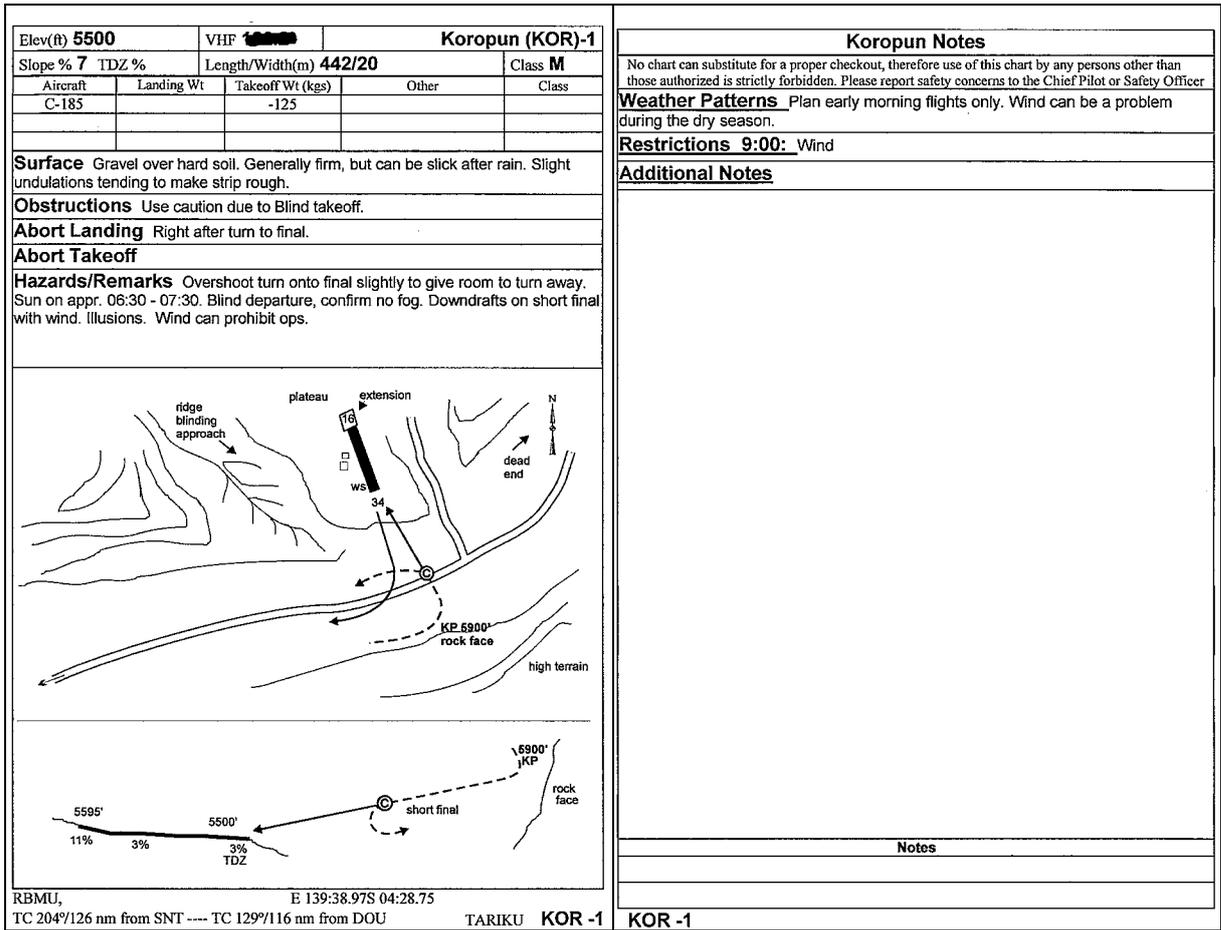
Figure 4: The Koropun aerodrome information

The aerodrome Koropun information issued by Tariku describes the takeoff & landing direction with the additional information of hazards and environment.

To review the ALA publication to include additional information such as weather phenomenon, departure and arrival procedure.

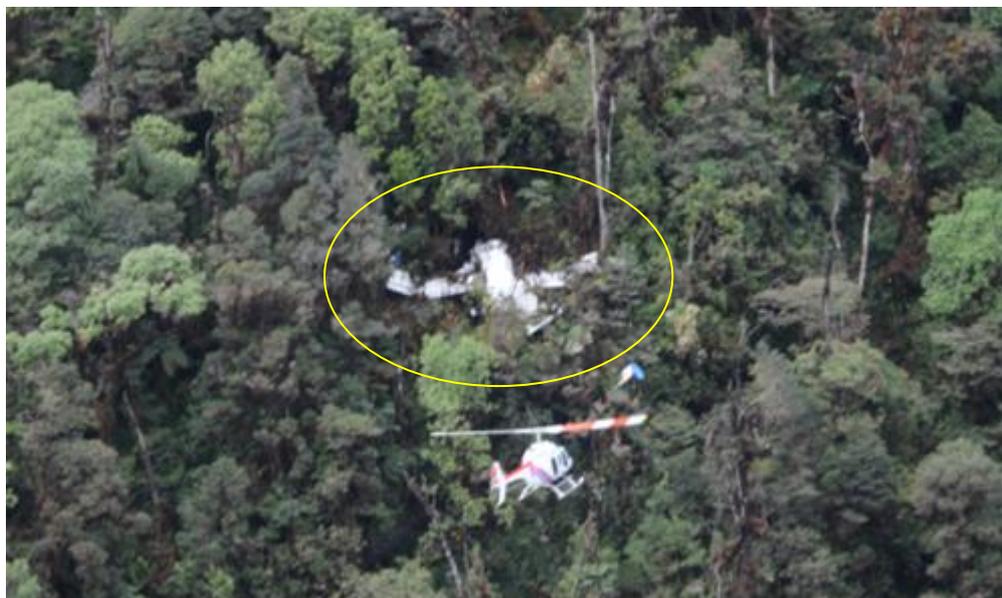
Figure 6: The crash site

Observation on crash site showed that the aircraft was rest in level position, the nose of the aircraft hit the hill and both wings were still attached on the fuselage.

The investigation could not find other wreckage information, due to limited facility and resources to reach the remote accident site at the time of occurrence.

After impact, the aircraft rested in relatively level with the horizon, and this was most likely that the aircraft was on straight and level position prior and during the impact. There was no indication of climb or pull up position.

The aircraft damage showed a major damage to the aircraft and could only occur in relatively high speed. The indication of aircraft impact in level position and high speed impact were strong indication that the accident was typical of Controlled Flight into Terrain (CFIT) where an aircraft, under control of the pilot, unintentionally impact to terrain.

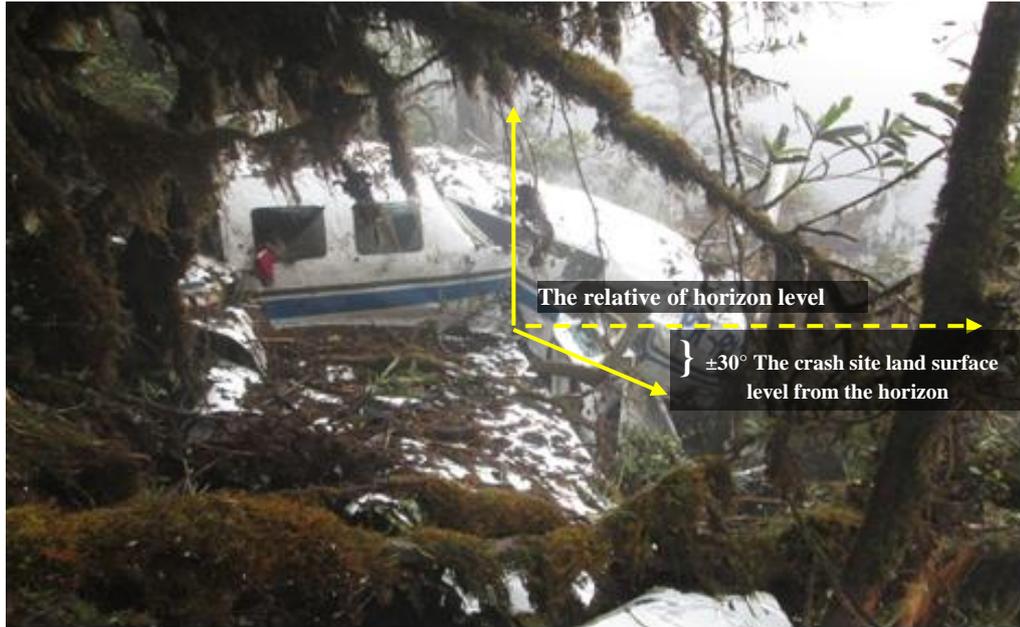
Figure 7: The aircraft impact direction

The figure 7 shows the relative impact direction to the uphill land.
