**FINAL**  
KNKT.14.04.10.04

# KOMITE NASIONAL KESELAMATAN TRANSPORTASI

Runway Excursion Investigation Report

**PT. Adventist Aviation Indonesia**  
**Kodiak-100; PK-SDF**  
**Doyo Baru Airstrip, Papua**  
**Republic of Indonesia**  
**09 April 2014**

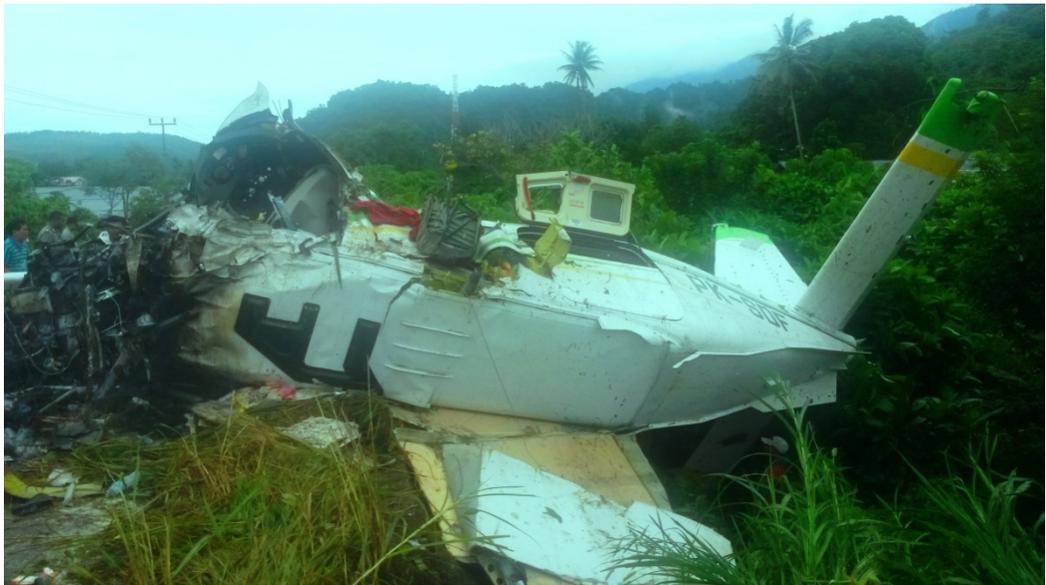
Figure 3: Aircraft main wreckage

The aircraft was substantially damaged. The nose section consumed by post impact fire. The landing gear and the wing were detached from the main wreckage. The passengers cabin relatively intact.

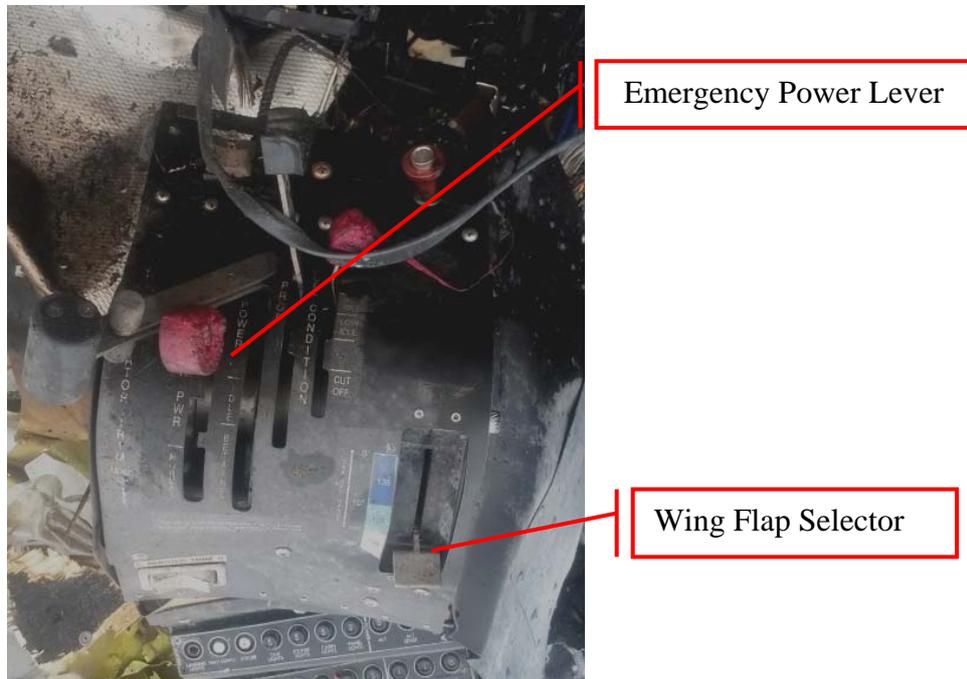
**Figure 6: Pedestal found after accident showed the position of wing flap selector and emergency power lever**

2. The wing flap selector was on position 35(full down).
3. The Emergency Power Lever and power lever on full forward position.

Other evidence found on the accident site was the flap lever selector on full down position. This can be predicted that during the impact, the flap was travelling toward full down position it indicated by the BLDC did not popped out.

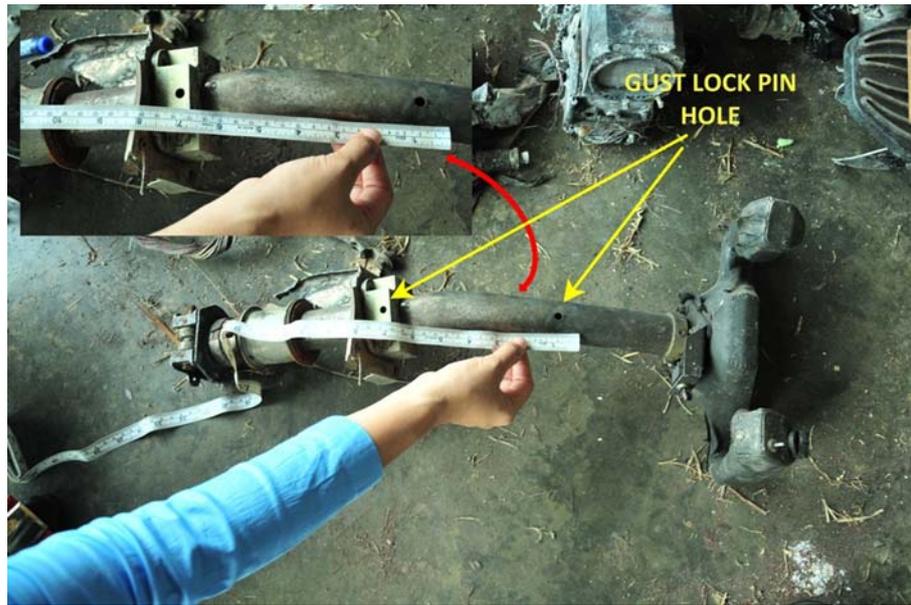
**Figure 7: gust lock pin hole**

4. Left control yoke bent.

The wreckage indicated that the distance of the gust lock pin and the gust lock housing separated approximately 15 cm. The yoke was found bent. This condition indicated that the gust lock has been disengaged and the yoke has been pulled backward to move the elevator.

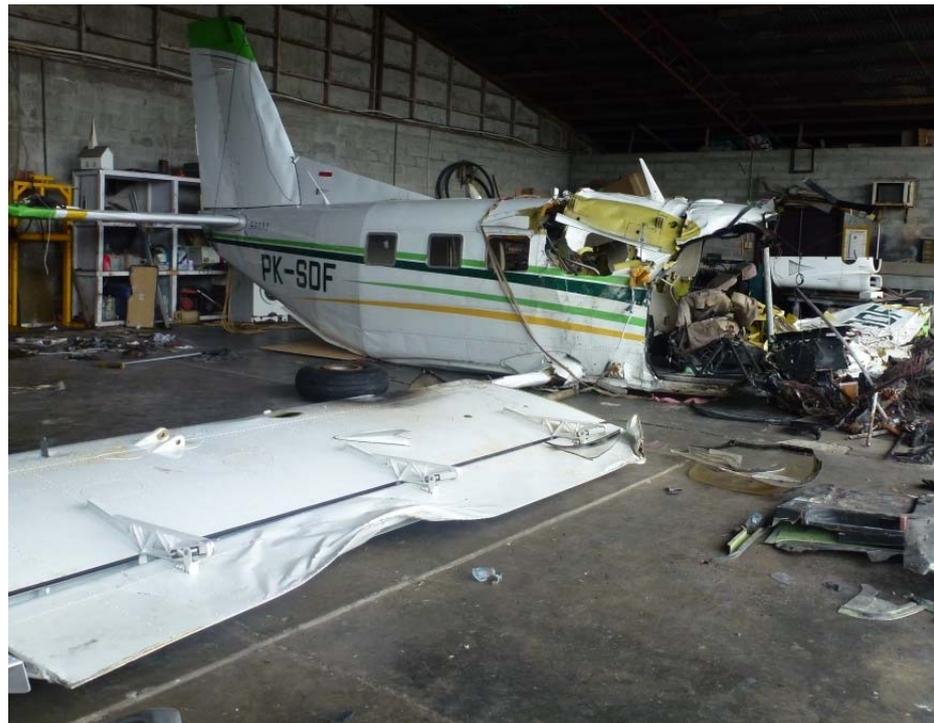
**Figure 8: Wing flap physically did not extend**

5. Flaps physically did not extend.

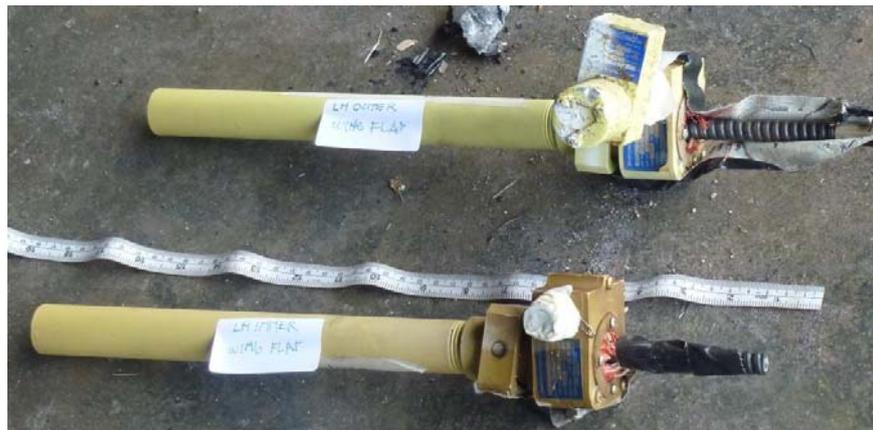
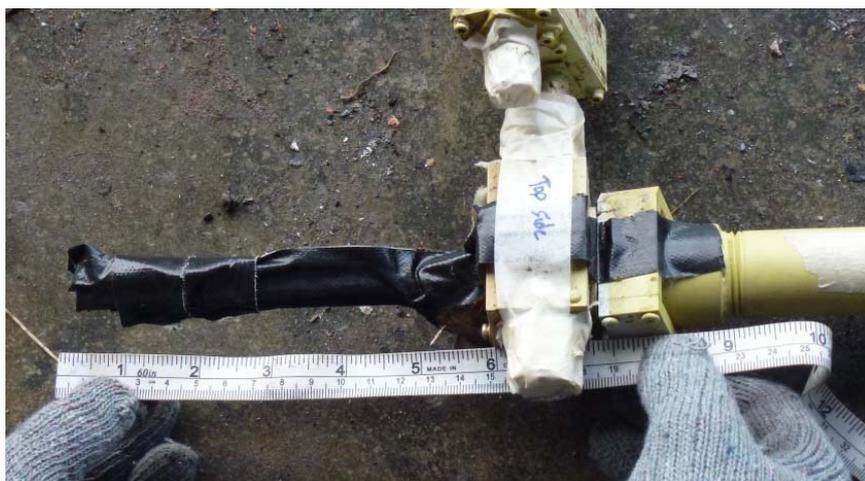
There were four screw-jacks of the wing flaps, two screw jacks for each wing. One screw jack was found broken presumably at the time of impact. The measurements of screw jack extensions (distance from the “flat plane” to the center of the “eye”). The extensions of three screw jacks were found similar.

The measurement of the 3 flap screw jacks were relatively equal and it was highly possible that the Left inner screw jack might have the equal distance.

This can be concluded that there was no flap asymmetry.

**Figure 9: The left inner and outer wing flap screw jacks**

**Figure 10: Measurement of the wing flap screw jack**

The examination of the wing flap screw jack found that 3 of 4 screw jacks travel relatively equal of 14.5 cm. There was no asymmetrical flap condition suspected. The measurement on a serviceable aircraft found that 14.5 cm extension of wing flap screw jack was equal to the wing flap extension of 5° or 6°.

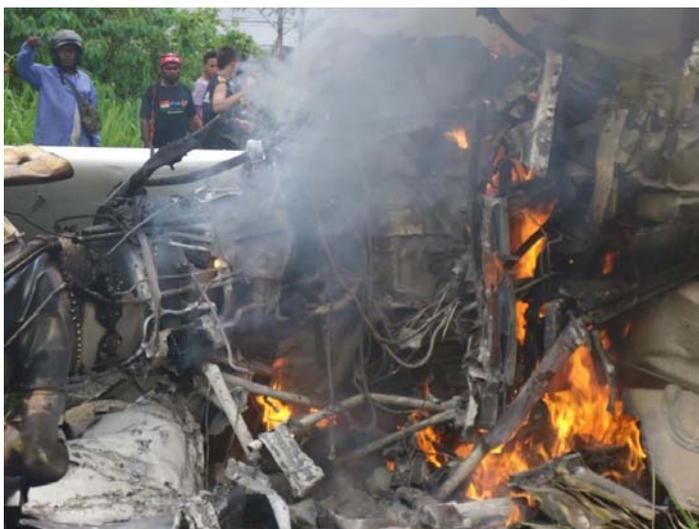
**Figure 11: Post impact fire**

There was post impact fire on the area of aircraft engine.

The forward section of the aircraft heavily damaged as result of impact and post impact fire. The Captain seat was detached and the copilot seat was still intact. The main passenger compartment was relatively intact.

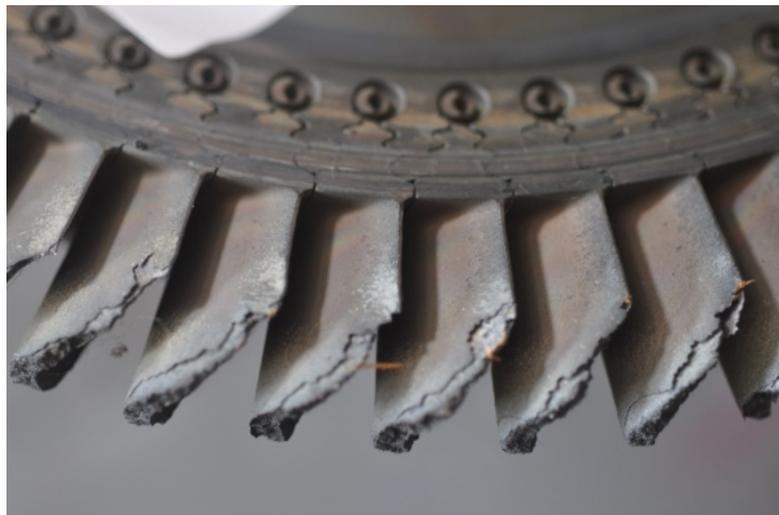
**Figure 14: Broken blades of the compressor turbine**

All blades of the compressor turbine (CT) were found broken (Fig.14). Coating materials near the broken surface peeled off.

The broken surfaces of the CT blades orientated in the tangential place, or almost at right angle to the radial direction. It indicated that the centrifugal stresses on the CT blades had exceeded the strength due to over temperature operation. To observe the thermal damage of the blades, a metallographic examination was performed.

The examination of the engine found Compressor Turbine (CT) blades damage. The damage of the CT blades was caused by exceeded the strength due to over temperature operation. A metallographic examination was performed and concluded that the over-temperature was excessive and occurred at short time.

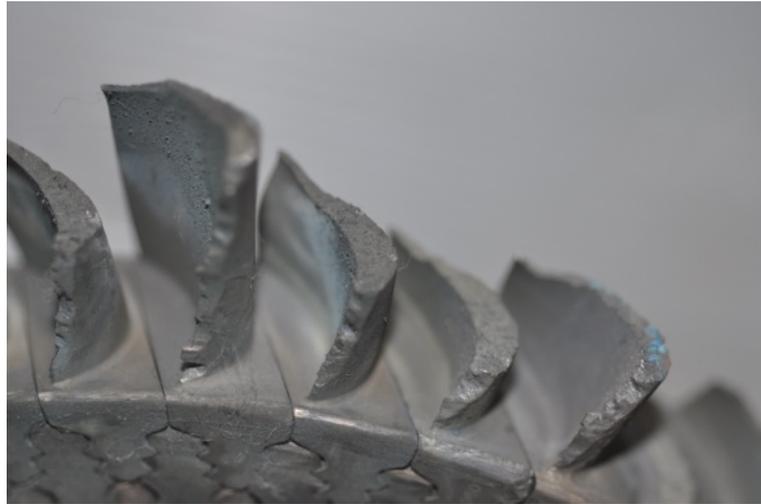
**Figure 15: Broken and deformed PT blades**

All blades of the power turbine were broken with deformation. (Figure.15)

The damages indicated that the PT blades were impacted by other parts.

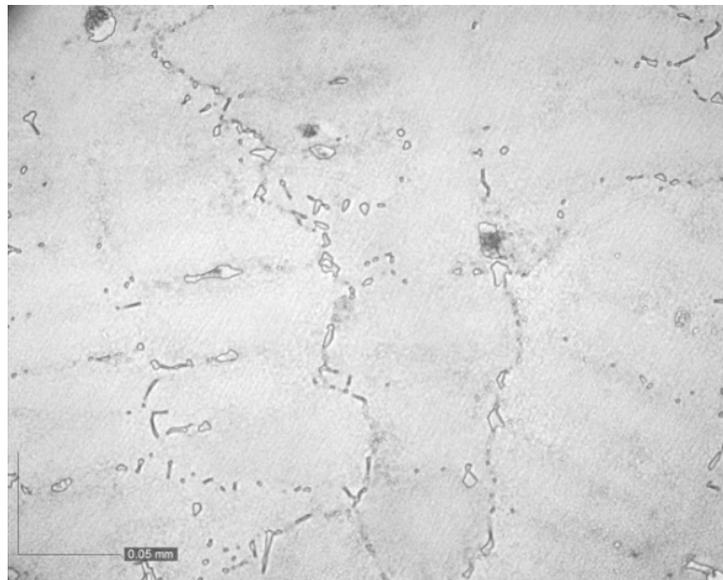
**Figure 16: Microstructure at a distance from the root**

The microstructure was similar to the one at the blade root.

The microstructures of the PT blade are quite similar from the root to the

broken edge. The damages were due to impacts with metallic CT blade debris, as well as impacts with the PT vane casing at the time of aircraft impact.

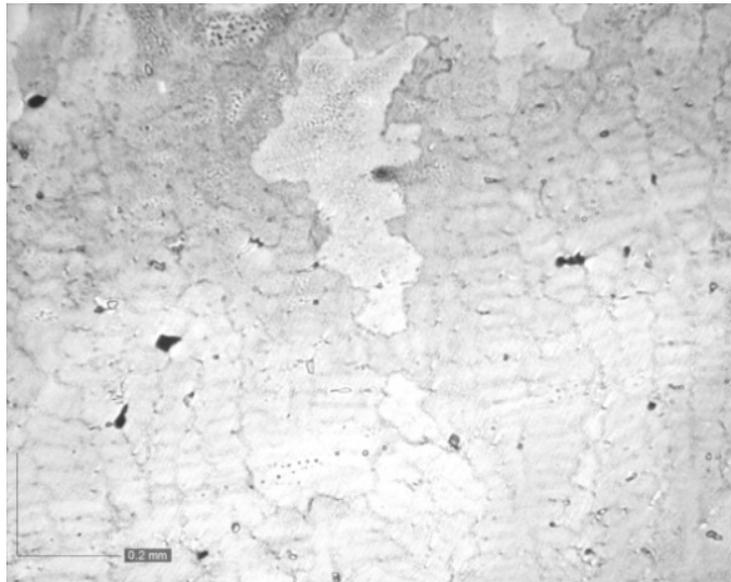
**Figure 17: Relative intact microstructure near the CT blade root**

Molten grain boundaries were found near the broken edge. It shows that the CT blade damages were due to over temperature. The microstructure at the root was still intact, showing no melted grain boundary. Nearing the broken edge, more grain boundaries were melted. It shows that the over-temperature was excessive and occurred at short time (in seconds).

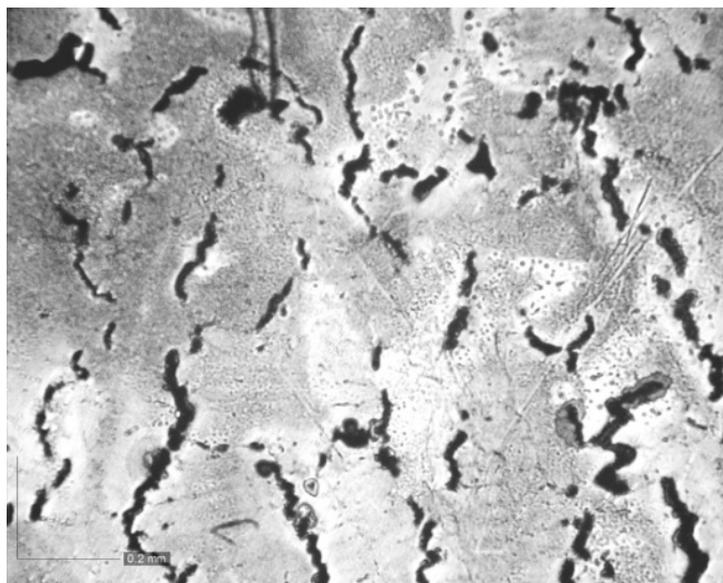
**Figure 18: Grain boundaries melted down and cracked approximately in the tangential plane**

The findings of no engine malfunction reported from the previous flights, the Emergency Power Lever found on full forward position and metallographic examination concluded that the over-temperature was excessive and occurred at short time this might due to the EPL was selected during the takeoff roll.
