# Fuel starvation and forced landing, involving PA31, VH-OFF

Near Aldinga ALA, South Australia, 29 January 2014

**ATSB Transport Safety Report**

AO-2014-017

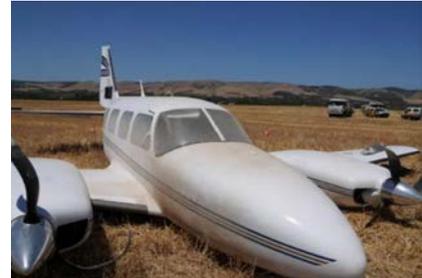
VH-OFF damage

The aircraft touched down and slid about another 75-100 metres before coming to rest. The impact marks of the propellers suggest the aircraft touched the ground facing north-easterly and rotated to the north-west prior to stopping.

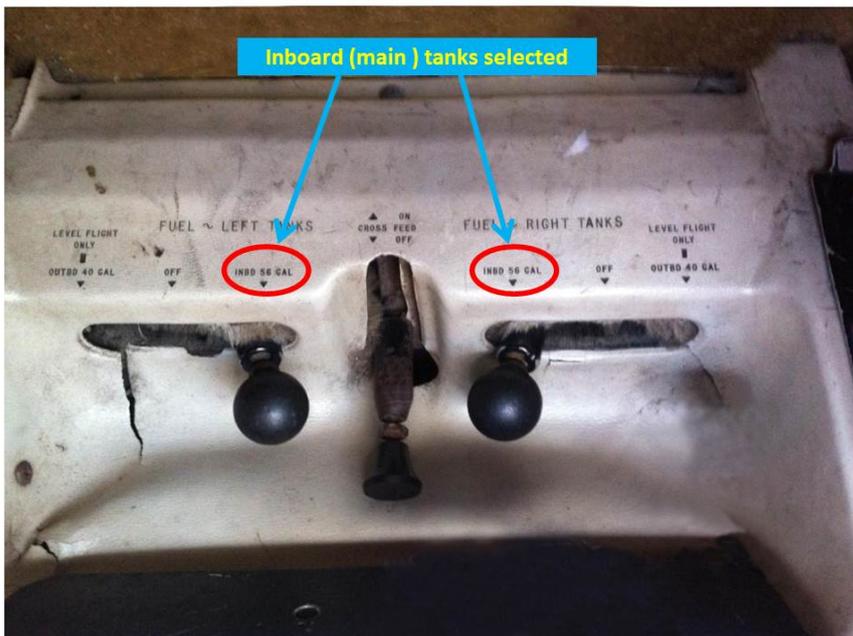
Figure 1: PA 31 fuel selectors on inboard (main) tanks

To check fuel quantities, the pilot entered the cockpit, turned on the master switch and placed the left and right fuel selectors onto the main tank (inboard) position (Figure 1). The gauge for each tank showed just under half full. He then placed each fuel selector onto the auxiliary (outboard) tank position, where the gauge indicated the right and left auxiliary tanks were each about a quarter full. He did not return the selectors to the main tanks. He estimated that refuelling the main tanks would allow sufficient fuel for the flight with over an hour in reserve. He exited the aircraft while it was refuelled and continued preparing for the flight.

Once the aircraft landing on runway 14 was clear of the runway, the pilot went through his usual memory checklist prior to take-off. He scanned and crosschecked the flight and panel instruments, power quadrant settings and trims, but did not complete his usual final check, which was to reach down with his right hand and confirm that the fuel selector levers were on the main tanks.

The pilot stated that the large mental workload of running a business may have taken some of his attention from an intended routine flight to a known destination on a clear day. This most likely contributed to his not reselecting the main tanks prior to start up, and also not completing his usual memory checks of physically reaching and checking the selector position during the pre- take-off checks.

Over time he had developed a mental checklist for pre-take-off and other checks, which had worked well up until this accident. In the future, he intends to revert to a manual checklist for every flight.

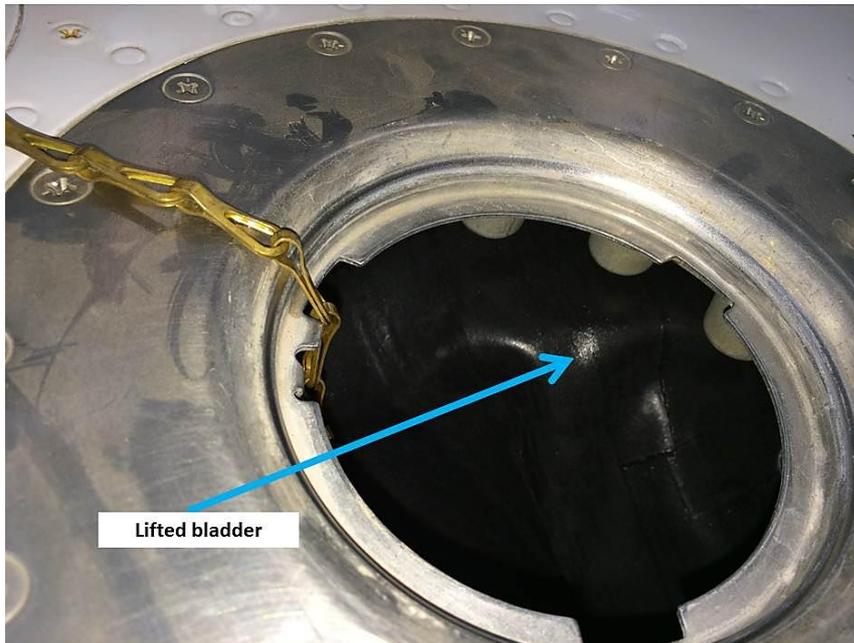
**Figure 3: Lifted bladder, VH-OFF left auxiliary tank**

A post-accident engineering report found all four fuel tanks were operational. When selected, the auxiliary tanks were almost empty. The left and right auxiliary tank fuel samples indicated about 0.5 ml of water was present. The left auxiliary fuel tank bladder was found to be lifted inside the tank (Figure 3). The engineer noted that in its extremities, the bladder can lift the fuel sender float, which gives a false indication that there is more fuel in the tank than available. Fuel pressure was tested and was normal.
