VFR flight into IMC involving de Havilland DH-84 Dragon VH-UXG

36 km SW of Gympie, Qld | 1 October 2012

ATSB Transport Safety Report
Aviation Occurrence Investigation
AO-2012-130
Final – 19 December 2013

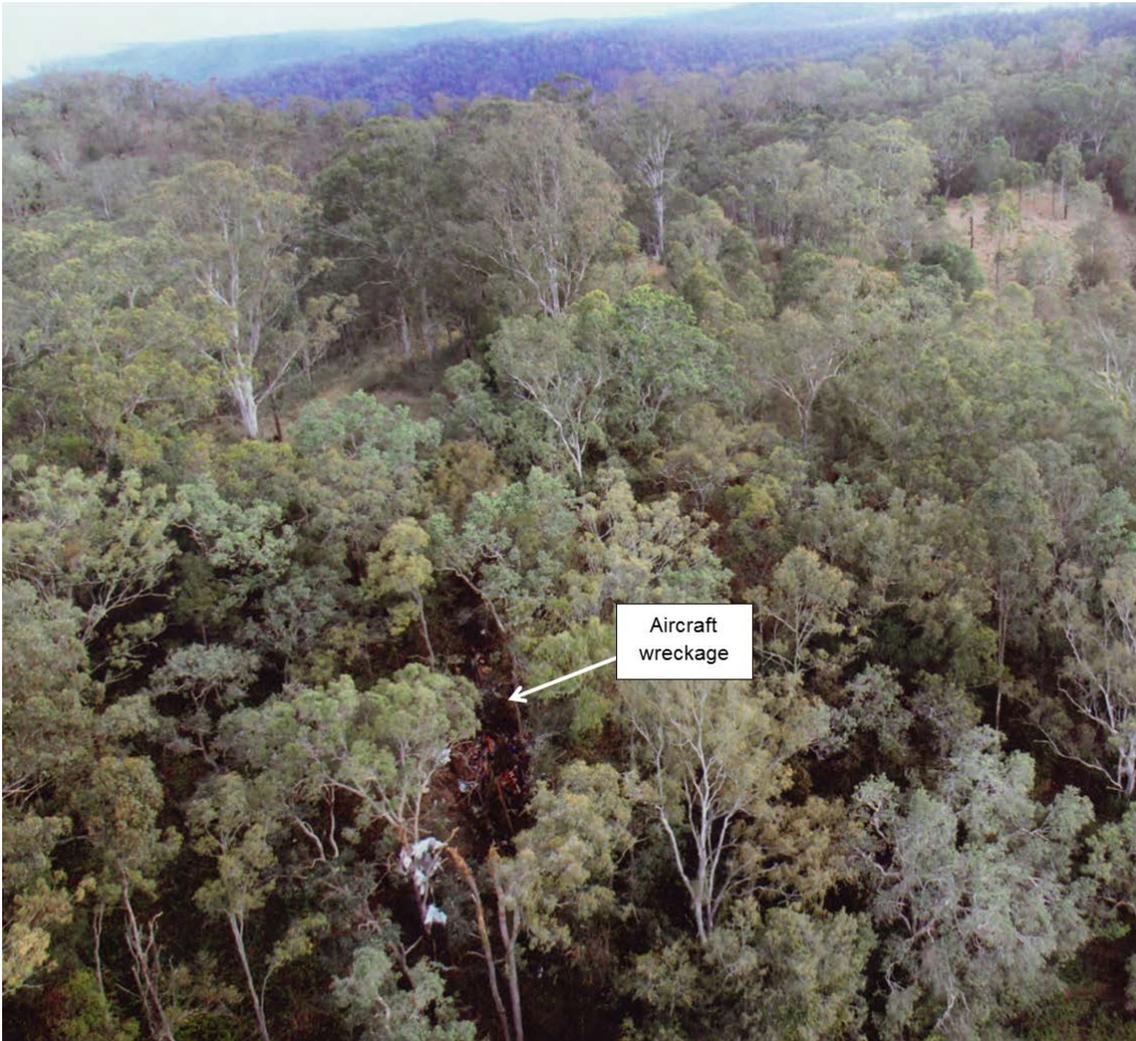
Figure 3: Aerial view of the accident site

The aircraft was destroyed in the impact with terrain and there were no survivors. Based on recorded information, reports from nearby aircraft about the PLB signal, and the time captured on a personal watch found on-site, the ATSB determined that the aircraft most likely impacted terrain between about 1413 and 1423 on 1 October 2012.

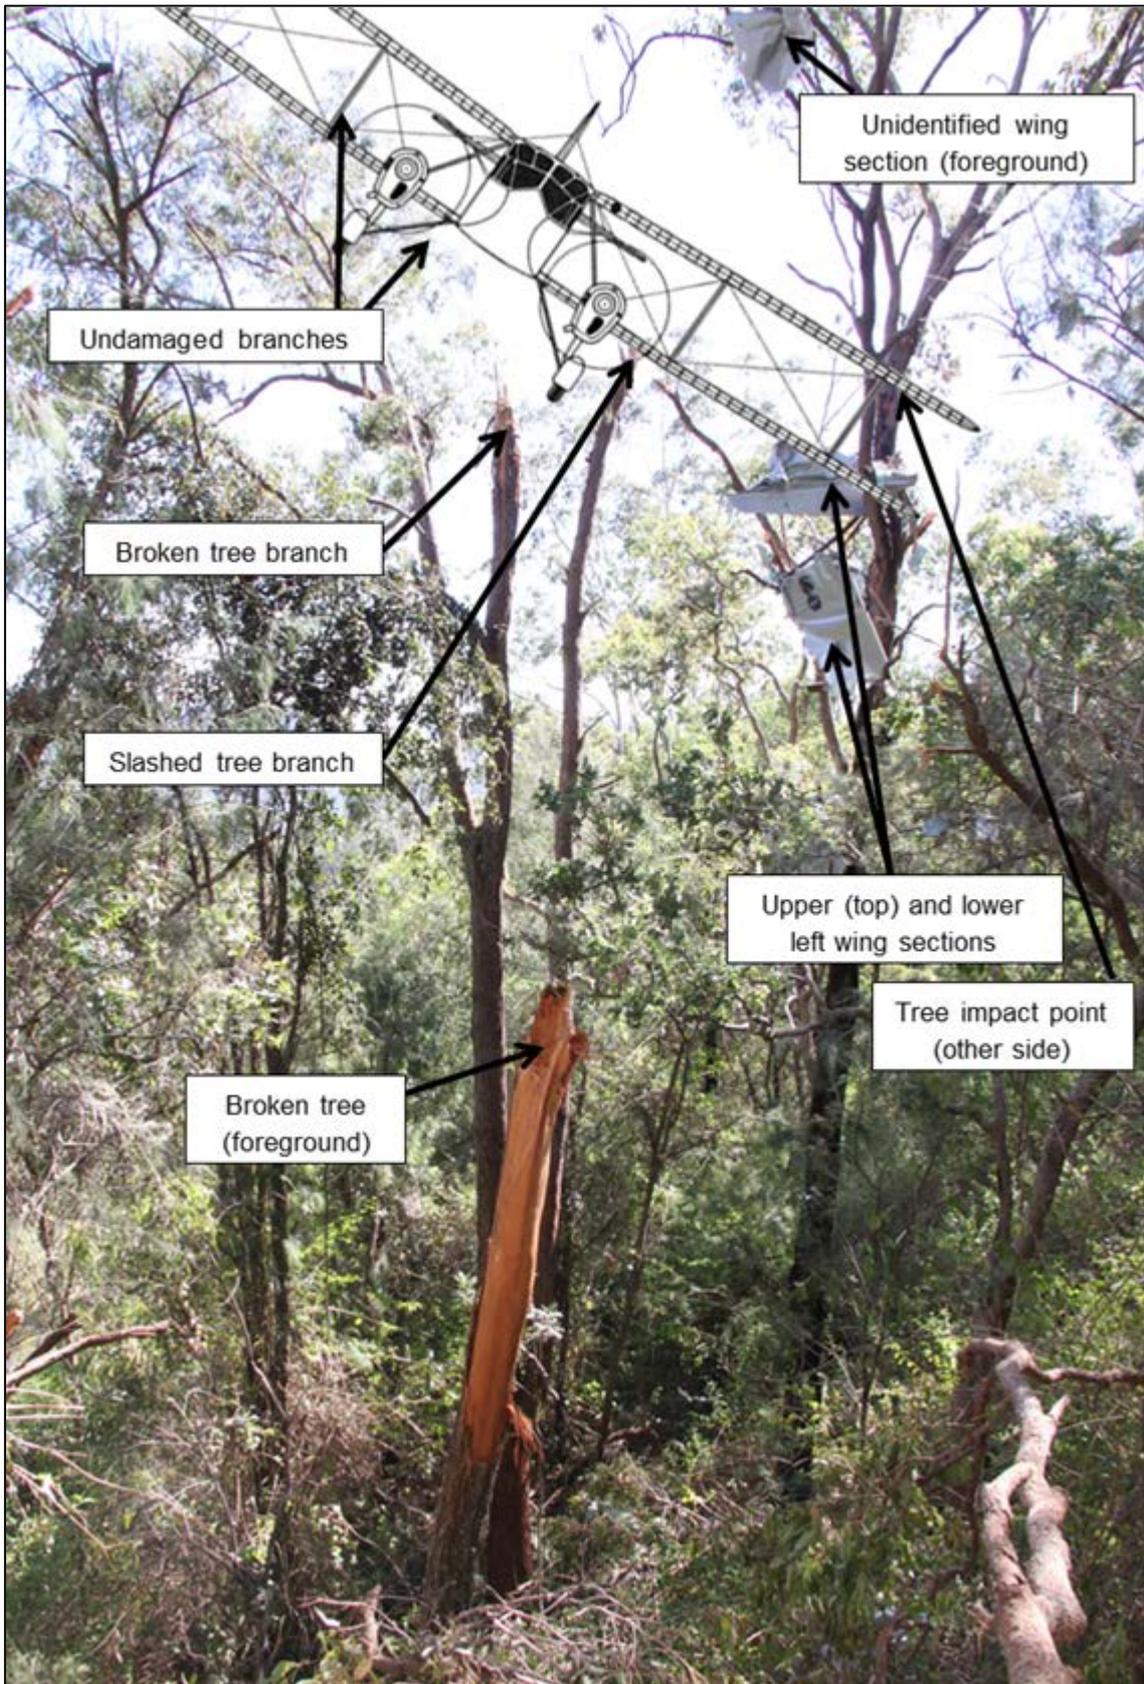
Figure 6: Representation of the aircraft's path through the trees (approximate scale)

The damage to the tree canopy and the approximate aircraft location and attitude at the time of the initial impact with trees are illustrated at Figure 6. The tree damage indicated that the aircraft's direction of travel at impact was to the south with a descent angle of about 30°. Sections of the outer left wings remained caught in a tree to the left of the flight path and, along with an undamaged tree immediately to the right of the flight path and the wreckage scatter pattern, indicated that the aircraft collided with trees while banked to the left at about 35°.

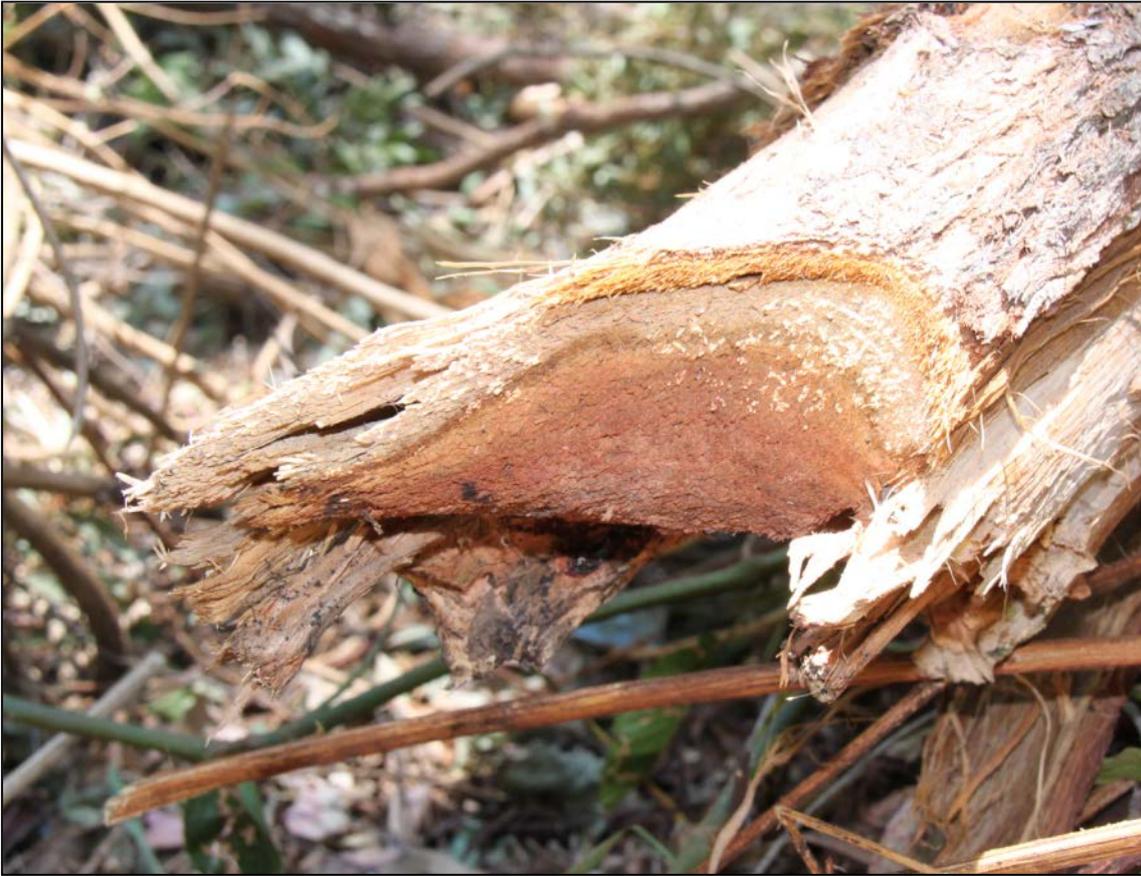
Figure 7: Slash-type cut to one of the trees at the accident site

One of the trees struck by the aircraft sustained a sharp, 8-cm deep slash, consistent with impact by a rotating propeller (Figure 6 and Figure 7). The geometry of the aircraft's path through trees indicated that the left propeller caused this slash.

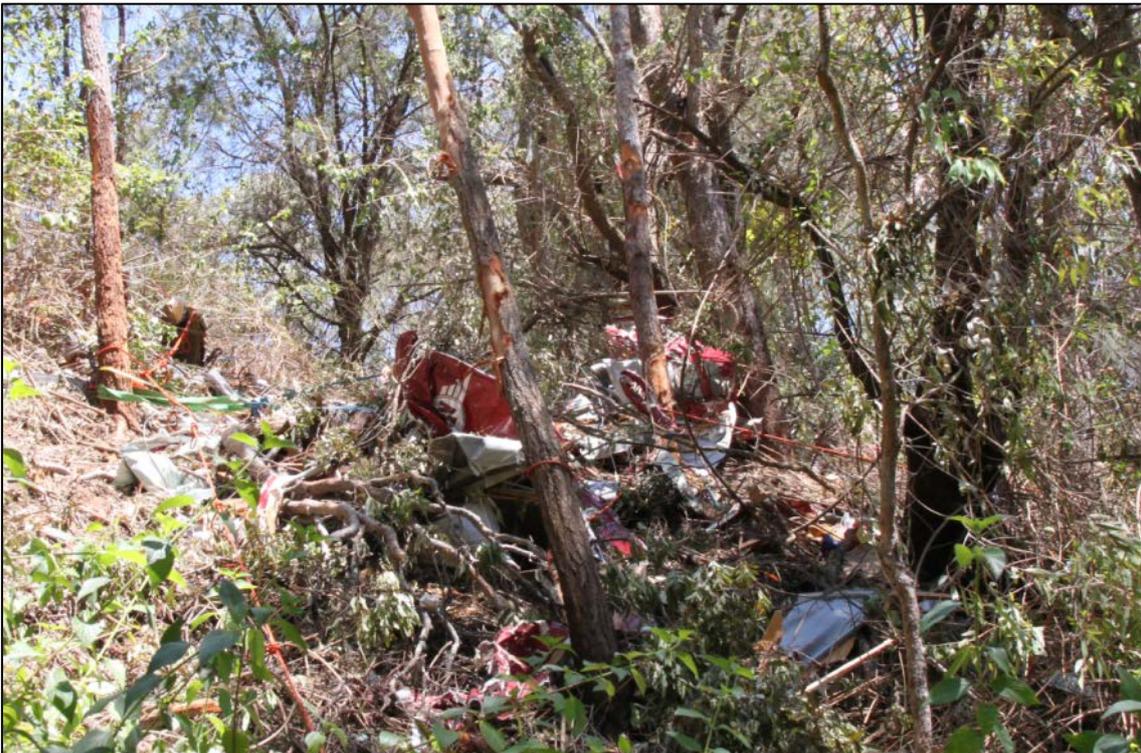
Figure 8: Aircraft wreckage

The airframe was extensively damaged as a result of impact forces and the tendency for the timber structure to break rather than bend (Figure 8). The damage was consistent with a collision at a moderate to high speed combined with a steep angle relative to the terrain. There was no fire.

All of the aircraft's major components, including all flight control surfaces, were located at the accident site and were severely damaged. The remnant aircraft structure and flight controls were inspected on-site with no pre-accident defects identified.
