Accident and Incident Investigations Division

## AIRCRAFT ACCIDENT REPORT AND EXECUTIVE SUMMARY

Reference:	CA18/2/3/9284	
<b>Aircraft Registration</b>	<b>ZS-CLT</b>	<b>Date of Accident</b>	3 February 2014		<b>Time of Accident</b>	04:54Z
<b>Type of Aircraft</b>	Beechcraft C90GTx (BE9I)		<b>Type of Operation</b>	Private (Part 91)		
<b>Pilot-in-command Licence Type</b>		ATPL	<b>Age</b>	58	<b>Licence Valid</b>	Yes
<b>Pilot-in-command Flying Experience</b>		Total Flying Hours	1 936		Hours on Type	101,5
<b>Last point of departure</b>		Rand Airport (FAGM), Gauteng Province				
<b>Next point of intended landing</b>		Lanseria Int. Airport (FALA), Gauteng Province				
<b>Location of the accident site with reference to easily defined geographical points (GPS readings if possible)</b>						
At Lanseria Inter. Airport (FALA) to the north of RWY 07 near the boundary fence (GPS S25° 56' 18" E027° 55' 18")						
<b>Meteorological Information</b>		Wind 090/10 Visibility 0800 Overcast 008 Temp 19/19				
<b>Number of people on board</b>	1+2	<b>No. of people injured</b>	0	<b>No. of people killed</b>	3

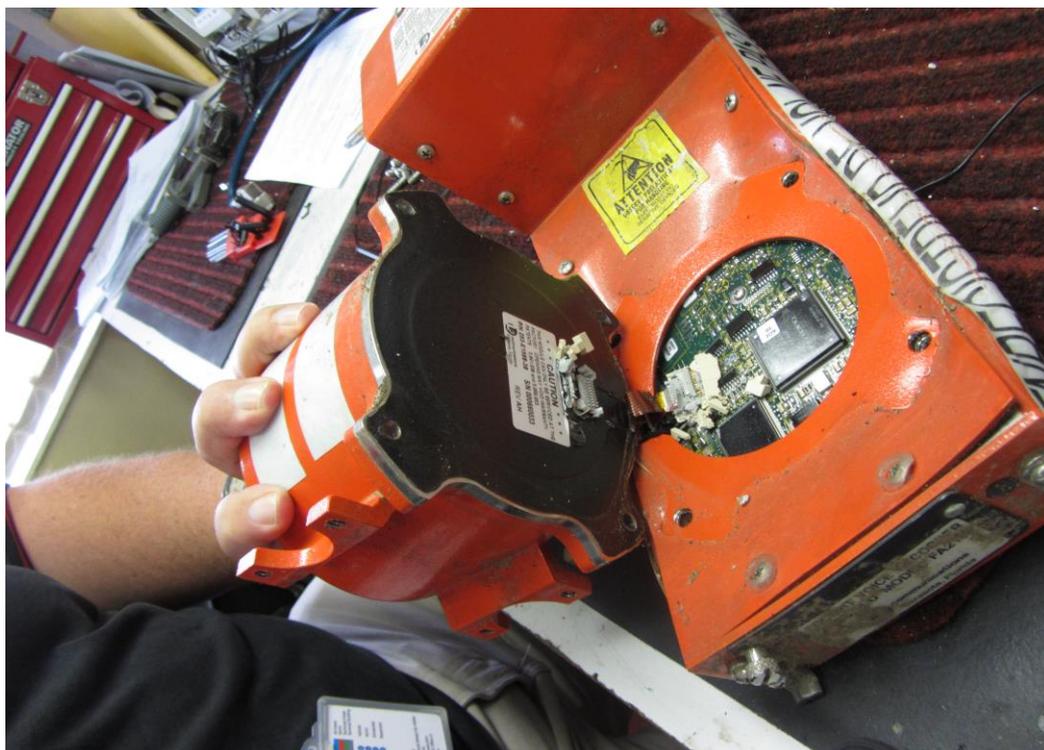
- 1.11.2 The CVR sustained significant structural damage and was not exposed to fire or water. The damages made it impossible for a download here in South Africa hence a request was made to United States of America's National Transportation Board (NTSB) to do the download. They first had to replace the damaged female connector and then replace the damaged L-3 chassis (the bottom part). The audio information was extracted without any difficulty.

**Figure 3:** Damages suffered by the Cockpit Voice Recorder.

- 1.12.4 The cockpit and its instruments and gauges were completely burnt. The CVR, which is located behind the rear pressure bulkhead, suffered serious damage.

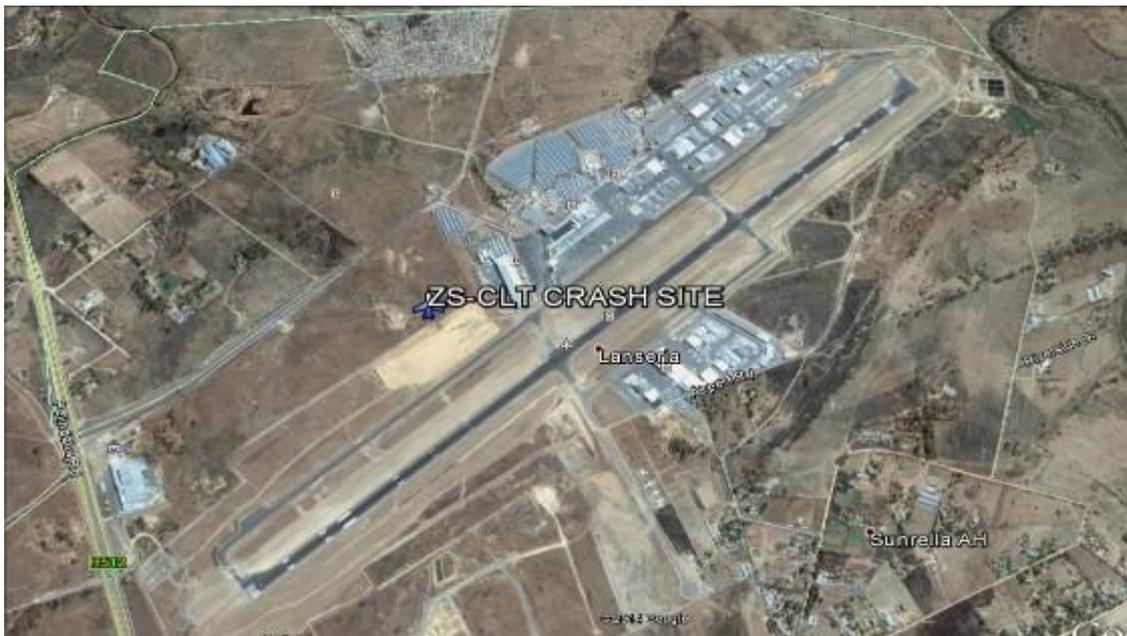
**Figure 4:** Accident site as seen from above  
**Source:** Google Earth

- 1.12.2 The accident site was inside FALA grounds and near the perimeter fence. It was 162 m away from the nearest taxiway and 383 m from the tower. The Executive Jet hangar between the crash site and the tower obscured the tower controller's view, hence he did not witness the aircraft falling.

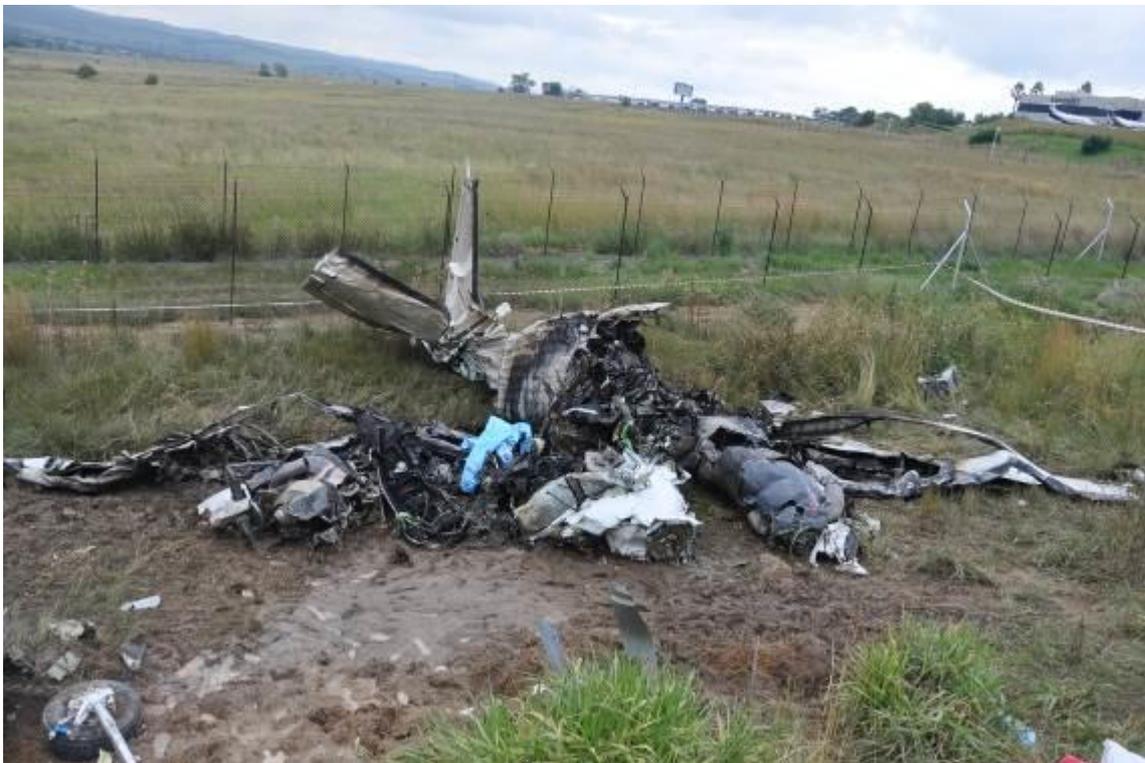
- 1.12.3 When the aircraft crashed, the engines had power and the undercarriage was down. The marks on the propeller were perpendicular to its length. The propeller was bent into an S shape in the impact. The left-hand propeller was completely severed from its shaft. The nose wheel was found approximately 4 m from the wreckage. The wings' skin cover was severely burnt, and some parts were flung approximately 5 m from the wreckage by the explosion. The back of the fuselage was twisted as a result of the spiral dive.

**Figure 5:** ZS-CLT wreckage after the accident

1.14.1 It is not clear at which height the aircraft stalled, but immediately after the stall, the aircraft went into an uncontrollable spin and hit high sloping ground with the right-hand wing and engine first then the resultant forces pushed it back. A post-impact fire started on the right-hand engine, followed by a big explosion as seen through the Execujet security camera. The aircraft was completely destroyed by the fire.

3.12 The aircraft was broken in several places and the tail deformation travelled forward in the direction of the crash.

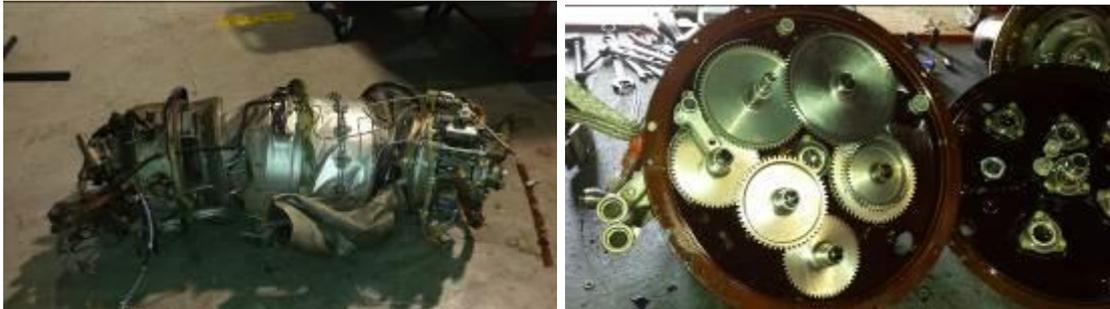
**Figure 6:** Left engine before and after teardown. The reduction gears had not been disturbed or affected.

1.16.2 The company representative's summarised findings were that the engines had power at the time of the accident and that there was enough fuel for the flight. The container rings of both engines had not been damaged. All the blades broke as a result of impact forces of an accident. The circular scarring on some engine parts indicated that the engine was producing power when it hit the ground.

No evidence of any pre-impact anomalies was found on any of the compressor components, bearings, reduction or accessories gearbox gears on either engine.

There were no anomalies observed which could have prevented the engines from producing power prior to impact.
