AIRCRAFT ACCIDENT INVESTIGATION

LOSS OF CONTROL INTO TERRAIN
INVOLVING
SKYWARD INTERNATIONAL AVIATION LTD
FOKKER B. V. F27 MARK 050,
KENYAN 5Y-CET
UTAWALA, NAIROBI, KENYA
02 JULY, 2014

PRELIMINARY REPORT

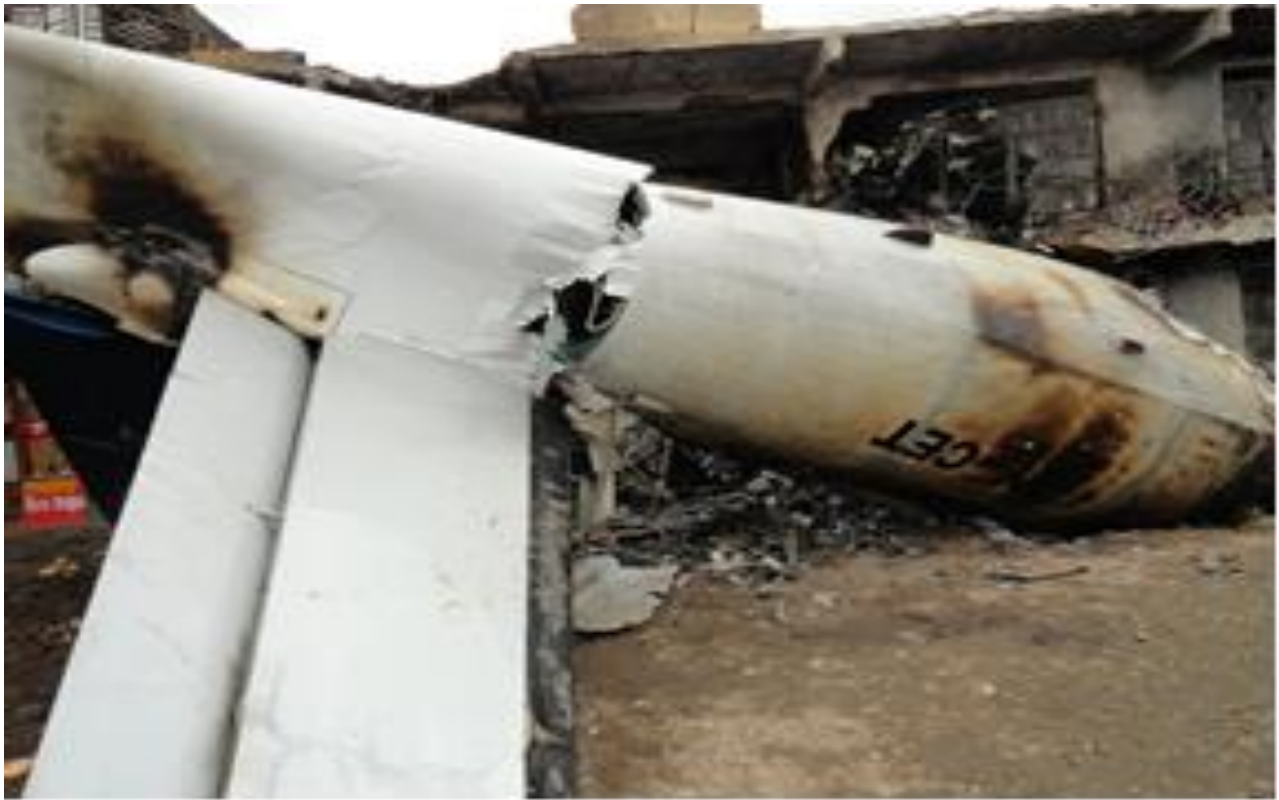
Figure1: The 5Y-CET wreckage at the accident site

The aircraft was destroyed by impact forces and the ensuing fire

The site of the accident was a commercial single storey building adjacent to a major road. The aircraft collided with the building at an angle in a “belly up” attitude. The front section of the aircraft remained mostly intact and come to rest upside down in one of the rooms of the building on the ground floor. Part of the cabin floor and cargo was found on the first floor of the building. The right (RH) wing and engine came to rest on the first floor. The wing was extensively damaged by fire. The left (LH) wing and engine were located on the ground adjacent to the building. The LH wing was extensively damaged from both impact and fire and was scattered across the debris trail. The LH engine had impacted the ground and imbedded therein.

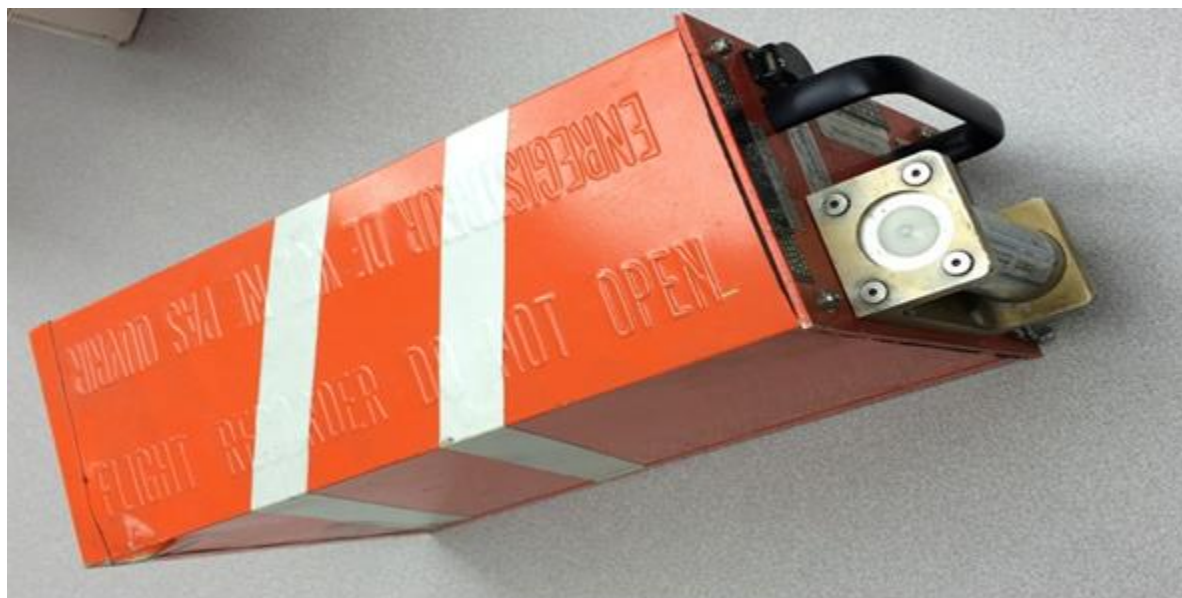
Recorder Serial Number: 59652

The CVR was located in the upper tail section of the aircraft, in the vicinity of the stabilizer attachment point. This section was not damaged by the post-crash fire and did not have much structural damage. The recorders were retrieved from the wreckage on the day of the occurrence without much difficulty.

The CVR had sustained minimal structural damage and the audio information was extracted from the recorder normally, without difficulty.

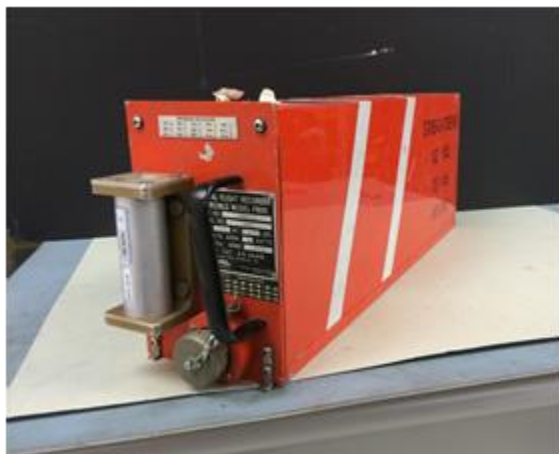
Recorder Serial Number: 04844

The FDR was also located in the upper tail section of the aircraft, adjacent to the CVR. As earlier indicated, this section was not damaged by the post-crash fire and did not have structural damage. The recorder was retrieved from the wreckage on the day of the occurrence without much difficulty.

The recorder was in good condition. The FDR was opened so that the FDR tape could be removed for download and the data were extracted normally using relevant readout equipment.

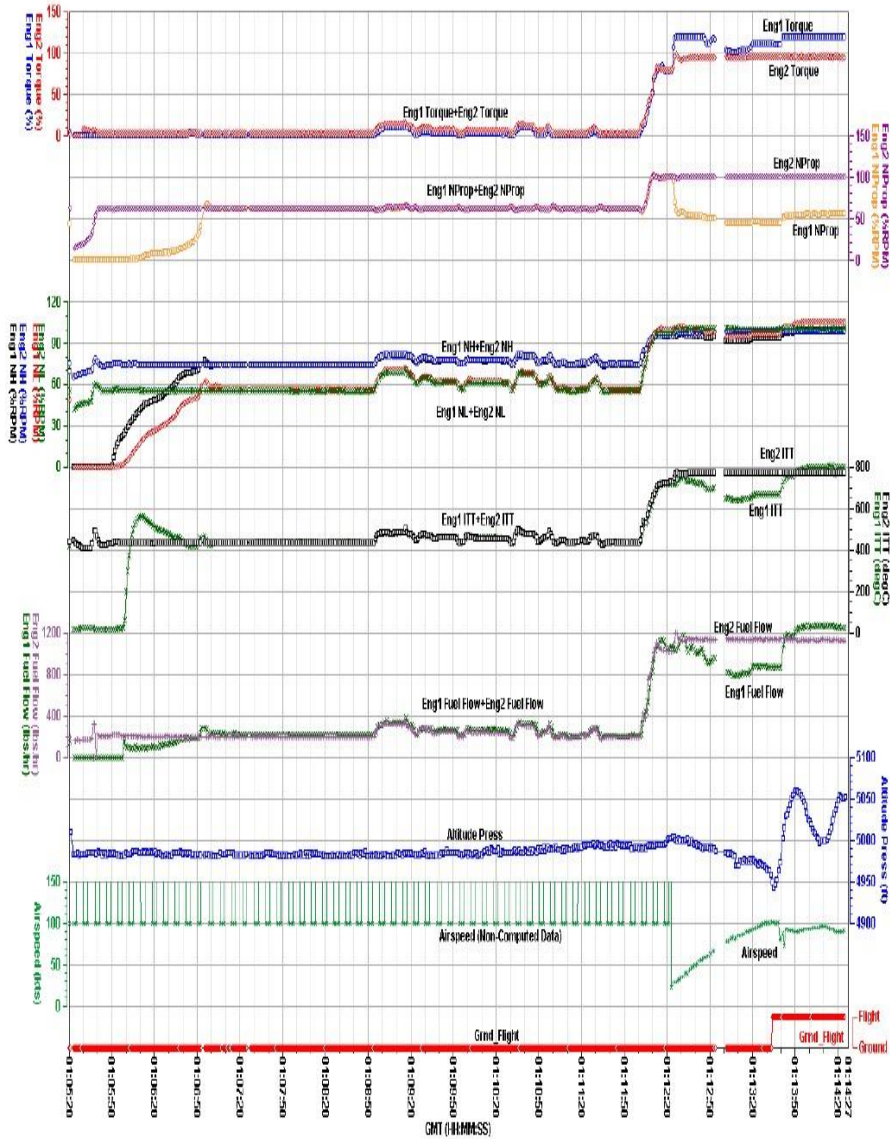
Engine Parameters (Beginning of Event Data to End of FDR Recording)

About 24 seconds after initial engine acceleration, engine 1 torque climbs over a period of 2 seconds to a recorded value of 119.9%, the maximum value the recorder is capable of recording. Simultaneously Engine 1 propeller speed falls from 100% to 57%. Other engine shaft speeds remain at approximately their original high power values. Airspeed at the point this change occurs was less than 30 knots. During this period, the FO called out “one twenty two now [pause] torque”. The Capt responded “it is rising eh? The FO then noted “torque one twenty six now”. About 31 seconds after initial engine acceleration, the FO called out “okay speed alive sixty”. About a second later the Capt asked “do we reduce or”? The FO responded “we can just cut”. The Capt inquired “do we abort or continue?” The FO responded, “okay one one twelve and nine four point three” and then “okay one sixteen [pause] ninety four.” The Capt acknowledged “yeah okay”
