### **Aircraft Accident Investigation Final Report**

# Crash Near Airfield Following Aircraft One Engine Failure Just Upon Lift-Off

Sepahan Airlines Flight 5915 Antonov 140-100, MSN 90-05 Tehran, Mehrabad International Airport August 10, 2014

File Number: A13930519EPGPA

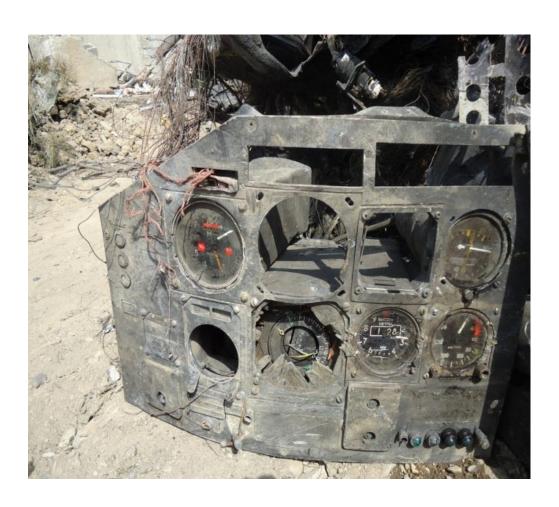
Figure 4. AN-140-100 control panel after accident.

Figure 4 shows some indicators of the AN-140-100(EP-GPA) after the accident.

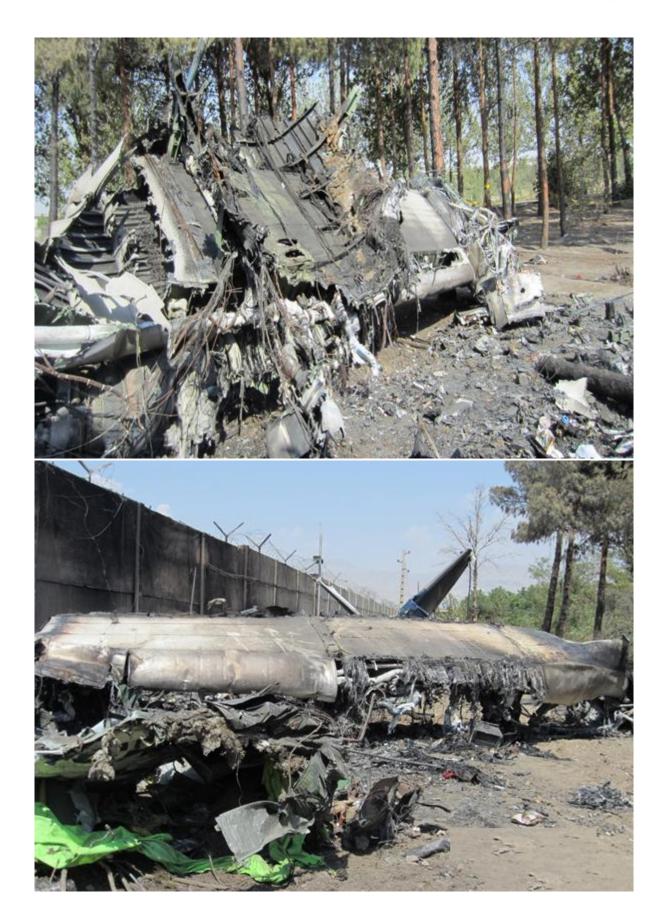
Figure 8. AN-140-100 wreckage

By the results of the crash site inspection, it was concluded that the initial collision with the ground was by the right wing with a significant right bank. Also the kind of damages of trees is indicating significant right bank. Right outer wing was not found on the crash site. At the crash site, due to the fuel spill was surface fire (there are burn marks on the ground). Left and right engines were detached from attaching points and located under the center wing. Crew cabin burnt. The central part of the fuselage burnt out as a result of ground fire. Aft fuselage as well as vertical and horizontal stabilizers were seriously damaged. Nose landing gear leg and main landing gears were in an extended condition (were not retracted). Flap position was about 10 degrees and an APU ramp in open position.

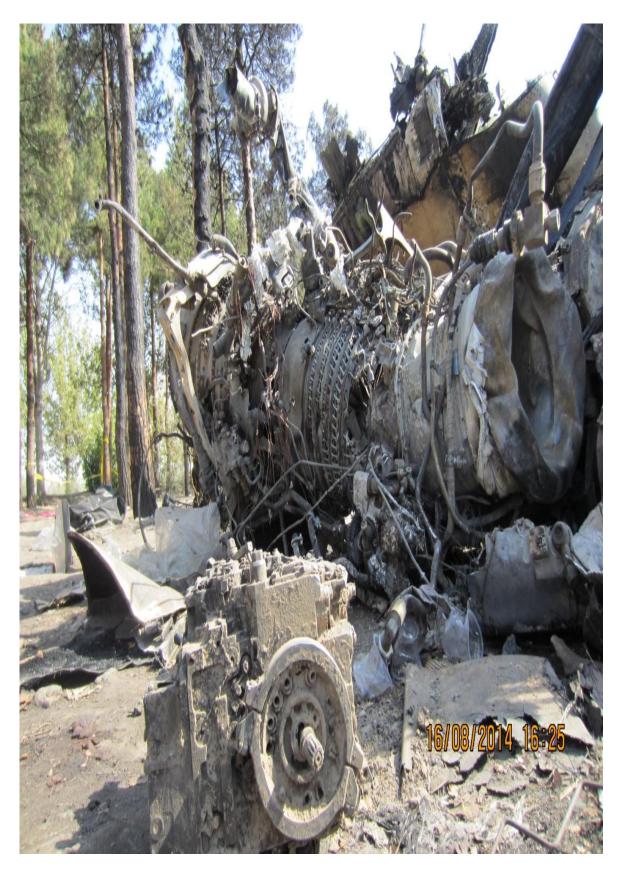
Figure 9. AN-140-100 wreckage-engine

There are multiple damages on the engines from the collision with obstacles and the ground. There are traces of surface fire impact on the engine structure. The left engine propeller blades damage suggests that the engine was in operation until collision with the ground.

The left engine was damaged to a larger extent and has traces of extensive fire in the area of accessory drive gearbox and front support casing; almost all large sized vendor items are shifted from their mounting points;

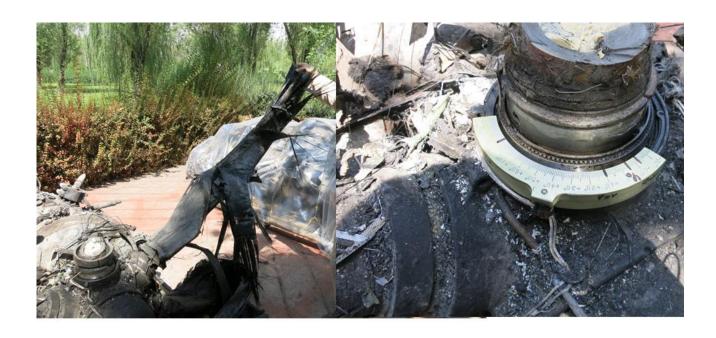
Figure 15. AN-140-100 Wreckage –propeller

Propeller blades were burnt, partially cut or broken; one blade was broken at the blade shank, located separately from the propeller and was not burnt.

The propeller blades are burnt and partially broken; two blades are located outside the propeller and are not burnt. The propeller blades position recorded on the BUR-92A, also the propeller blades position, measure with a special tool directly on the propeller hub, which indicates the propeller blades were feathered at 84° to 85°. The engine was exposed to ground fire (the accessory gearbox and part of the compressor were burnt out).

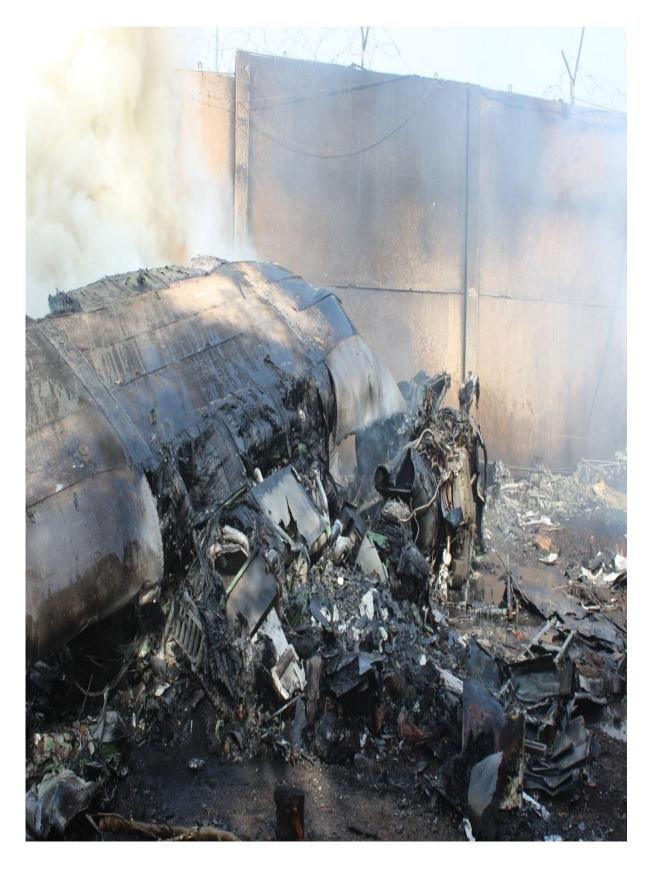
Figure 16: fire damage to the airplane.

Examination of the accident site and the airplane's fuel tanks showed no evidence of Pre-crash fire involving fuel. Skins were burned away, and the fire did penetrate internal insulation and mechanisms into the cabin. However, below the cabin floor in the cargo bay, severely burned.

Aircraft fuel was about 500 kg more than required fuel for the accident flight. After aircraft impact, remaining additional fuel aggravated the fire.

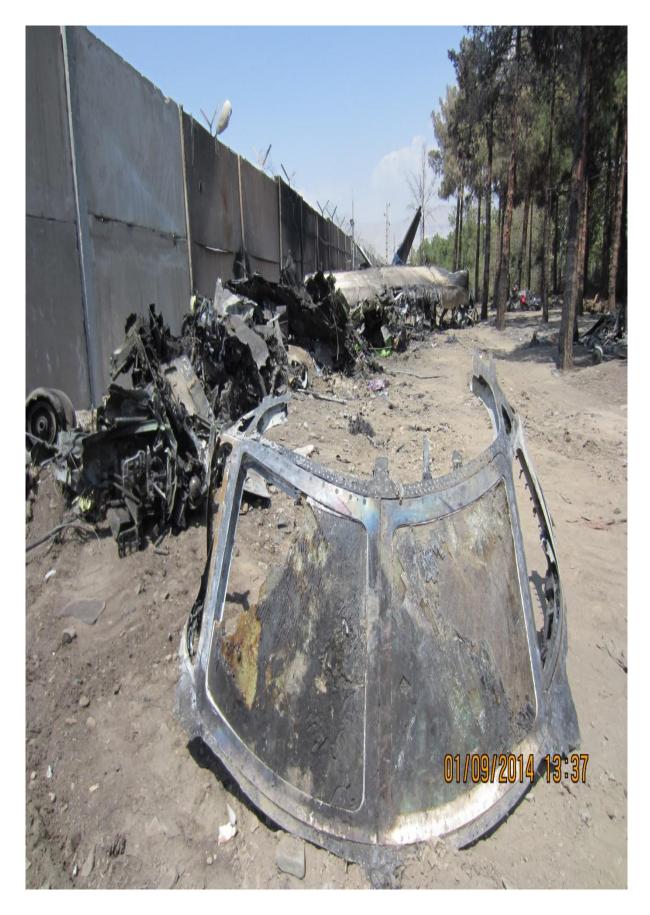
Figure 17. Fire damage to the fuselage

The cabin was heavily damaged by the impact and post-crash fire. All of the seats were damaged and deteriorated by the impact and the post-crash fire. The fire appeared to be more severe on the left side than the forward right side of the area which received the severe fire damage.

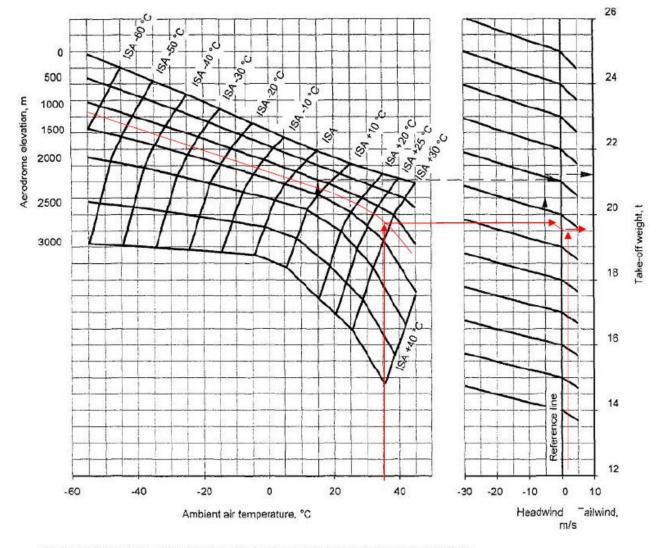
Figure 21: MTOM calculation chart

Therefore, the AFM confusing performance chart caused the pilots relying on performance calculation that, significantly overestimate the aircraft MTOM for the accident flight.
