ACCIDENT

Aircraft Type and Registration:	Gulfstream III (G-1159A), N103CD	
No & Type of Engines:	2 Rolls-Royce Spey Mk511-8 turbofan engines	
Year of Manufacture:	1984 (Serial no: 418)	
Date & Time (UTC):	24 November 2014 at 2030 hrs	
Location:	Biggin Hill Airport, Kent	
Type of Flight:	Private	
Persons on Board:	Crew - 2	Passengers - 5
Injuries:	Crew - None	Passengers - None
Nature of Damage:	Aircraft damaged beyond economic repair	
Commander's Licence:	Airline Transport Pilot's Licence	
Commander's Age:	36 years	
Commander's Flying Experience:	4,120 hours (of which 3,650 hours were on type) Last 90 days - 60 hours Last 28 days - 19 hours	
Information Source:	AAIB Field Investigation

Synopsis

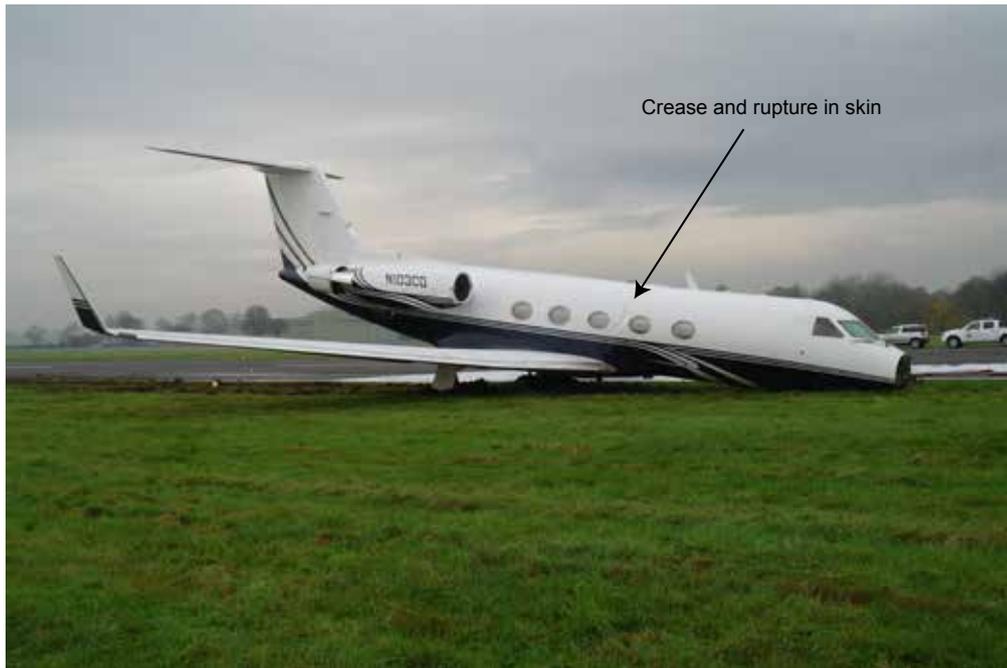
Figure 3

After the nose landing gear separated from the aircraft, it struck the lower fuselage approximately 0.3 m aft of the nose landing gear bay, tearing a hole in the skin 6.5 m long. A number of frames in this area were damaged and all the aerials mounted on the forward lower section of the fuselage were found detached. There was also a crease and rupture in the skin over the top of the fuselage, just aft of the second window in the cabin (Figure 3). The aircraft was assessed as being beyond economic repair.

The aircraft as it came to rest, showing area of skin crease and rupture

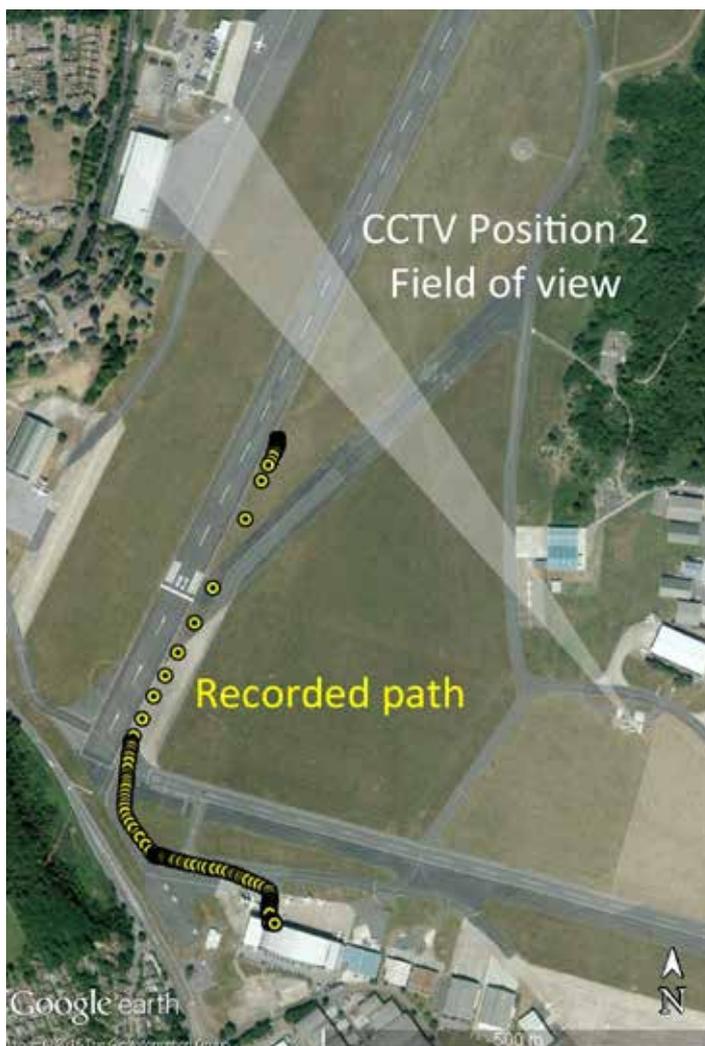
Figure 4

Three iPad tablets were recovered from the aircraft and the path of the aircraft during the attempted takeoff was recorded by 'apps' installed on two of them. These tablets use built-in GPS receivers as part of their positioning capability, which are less effective when used within an aircraft. However, whilst the accuracy of the recorded tracks is not known, the two recordings were largely consistent with each other. One of the recordings started at 1956 hrs but no motion was recorded until 2025 hrs and the motion stopped at the final location of the aircraft at 2030 hrs. The recorded ground speed reached a maximum of approximately 70 kt during this period. The path recorded by the iPads is shown in Figure 4.

Recorded path of the aircraft and relevant CCTV image coverage

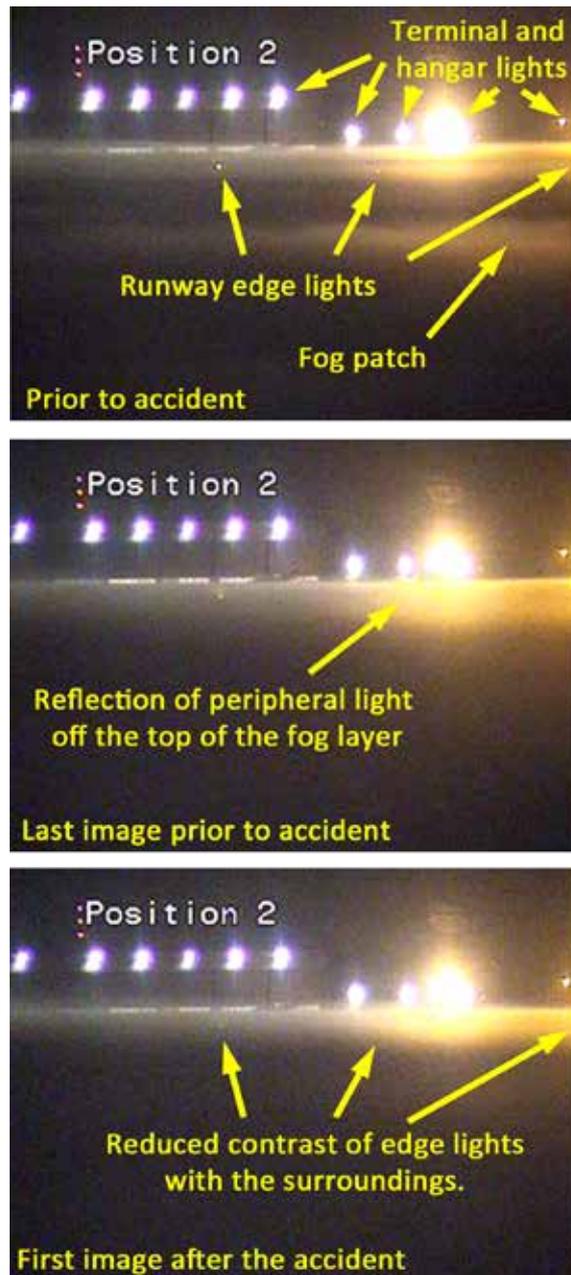
Figure 5 illustrates the low-level fog patches drifting across the airfield during the accident period, and the patches are also prevalent in the rest of the recording, in which their movement is seen more clearly. The CCTV snapshots were taken from the side of the runway, so only the low-intensity omnidirectional components of the runway edge lights were captured, and not the high-intensity directional component as viewed when looking along the runway.

CCTV images from Position 2 taken 1 minute 25 seconds apart

The lights associated with the hangars, terminal and apron areas are significantly brighter than the runway lights. The CCTV images do not fully represent the extent of this as the image brightness of the peripheral lights (such as those at the apron and the terminal) was recorded at the maximum brightness the image can represent. Therefore the contrast in actual brightness was greater than the images in Figure 5 indicate.

The UK AIP states that there is no centreline lighting on Runway 03, and that the pavement width at the beginning of the runway is twice the normal runway width. It recognises the potential for confusion and urges crews to ensure that they have lined up correctly. This information was not available to the crew on their aerodrome charts and both crew members believed that the runway had centreline lighting. Further, the light from those left-side runway edge lights covered in fog would have been scattered, making it harder for the crew to perceive them as a distinct line of lights. The situation is likely to have been made worse by the bright lights reflecting off the top of the fog layer, making the underlying runway lights even harder to see, or swamping them completely as shown in Figure 5.

The CCTV images in Figure 5 show that peripheral lighting can interact with low fog layers to reduce the visibility of underlying aerodrome lighting. Current standards associated with apron lighting only address the minimum light levels required to make the areas safe and there are no standards relating to light spilling into other areas.

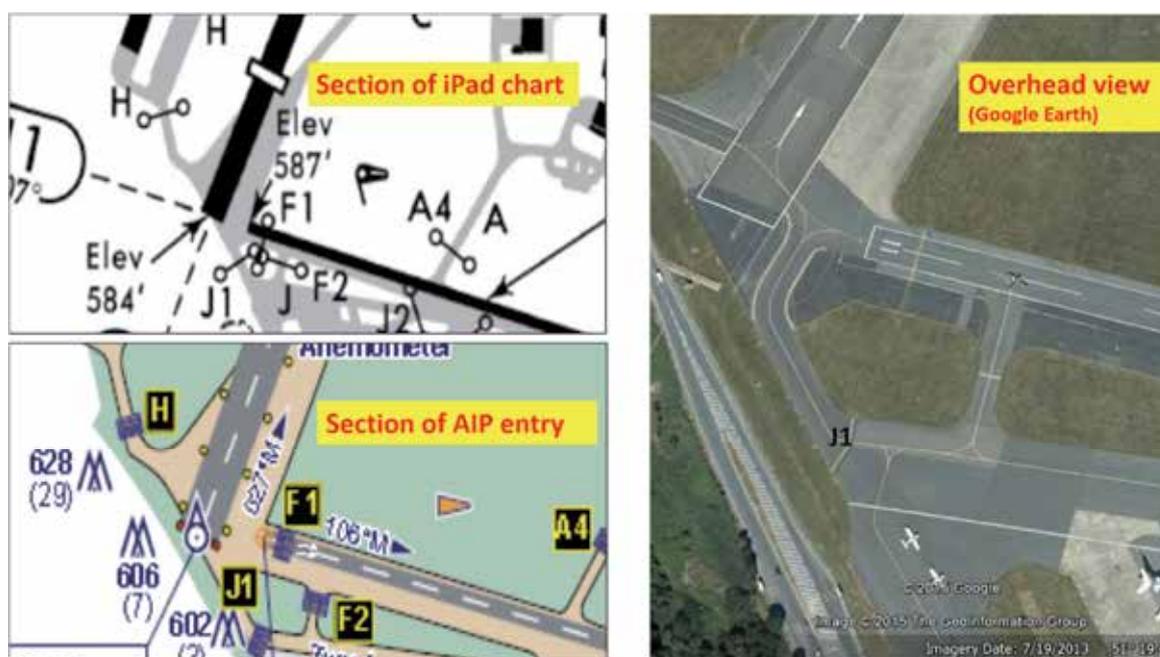
Figure 6

Taxi route from J1 to Runway 03

The information on the aerodrome chart used by the crew, and the source of information in the UK AIP, suggested that the aircraft would be required to taxi in a straight line from J1 to the runway and then make a right turn onto the runway heading. In fact, in order to taxi from J1 onto the runway, an aircraft must: taxi in a straight line; follow a curve to the right onto runway heading but still displaced to the right of the runway itself; turn left towards the runway; and then turn right again onto runway heading.

Following this accident, the chart supplier decided to revise its Biggin Hill Airport Diagram Chart to include the information contained in Section AD 2.20, paragraph 6 (a) of the airport's entry in the UK AIP (see earlier section on Aerodrome information). It decided to include the information in its Chart Change Notices for the UK to cover the period until the revision was issued.

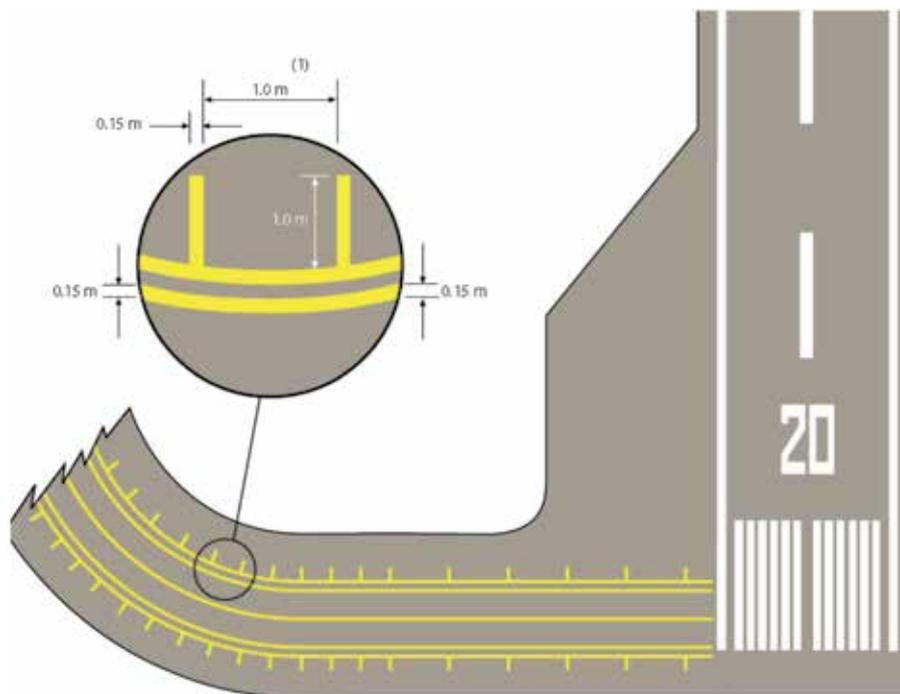
Extract of CAP 168 showing taxiway edge markings at a representative aerodrome

The eastern side of the ORP at the beginning of Runway 03 at Biggin Hill Airport is used as Taxiway C and the boundary between the southern end of the ORP and Taxiway J was not marked as shown in Figure 9 at the time of the accident.
