## *Final report RL 2016:02e*

**Accident on Björnö on 13 February 2015  
with aircraft N164ST of the model  
PA46-500TP (Malibu Meridian), operated  
by a private person.**

File no. L-15/15

2016-03-01

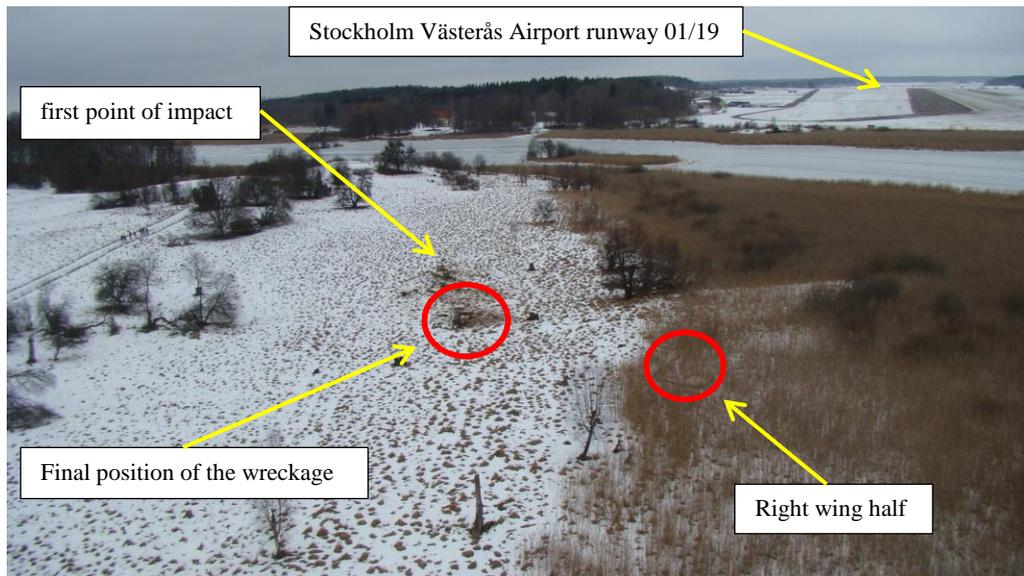
Figure 2. The crash site

The traces that could be measured along the wreckage path showed that the distance from the first point of impact with the left-hand wing leading to the final position of the fuselage was approximately 50 metres. However, the main part of the right-hand wing was found approximately 60 metres from the main wreckage, see figure 2. The approximate time from the initial impact until final stop has been estimated at just under four seconds. For further descriptions of the course of events and damage analysis, see section 1.15.

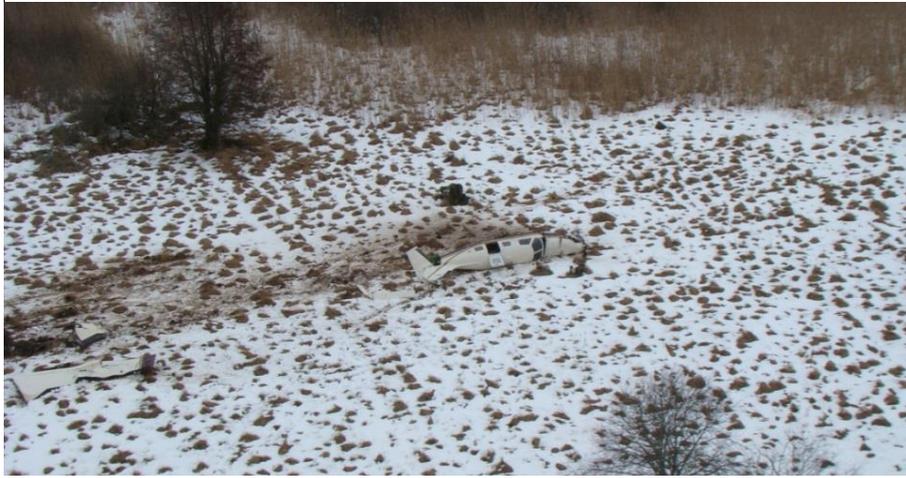
The aircraft received significant damage. The fuselage rested on the right-hand side in the direction of the impact. Both wings had been

broken off at their mountings to the fuselage. The left-hand wing was approximately 20 metres to the rear of the fuselage and the right-hand wing was found in the reed approximately 60 metres in front of the wreckage.

Figure 7. Site of the accident, with aircraft wreckage.

The major parts of the engine section had been broken off at the firewall that separates the cabin section from the engine. All four propeller blades were damaged and bent, but did not show any signs of damage that could indicate thrust upon impact. Both wing tanks were deformed in the accident, resulting in extensive fuel leakage.

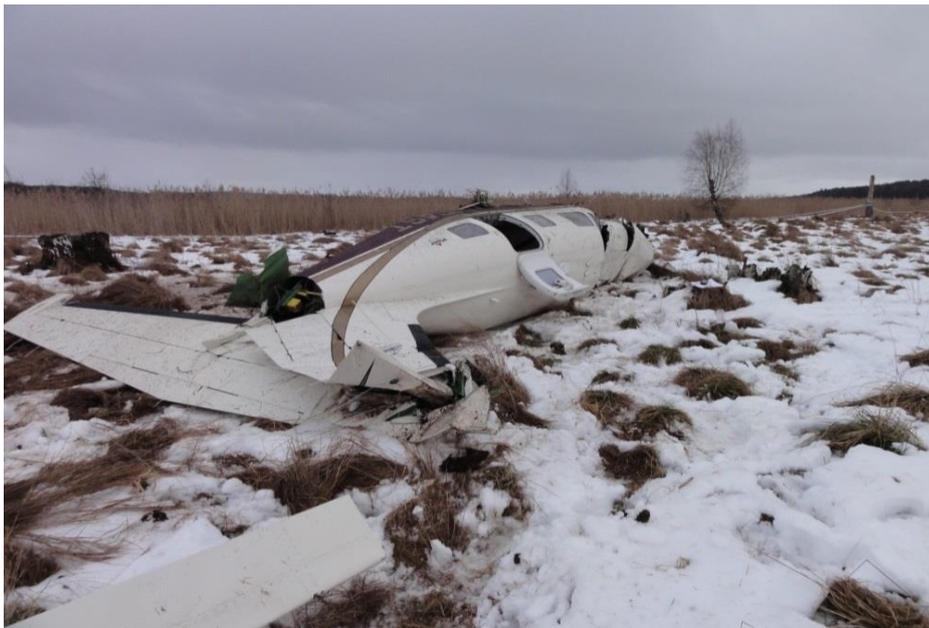
Figure 8. Site of the accident, with fuselage.

The fuselage was comparatively intact, without any large structural damage. All the seats were intact and had not detached from their mounts. The aircraft door on the left-hand side of the fuselage was mostly undamaged and had not been blocked, hence it could be used by those on board for evacuation after the accident. See section 1.15.5 for information about the safety belts.

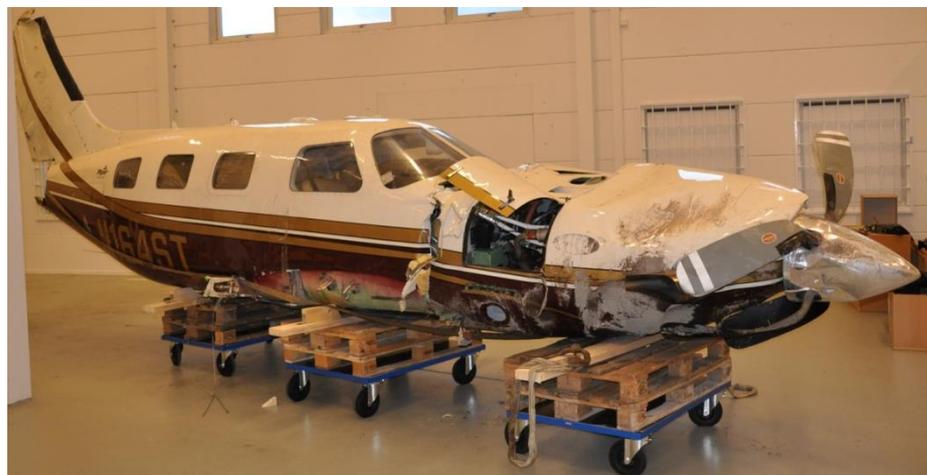
Both wings had separated from the fuselage at their mounts. The right-hand wing had been broken off in two parts. The horizontal stabilizer had partially separated from the fuselage. The vertical fin had received damage from the impact, but remained attached to the fuselage. The main landing gear had received significant damage and was found underneath each respective wing. The nose landing gear had broken off at its mount and had separated from the fuselage.

Figure 9. The fuselage in the SHK hangar.

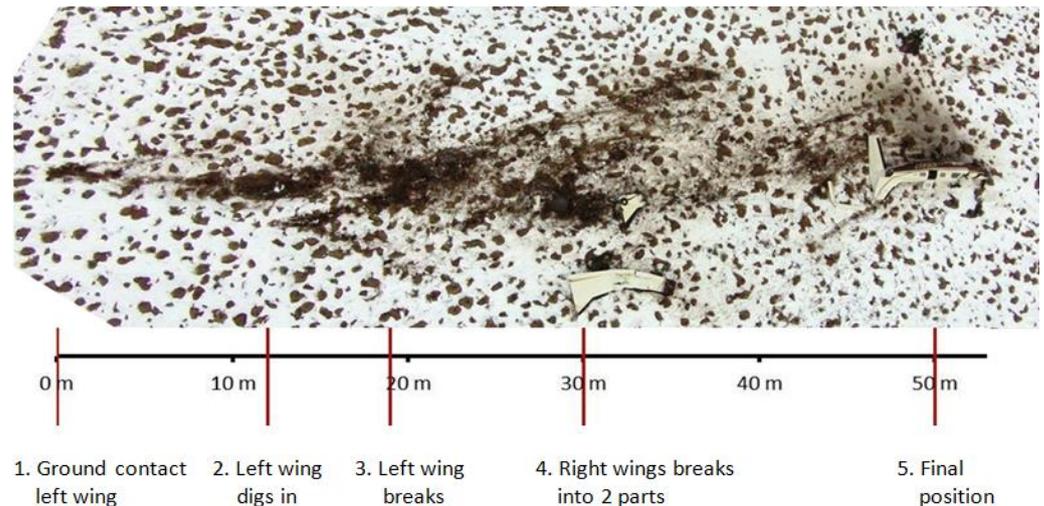
Figure 11. Image of accident trail and wreckage with reference points, taken from a drone (XICE AB).

1. The initial contact with the ground was when the tip of the left wing at a distance of 0 metres, most likely with certain remaining lift but moderate decent rate. In this instance the likely attitude was slightly nose-down.

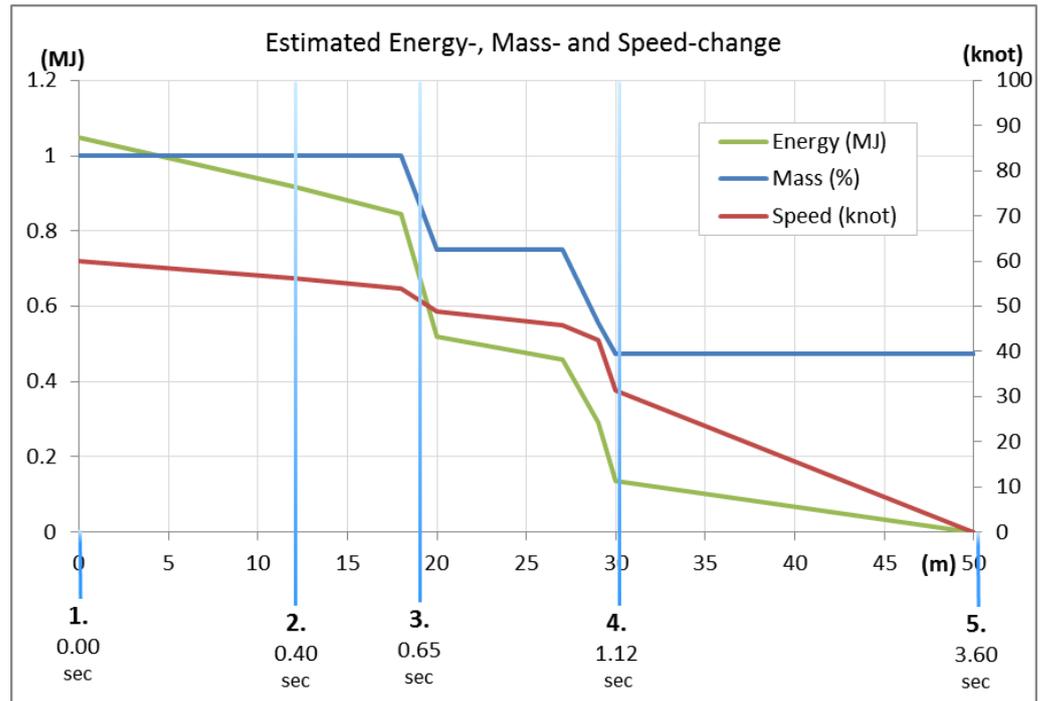
Figure 13. Graph of the changes that occurred during the course of the accident.

The graph in Figure 13 shows how the energy decreases over time and as mass reduces with the separation of the wings from the fuselage.

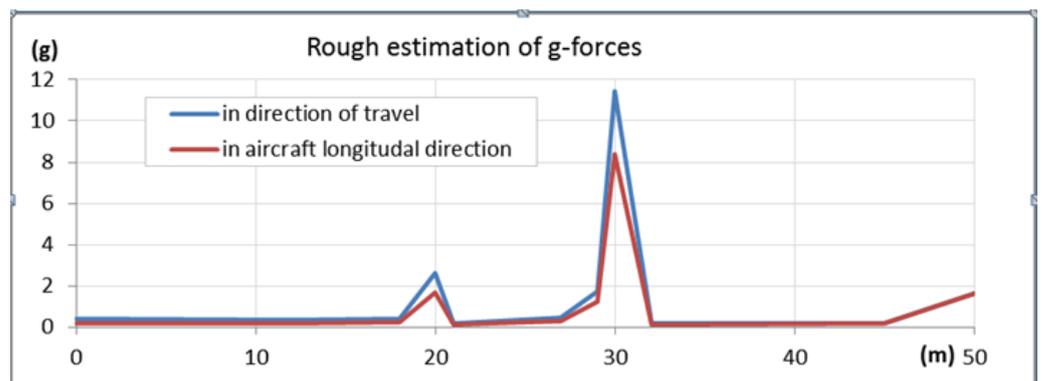
Figure 14. Graph showing the G-force over the course of the accident.

The diagram in Figure 14 shows that the G-force along the aircraft's longitudinal axis most likely reached approx. 8.5 G. This meant that the inflatable airbags installed in the front-seat safety belts and activated at a force of 9 G did not inflate during the accident.

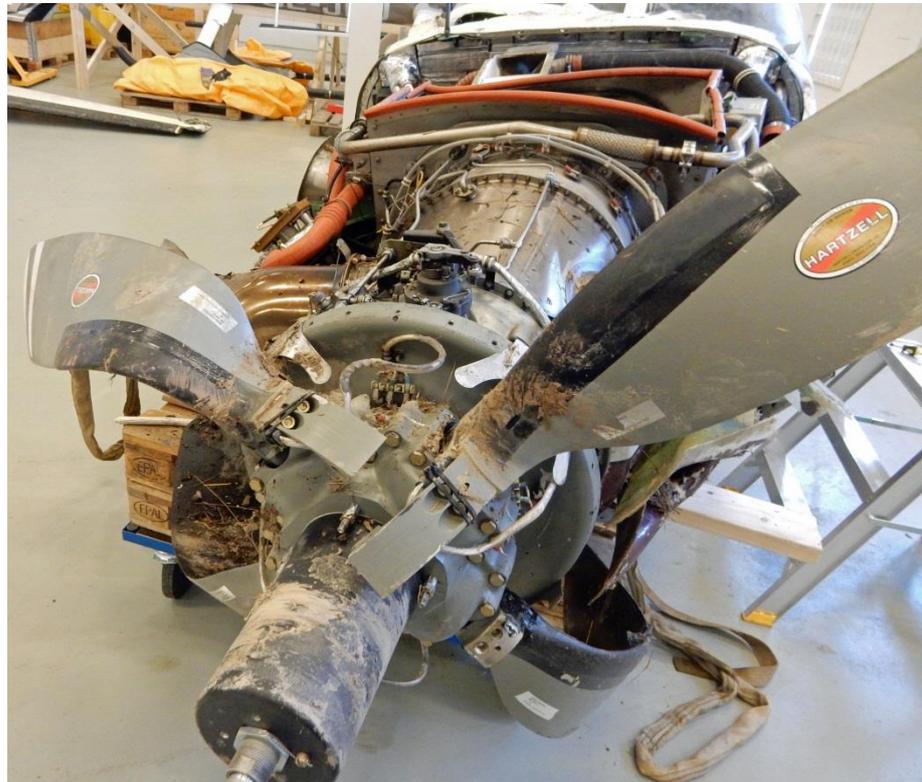
Figure 16. Propeller and engine.

SHK performed an initial examination of the engine and propeller. Damages were observed on the heavily bent propeller blades. A counter weight had been broken off from the propeller and was found loose in the spinner. Two of the blades could be freely rotated in the propeller hub. There were deformities to the engine's outlet section and exhaust pipe, as well as a minor oil leak from the underside of the engine.

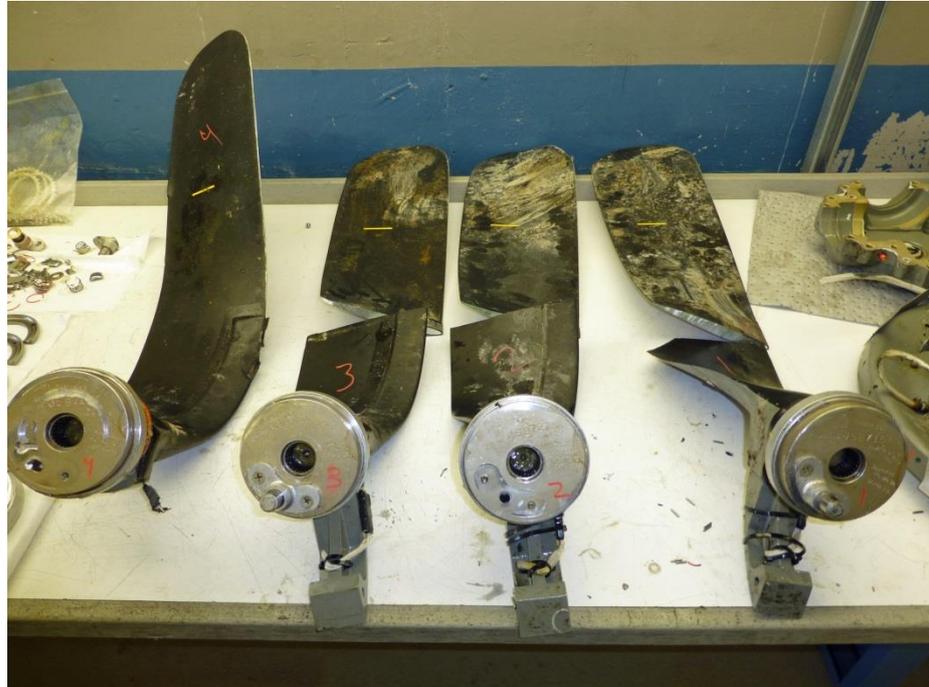
marks, indicating a low blade angle upon impact. The characteristics of the damages to the propeller and blades indicated either low or no engine power upon the crash. No damage or problems were found that could have prevented normal function prior to the accident. All damages was consistent with those that occur upon a crash.

Figure 19. Examination of propeller blades.

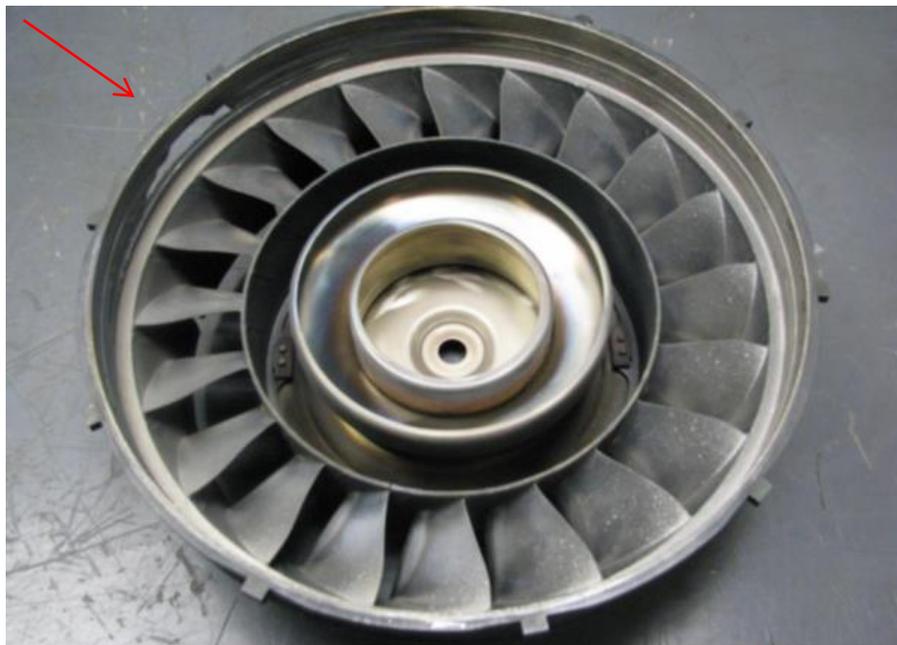
power turbine's case caused by contact with the first stage blade tip shrouds. Damage caused by rubbing to the turbine casing covered over half of the periphery. The deepest damage was in the 10 o'clock position, see picture in figure 20, where the casing had been perforated.

Figure 20. The casing for the first turbine stage, perforated at 10 o'clock.

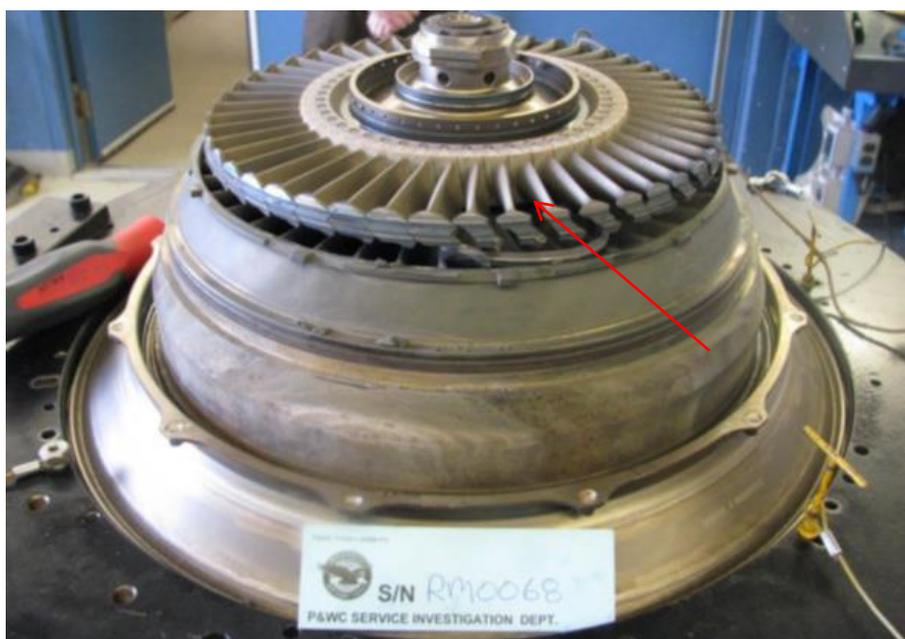
The blade tip shrouds in the first stage of the power turbine had rubbing wear around the entire periphery, with the largest wear diametrical to the smallest wear. A piece of metal was found tightly wedged between the first turbine stage and the second stator stage.

Figure 21. Damage to the blade tip shrouds in the first turbine stage.

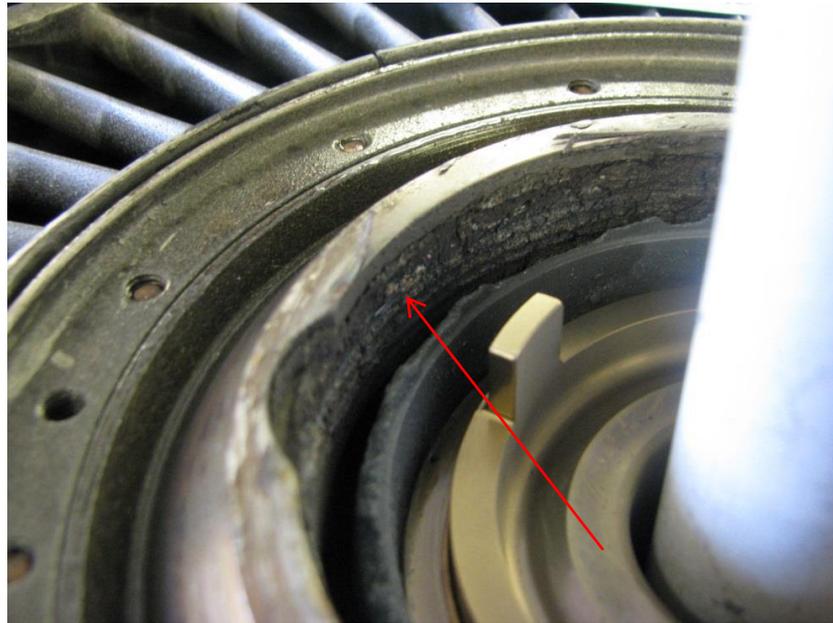
Upon continued dismantling, it became clear that the piece of metal was part of the rotor section of the power turbine's labyrinth seal. It had fractured circumferentially. The broken rotor section of the labyrinth seal shown in Figure 24, compared with an undamaged example of a rotor section in Figure 25. There was also significant rubbing to the inner diameter of the stator labyrinth seal section.

Figure 22. Damage to the inner diameter of the stator labyrinth seal section.

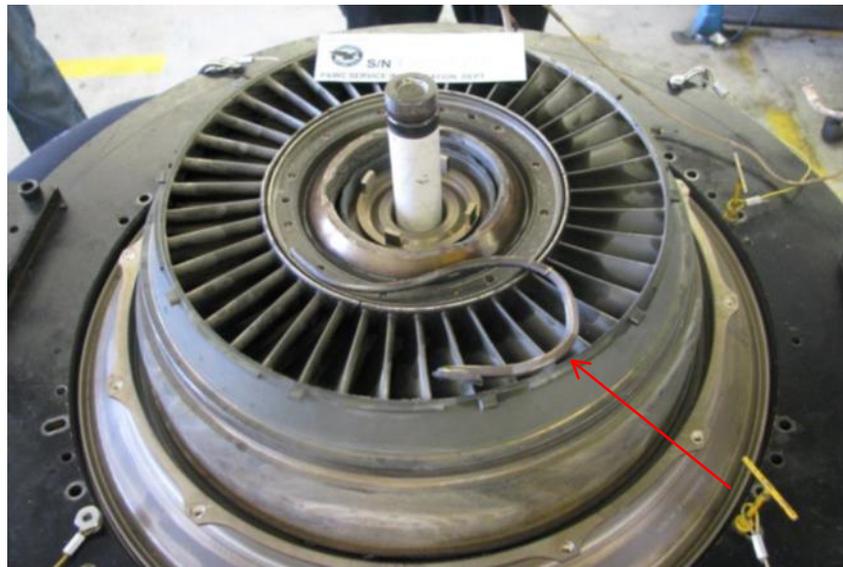
Figure 23. Broken section of labyrinth seal's rotor.

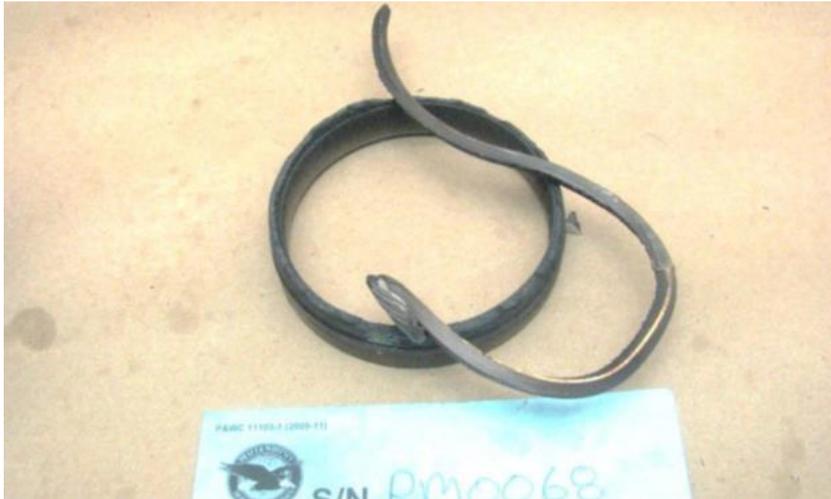
Figure 24. The broken rotor section of the labyrinth seal.

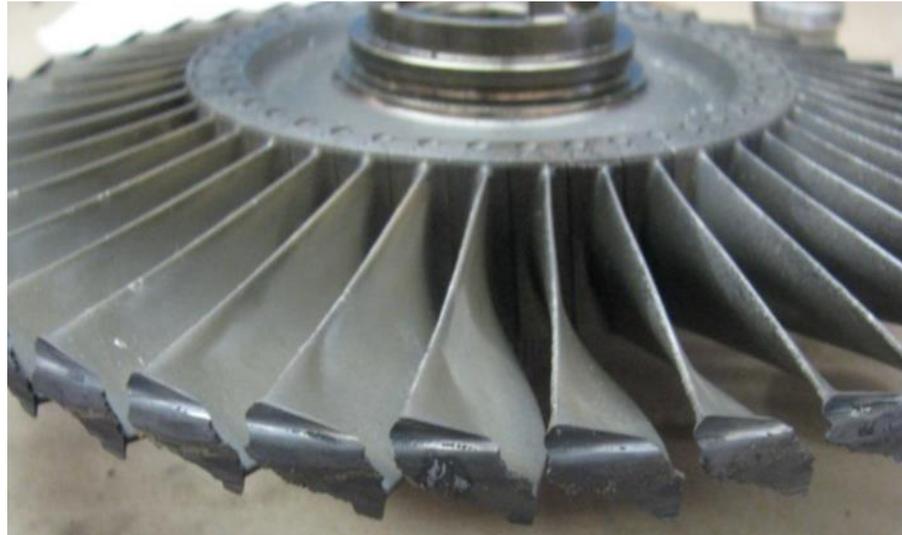
With the second stage power turbine stator removed, damages were also discovered that had been caused by rubbing between the second stage of the tip of the power turbine's blade against the turbine casing. The rubbing wear was most prominent on one section of the blade. The most worn blade tips placed at 180 degrees against the least worn blade tips.

Figure 26. Second turbine section with damaged blade edges.

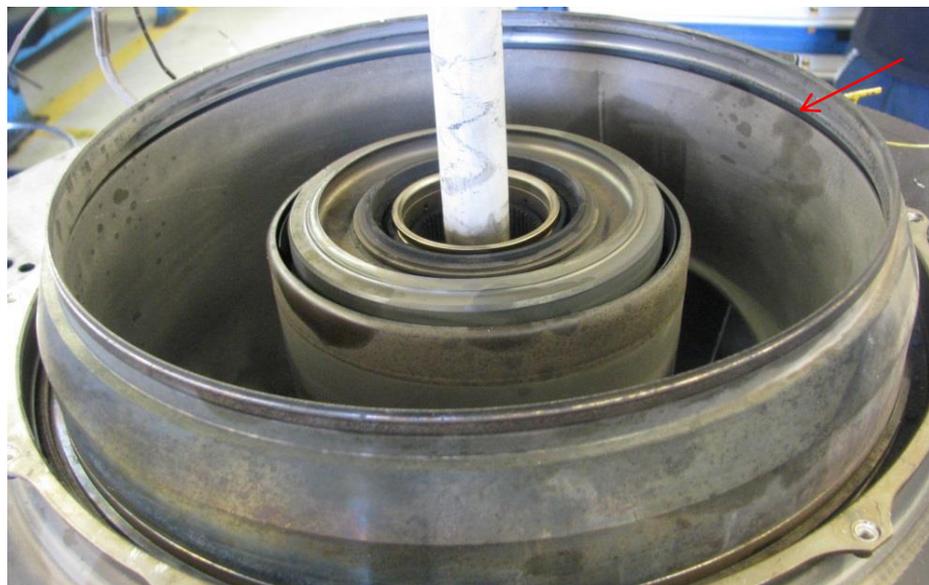
Figure 27. Rubbing damage in the turbine casing.

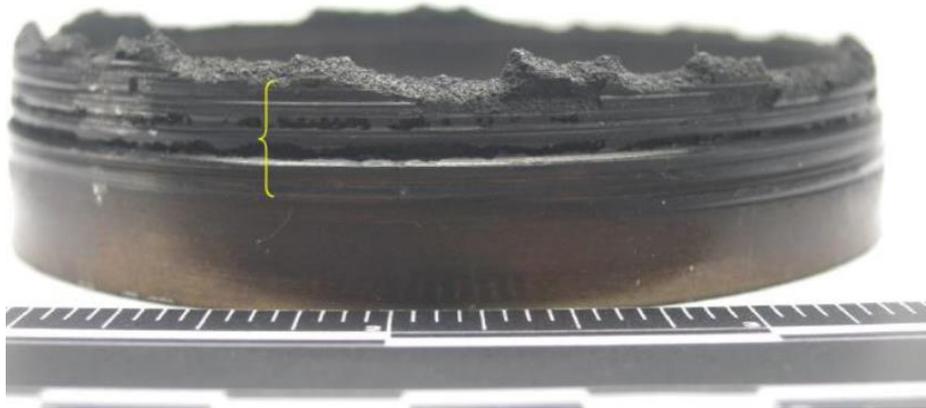
A laboratory investigation of the broken rotor section of the labyrinth seal showed evidence of cracks on the inner diameter of the rotor. No cracks were found on the outer diameter surface. This indicates that the cracking progressed outwards from the inner surface section of the rotor to the outer surface section.

An examination using a microscope showed an intergranular surface fracture. Hardness testing of the seal's material showed a low hardness value close to the area of the fracture and normal values outside of it. This indicates that the area of the fracture had been subjected to an increased temperature, which was most likely caused by significant rubbing.

Figure 28. Rotor labyrinth seal.

Metallographic examination of a cross-section of the fracture's surface of the air seal confirmed an oxidised intergranular fracture surface, with oxidised secondary cracks.

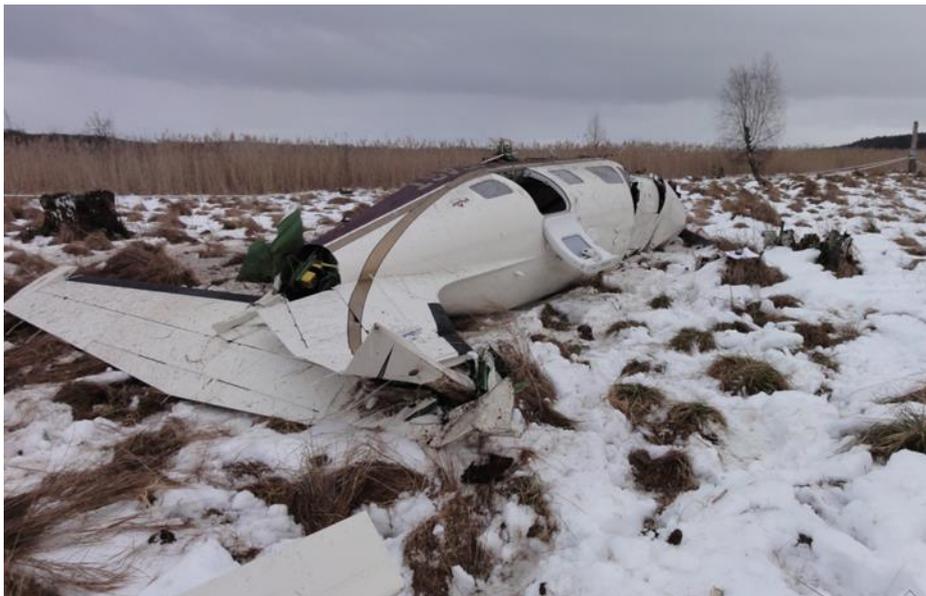
Figure 29. Final position of the fuselage in the field.

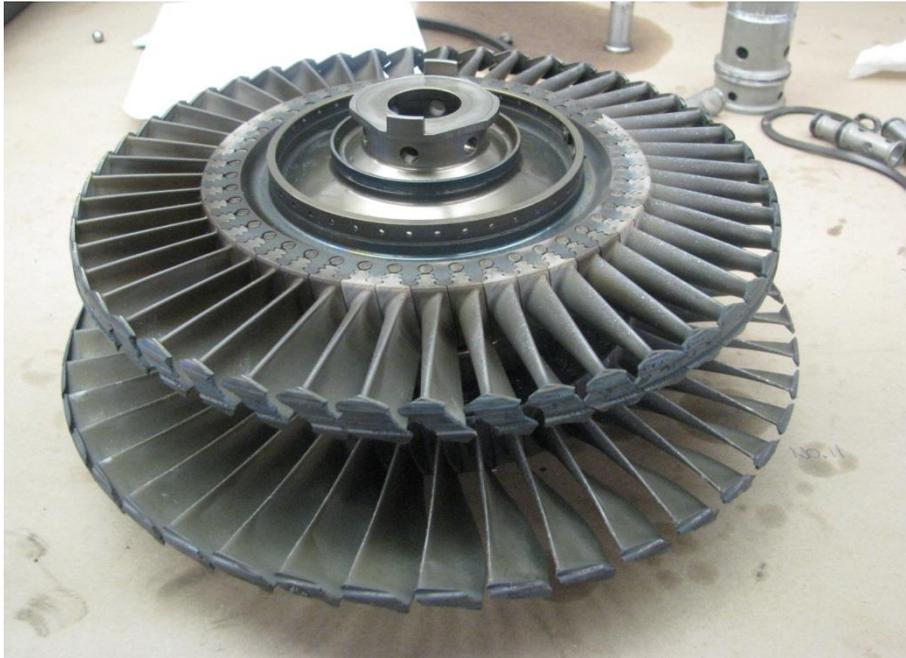
Figure 30. Damages to the turbine blades.

The final stage, in which the rotor section of the labyrinth seal was fractured and the turbine blade perforated the turbine casing, most likely occurred suddenly just after lift off.

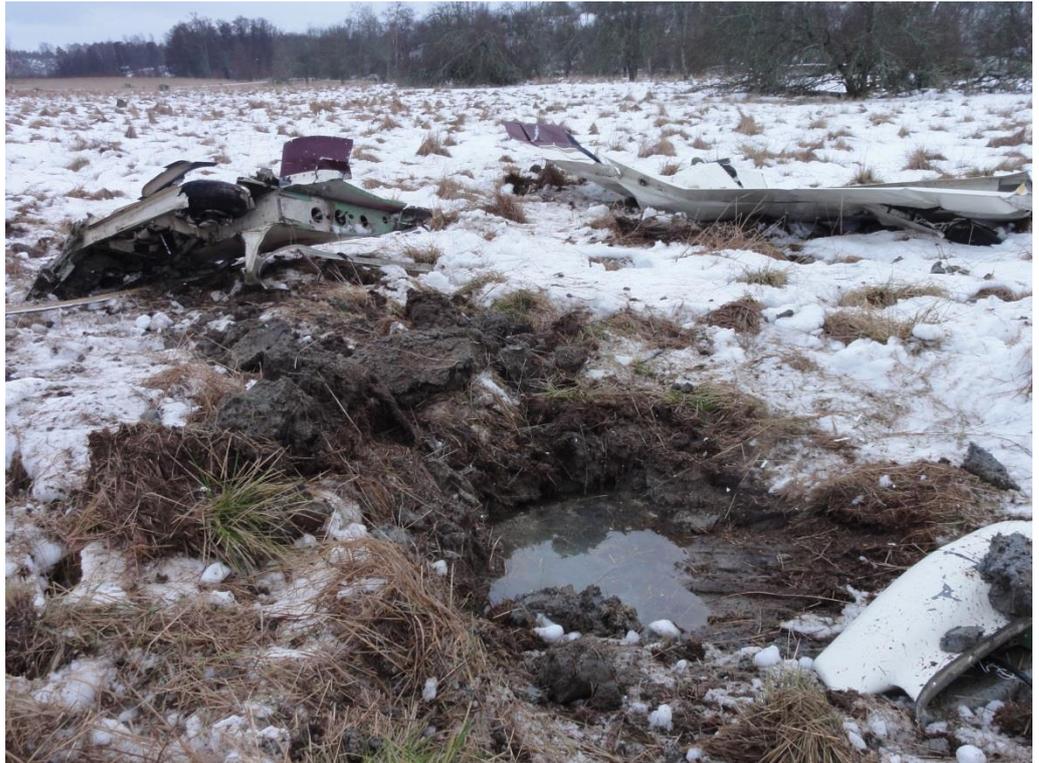
Figure 31. Picture from the scene of the accident showing leaked fuel.

A consequence of the way the work on the site was distributed was that the efforts to distribute sorption agents by the rescue services were delayed. This is unfortunate, considering the risk of the negative effects on the area's water source, for example. With hindsight and with all these available facts, it can however be established that there is nothing to indicate that the delay to the environmental rescue operation has led to any negative consequences.
