**AIC 14-1003**

**PAPUA NEW GUINEA  
ACCIDENT INVESTIGATION COMMISSION  
SHORT SUMMARY REPORT**

**P2-RNB**

**Go-around— collision with terrain**

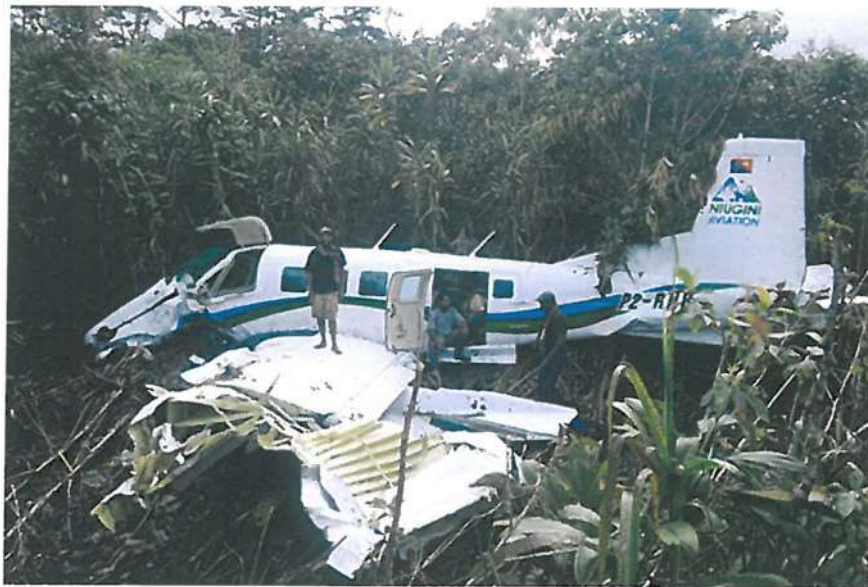
The aircraft was substantially damaged during the impact with vegetation and terrain. (See Fig. 3).

**Figure 3: View of damaged aircraft from the left wing**
