FINAL REPORT
A - 109/CENIPA/2014

OCCURRENCE:	ACCIDENT
AIRCRAFT:	PP-PIM
MODEL:	525
DATE:	13JUN2014

This is the Final Report of the 13JUN2014 accident with the 525 aircraft, registration PP-PIM. The accident was classified as “[SCF-NP] System/Component Failure or Malfunction”.

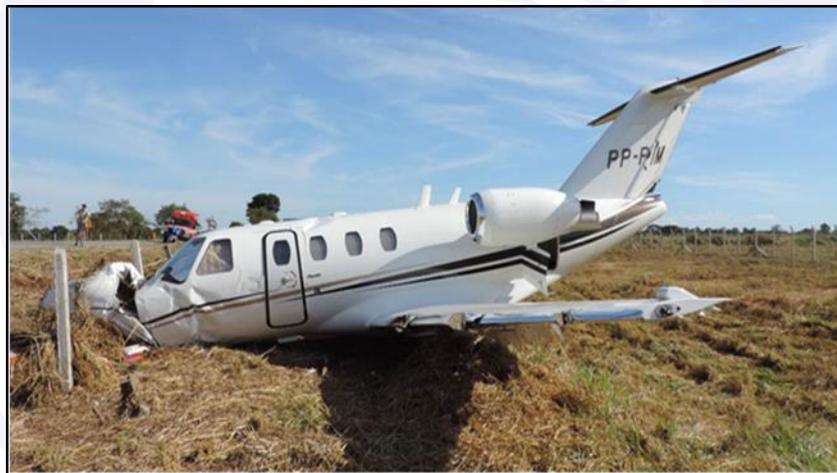
During the run after landing, the pilots failed to brake the aircraft, which overpassed the final boundary of the runway, crashed into the aerodrome fence and into a ravine, stopping near a highway.

Figure 1 - Left side view of the aircraft after full stop.

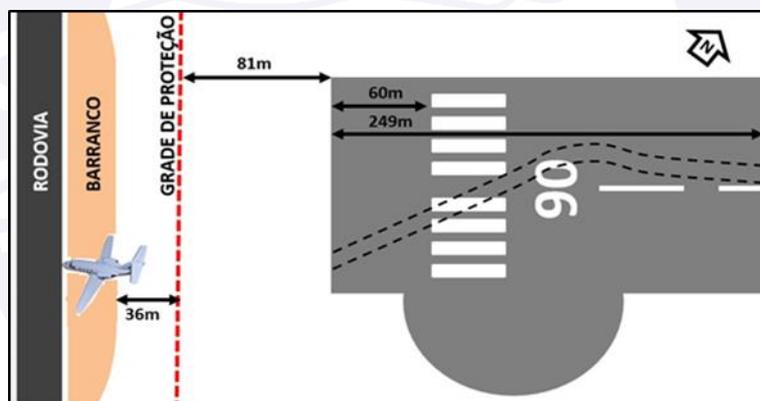
No braking marks were found on the runway. There were only subtle marks of the tire passing over the last 249m, as depicted in the diagram in Figure 2 below:

Figure 2 - Trajectory diagram of the aircraft. The black dashes represent subtle markings left by the aircraft tires on the runway in the last 249m.

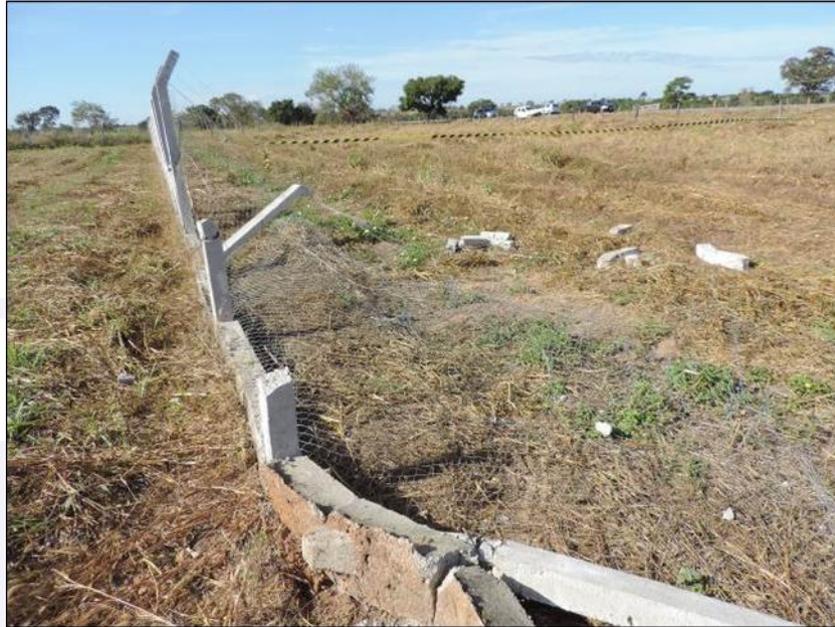
At the end of the runway, the aircraft traveled 81 meters, on unpaved ground and with ground vegetation until reaching the wire fence, supported by pillars and concrete foundation (Figures 3 and 4). Then, it advanced another 36m until its full stop, after colliding against a ravine near the highway.

Figure 3 - Wire fence with pillars and concrete foundation overturned by the aircraft.

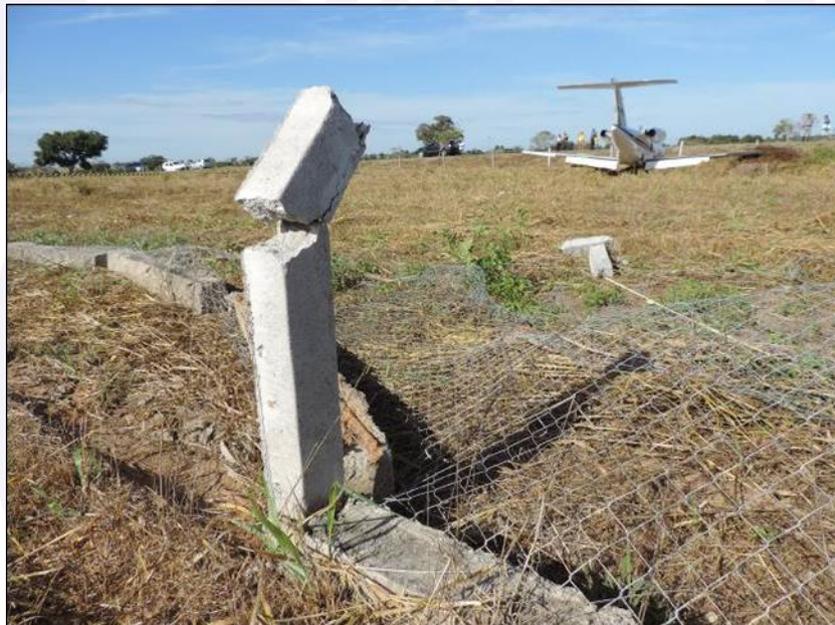
Figure 4 - Wire fence and aircraft in the final position.

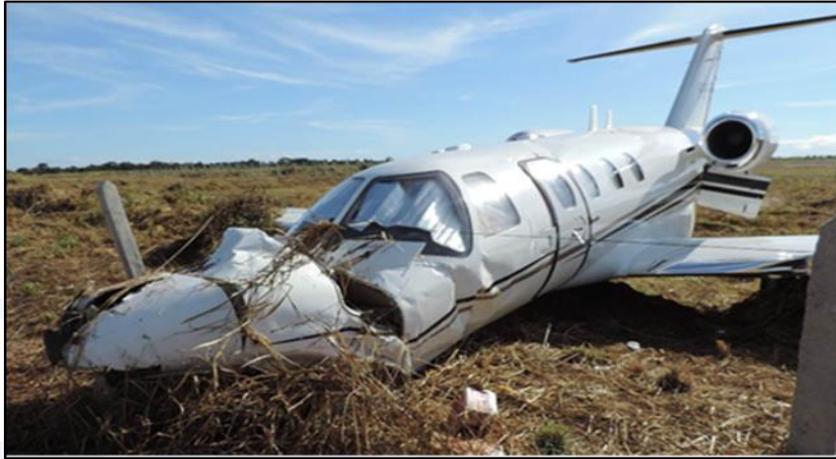
The wreckage of the aircraft got concentrated. The front section absorbed the largest amount of energy from the final impact, resulting in the most significant damage (Figure 5).

The impact also resulted in a breakdown of the nose landing gear and some fuselage deformations that prevented the opening of the aircraft door for evacuation.

Figure 5 - Damage to the front section of the aircraft.

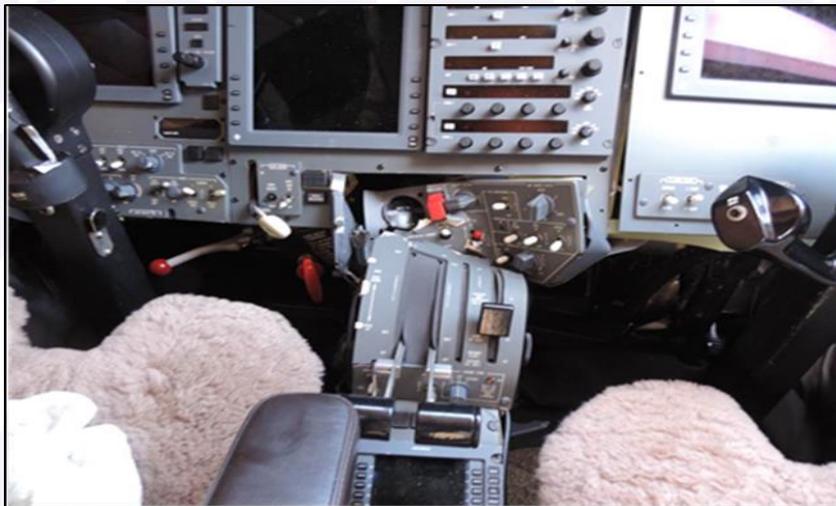
In an attempt to shut down the right engine, the Aruanã City Fire Brigade team moved some switches in the cockpit.

Figure 6 - Deformations in the aircraft panel and in the levers console. The right engine lever is already repositioned after the action of the fire brigade.

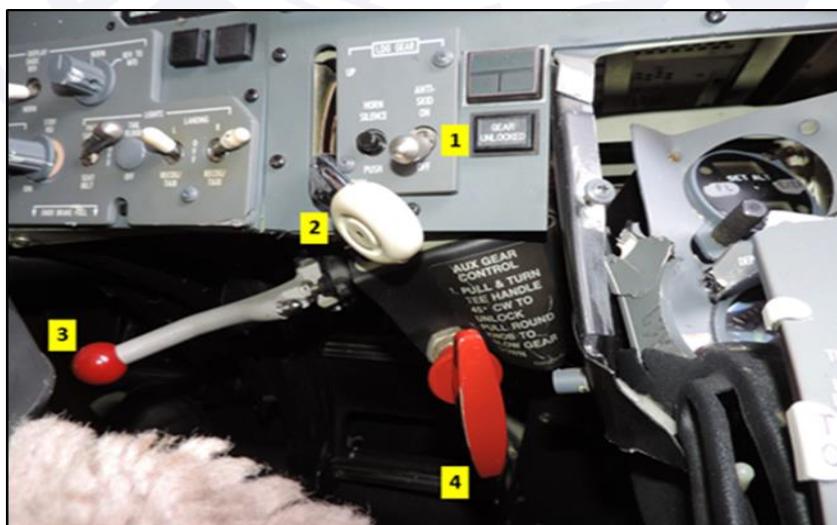
The anti-skid switch was found in the OFF position (item 1 - Figure 7). The landing gear lever was in the down position and deformed with the impacts (item 2 - Figure 7). The support panel of the emergency brake lever (item 3 - Figure 7) and the auxiliary gear control (item 4 - Figure 7) deformed with the impact.

Figure 7 - (1) anti-skid switch in the OFF position; (2) landing gear control lever in the down position; (3) emergency brake lever; and (4) emergency landing gear lowering lever (auxiliary gear control).

In the same way, the anti-skid switch found in the "OFF" position would not be consistent with the situation before and during the landing. The crew said they had checked the procedures before landing, a fact that was recorded in the CVR.

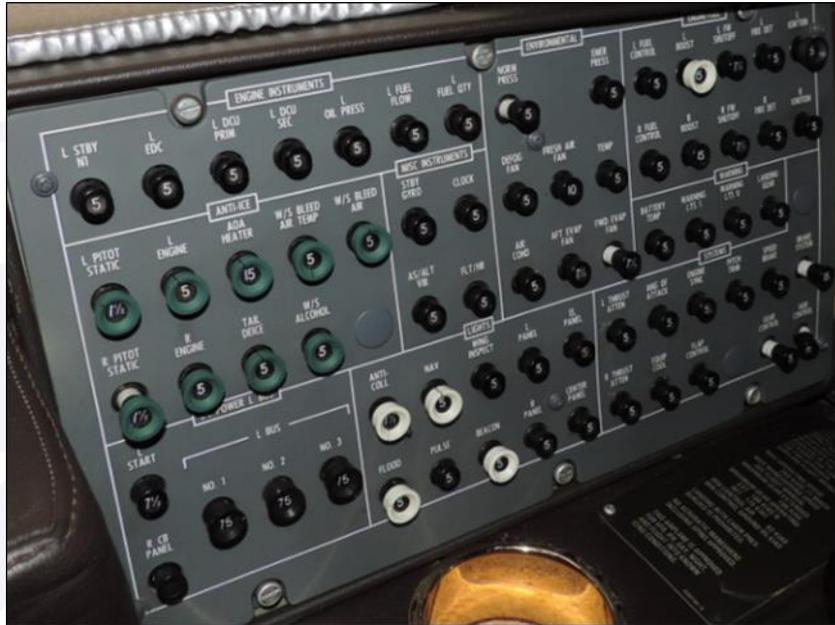
On the left circuit breaker panel, the NORM PRESS and FWD EVAP FAN (ENVIRONMENTAL) circuit breakers; R PITOT STATIC (ANTI-ICE); and BRAKE SYSTEM, GEAR CONTROL and SKID CONTROL (SYSTEMS) were found disarmed after the aircraft has stopped (Figures 8 and 9).

Figure 8 - Left circuit breaker panel.

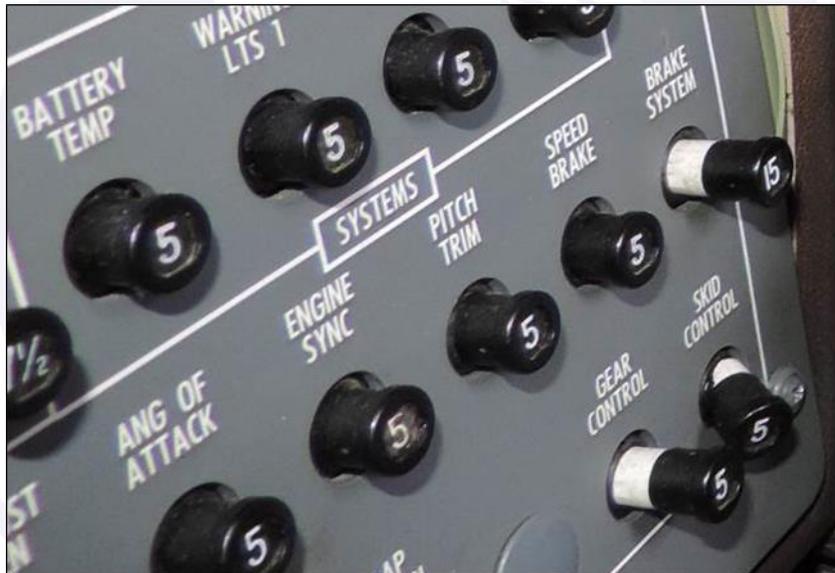
Figure 9 - Disarmed circuit breakers - BRAKE SYSTEM, GEAR CONTROL and SKID CONTROL (SYSTEMS).

Regarding the circuit breakers found to be unarmed, the pilot mentioned that he had pulled some of these, without however remembering how many and which ones they were. In any case, if these circuit breakers were disarmed before landing, the aircraft would have indicated that the system was inoperative by turning on the light on the alarm panel, a fact that was not reported.

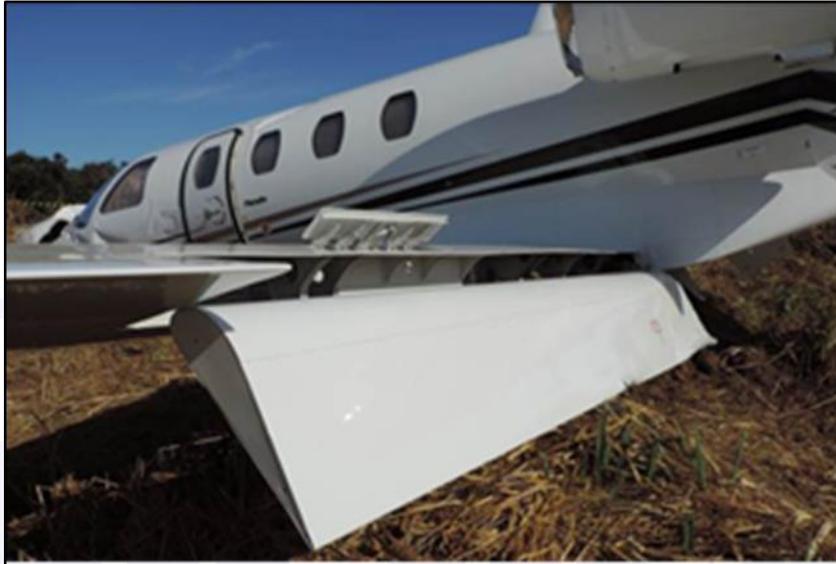
On the right circuit breaker panel, the DME 1, MKR BCN, RFGC, LFGC, AHRS 2, RADAR, ADC 2, PFD2 HTR circuit breakers were found disarmed after the aircraft stopped. The flaps were in the position 60° and the speed brakes panels were open.

Figure 10 - Flaps configuration in 60° and open speed brake - left wing.

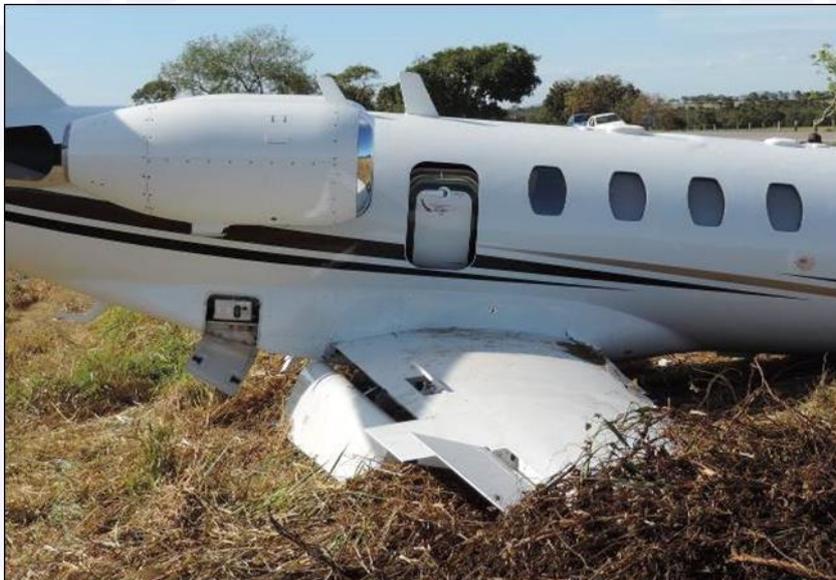
Figure 11 - Flaps configuration in 60° and open speed brake - right wing.

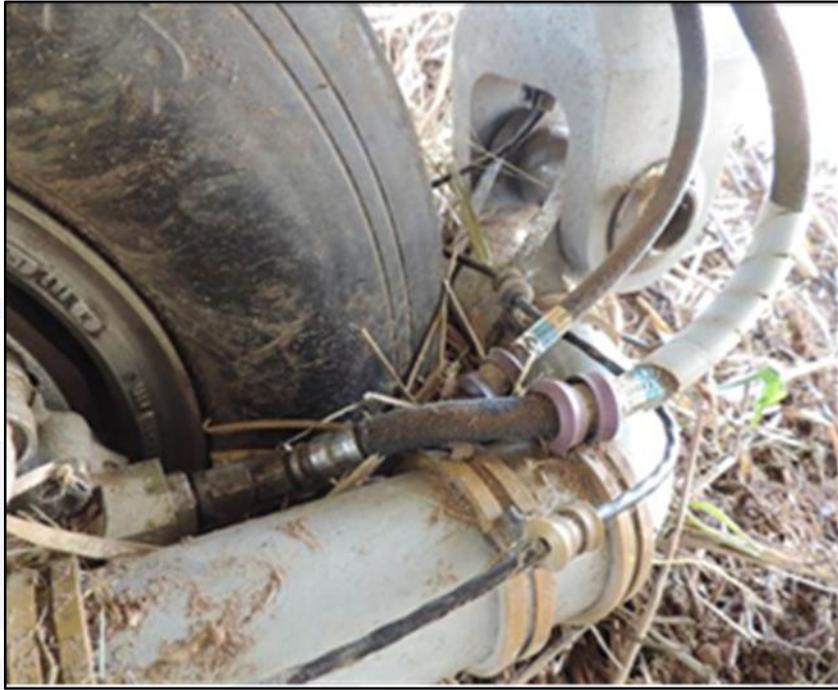
The hydraulic and pneumatic power lines of the normal and emergency brake systems and their connections to the right and left brake sets did not show signs of leakage (brake shuttle valve and nitrogen vent line - Figure 12). There was fluid leakage from the brakes only inside the hydraulic components compartment, located in the front section of the aircraft, that is, at the direct impact site against the ravine. The impact caused the rupture of the hydraulic reservoir.

Figure 12 - Hydraulic power line and nitrogen vent line of the brake system.

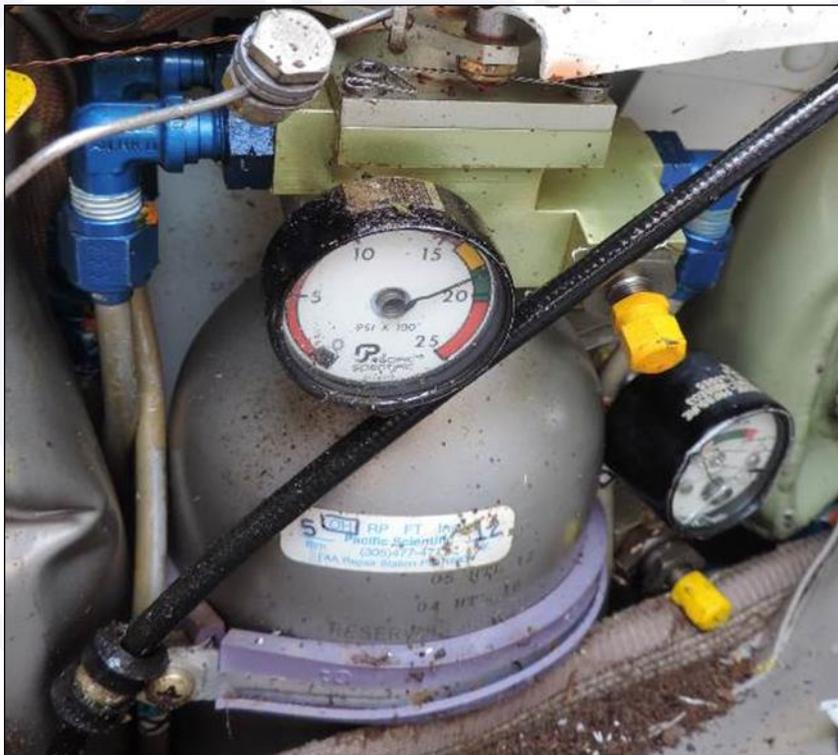
The nitrogen accumulator of the emergency brake system (Figure 13) was under pressure in the normal range and its pneumatic power lines from the reservoir to the right and left brake sets remained undamaged.

Figure 13 - Nitrogen accumulator of the emergency brake system (green band from 1,800 to 2,050psi)

During the execution of the test, it was verified that the nitrogen accumulator of the emergency brake system (shown in Figure 13) was in the operating green band, indicating between 1,800 and 2,050psi. The pneumatic lines from the accumulator to the right and left shuttle valve remained intact after impact. In the successive applications of the emergency brake handle, it was found that the nitrogen was being discharged with pressure in the connection of the right and left shuttle valve.

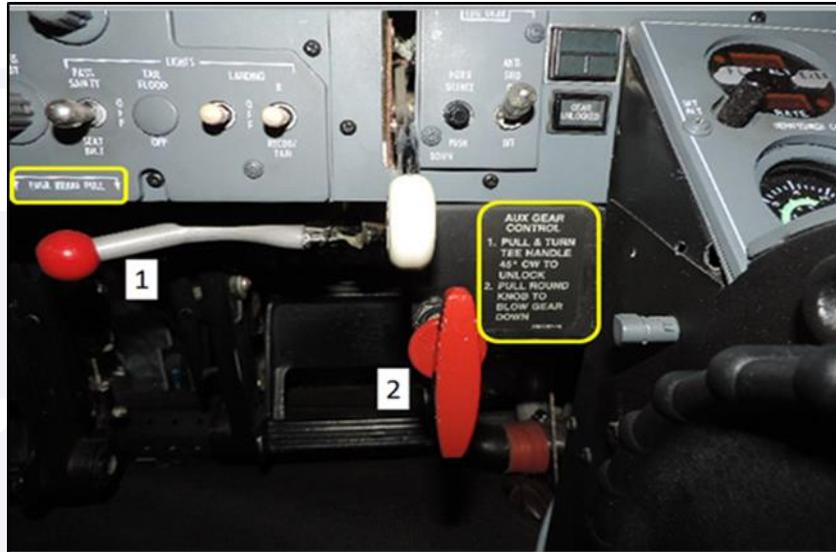
In Figure 14, it is possible to check the emergency brake and emergency landing gear handles, as well as their descriptions in English. It should be noted that the description of the emergency brake is concealed for the pilot positioned on the left seat, since the stick column obstructs the view.

Figure 14 - Panel of the 525. (1) - emergency brake actuator handle, with the description EMERG BREAK PULL, highlighted in the yellow photo; (2) - auxiliary gear control, with the description AUX GEAR CONTROL.

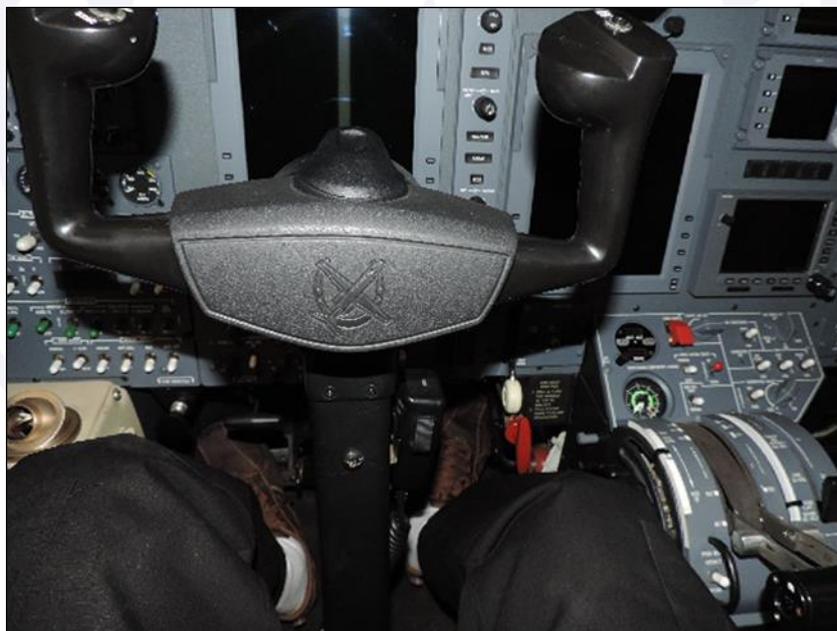
The pilot, positioned on the left seat of the Cessna 525, has the view of the emergency brake system handle obstructed by the stick column (Figure 15).

Figure 15 – View of the panel for the pilot positioned on the left seat of the Cessna 525. The stick column obstructs the view of the emergency brake handle.

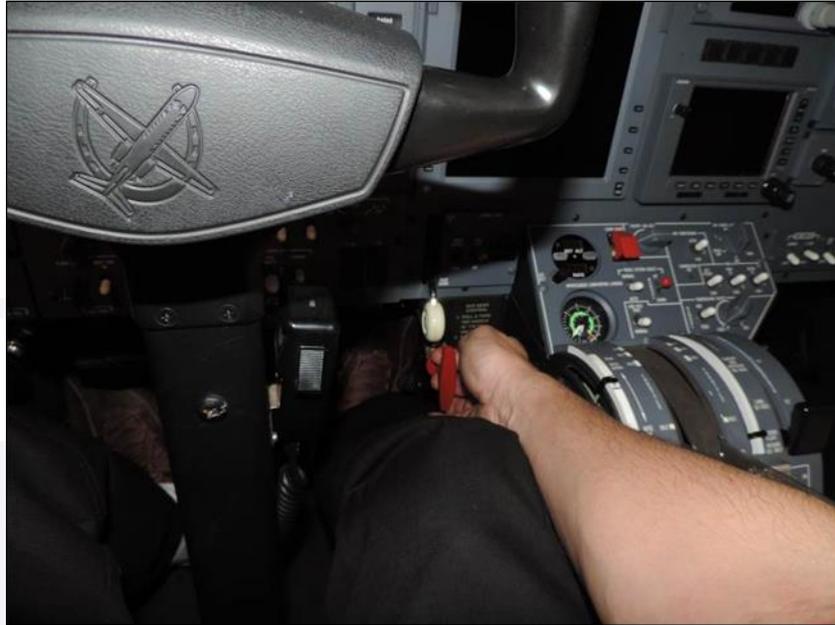
The auxiliary gear control lever is easily visible, in front of the pilot's right leg (Figure 16).

Figure 16 - Visualization of the emergency landing gear lever by the pilot positioned on the left seat.

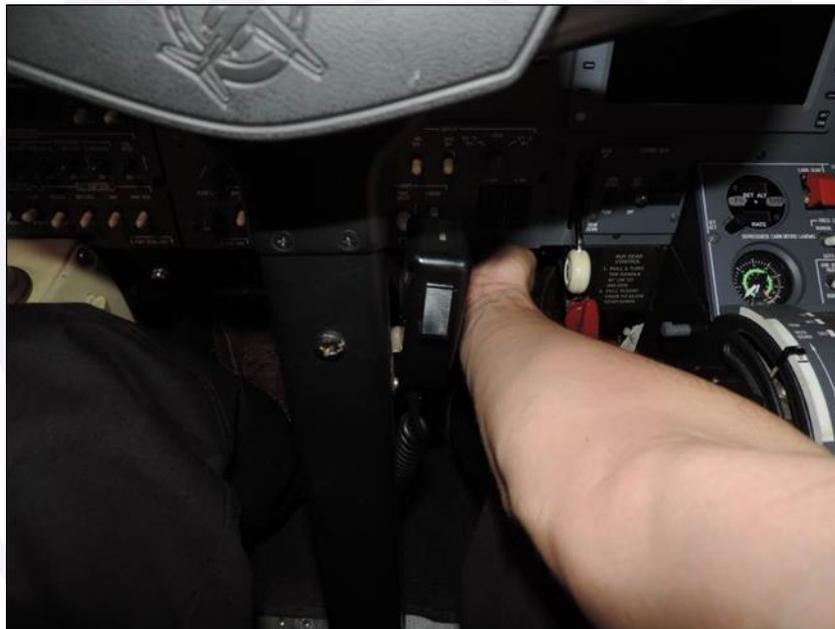
When the emergency brake is activated, the pilot cannot see the handle, since it is out of sight (Figure 17).

Figure 17 - Simulation of the emergency brake lever drive.

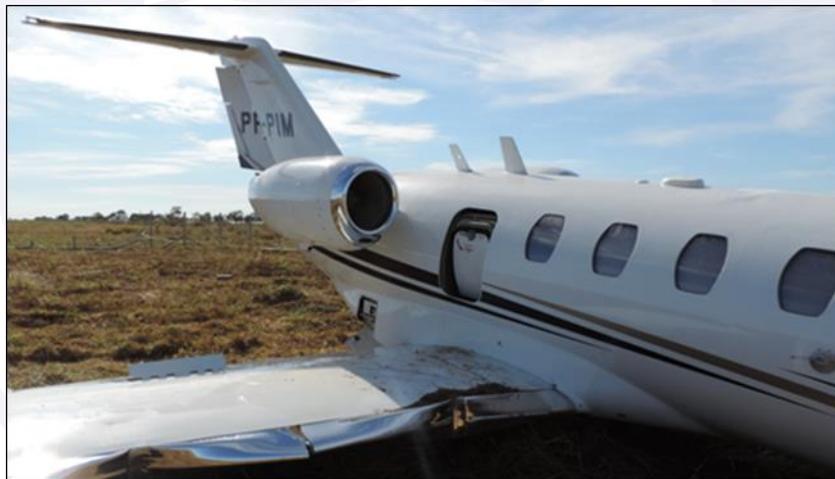
The right engine stayed on, even after the evacuation of all occupants.

Figure 18 - View of the emergency exit and air intake of the right engine.

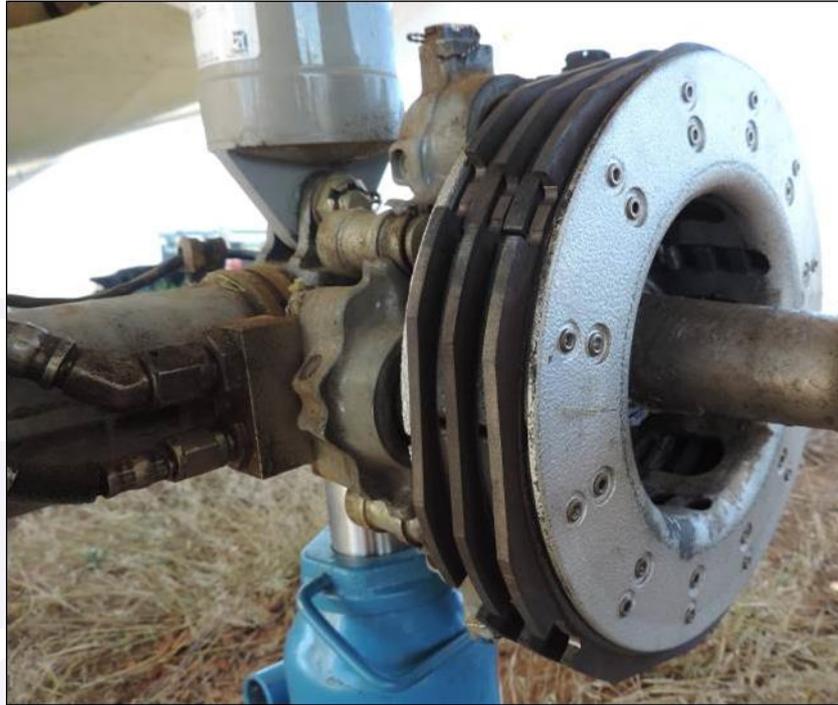
The hydraulic and pneumatic power lines of the right and left brakes, normal and emergency ones were in good condition and there were no signs of leaks.

Figure 19 - Left brake assembly and hydraulic and pneumatic power lines.

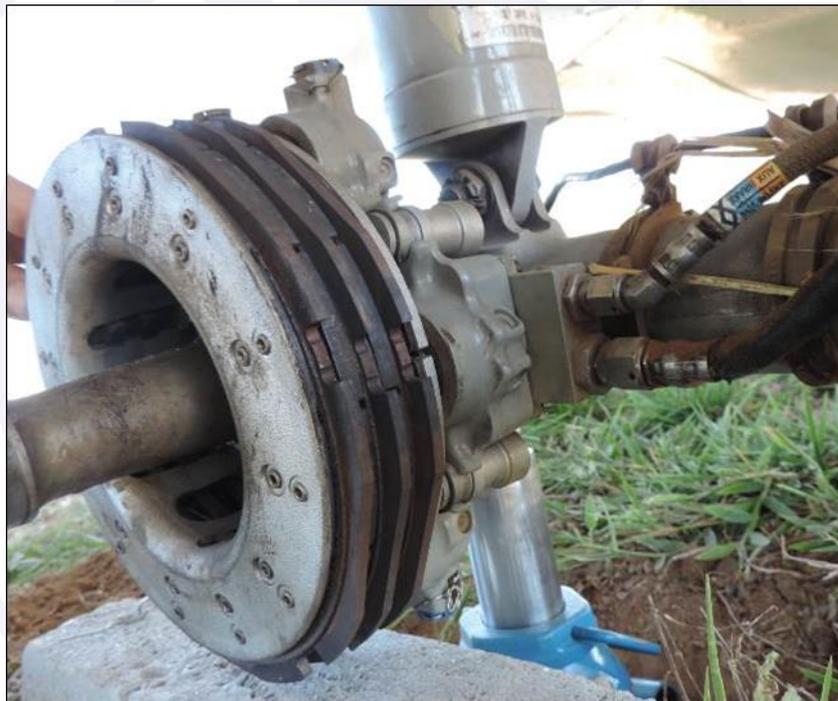
Figure 20 - Right brake assembly and hydraulic and pneumatic power lines.

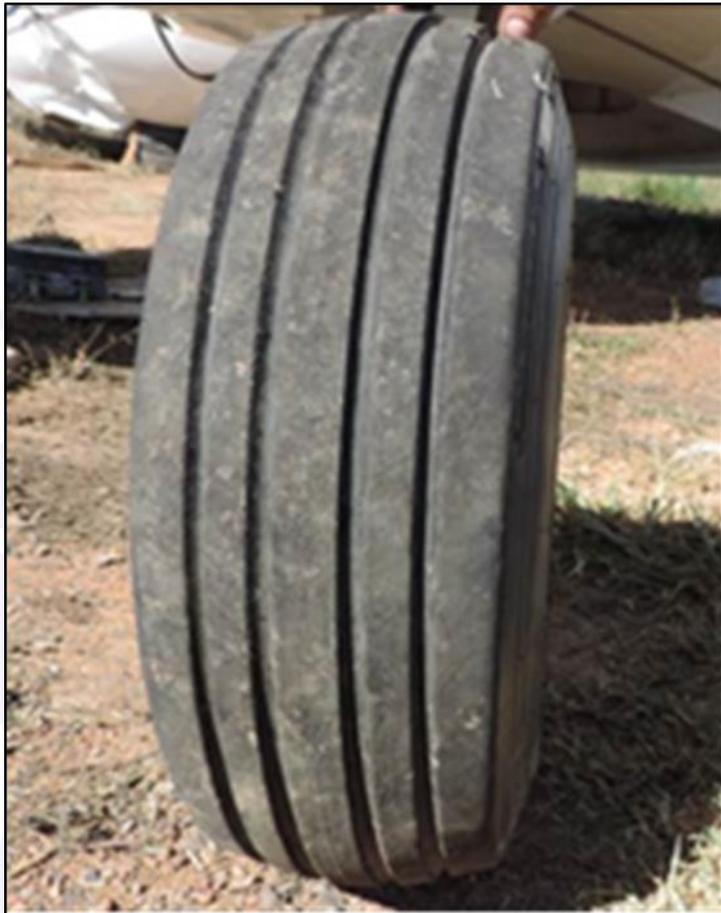
The tires installed were new and, at the last inspection, they were in good condition and showed no wear marks due to intense braking.

Figure 21 – Left tire.

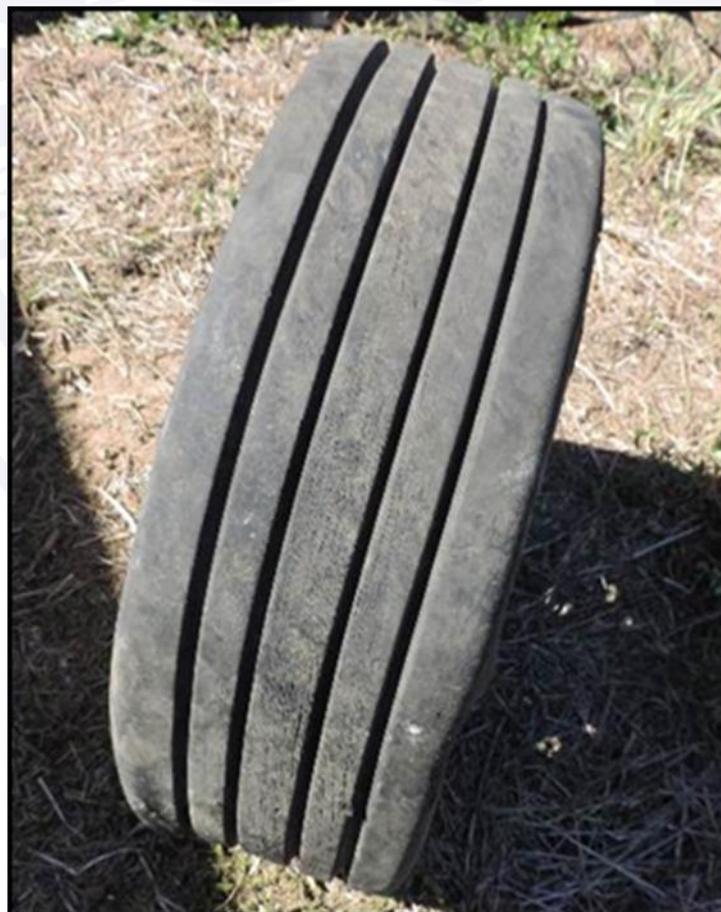
Figure 22 – Right tire.

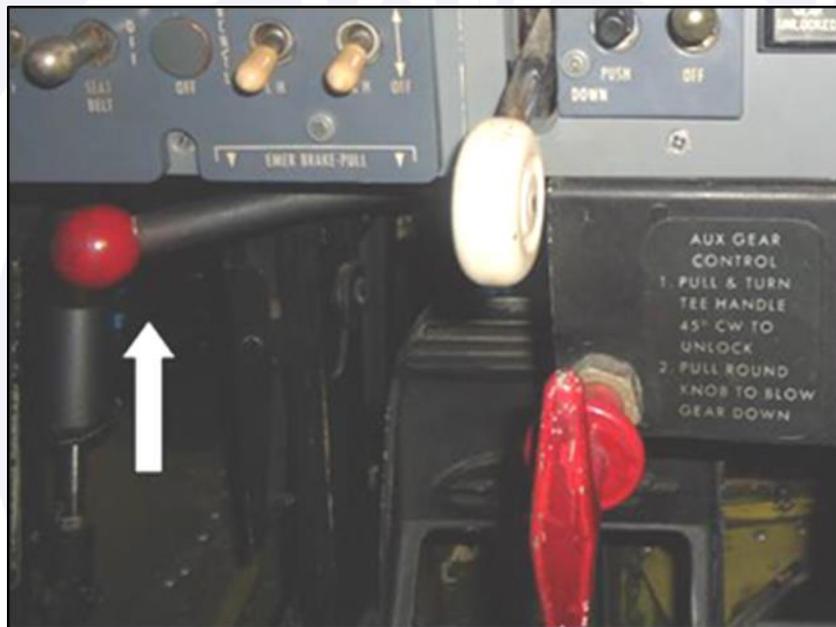
For C-500 aircraft, Cessna Aircraft issued the Service Bulletin No. 32-11 of a non-mandatory nature, repositioning the emergency brake drive handle, so as to be less concealed by the panel. However, for the pilot positioned on the left seat, the view of the handle remained obstructed by the stick column.

Figure 26 - Citation I aircraft panel with bulletin application.

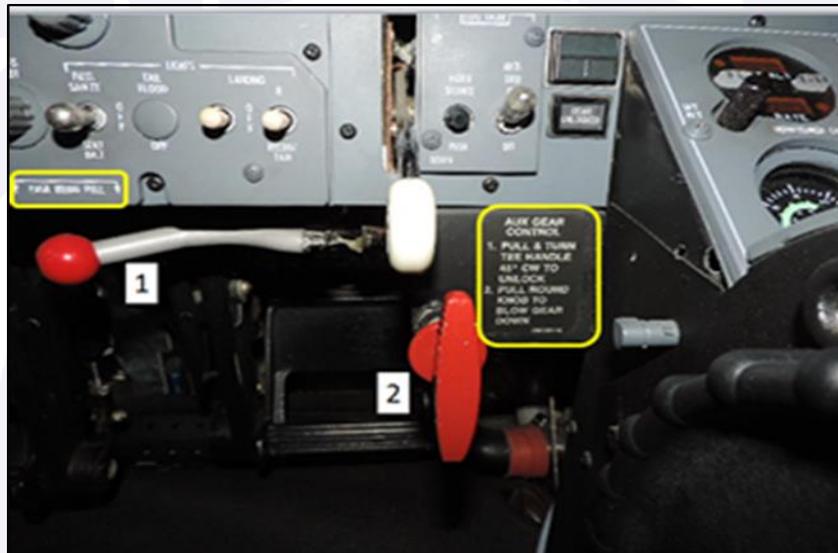
In terms of ergonomics, for the pilot occupying the left seat, the display of the emergency brake system lever and the sign indicating its position (Figure 27) are obstructed by the stick column (Figure 28), both of which remain outside the pilot's sight field.

Figure 27 - Panel of the 525. (1) - emergency brake actuator handle, with the description EMERG BREAK PULL, highlighted in yellow in the photo; (2) - auxiliary gear control, with the description AUX GEAR CONTROL.

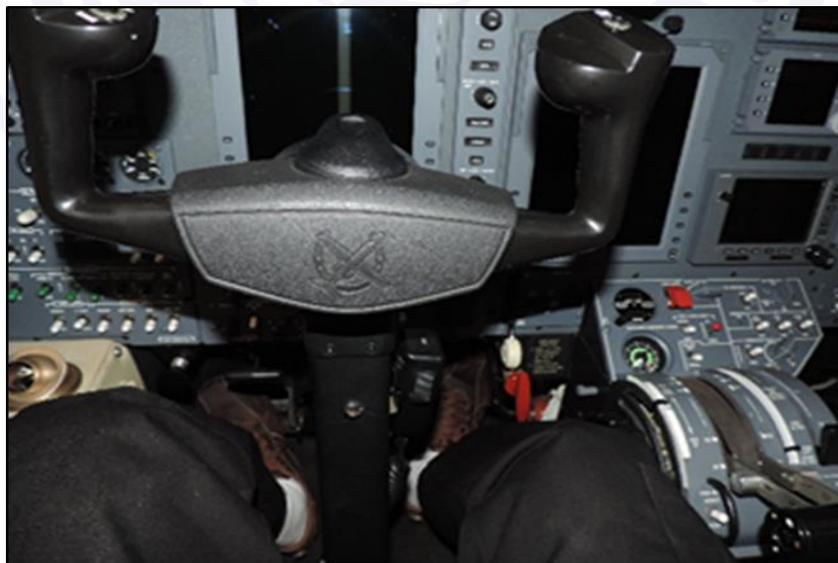
Figure 15 – View of the panel for the pilot positioned on the left seat of the Cessna 525. The stick column obstructs the view of the emergency brake actuator handle.
