**FINAL REPORT**  
**A - 101/CENIPA/2014**

<b>OCCURRENCE:</b>	<b>ACCIDENT</b>
<b>AIRCRAFT:</b>	<b>PR-TKB</b>
<b>MODEL:</b>	<b>ATR-42-500</b>
<b>DATE:</b>	<b>30MAY2014</b>

This is the Final Report of the 30MAY2014 accident with the ATR-42-500 aircraft, registration PR-TKB. The accident was classified as “[WILD] Wildlife Strike”.

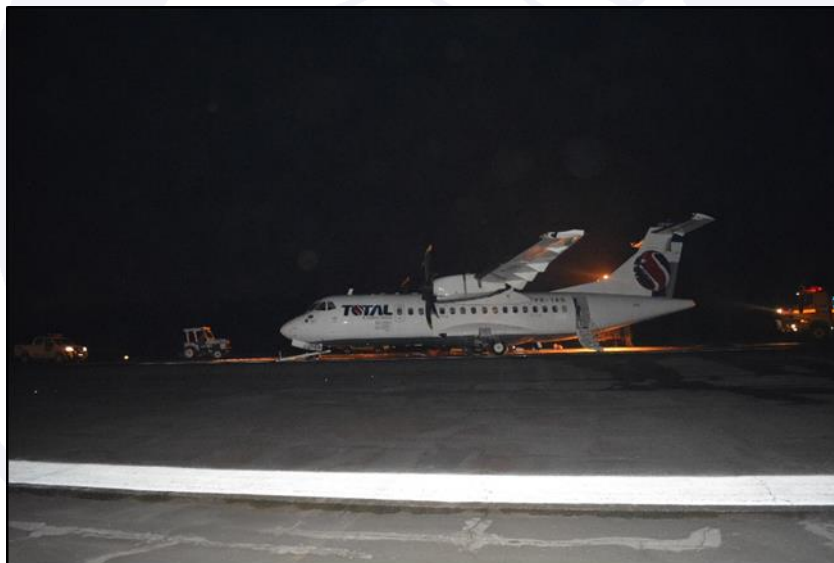
During the landing, after the touchdown of the broken landing gear on the ground, the aircraft turned to the right. The crew managed to keep the aircraft within the lateral limits of the runway.

Figure 1 - Aircraft after stop at the SBEG runway.

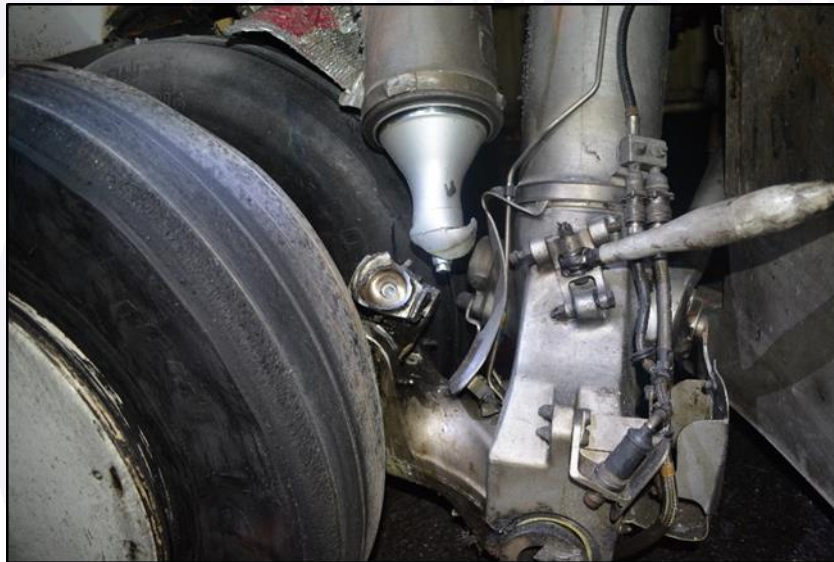
The aircraft main right landing gear collided with a tapir (*Tapirus terrestris*) during the rotation of the aircraft. After the collision, the aircraft lost the normal braking system and its directional control system was used on landing to stay on the runway.

Figure 2 - Damage to the right landing gear.

The shock absorber, hydraulic lines, aerodynamic fairings and doors of the right main landing gear have been damaged.

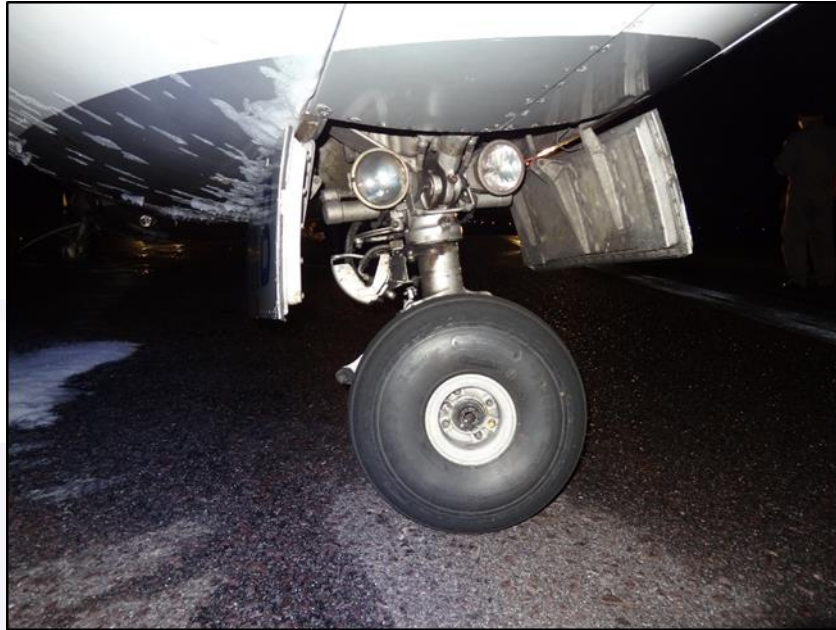
The nose landing gear and its shock absorber strained above the specified maximums, making them unavailable for return to service.

Figure 3 - Damage to the nose landing gear.

The dynamics of SBEG landing resulted in efforts beyond the maximum limits set on the nose landing gear, which made it impossible for the component and its shock absorber to return to service.
