Engine failure involving a Piper PA-46, VH-TSV

46 km SW Narrabri airport, New South Wales, 12 June 2014

ATSB Transport Safety Report
Aviation Occurrence Investigation
AO-2014-106
Final – 3 September 2014

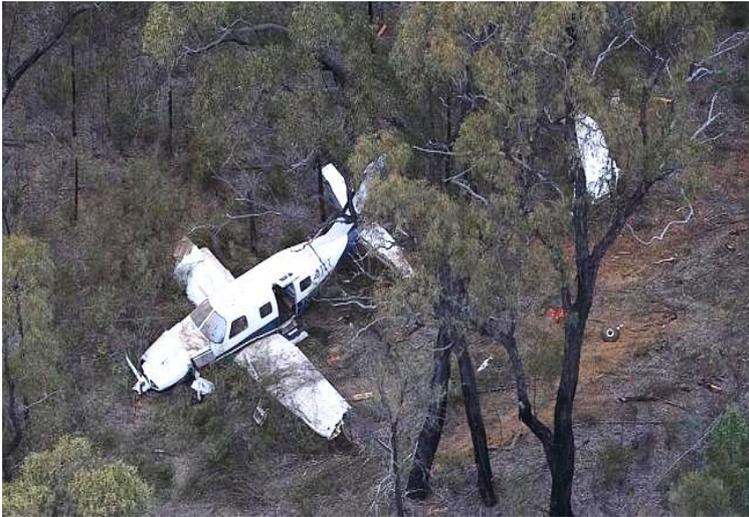
As the aircraft entered the tree tops, he flared to stall³ the aircraft. On impact, the pilot was seriously injured and lost consciousness. The passenger reported the wings impacted with trees and the aircraft slid about 10 m before coming to rest. The passenger checked for any evidence of fuel leak or fire and administered basic first aid to the pilot.

The aircraft sustained substantial damage (Figure 1).

Figure 1: Damage to VH-TSV

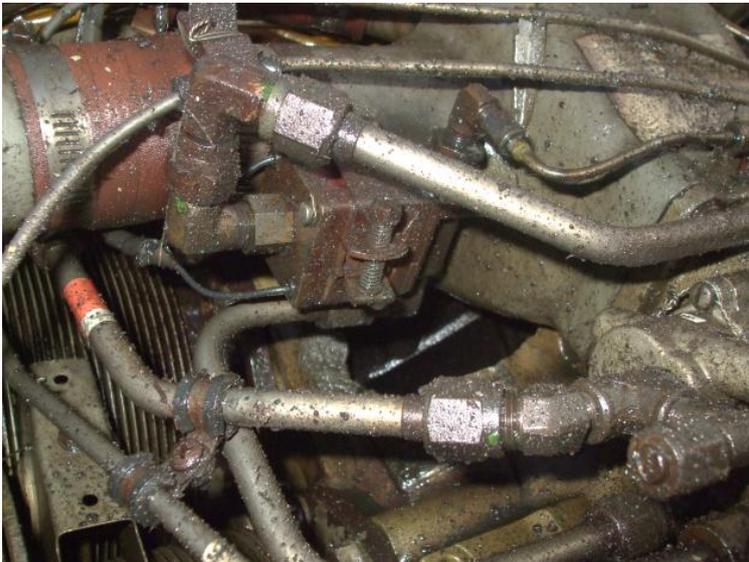
A preliminary post-accident inspection of the engine found a hole in the right side of the crankcase, indicating an internal mechanical failure (Figure 2).

Figure 2: Hole in upper crankcase
