This document is an English translation of the Preliminary Report on the fatal accident involving the An-12B aircraft registered 4K-AZ25 that occurred on May 18, 2016 at Camp Dwyer, Afghanistan.

**INTERSTATE AVIATION COMMITTEE
AIR ACCIDENT INVESTIGATION COMMISSION**

PRELIMINARY REPORT

Type of occurrence	Fatal accident
Type of aircraft	Airplane, An-12B
Registration	4K-AZ25 (Azerbaijan)
Owner	Silk Way Airlines
Operator	Silk Way Airlines
Place of occurrence	Camp Dwyer, Islamic Republic of Afghanistan
Date and time	18.05.2016, 14:07 local time (10:07 UTC), daytime

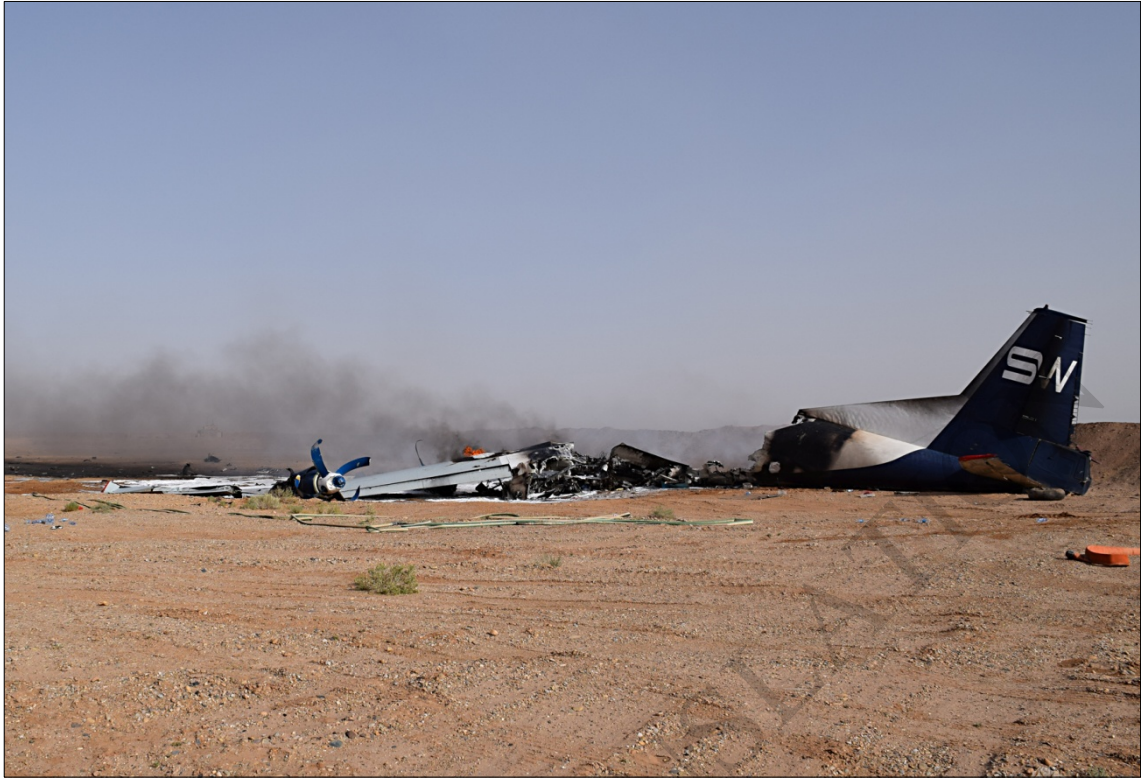
After the a/c overran the RWY it collided with a metal net fence with barbed wire at a distance of 320 m from the RWY end, veering off about 80 m to the right of the RWY extended centerline. At that moment the right wing was destroyed, which resulted in fuel spill and post-crash fire.

While the a/c was moving further beyond the RWY it was further destroyed: right main landing gear and right wing were separated, Engines # 3, #4 and #1 were ripped off their mounts.

The a/c came to rest at a distance of about 600 m from the RWY end and lateral deviation of 250 m to the right of the RWY extended centerline. Most of the a/c structure was destroyed by the post-crash fire.

Figure 1. A/c at the accident site destroyed by the post-crash fire
