This document is an English translation of the Final Report on the accident involving the Boeing 737-8KN aircraft registered A6-FDN that occurred on March 19, 2016 (00:42 UTC) at Rostov-on-Don aerodrome, the Rostov Region, Russian Federation.

**INTERSTATE AVIATION COMMITTEE
AIR ACCIDENT INVESTIGATION COMMISSION
FINAL REPORT**

Type of occurrence	Fatal accident
Type of aircraft	Boeing 737-8KN, airplane
Nationality and registration marks	A6-FDN
Owner	Celestial Aviation Trading 38 Limited, Shannon, County Clare, Ireland
Operator	Dubai Aviation Corporation, P.O. Box: 353, United Arab Emirates
Aviation authority of the place of occurrence	Southern FATA Interregional Territorial Department
Place of occurrence	Russian Federation, the Rostov region, the Rostov-on-Don aerodrome, reference position: 47°15'54.7" N, 039°49'43.8" E
Date and time	19.03.2016, 03:42 local time (00:42 UTC), nighttime

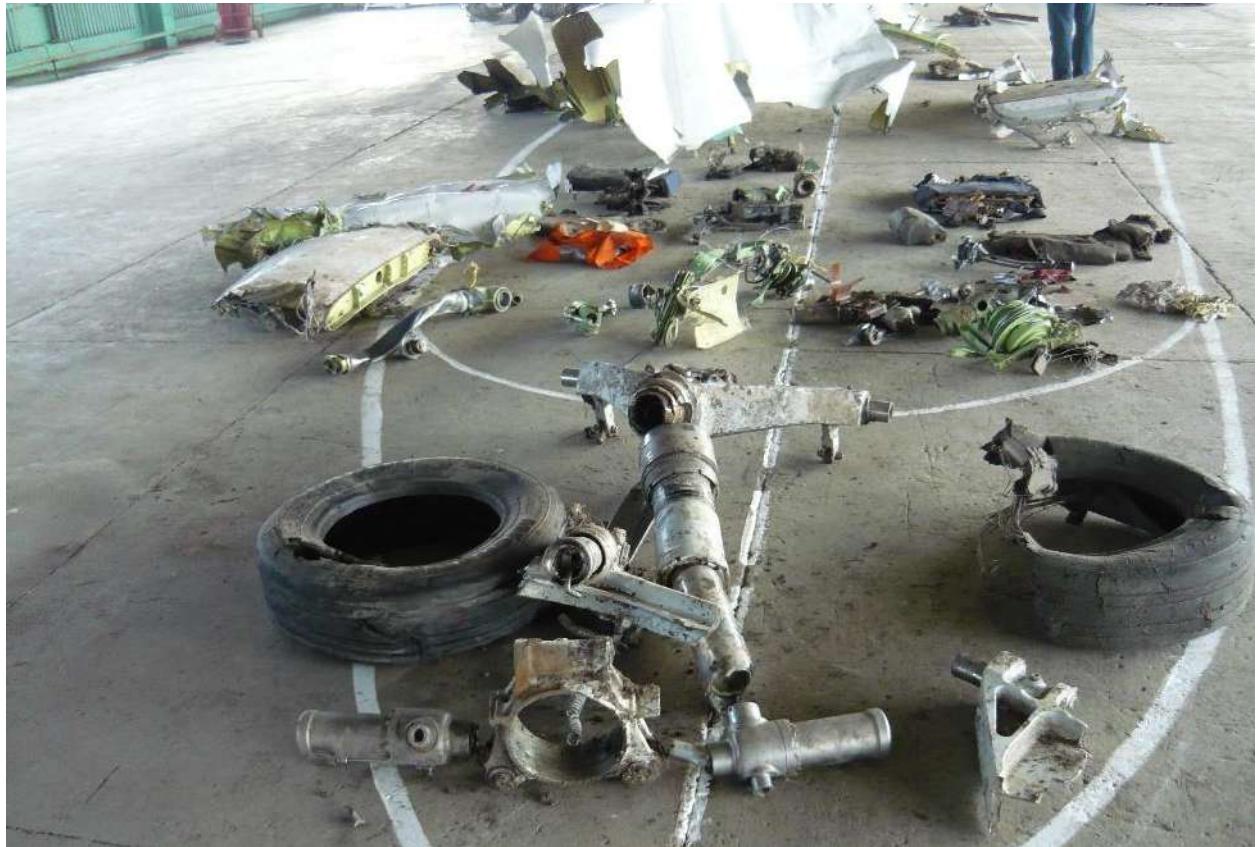
The aircraft flight controls and the equipment, located inside the cockpit are almost completely destroyed (Fig. 1).

Fig. 1. The elements of the cockpit and the nose landing gear leg

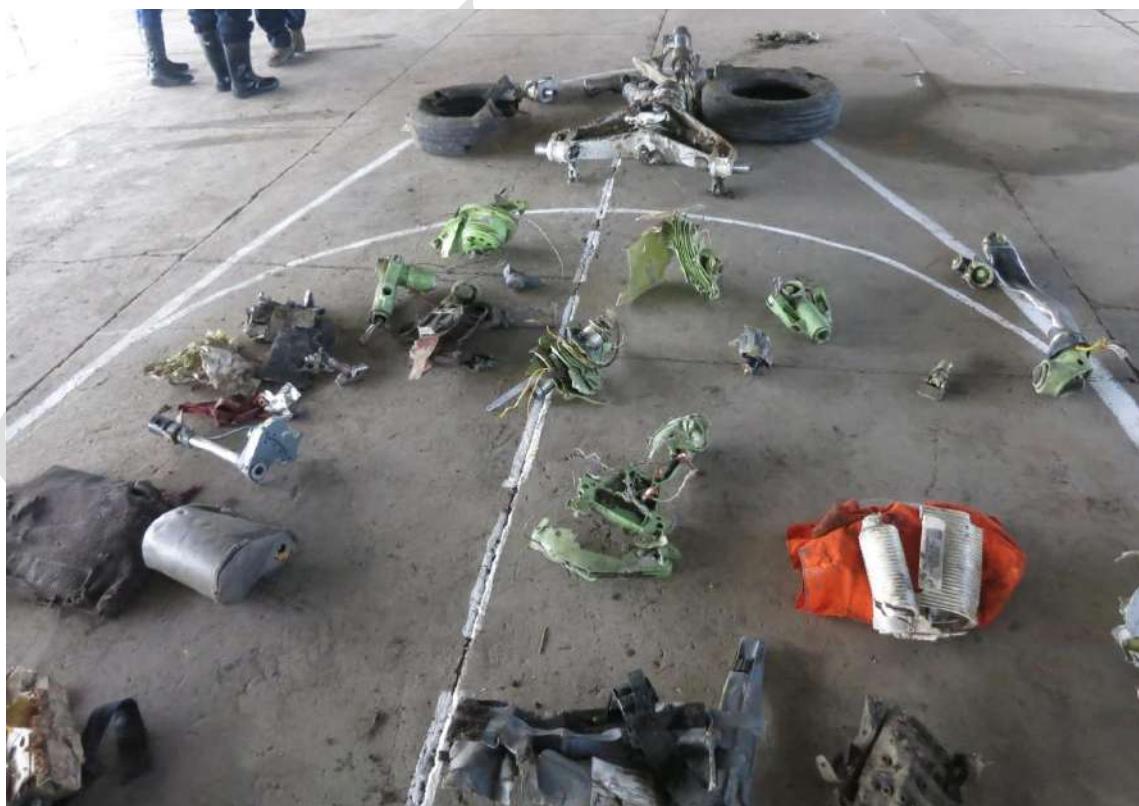
The elements of the elevator, ailerons and rudder control systems, mounted in the cockpit underfloor compartment, are presented on Fig. 3.

Fig. 3. The elements of the elevator, ailerons and rudder control systems, mounted in the cockpit underfloor compartment

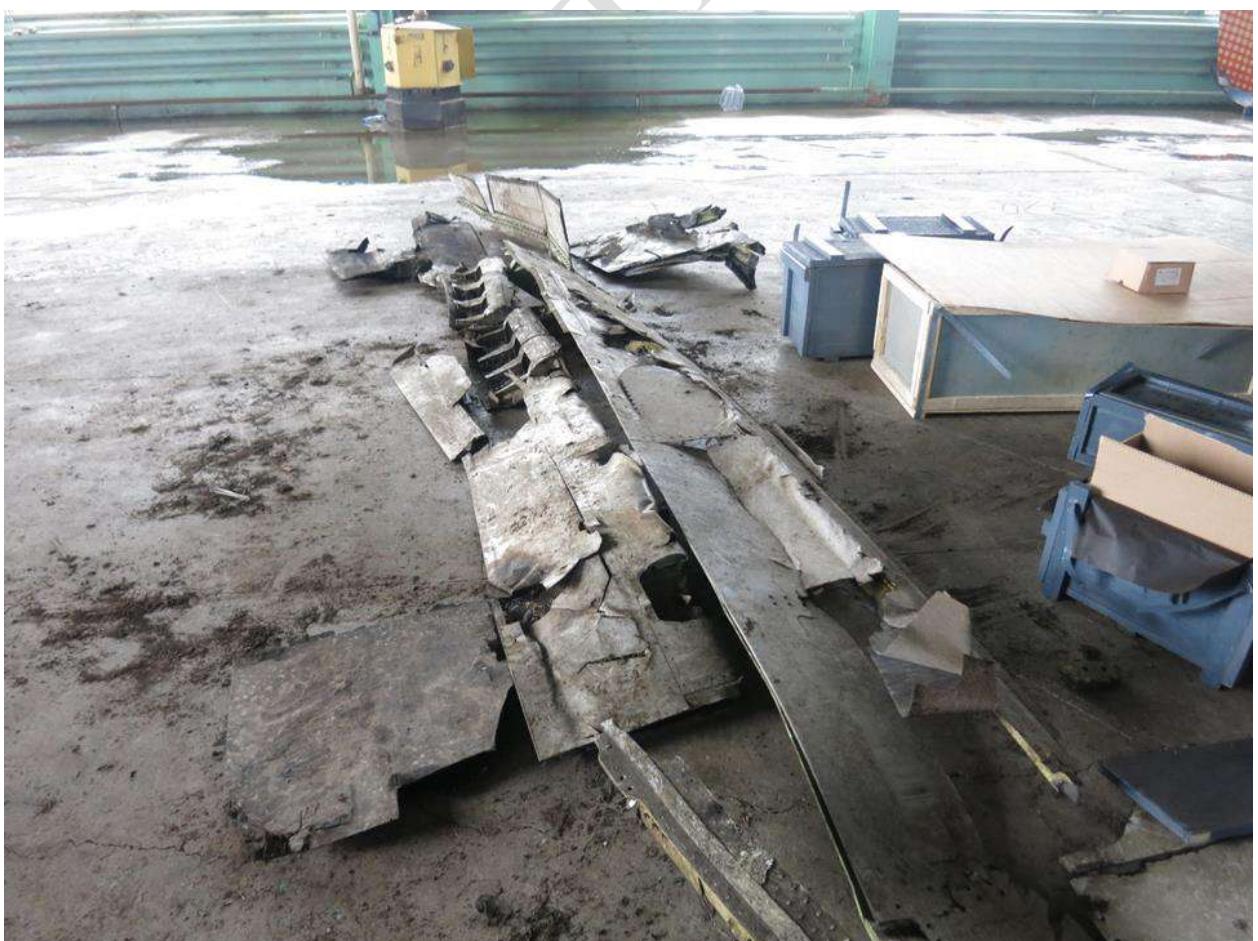
Fig. 5. The fragments of the LH wing panel

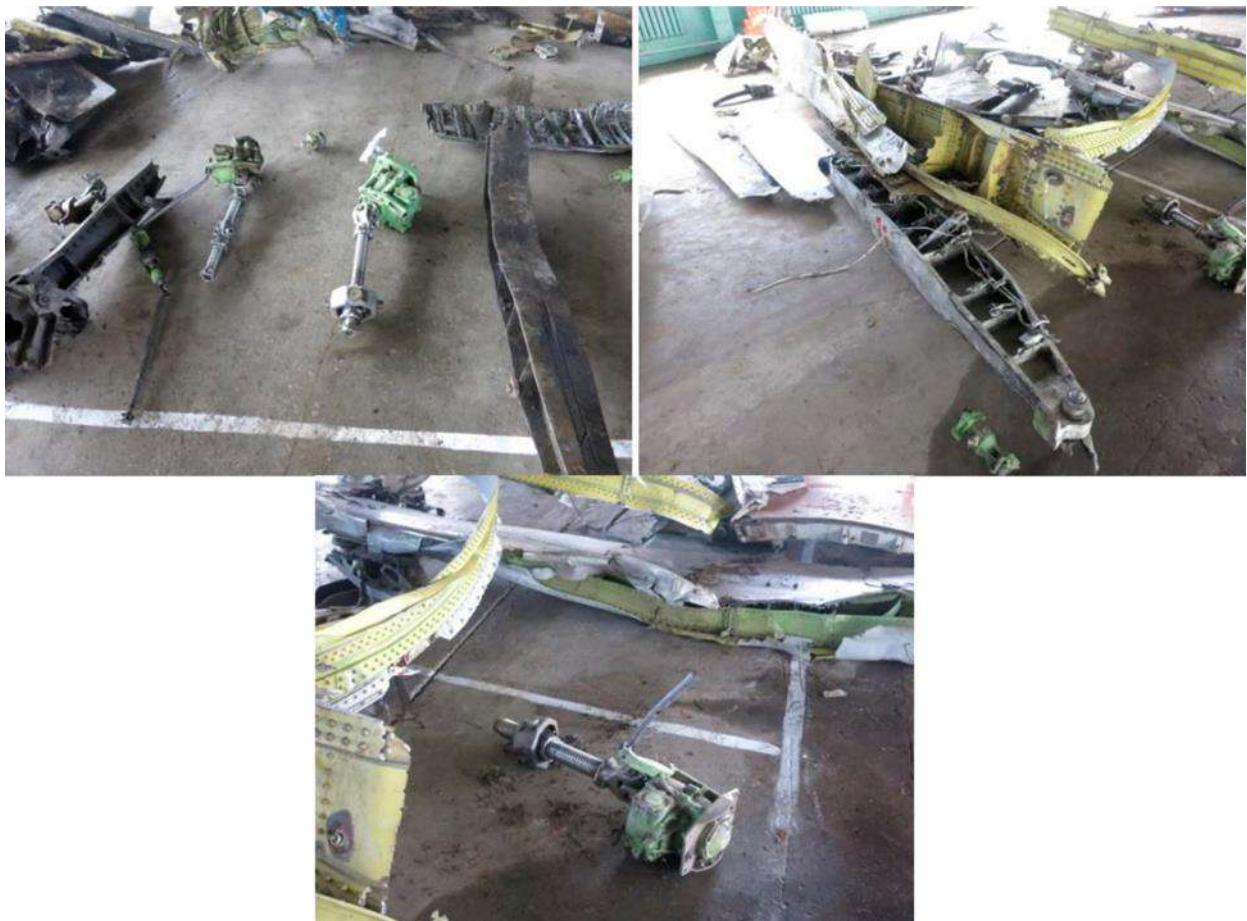
As the result of the aircraft impact with ground, the slats had been totally destroyed, in the progress of the layout only the smaller fragments of the flaps were retrieved. The transmission of the flaps, laid along the aft wing spar, is destroyed. All the eight jackscrews and eight single unit tracks of the flaps retraction/extension mechanism had been discovered (Fig. 6). The elements in question are mechanically damaged, the screw parts are destroyed and deformed.

Fig. 6. Jackscrews and single unit tracks

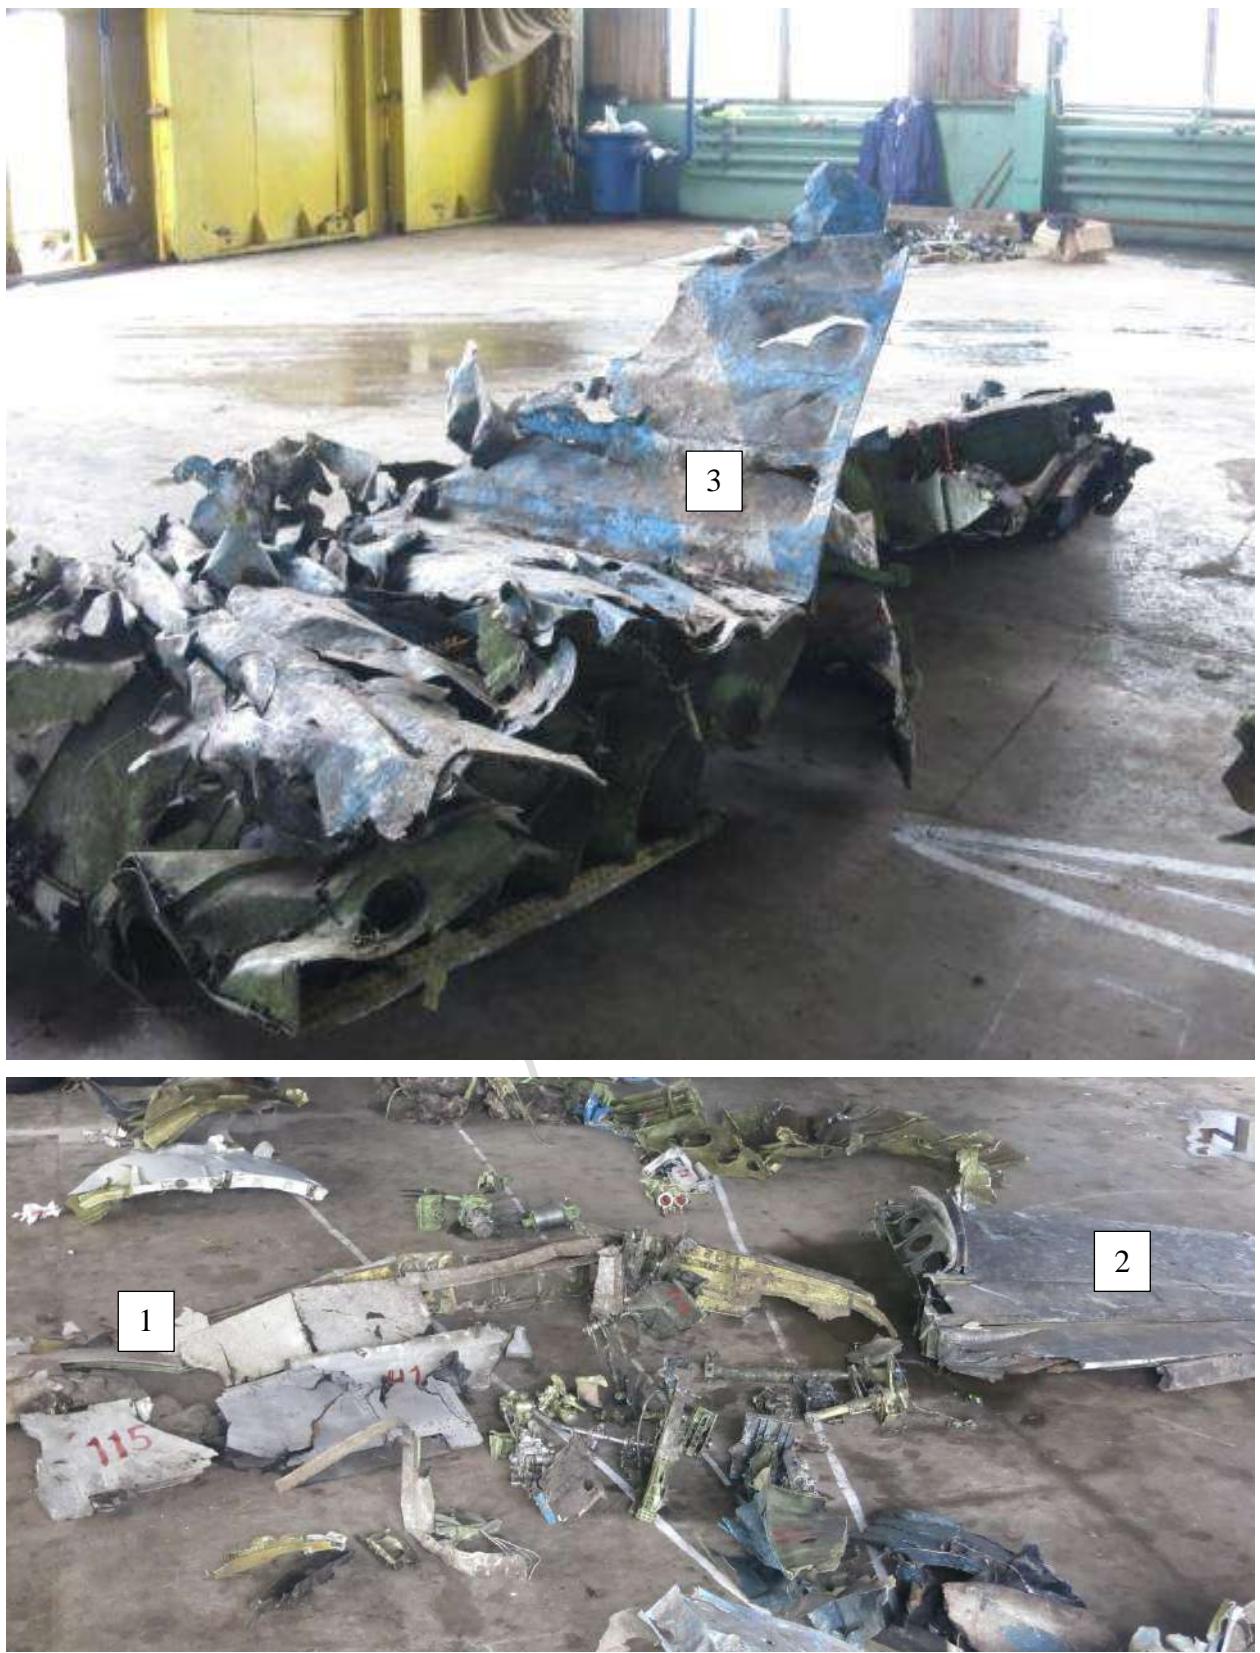
The vertical stabilizer, disintegrated in several parts, separated from the fuselage at the area of attachment. The composite rudder is completely destroyed as the result of the impact with ground. The skin and the frame of the vertical stabilizer are considerably damaged. There are no signs of fire and soot on the vertical stabilizer. The horizontal stabilizer had been destroyed and separated from the vertical stabilizer structure.

Fig. 7. The vertical and horizontal stabilizer elements (1 – LH half of the stabilizer, 2 - RH half of the stabilizer, 3- the vertical stabilizer elements)

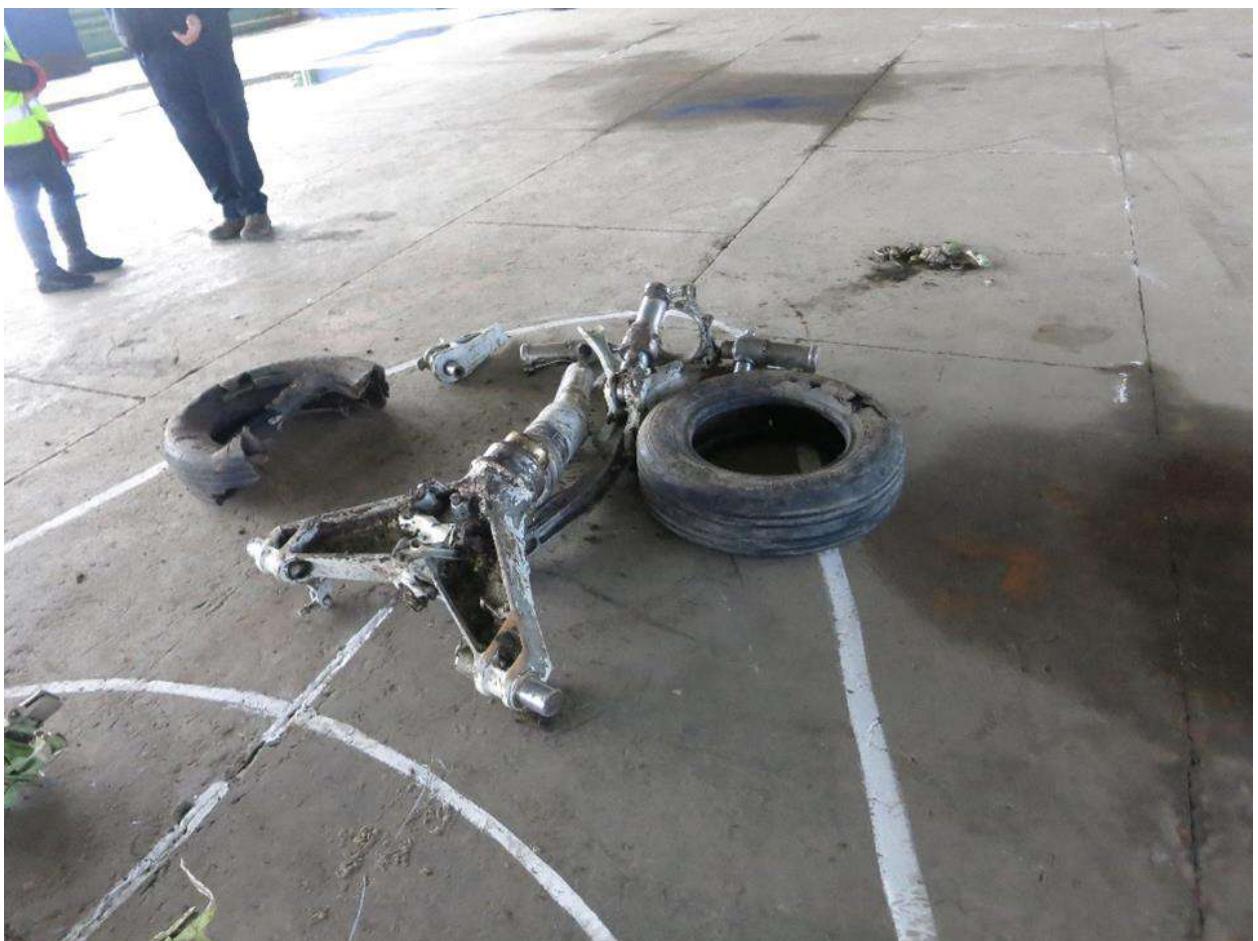
nose landing gear steering actuator cylinders are separated from the standard attachment points. The nose landing gear wheels attachment pivot and the wheels' disks are totally destroyed.

Fig. 8. Nose landing gear

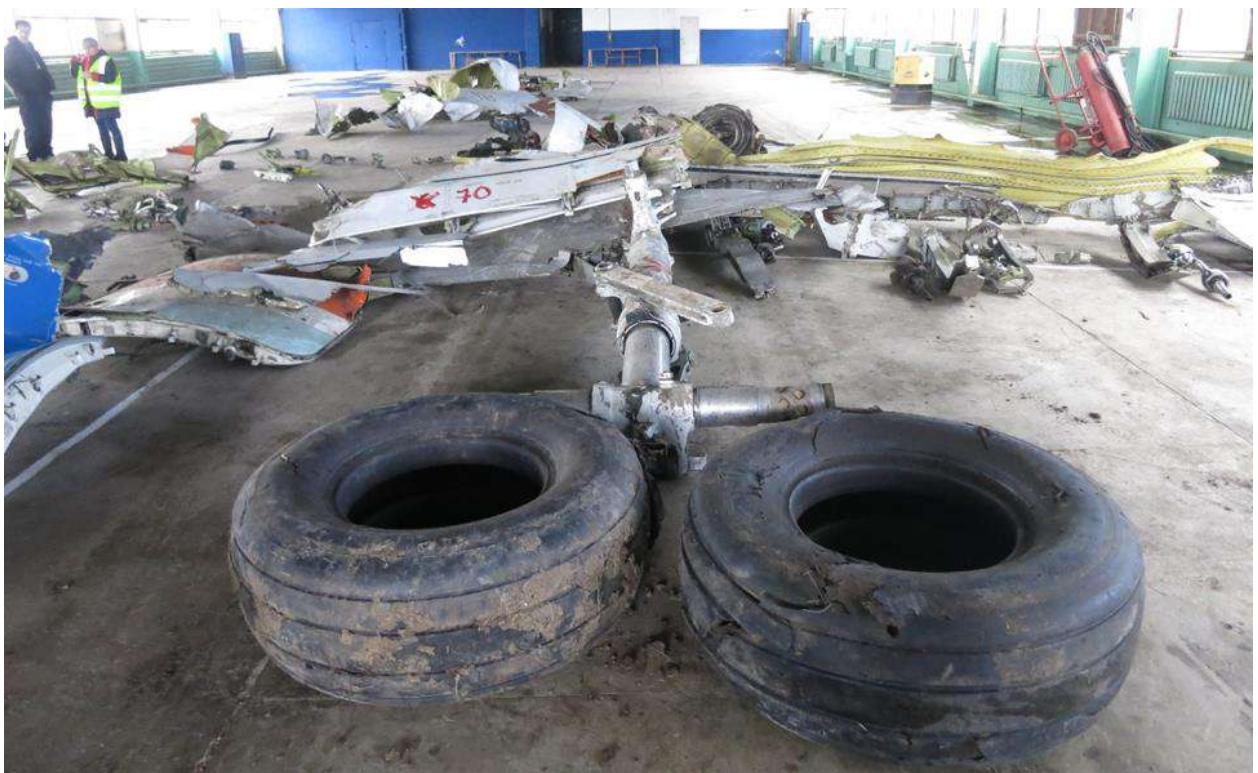
The right and left main landing gear legs (Fig. 9 and Fig. 10) are considerably damaged. The landing gear legs are separated from the fuselage attachment beams. The torsion links of the shock struts are destroyed. The retraction/extension actuators are separated off the legs main structure. The disks of the brakes are broken off. The brakes hubs are considerably damaged. The hubs of the wheels are separated off the tires.

Fig. 9. The elements of the right main landing gear leg

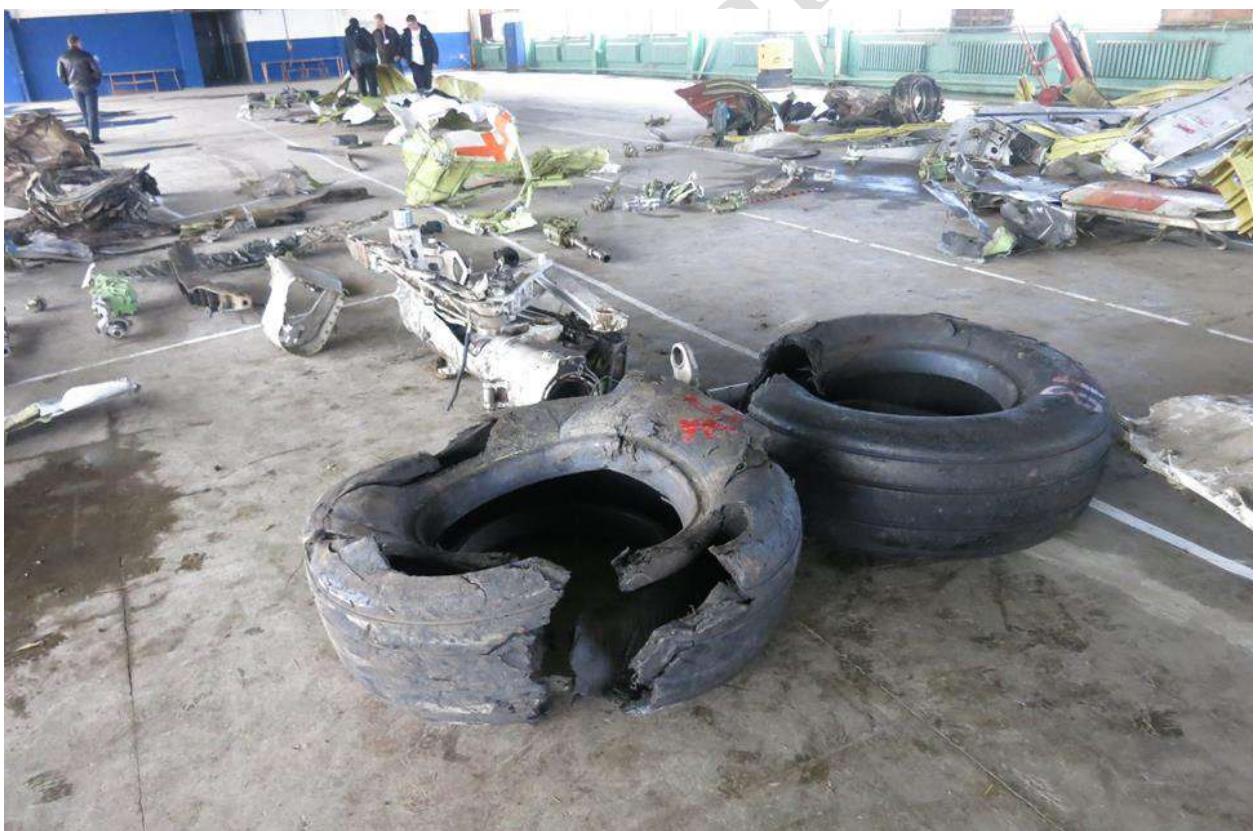
Fig. 10. The elements of the left main landing gear leg

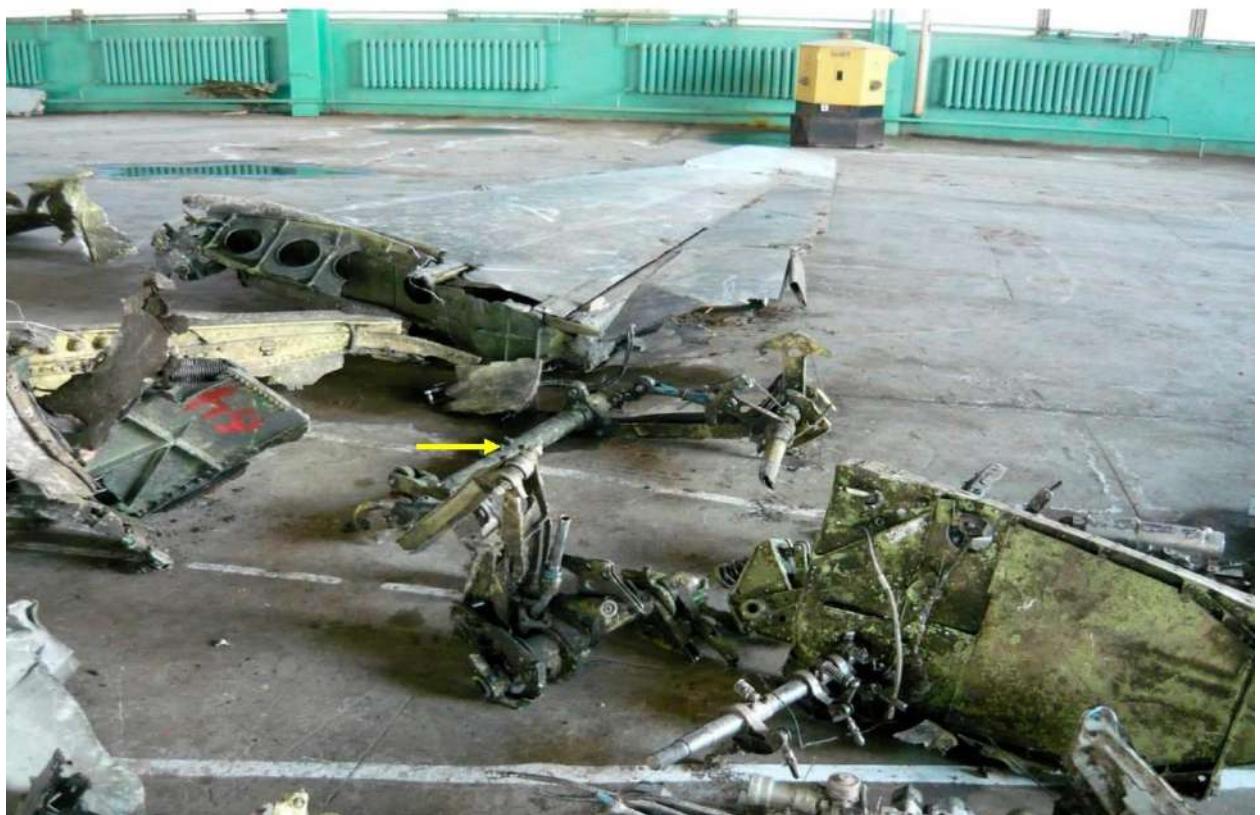
The fragments of the elevator control system (the input rods, the PCUs and the elevator autopilot electrohydraulic actuator) (Fig. 11) are significantly damaged as the structure had disintegrated at the aircraft impact with ground.

Fig. 11. The elevator control system output shaft (pointed with arrow)

The left elevator PCU is separated off the output shaft and partially broken, the right PCU rests at its standard attachment point.

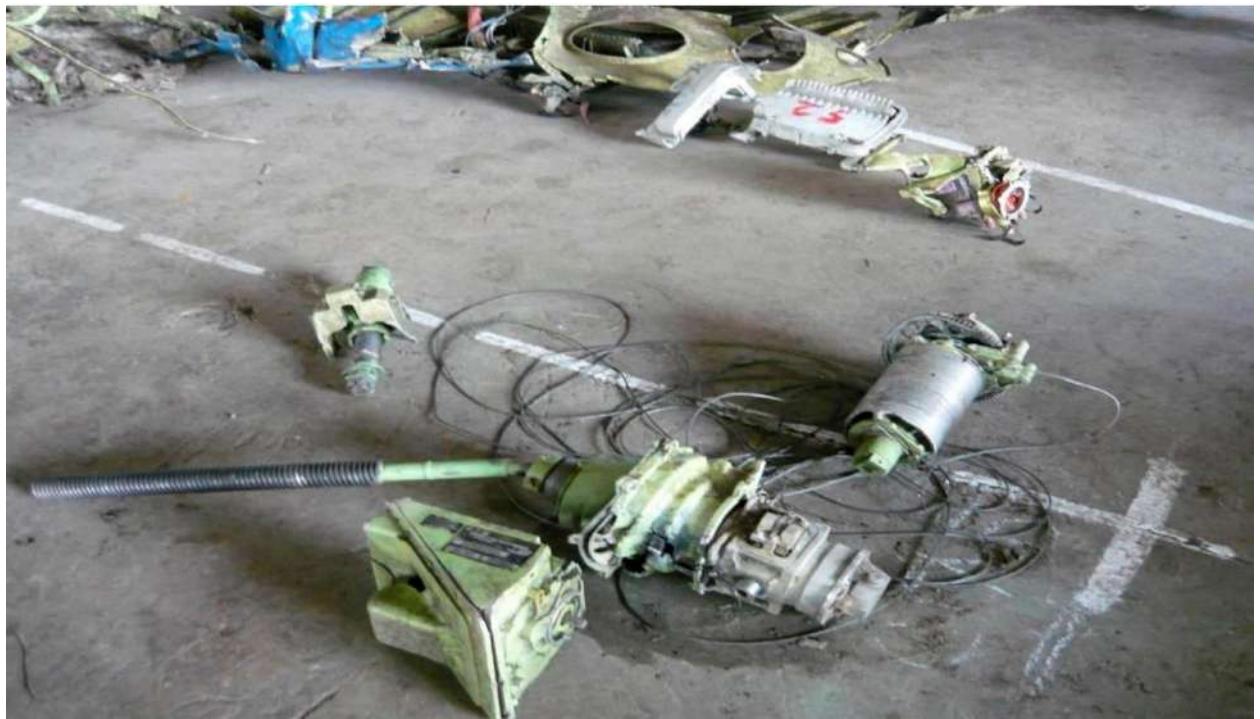
In the progress of the accident site inspection, the majority of the stabilizer trim actuator gearbox had been retrieved. The aft cable drum had been separated from its connection point on the stab trim actuator. The drive mechanism had been damaged and deformed.

the off-design loads application. The jackscrew with the attachment fitting to stabilizer (Fig. 12) had been discovered apart of the stabilizer being disintegrated due to the off-design loads.

Fig. 12. The recovered elements of the stab trim actuator

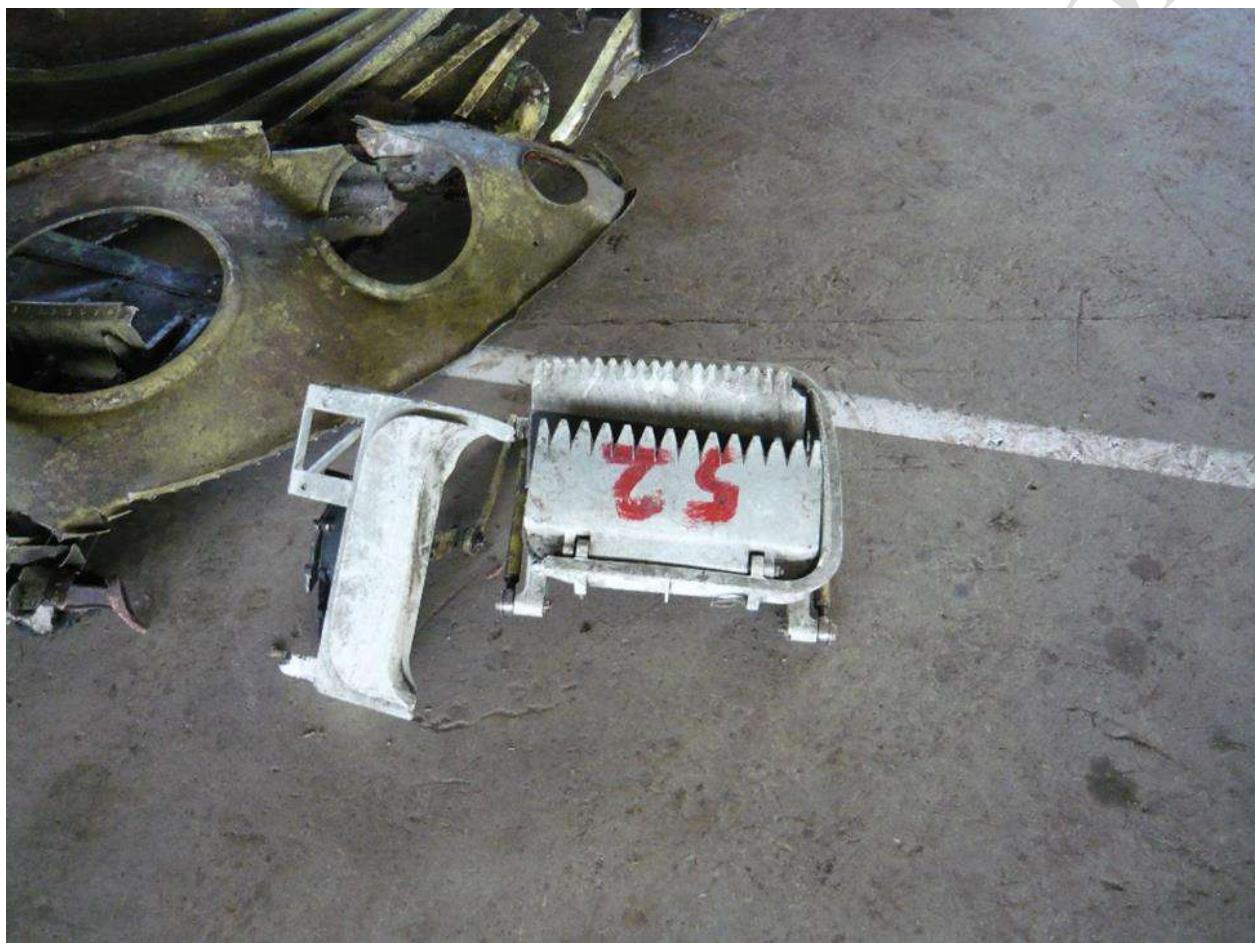
The pressurization control assemblies are totally disintegrated as well. In the progress of the accident site inspection only the outflow valve out of this system had been discovered (Fig. 13).

Fig. 13. The air conditioning system outflow valve

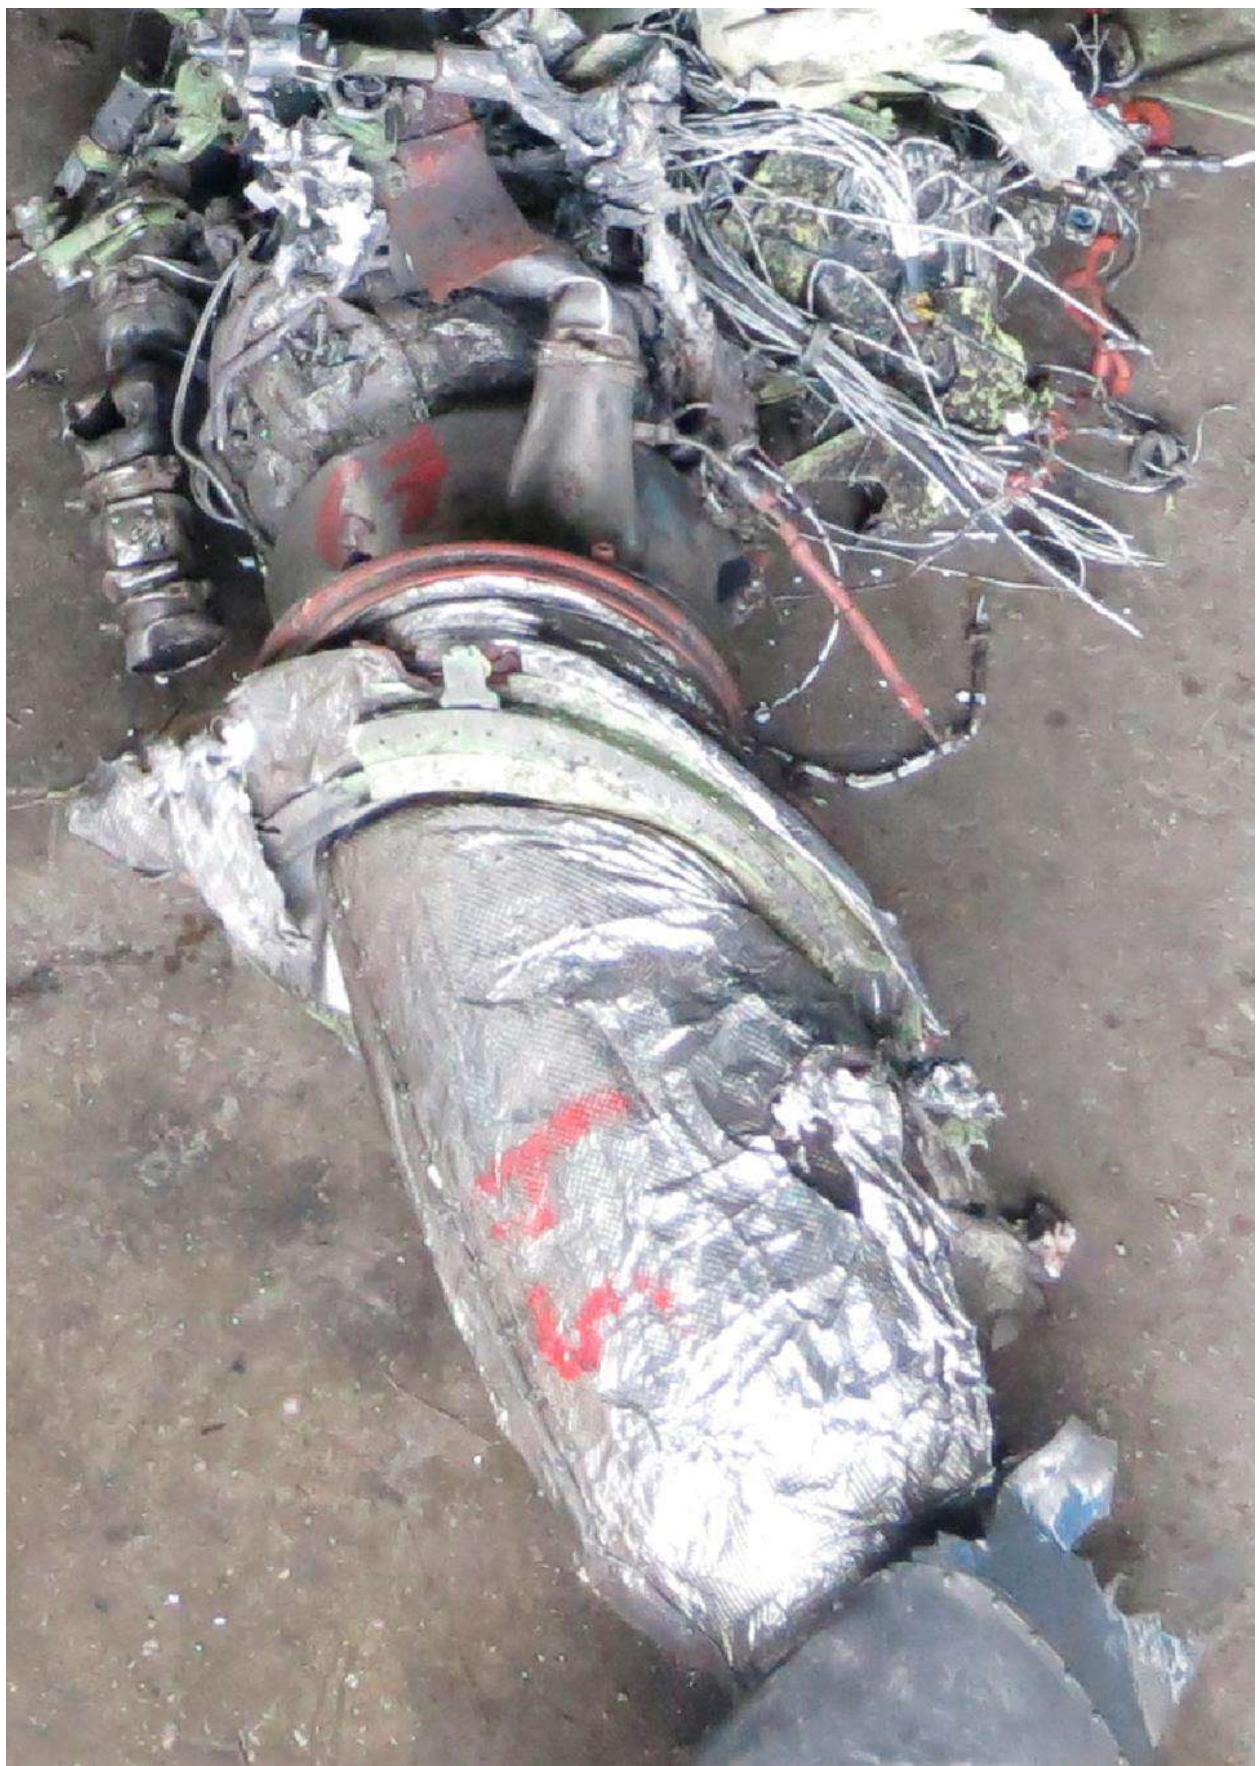
The APU is disintegrated (Fig. 14). The inspection of the APU gas generator plumbing and wiring assemblies did not reveal the ducting and control elements uncoupling.

Fig. 14. The APU fragment with the exhaust duct and the fuselage tailcone

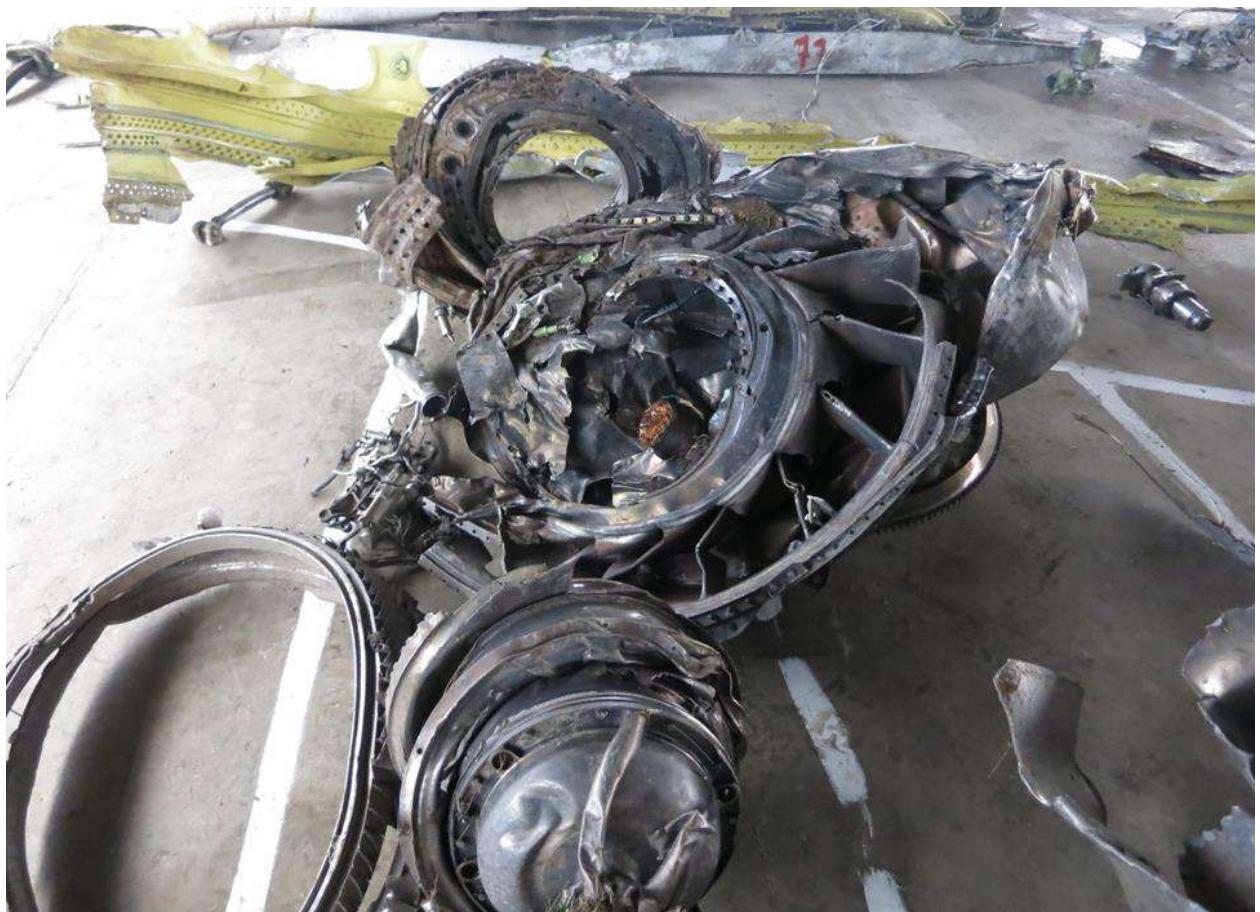
The left and the right engines are totally destroyed (Fig. 15, Fig. 16).

Fig. 15. The left engine fragments

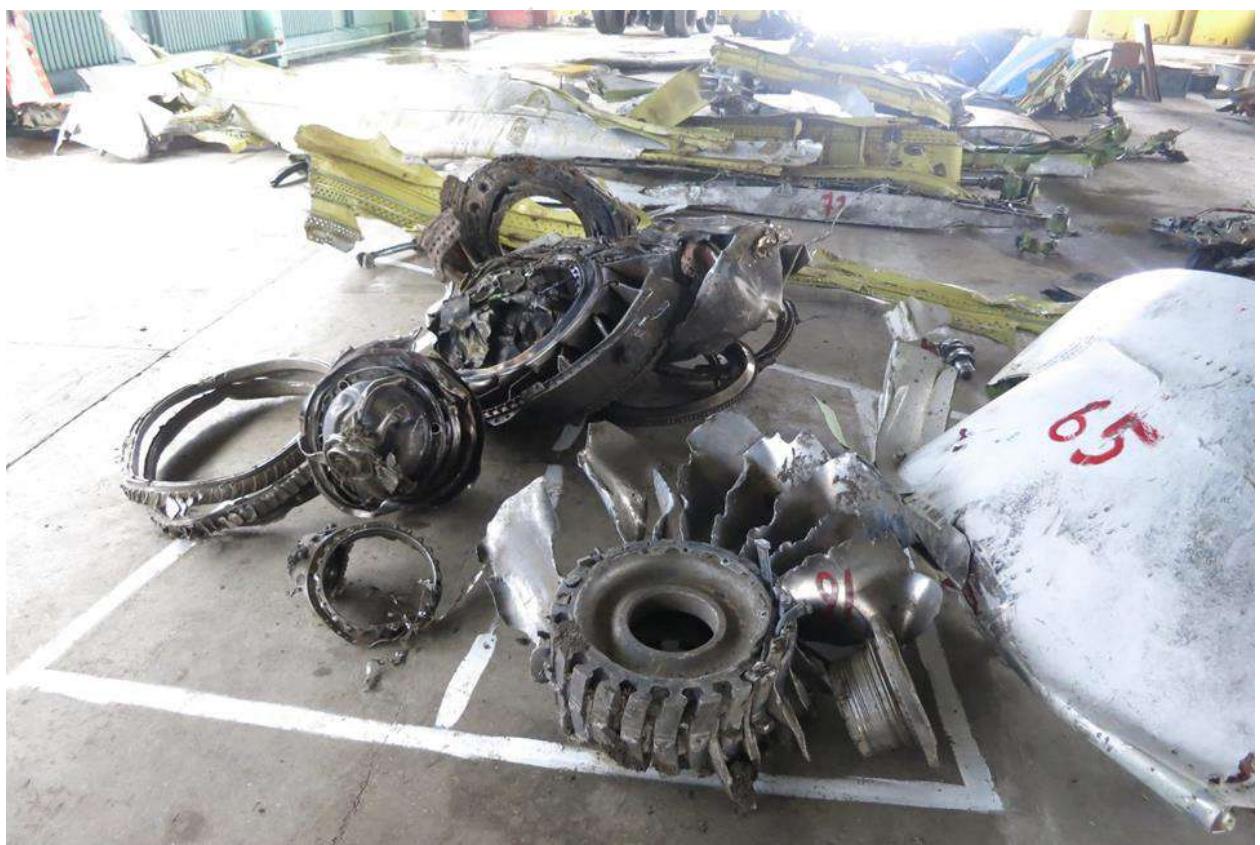
Fig. 16. The right engine fragments

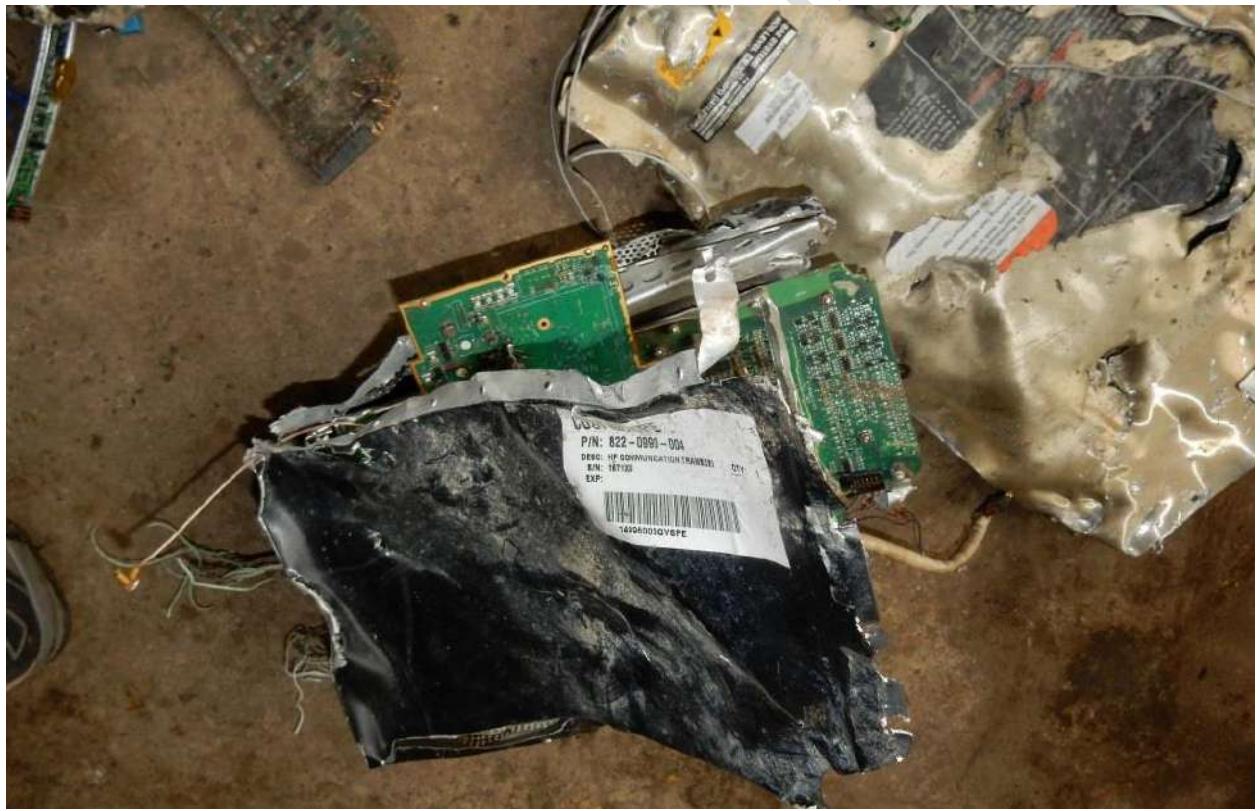
The radio communication units are completely destroyed and are impossible to identify. There were retrieved the fragments of the HF radio set switching unit (p/n 822 0990 004, s/n 1871X9) (Fig. 17).

Fig. 17. The HF radio set switching unit fragments

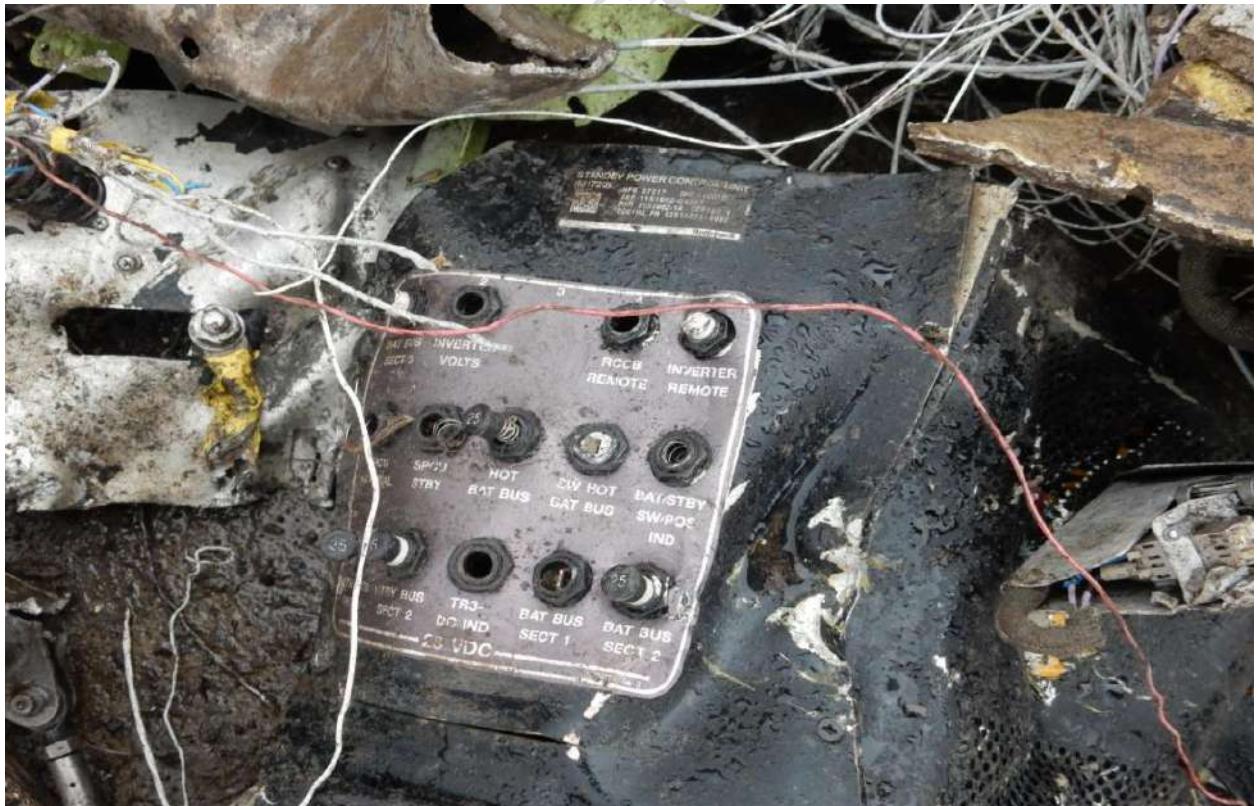
Fig. 19. The standby power control unit

All the units sustained considerable damage.

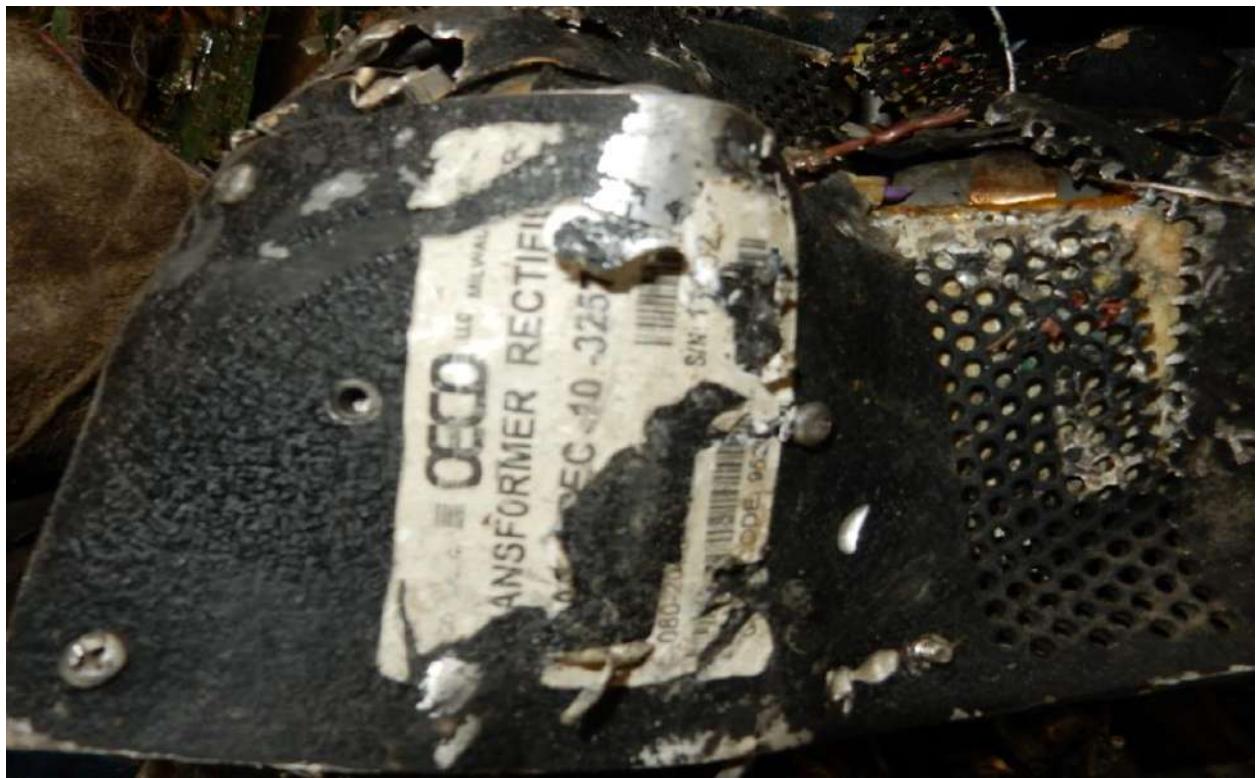
Fig. 20. The transformer-rectifier unit

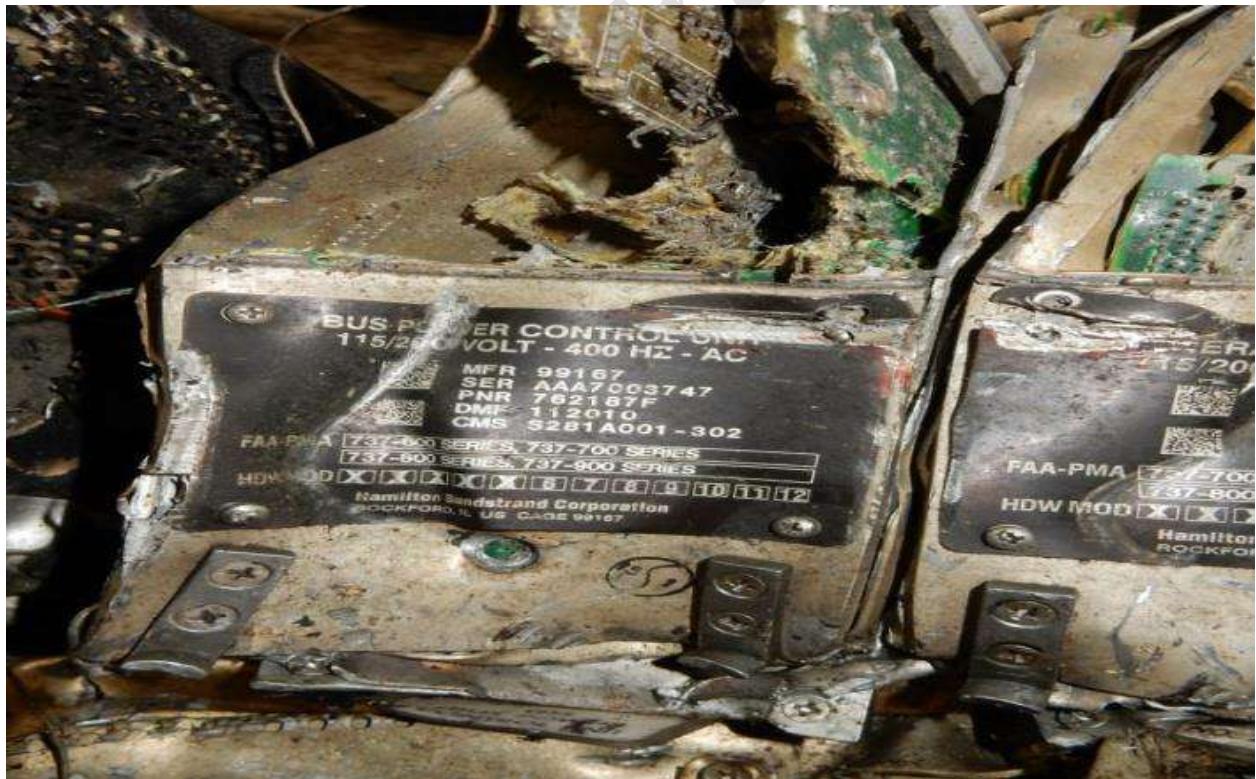
Fig. 21. The bus power control unit No 1
