This document is an English translation of the Final Report on the accident involving the Boeing 737-8KN aircraft registered A6-FDN that occurred on March 19, 2016 (00:42 UTC) at Rostov-on-Don aerodrome, the Rostov Region, Russian Federation.

**INTERSTATE AVIATION COMMITTEE
AIR ACCIDENT INVESTIGATION COMMISSION
FINAL REPORT**

Type of occurrence	Fatal accident
Type of aircraft	Boeing 737-8KN, airplane
Nationality and registration marks	A6-FDN
Owner	Celestial Aviation Trading 38 Limited, Shannon, County Clare, Ireland
Operator	Dubai Aviation Corporation, P.O. Box: 353, United Arab Emirates
Aviation authority of the place of occurrence	Southern FATA Interregional Territorial Department
Place of occurrence	Russian Federation, the Rostov region, the Rostov-on-Don aerodrome, reference position: 47°15'54.7" N, 039°49'43.8" E
Date and time	19.03.2016, 03:42 local time (00:42 UTC), nighttime

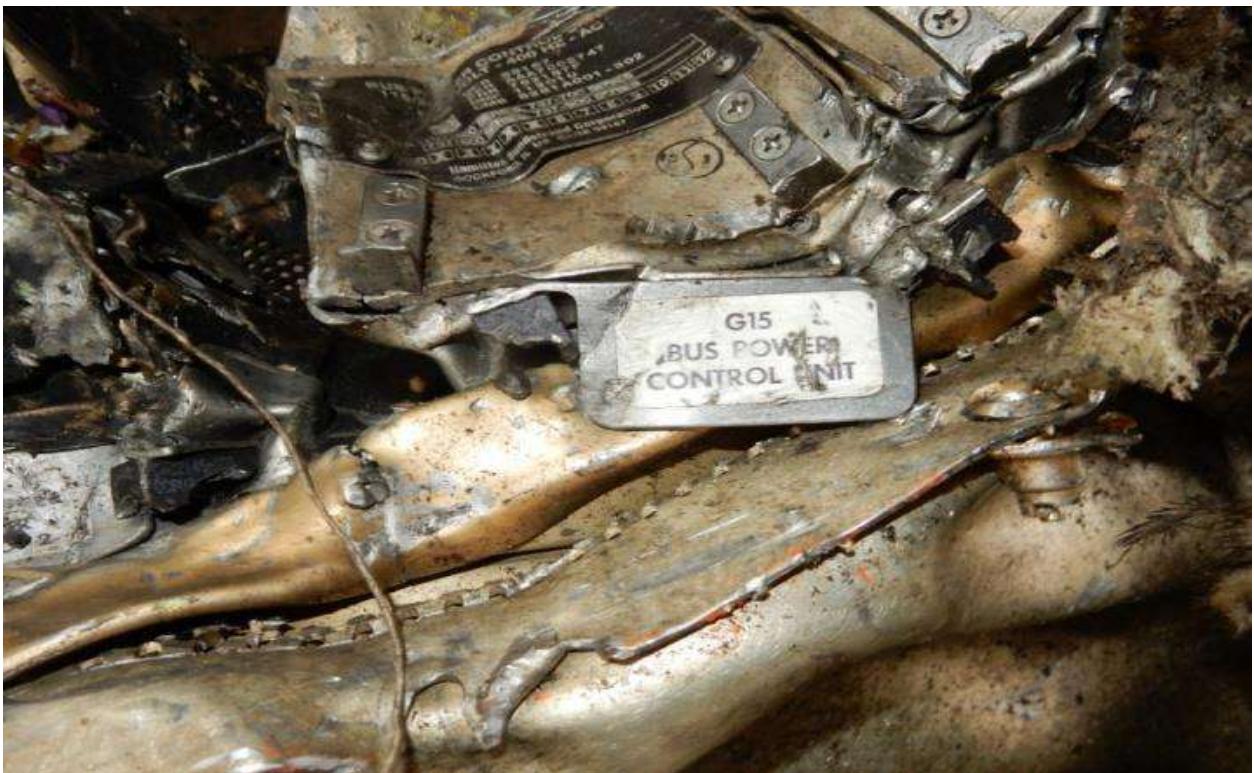
Fig. 22. The bus power control unit No 2

All the units sustained considerable damage.

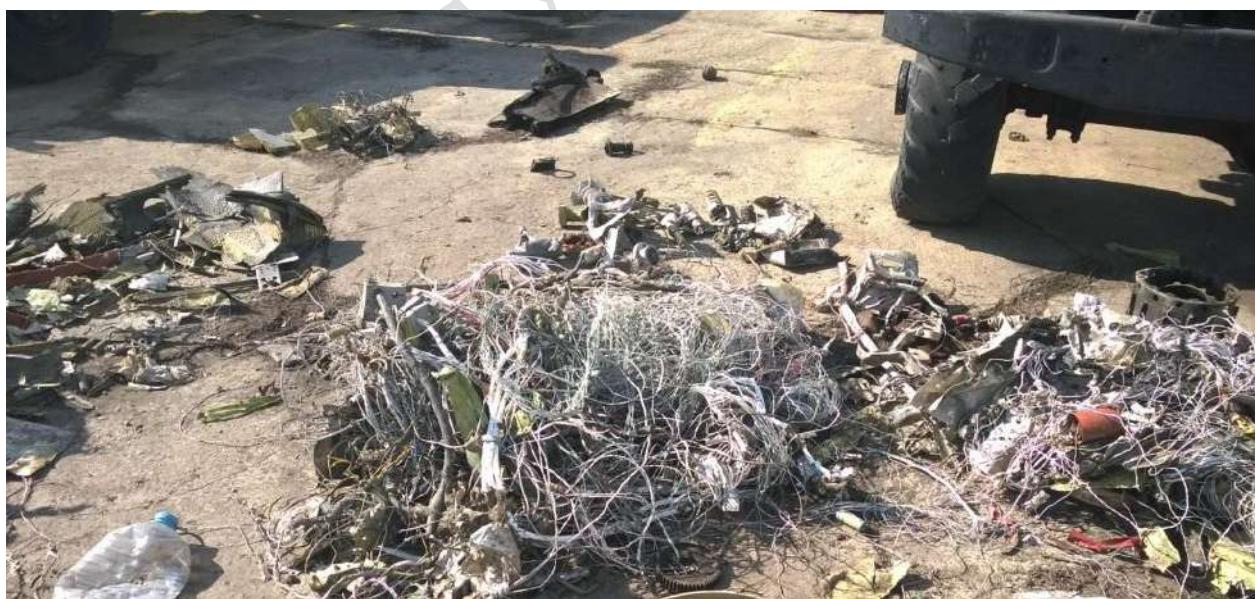
At the site of the aircraft impact with ground the debris of the aircraft electrical supply were retrieved along the impact heading (Fig. 23). The aircraft electrical supply is totally destroyed, there were no signs revealed of the short circuit, might have been evident in the electrical wiring isolation melt.

Fig. 23. The debris of the aircraft electrical supply

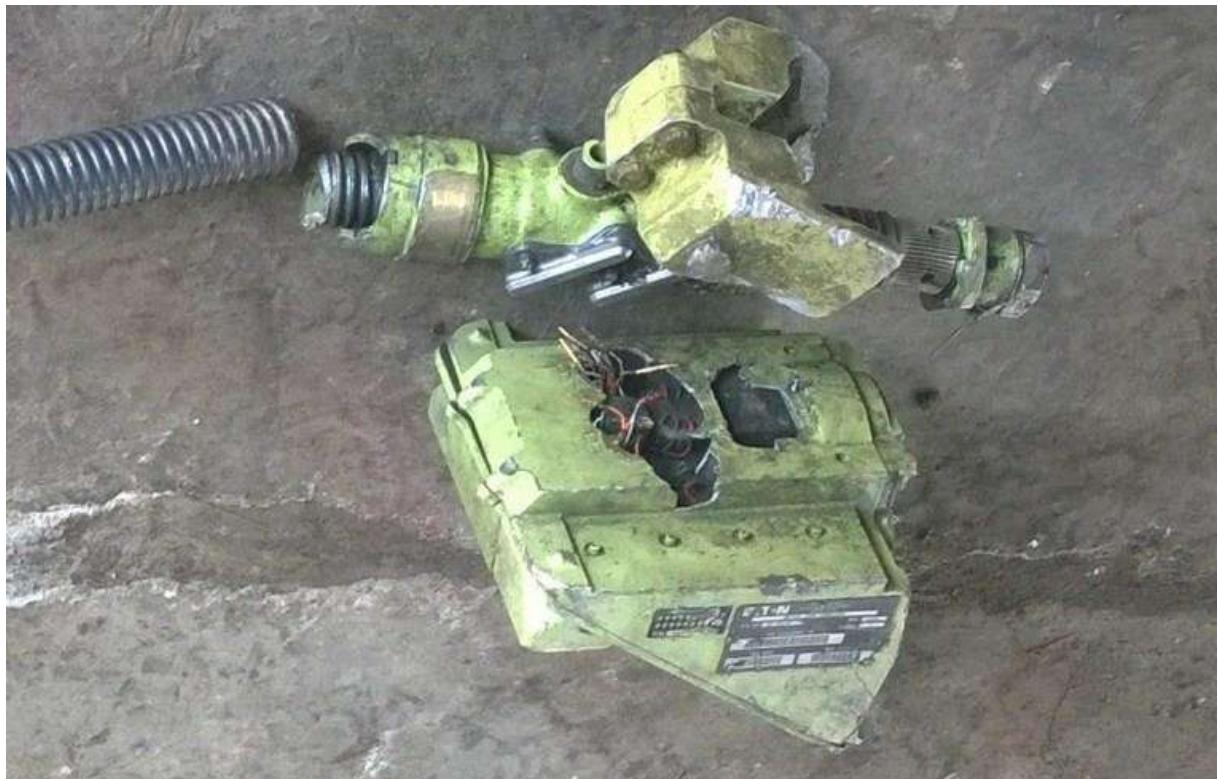
The stab trim motor, p/n 6355C0001-01, s/n 2062 had been retrieved (Fig. 24).

Fig. 24. The stab trim motor elements

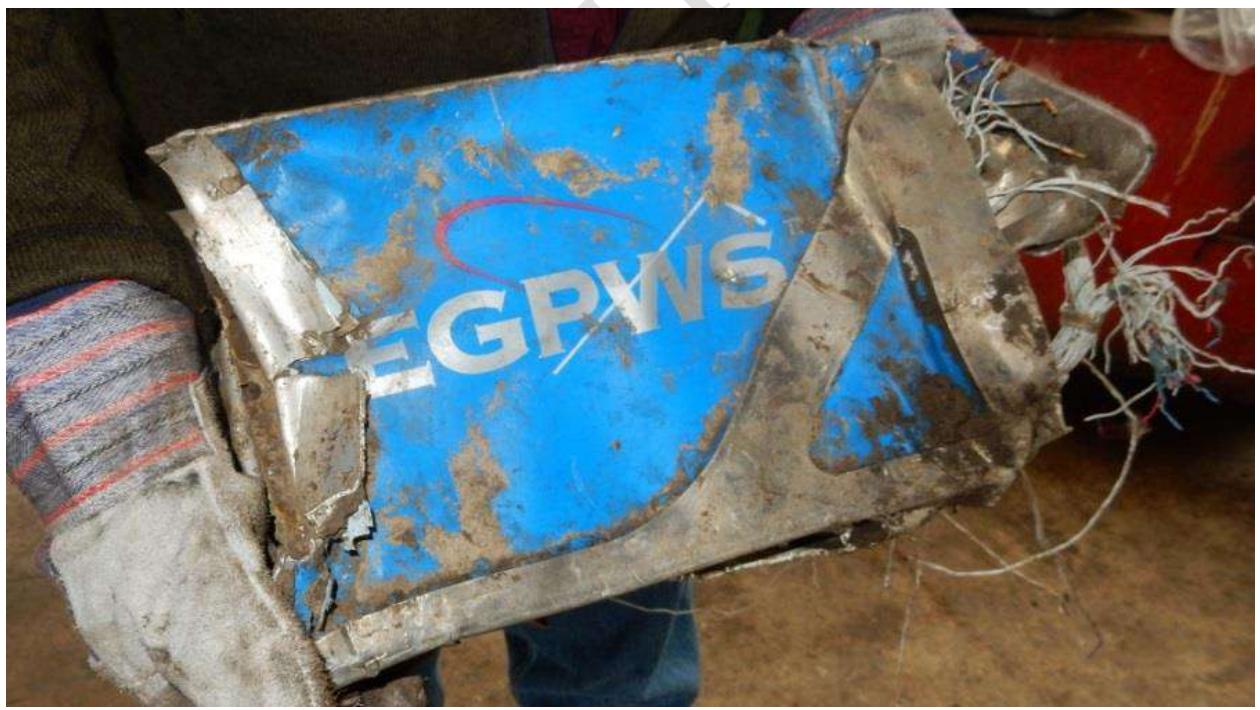
Fig. 27. The EGPWS unit

All the units have the signs of the physical damage on them.

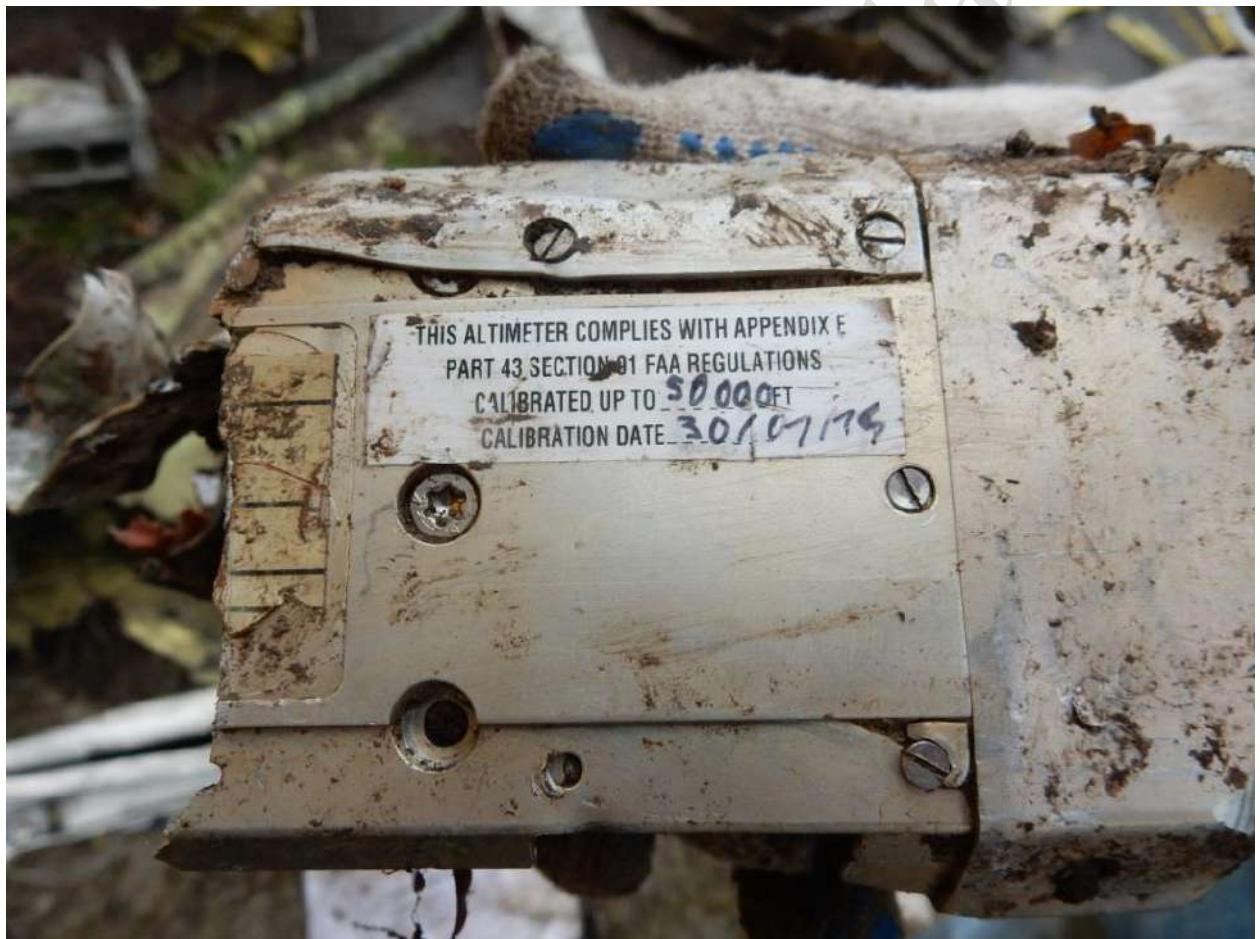
Fig. 29. The standby altimeter

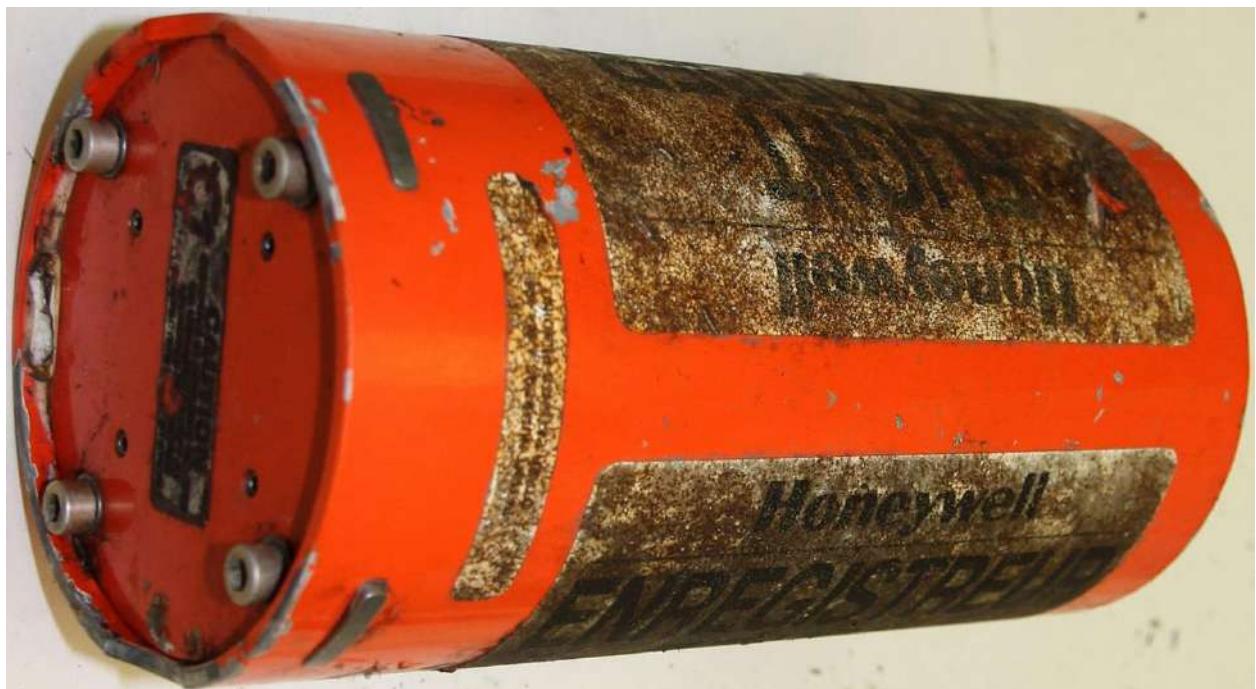
The Honeywell SSFDR p/n 980-4700-042 with the secure memory unit s/n 35907 had been installed on the accident aircraft. On the accident scene, the secure memory unit was retrieved being out of the recorder case (Fig. 35).

Fig. 35. The FDR secure memory unit

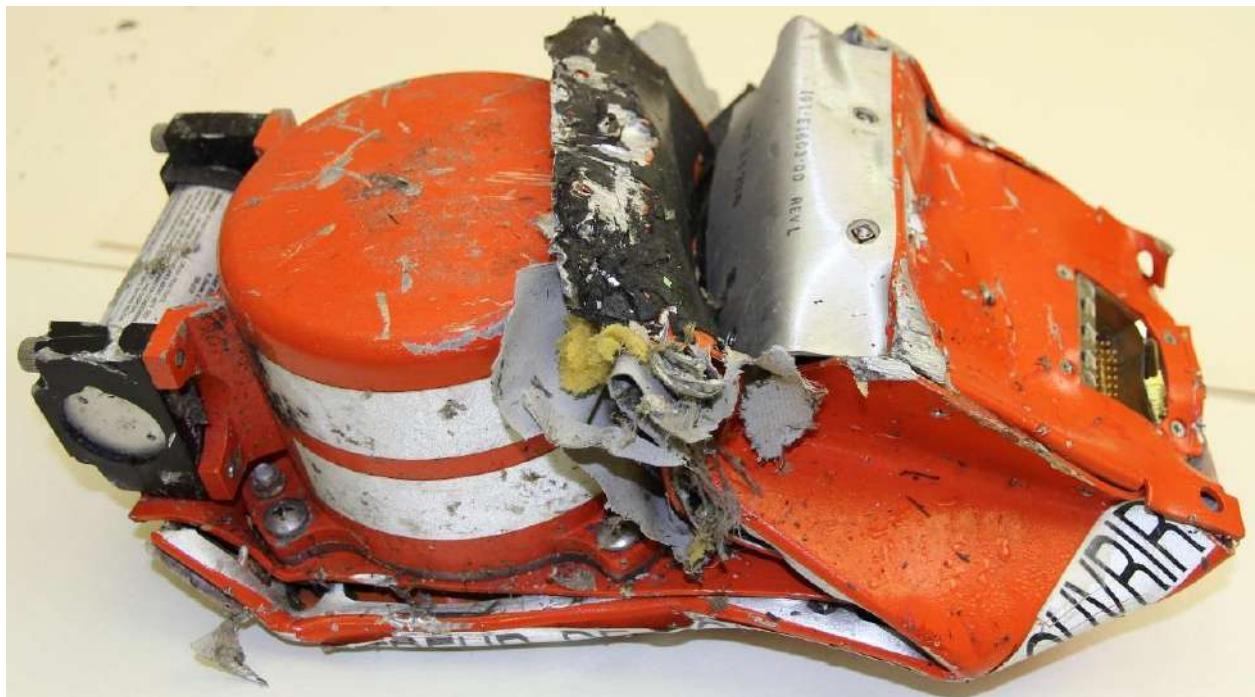
The L3 FA2100 2100-1020-00 cockpit voice recorder (CVR) had been installed on the accident aircraft. The recorder case had been removed from the accident site. At the inspection, it was noted that the case sustained considerable mechanical damage (Fig. 36).

Fig. 36. The external view of the CVR

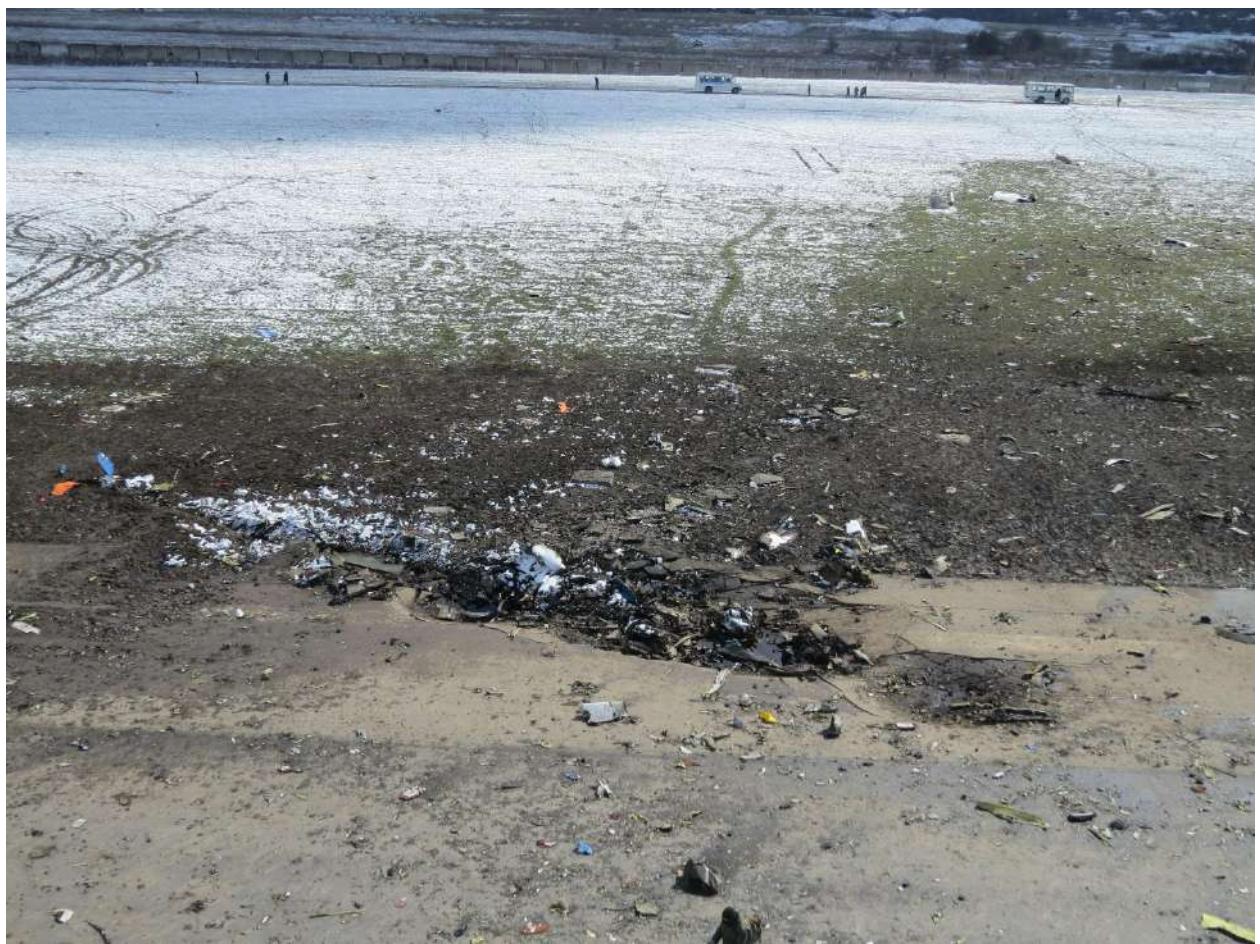
The accident scene is located at the Rostov-on-Don airport airfield. The first point of impact with ground (the RWY concrete surface) occurred at the ≈ 120 m off the RWY22 threshold along the RWY left edge looking forward, reference position: $47^{\circ}15'54.7''$ N, $039^{\circ}49'43.8''$ E. The main wreckage scatter area is located at the distance of 150-400 m off the RWY22 threshold to the left (the major portion of the wreckage) and to the right of the RWY centerline (Fig. 37).

Fig. 37. First point of impact with ground (the left-to-right direction of flight)

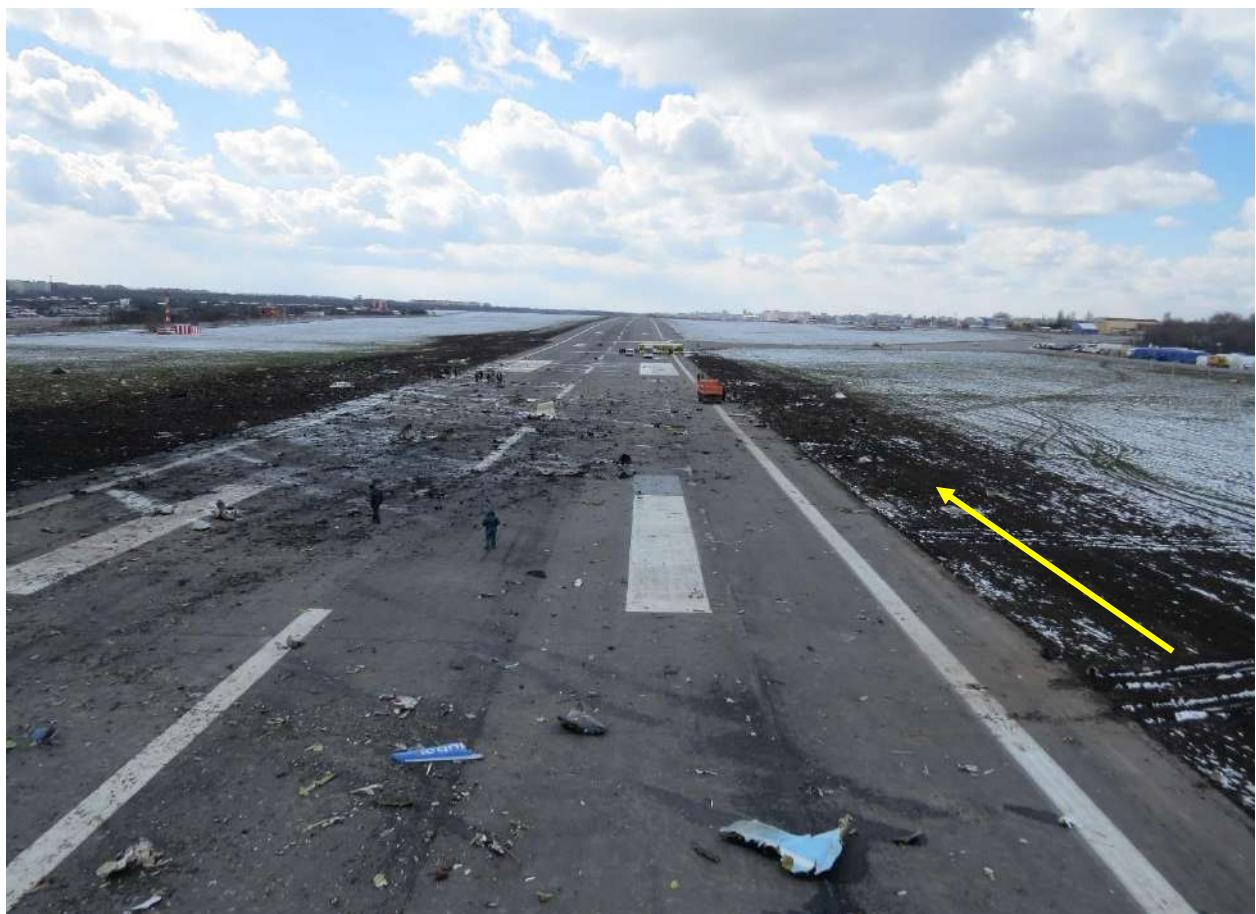
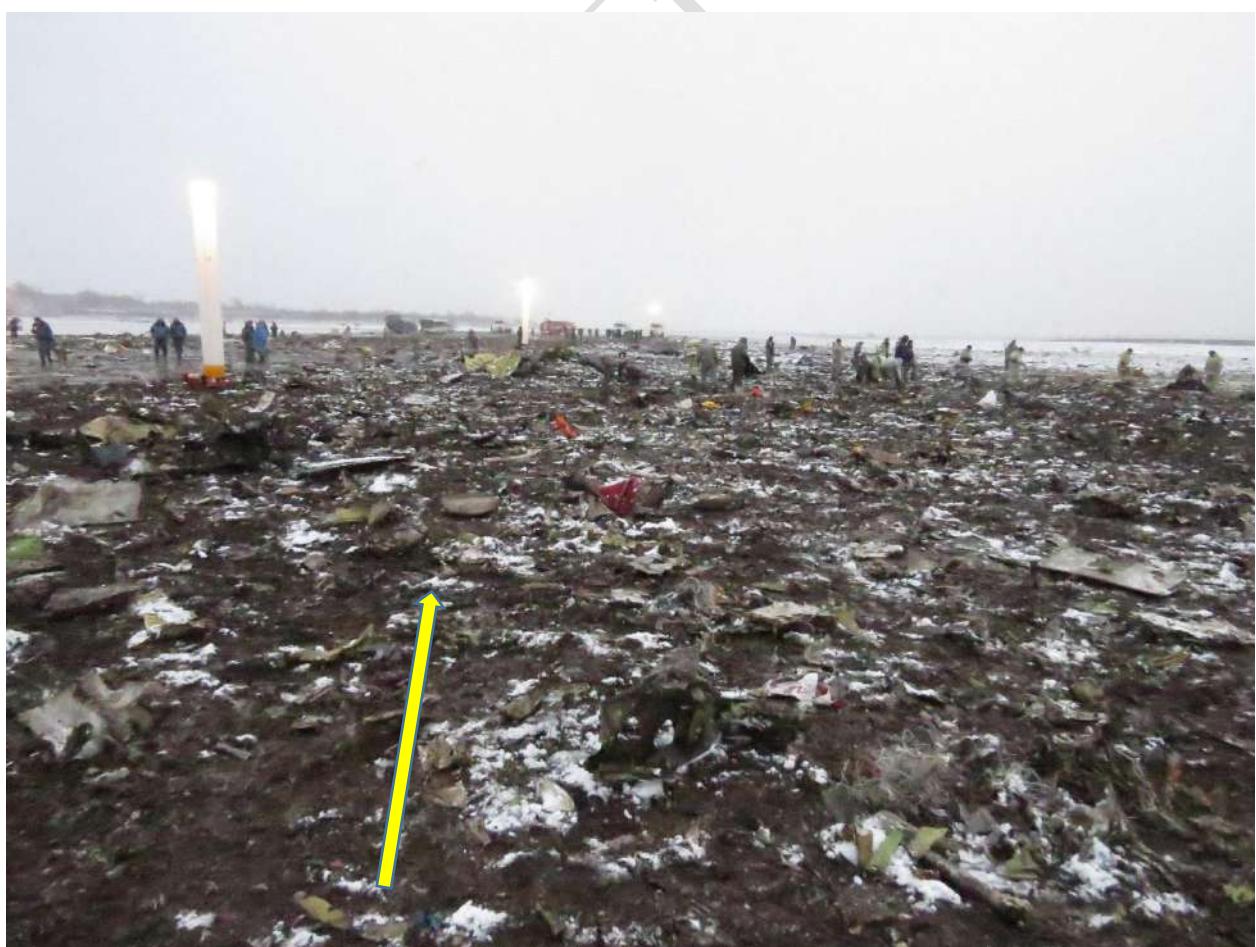
The main wreckage scatter zone is located at the distance of 150-400 m off the RWY threshold on the left side (the larger portion of wreckage) and on the right side off the RWY centerline (Fig. 38).

Fig. 38. The general view of the accident scene (the arrow indicates the flight heading)

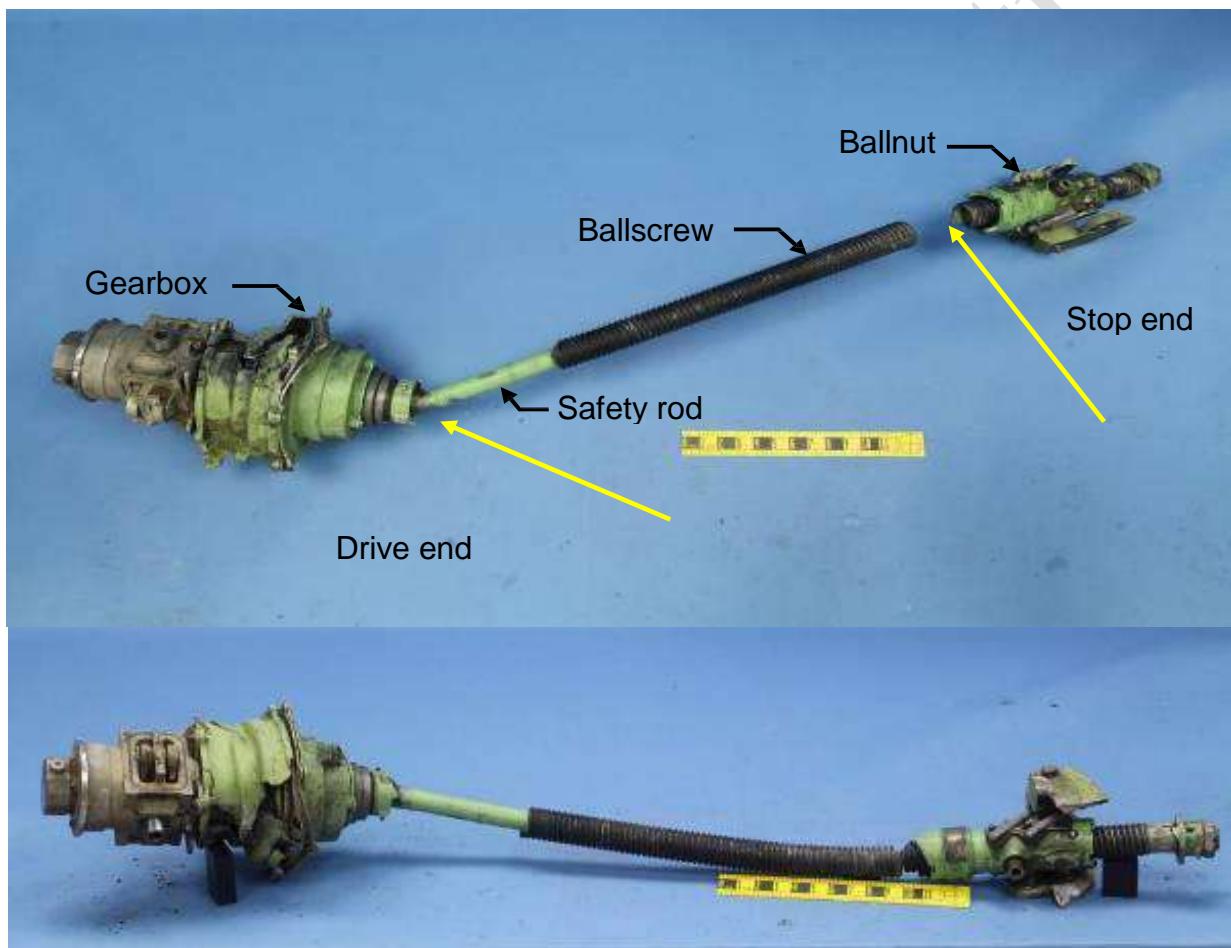
The jackscrew elements (Fig. 42) in an assembly were retrieved from the aircraft wreckage and transferred to the NTSB Material lab, where on 20.10.2016 they had been examined to perform the physical and chemical analysis of the fractured areas and the developed bend with the measurement of the inner diameter and the safety rod wall thickness. In addition, the works were carried out on the identification of the metal samples of the jackscrew and safety rod with the aim to determine whether they met the material specification requirements (AMS 6265 and AMS 6411/6427). The examination of the jackscrew of the stabilizer trim mechanism (p/n 07322P000-05, s/n 1847) was performed at the participation and under the guidance of the air accident investigation team representatives, as well as with the participation of the AAIS experts.

Fig. 42. The jackscrew assembly with the fractures (the fractures are pointed with arrows)

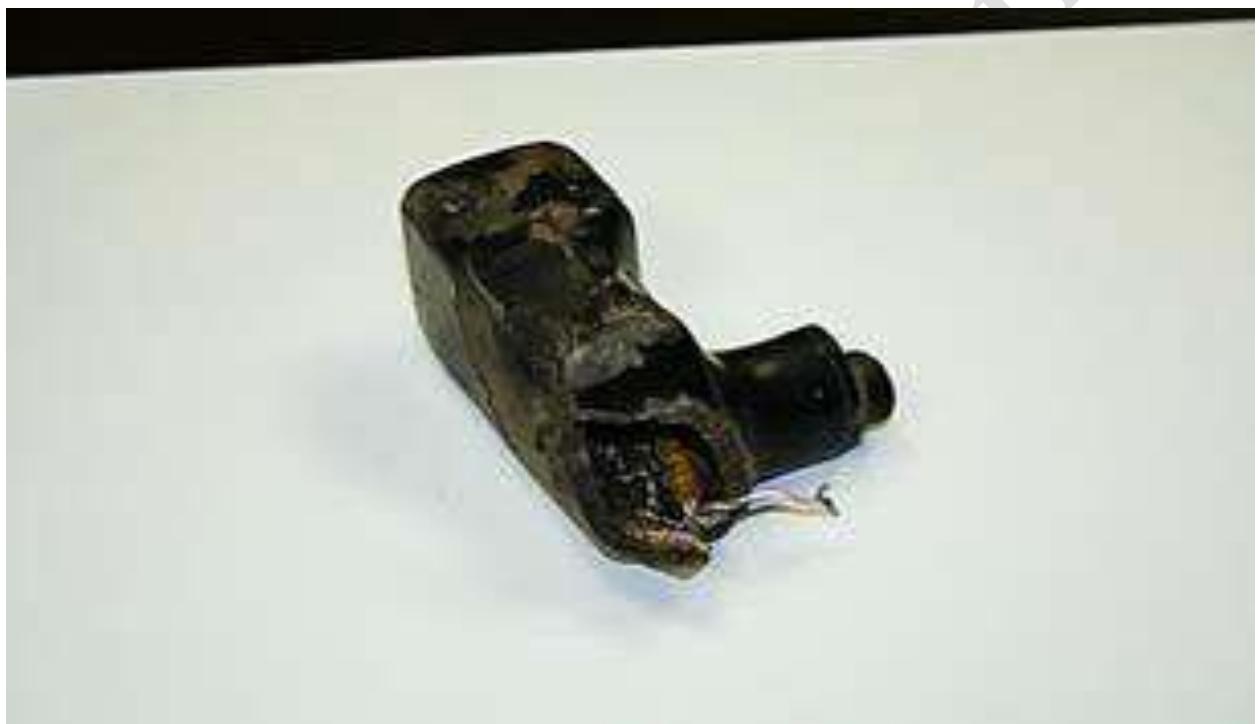
On the accident scene the stabilizer trim control switch (ensuring the “power supply”)¹⁰, integrated to the F/O control wheel, had been discovered (Fig. 43).

Fig. 43. Stabilizer trim control switch of the F/O control wheel

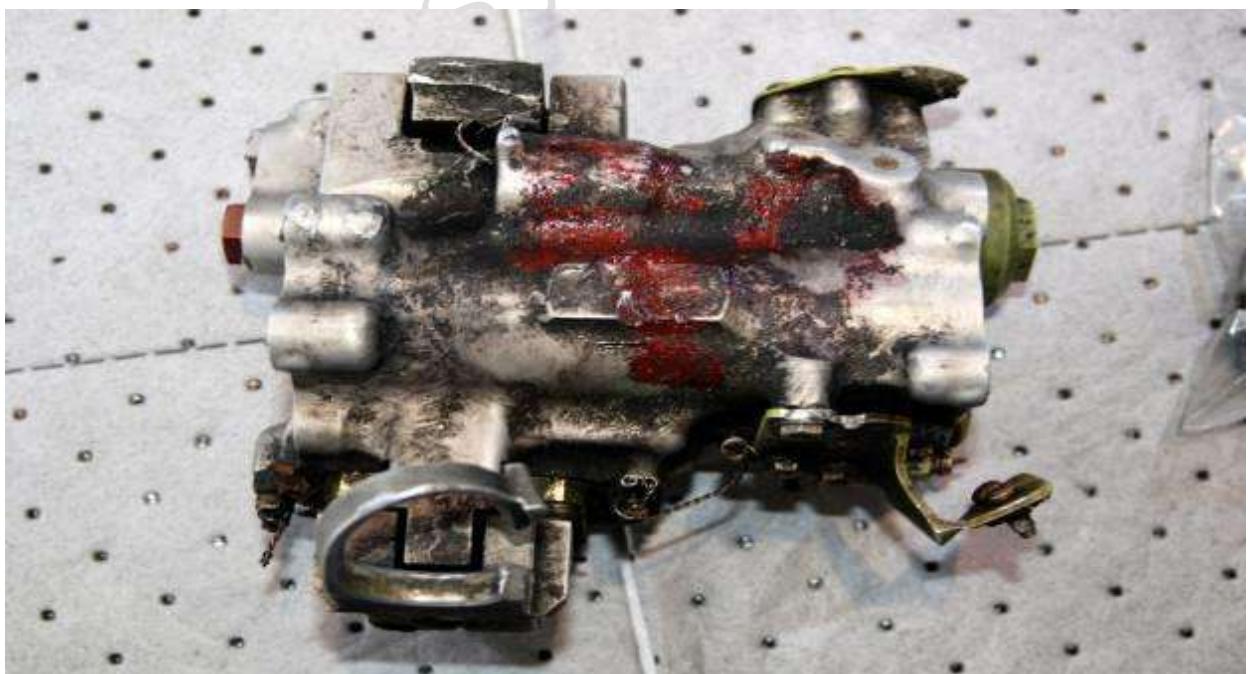
Left PCU (Fig. 44) sustained considerable damage in the accident sequence as follows:

Fig. 44. The left PCU external view

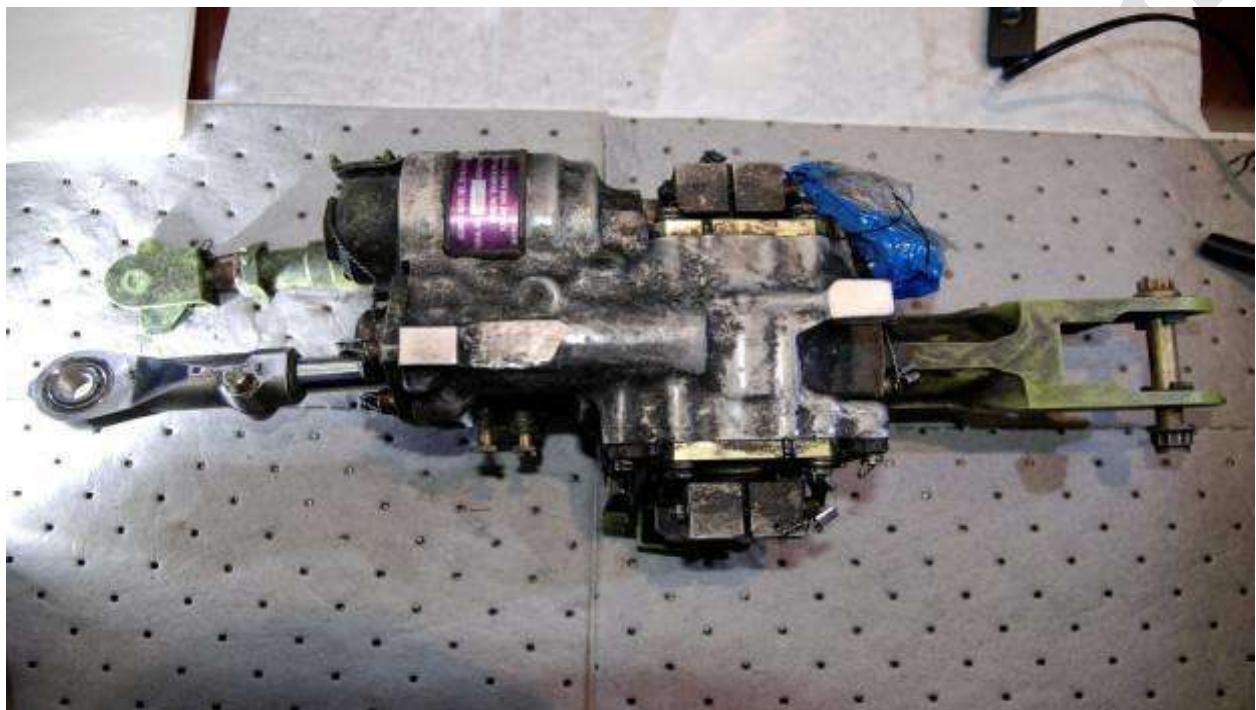
The right PCU (Fig. 45) had been submitted for the examination with the elements of the input pogos. The external surfaces of the PCU are significantly dirtied.

Fig. 45. The external view of the right PCU
