National Transportation Safety Board

Aviation Accident Final Report

Location:	San Diego, California	Accident Number:	WPR15MA243
Date & Time:	August 16, 2015, 11:03 Local	Registration:	N1285U
Aircraft:	Cessna 172M	Aircraft Damage:	Destroyed
Defining Event:	Midair collision	Injuries:	1 Fatal
Flight Conducted Under:	Part 91: General aviation - Personal

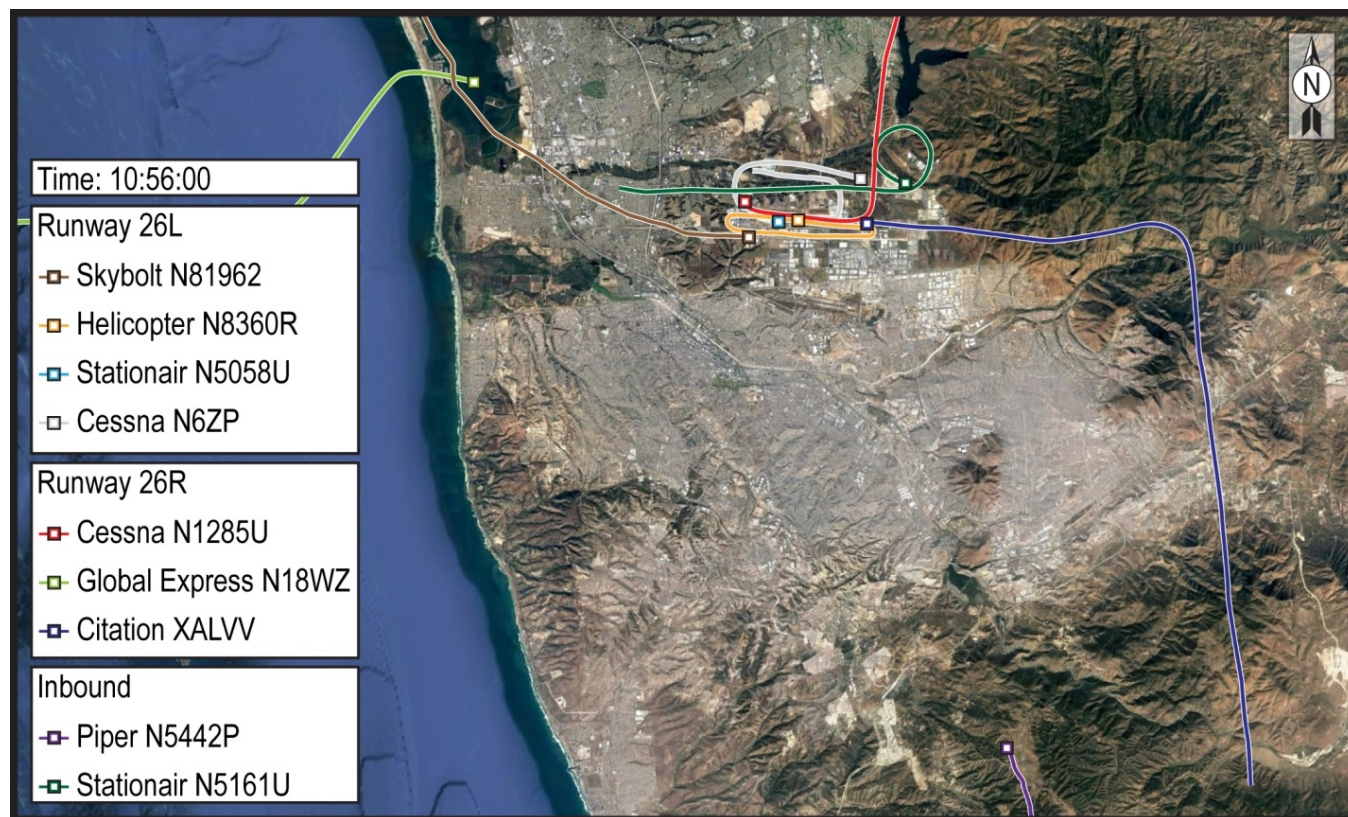
[N18WZ] was inbound for landing, N6ZP was on a right base for a touch-and-go, and XALVV was on short final) and three aircraft were using runway 26L (N1285U was turning right downwind for the touch-and-go, N81962 was on a left downwind for landing, and N8360R was conducting a touch-and-go operation). Figure 1 shows the aircraft in the SDM traffic pattern about 8 minutes before the accident.

Figure 1. Aircraft in the SDM traffic pattern about 8 minutes before the accident.

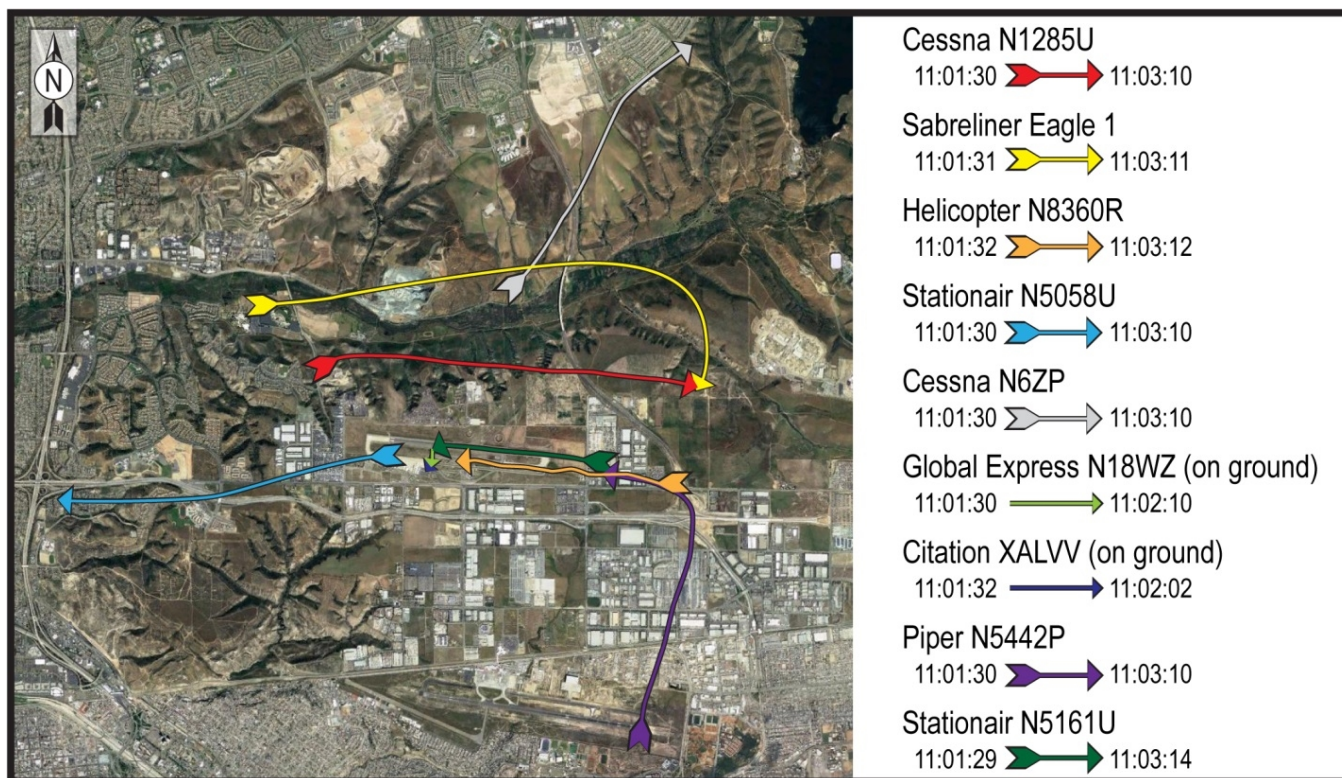
During the next 2 minutes, the LC made several errors that were either corrected by him or by the pilots under his control. At 1059:44, after the pilot of N6ZP completed a touch-and-go on runway 26R, he requested a right downwind departure from the area. The LC did not respond. At 1100:23, the LC instructed, "stationair five eight uniform two six right cleared for I'm sorry two six left cleared for takeoff." At 1100:29, the pilot of N5058U stated, "uh I'm sorry was that for five eight uniform?" The LC then cleared the pilot of N5058U for takeoff from runway 26L. At 1100:36, the LC transmitted, "helicopter six zero romeo there is a ces ah cen ah correction stationair just ahead they are going to the right runway base leg for two six left." At 1100:46, the pilot of N6ZP repeated his request for departure; the LC then approved N6ZP's departure request, and N6ZP departed the traffic pattern in a northeasterly direction. At 1100:53, the LC instructed the helicopter pilot, "helicopter six zero romeo listen up turn crosswind" before correcting the instruction 4 seconds later to "turn base." At 1101:15, the Eagle1 CVR recorded the copilot state, "got one on the runway," and at 1101:19, the Eagle1 CVR recorded the pilot comment, "wowww. he's like panicking" (with an emphasis on panicking). Figure 2 shows the aircraft in the SDM traffic pattern from about 1101 until the time of the accident.

Figure 2. Aircraft in the SDM traffic pattern from about 1101 until the time of the accident.

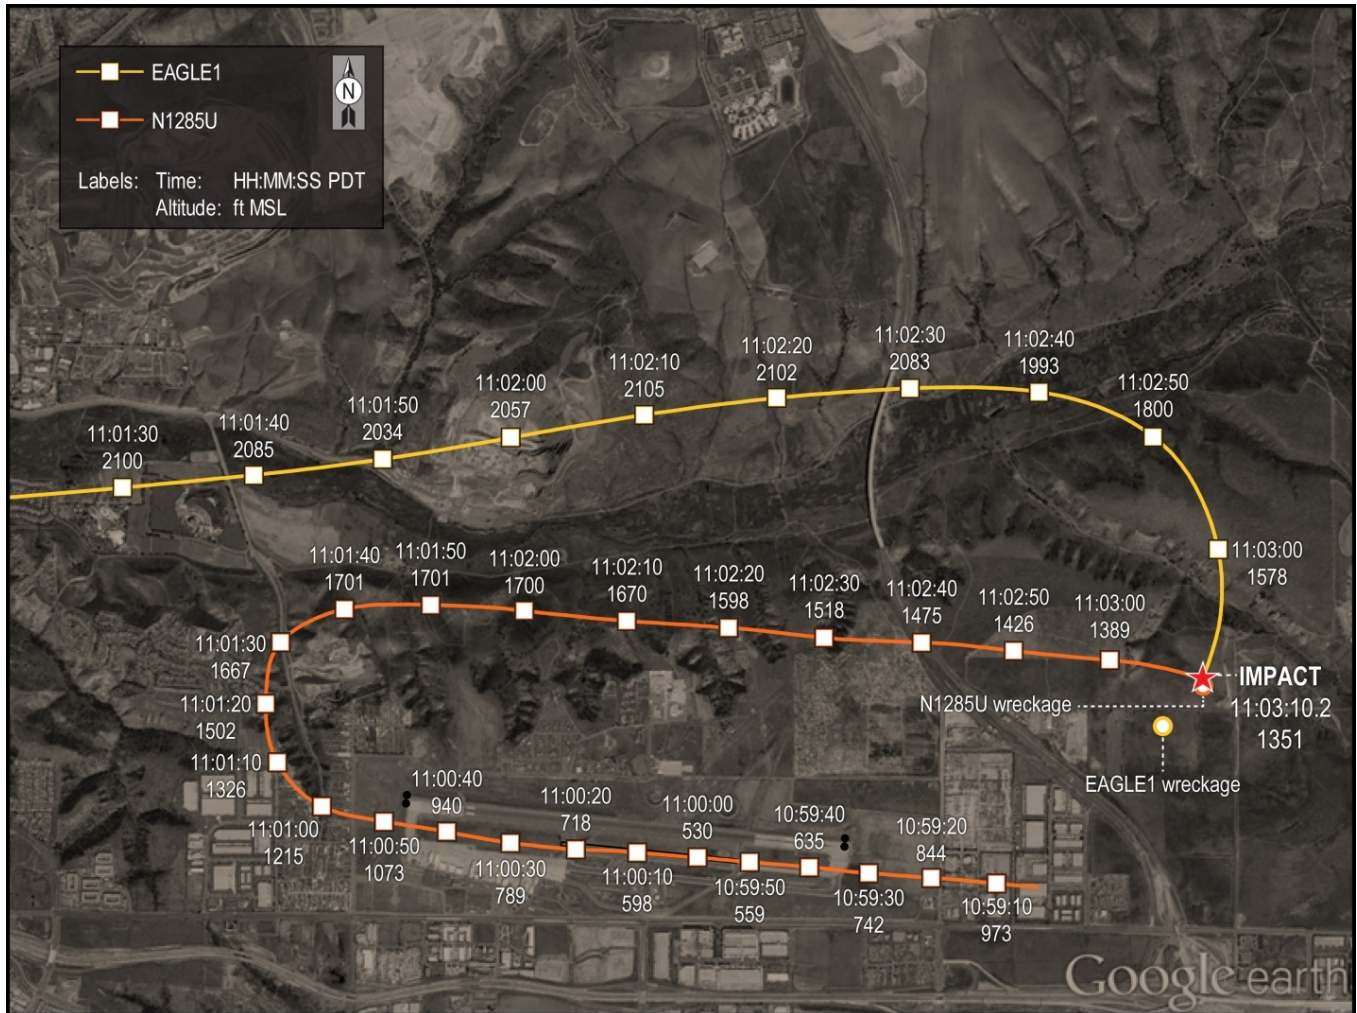
Figure 3. Calculated flight tracks of Eagle1 and N1285U.

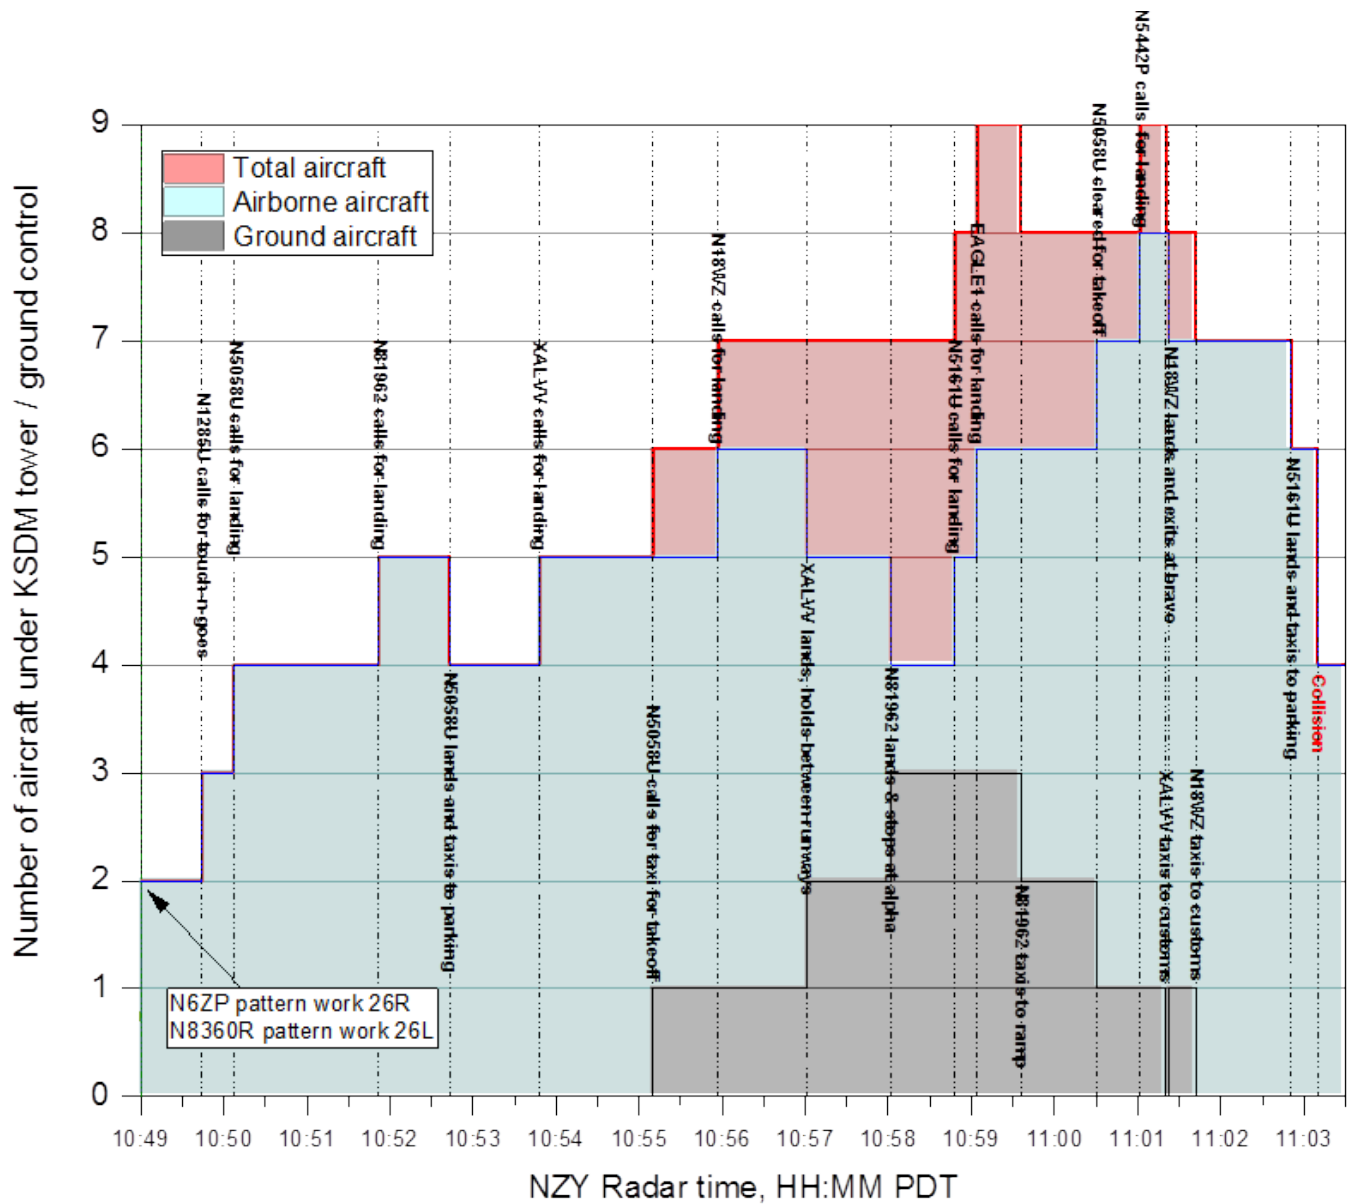
Figure 4. Total aircraft under SDM ATCT control from 1049 until the time of the collision.

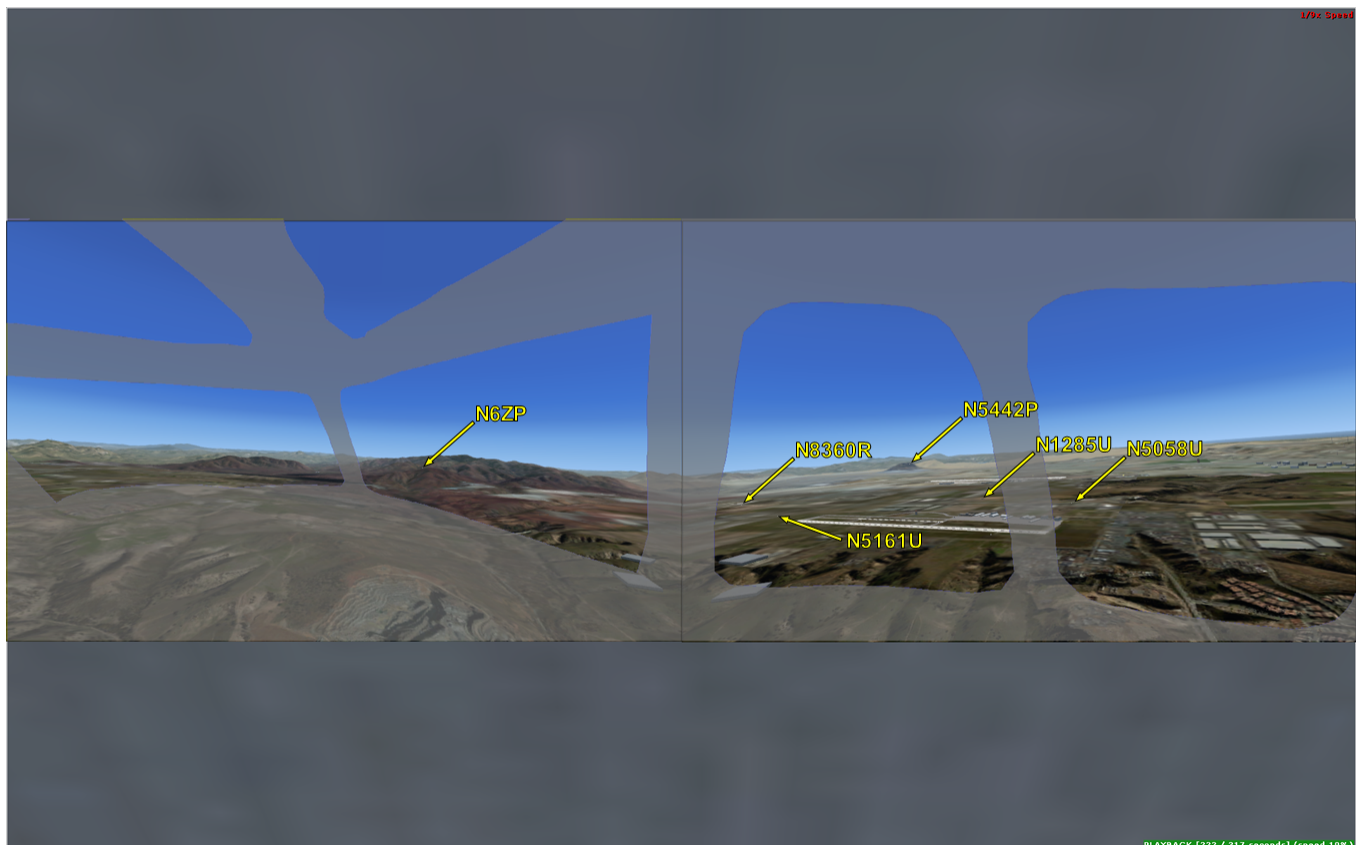
At 1101:43.1, N1285U would have been located just to the left of the window post separating Eagle1's R2 and R3 windows, and N5058U would have been just to the right of this post (see figure 7a). Eagle1 would have appeared in the left window of N1285U, just below the wingtip (see figure 7b). Eagle1 and N1285U were both on the right downwind leg for runway 26R, with Eagle1 about 0.4 nm north of N1285U.

Figure 7a. View from the copilot seat of Eagle1 at 1101:43.1, when the airplanes were 0.5 nm apart.

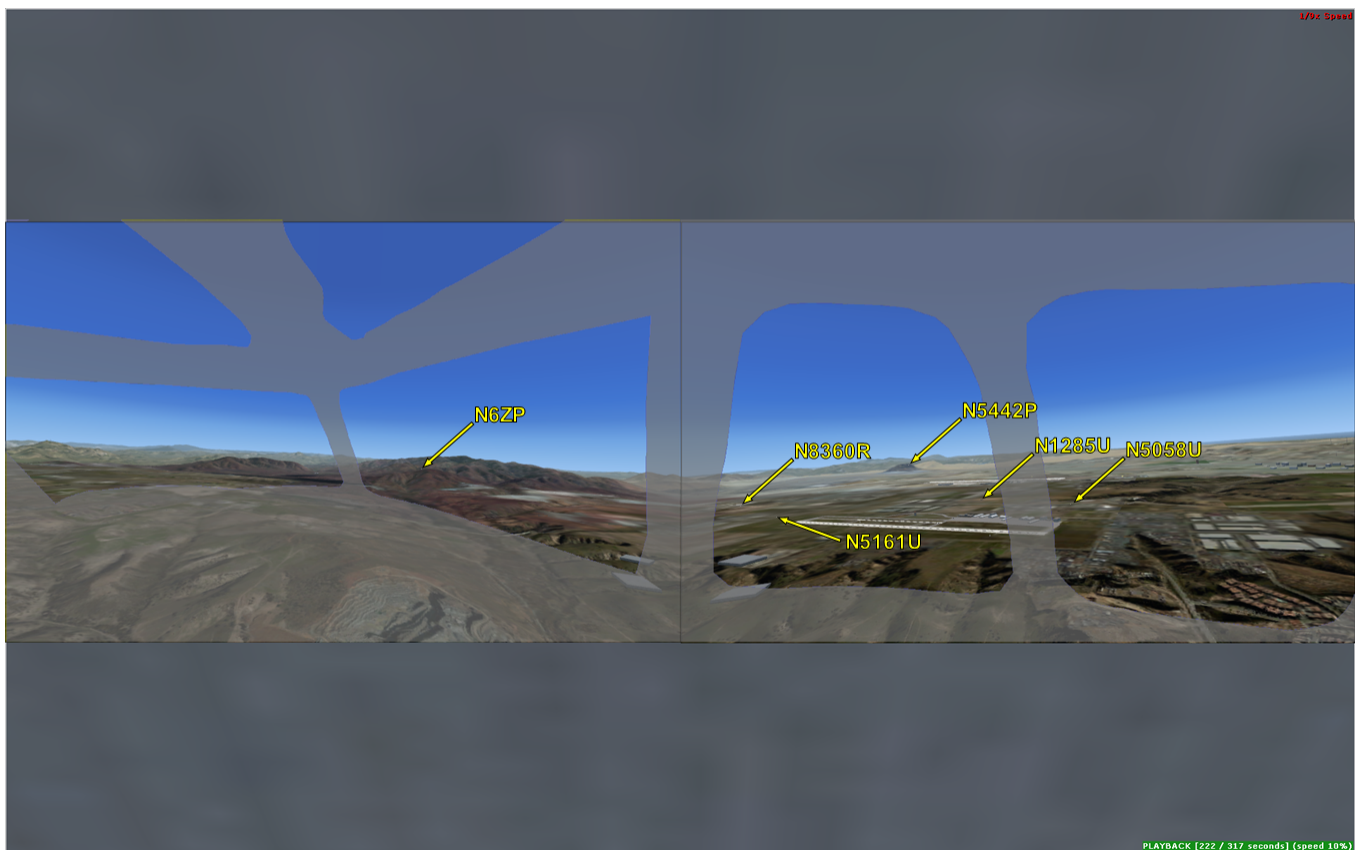
At 1102:32.0, when the LC mistakenly instructed N6ZP to make a right 360° turn, intending the instruction for N1285U, Eagle1's CVR recorded the pilot ask "you still got the guy on the right side?" N1285U was 0.8 nm away and would have appeared in Eagle1's R3 window (see figure 8a). Also to Eagle1's right were N8360R (on short final approach for runway 26L), N5442P (on a left base leg for runway 26L), and N5058U (which was climbing through 1,500 ft about 2.6 nm to the west of the runway 26R threshold). Eagle1 would have been obscured from the N1285U pilot's field of view by the left wing and strut (see figure 8b). Eagle1 started banking to the right, turning toward right base, shortly after this time.

Figure 8a. View from the copilot seat of Eagle1 at 1102:32.4, when the airplanes were 0.8 nm apart.

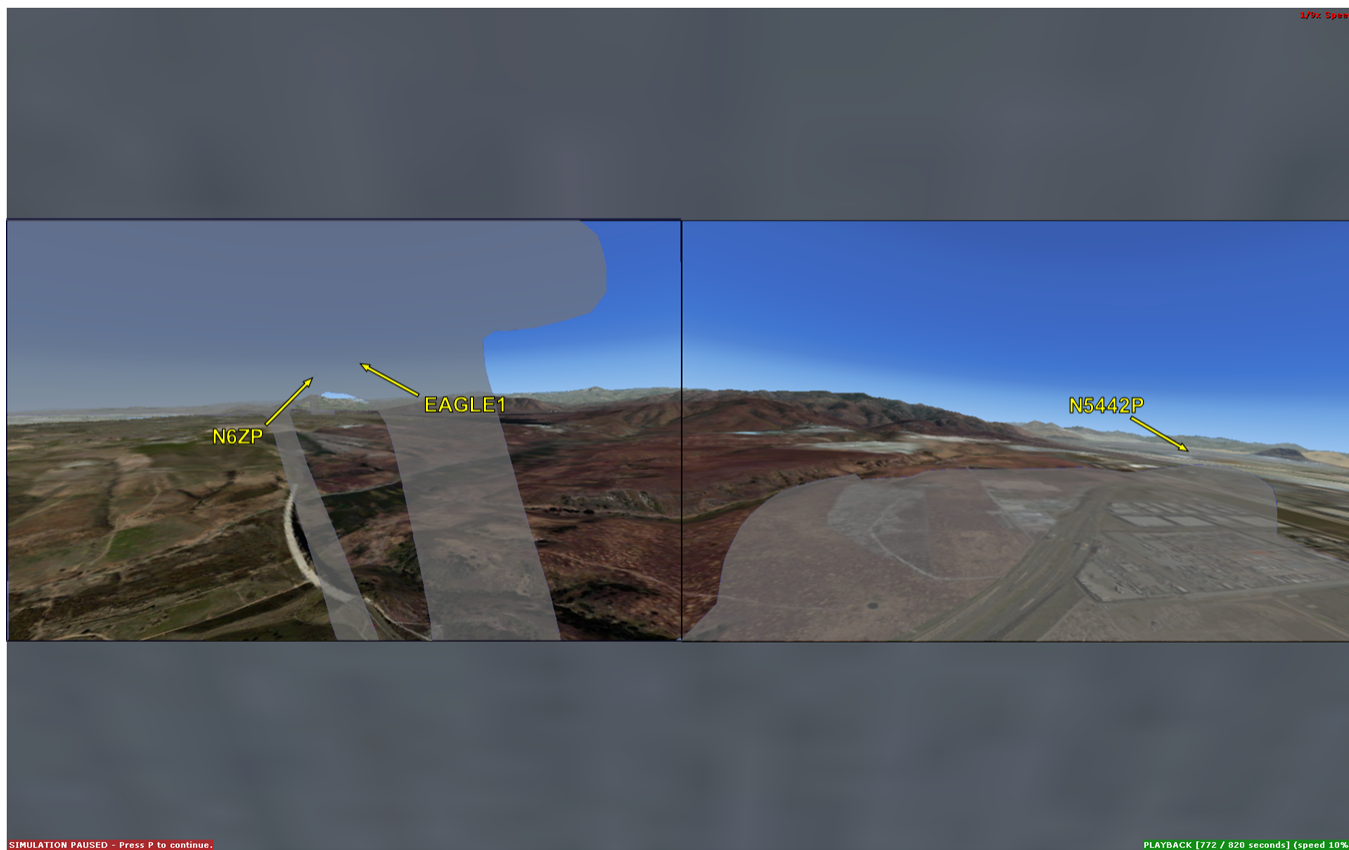
Figure 8b. View from the pilot seat of N1285U at 1102:32.4, when the airplanes were 0.8 nm apart.

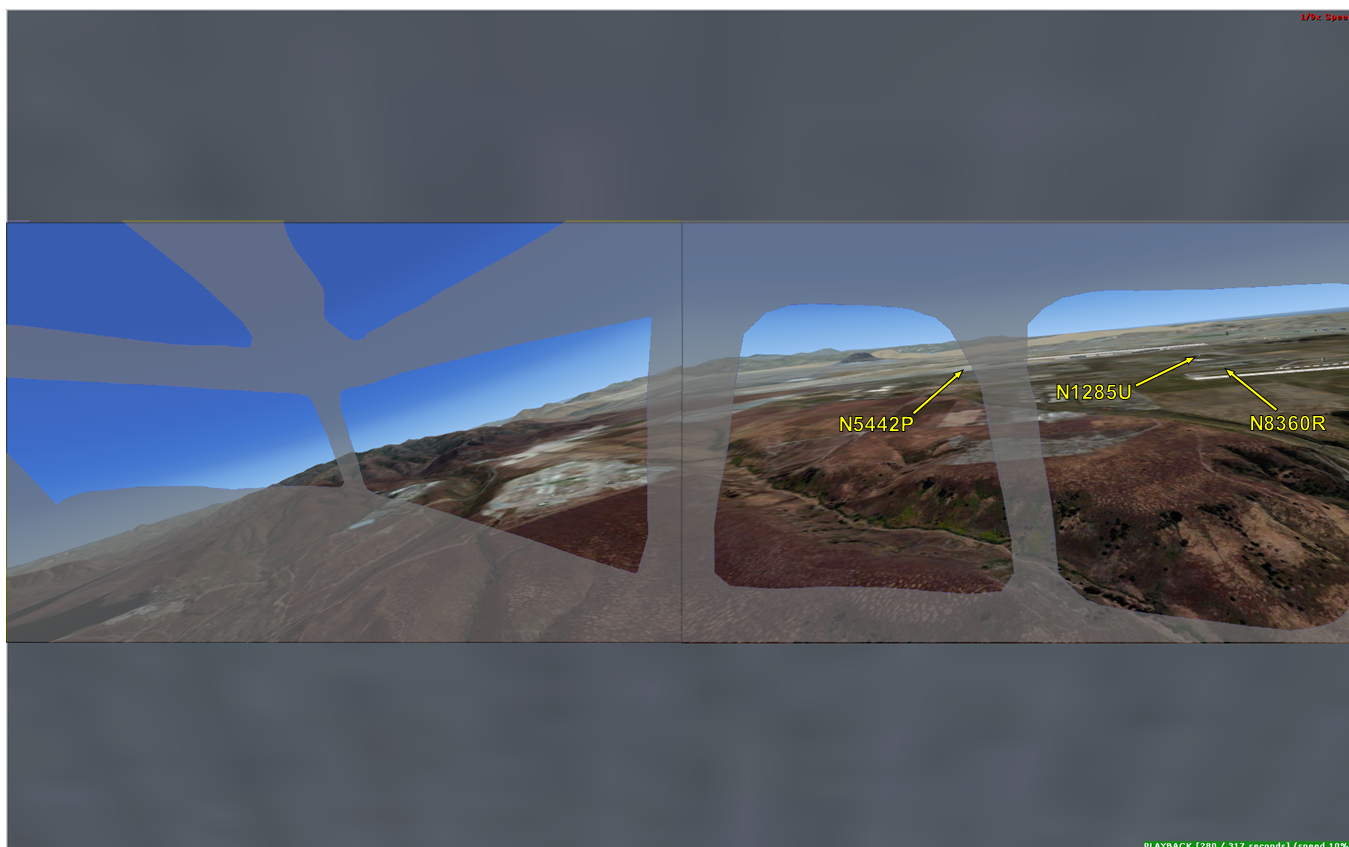
At 1102:42.0, when the LC instructed the pilot of Eagle1 to "turn base two six right cleared to land," Eagle1 was descending through 1,960 ft in a right bank, about 1.3 nm north and 0.7 nm east of the runway 26R threshold. N1285U was descending through 1,460 ft, about 0.6 nm north and 0.3 nm east of the threshold, and would have appeared in Eagle1's R3 window (see figure 9a). Eagle1 would have appeared in the N1285U pilot's field of view near the edge or slightly behind the window post separating the left window from the windshield (see figure 9b). The airplanes were still about 0.8 nm away from each other.

Figure 9a. View from the copilot seat of Eagle1 at 1102:42.0, when the airplanes were 0.8 nm apart.
