National Transportation Safety Board

Aviation Accident Final Report

Location:	Rome, Georgia	Accident Number:	ERA16LA131
Date & Time:	March 14, 2016, 15:08 Local	Registration:	N465FL
Aircraft:	RAYTHEON AIRCRAFT COMPANY 400A	Aircraft Damage:	Substantial
Defining Event:	Runway excursion	Injuries:	2 Minor
Flight Conducted Under:	Part 91: General aviation - Positioning

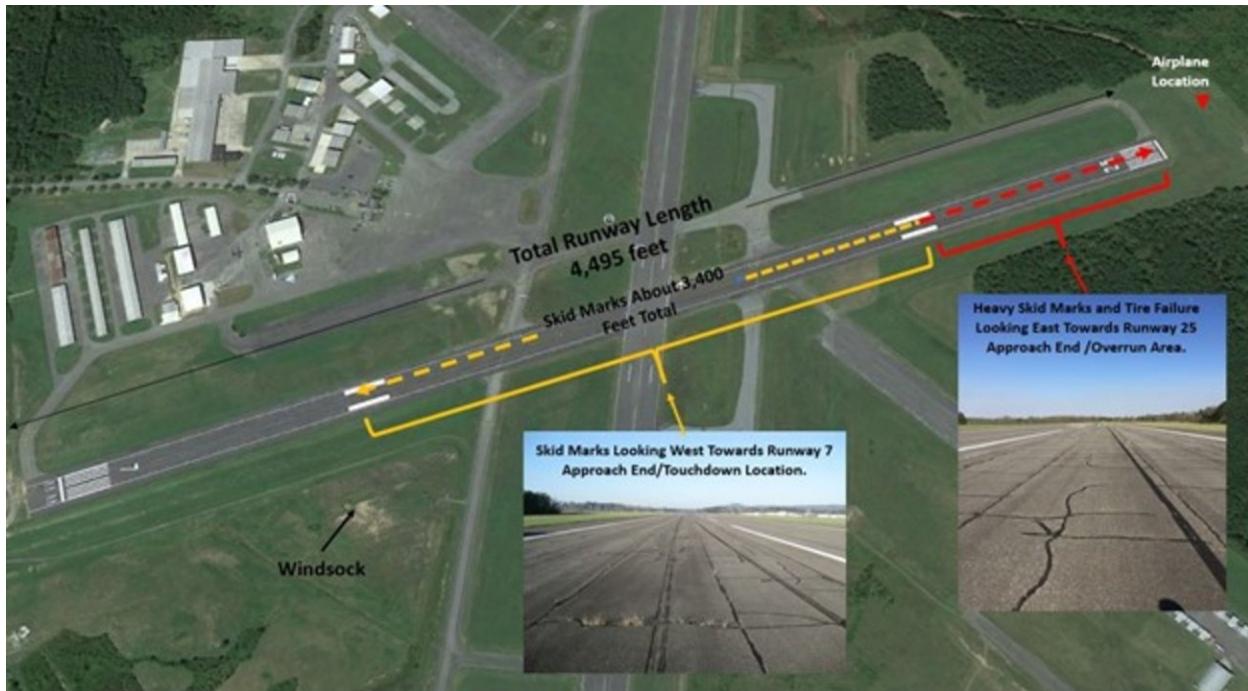
Tire skid marks were found beginning about 1,000 feet from the approach end of runway 7. The PF stated that the airplane touched down "abruptly at Vref+5 and he applied the brakes while the PM applied the speed brakes. Neither pilot felt the airplane decelerating, so the PF applied harder pressure to the brakes with no effect and subsequently applied full braking pressure. When it was evident that the airplane was going to depart the end of the runway, the PM applied the emergency brakes, at which point he felt some deceleration; however, the airplane overran the end of the runway and travelled through grass and mud for about 370 feet before stopping.

Based on the available evidence, the pilots failed to recognize performance cues and use available sources of wind information that would have indicated that they were landing in significant tailwind conditions and conduct a go-around. Landing under these conditions significantly increased the amount of runway needed to stop the airplane and resulted in the subsequent runway overrun and the collapse of the NLG.

During a postaccident examination of the runway, tire skid marks were found beginning about 1,000 ft from the approach end of the runway 7. The tire marks swerved slightly toward the right about 20 ft right of the centerline and then slightly left toward the centerline and extended to the runway end. Further down the runway, the tire marks became increasingly more pronounced, flattened out, and widened. The tire marks continued and veered left through grass and mud for another 370 ft past the departure end of the runway, where the airplane came to rest (see figure 1).

Figure 1 - Overhead view of runway layout showing the approximate measurements of the skid marks and the airplane's final resting location.
