National Transportation Safety Board

Aviation Accident Final Report

Location:	Nashville, TN	Accident Number:	DCA16LA032
Date & Time:	12/15/2015, 1730 CST	Registration:	N649SW
Aircraft:	BOEING 737 3H4	Aircraft Damage:	Substantial
Defining Event:	Landing gear collapse	Injuries:	138 None
Flight Conducted Under:	Part 121: Air Carrier - Scheduled

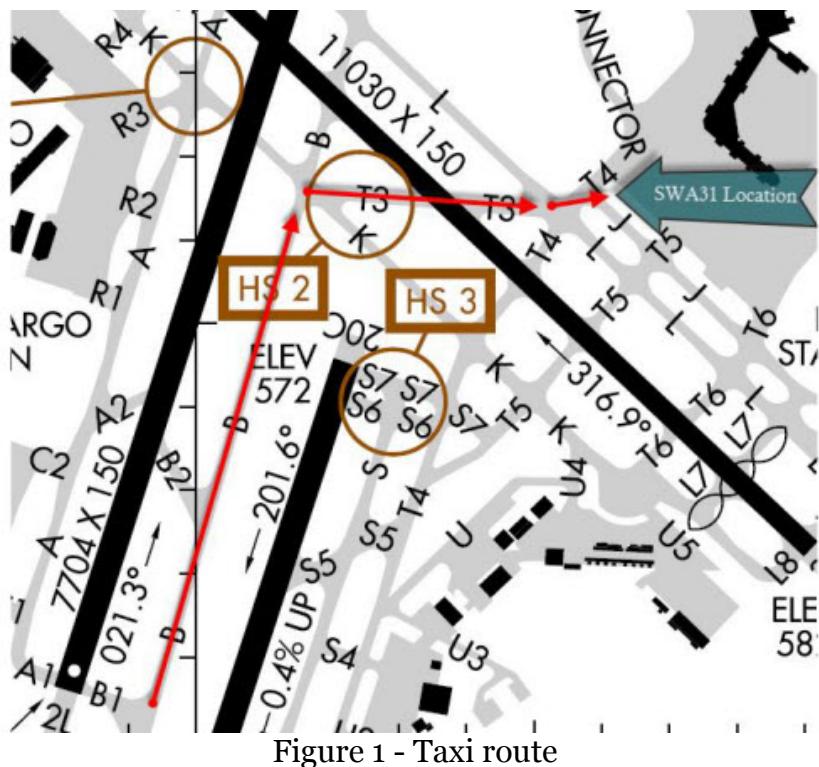
The airplane landed normally on runway 20R and exited at taxiway B2. ATC instructed the flight to taxi to the ramp (gate C20) via taxiway B, T3, and T4. (Figure 1)

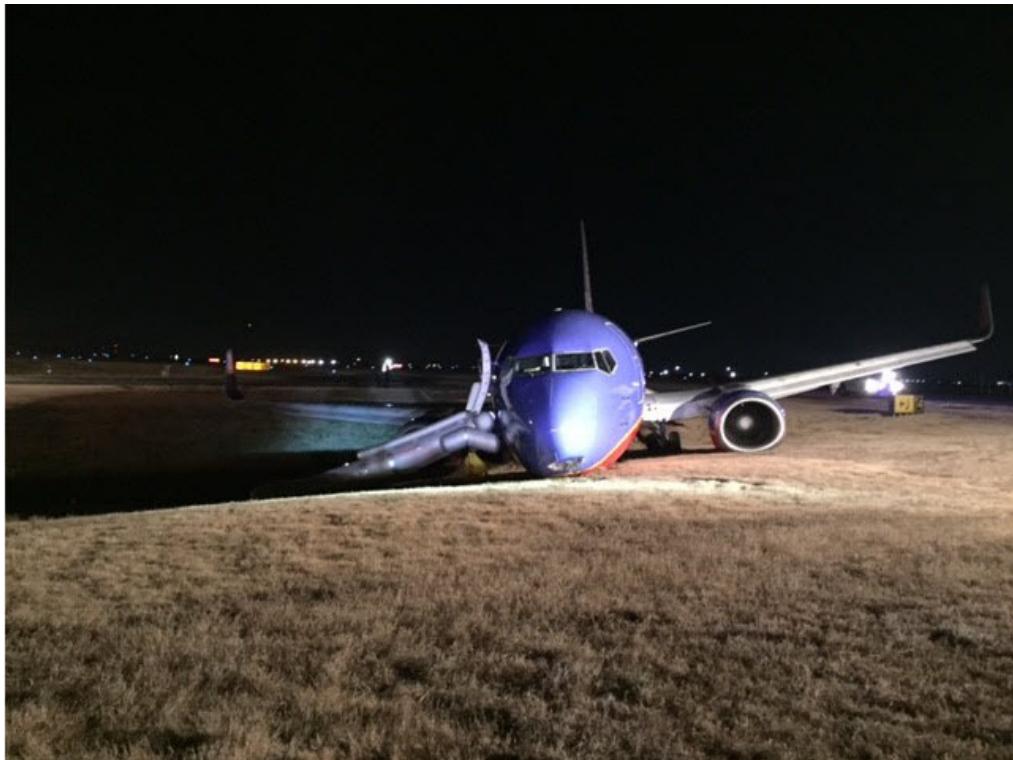
Figure 2 - Aircraft resting position

with the heading toward gate C20. Three seconds later the airplane exited the taxiway into a grassy area with a large drainage ditch, east of the intersection of taxiways T4 and J. The nosegear collapsed, and the airplane came to rest angled to the right, on the left nacelle, right wing tip, and nose. (Figure 2)

The nose landing gear collapsed in a rearward direction resulting in substantial damage to frames, stringers, and the bulkhead aft of the nose gear well. Additional minor damage to engine nacelles, fairings, and skin was also found.

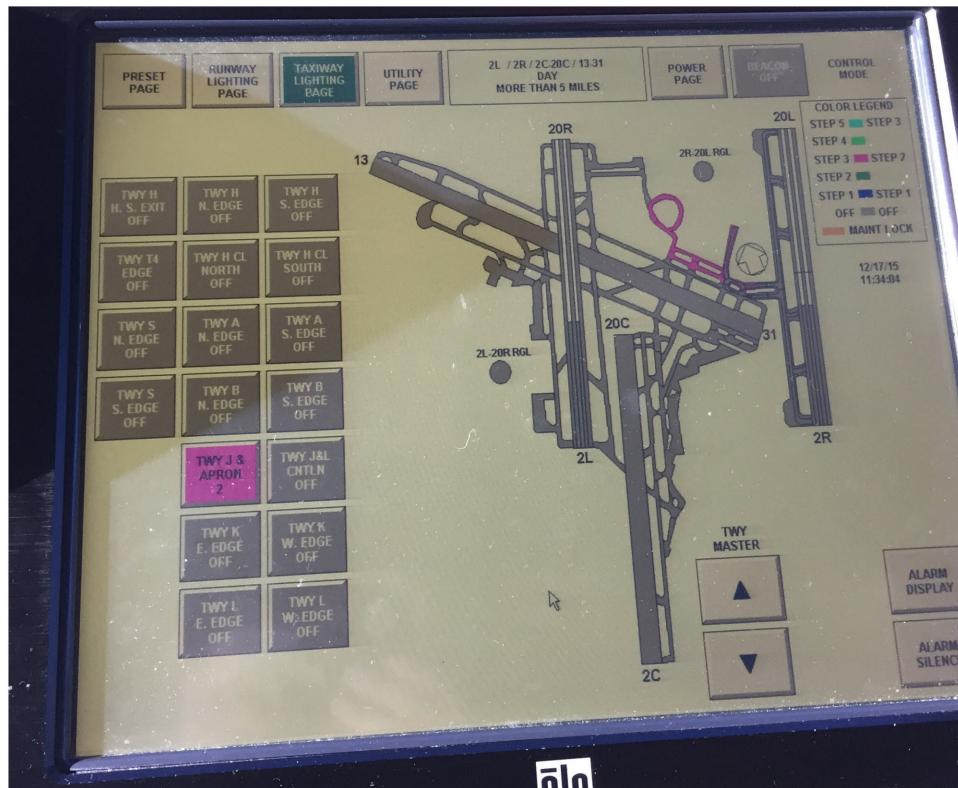
Figure 3 - Lighting panel

Contributing to the accident was the operation of the screen-saver function on the lighting control panel that prevented the tower controllers from having an immediate visual reference to the status of the airfield lighting.

The airfield lighting panels (Figure 3) were owned by the Metropolitan Nashville Airport Authority (MNAA) and were operated using software installed in 2010. The airfield lighting was operated in accordance with requirements contained in FAAO 7110.65, Air Traffic Control, and a letter of agreement between the control tower and MNAA dated December 16, 2013.

The lighting panel had preset intensity selections used according to current weather/day/night conditions and was operated by the tower controllers via a touch screen that selected lighting intensities as required by the current conditions. Specific airfield lighting configurations could be selected to operate independently of the pre-set conditions, such as turning off a specific taxiway lighting circuit. The touch screen control circuit that activated or deactivated the taxiway centerline lights was located next to the touch screen control circuit that activated or deactivated the lighting for the ramp/apron and a portion of taxiway T4.

The lighting panels had a screensaver mode that caused the screen to go black after approximately five minutes if the panel was not accessed by a controller.

ATCT staff informed investigators that as a result of past complaints regarding the brightness of the green taxiway centerline lights on taxiways H, J, L, and T6, BNA tower controllers routinely turn off the centerline lighting. On the date of the accident the facility had not received any specific request to turn off the centerline lights; however, prior to the event, the controller in charge (CIC) attempted to turn off the centerline lights as a matter of routine. In doing so, the CIC inadvertently turned off the "TWY J & Apron 2" selector.

Subsequent to the accident, Nashville ATCT modified their standard operating procedure regarding responsibility for taxiway lighting and eliminated the lighting panel screensaver function.
