**KOMITE NASIONAL KESELAMATAN TRANSPORTASI
REPUBLIC OF INDONESIA**

KNKT.16.10.37.04

Aircraft Accident Investigation Report

DHC – 4 Caribou, PK-SWW

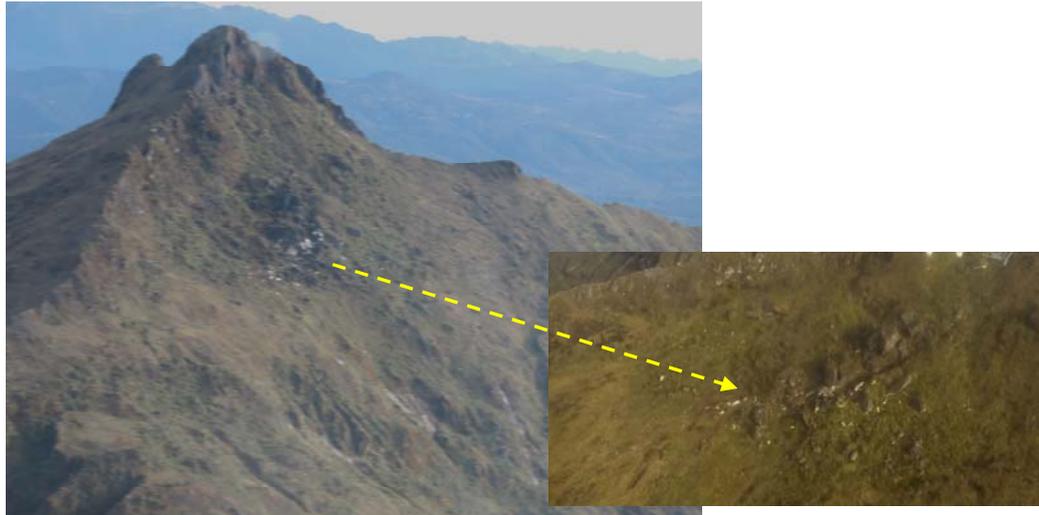
On 1 November 2016, the aircraft wreckage was found on a ridge of mountain between Ilaga Pass and Jila Pass at coordinate 4°5'55.10" S; 137°38'47.60" E with altitude approximately of 13,000 feet.

Figure 1: The location of the aircraft wreckage

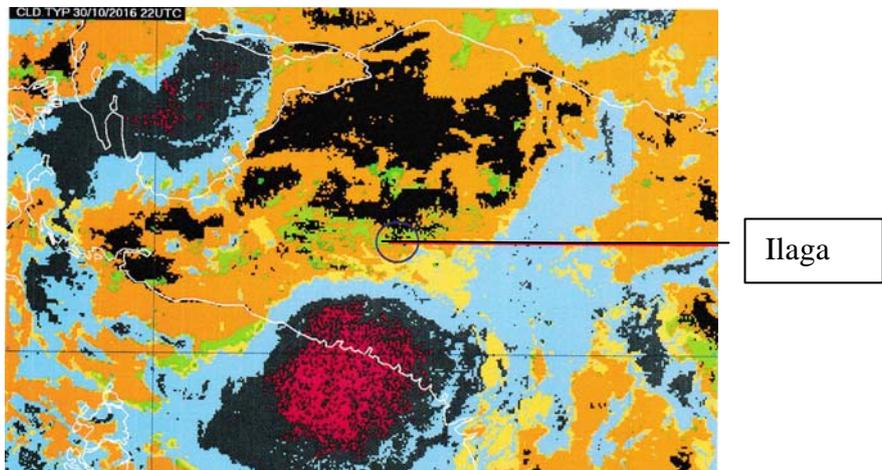
Figure 2: Satellite weather image 31 October 2016 at 2200 UTC.

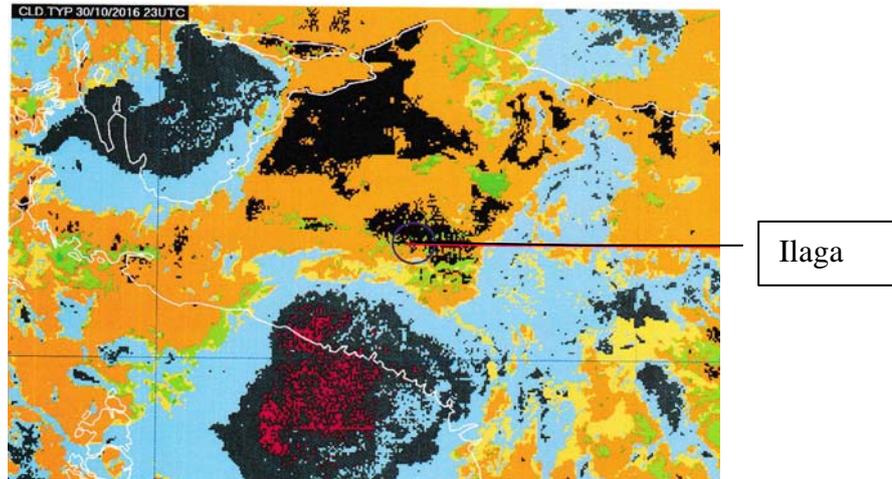
Figure 3: Satellite weather image 31 October 2016 at 2300 UTC

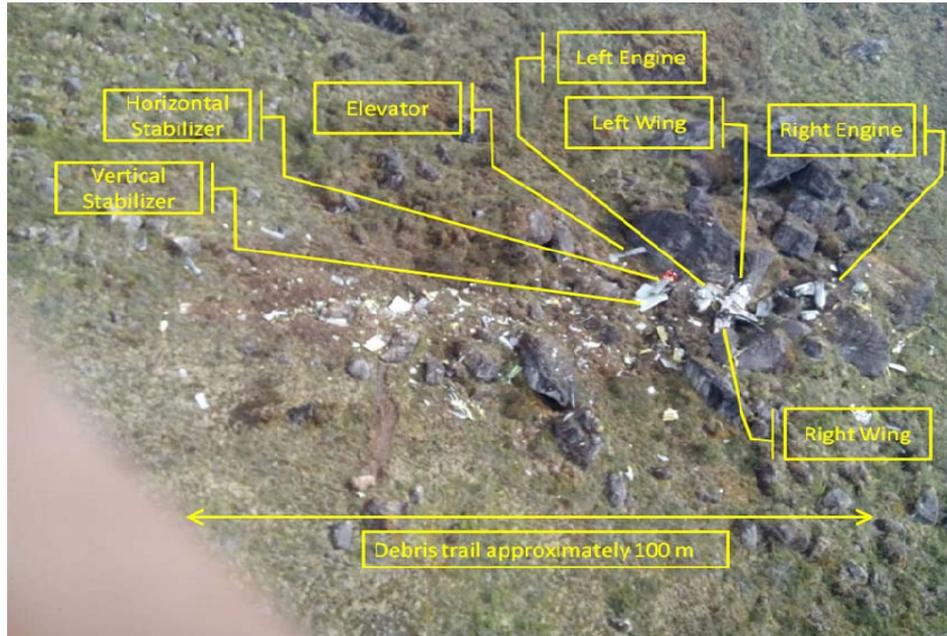
The aircraft was found at the ridge of mountain at elevation approximately 13,000 feet. The impact location was on coordinate 4° 5' 55.10" S 137°38' 47.60" E. The wreckage spread approximately 100 m long on direction of 080°.

Figure 4: The wreckage distribution

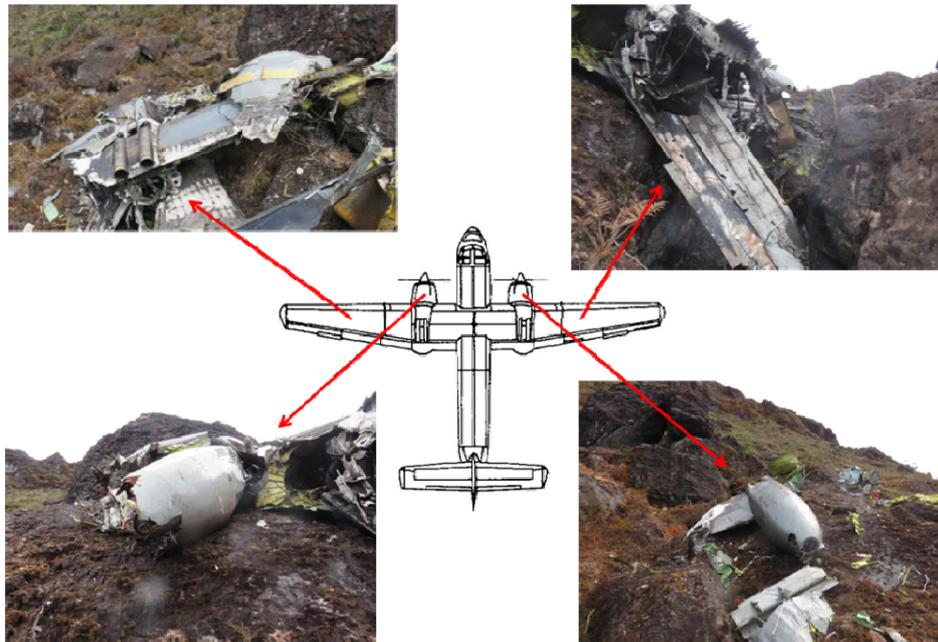
Figure 5: Wings and engines wreckage

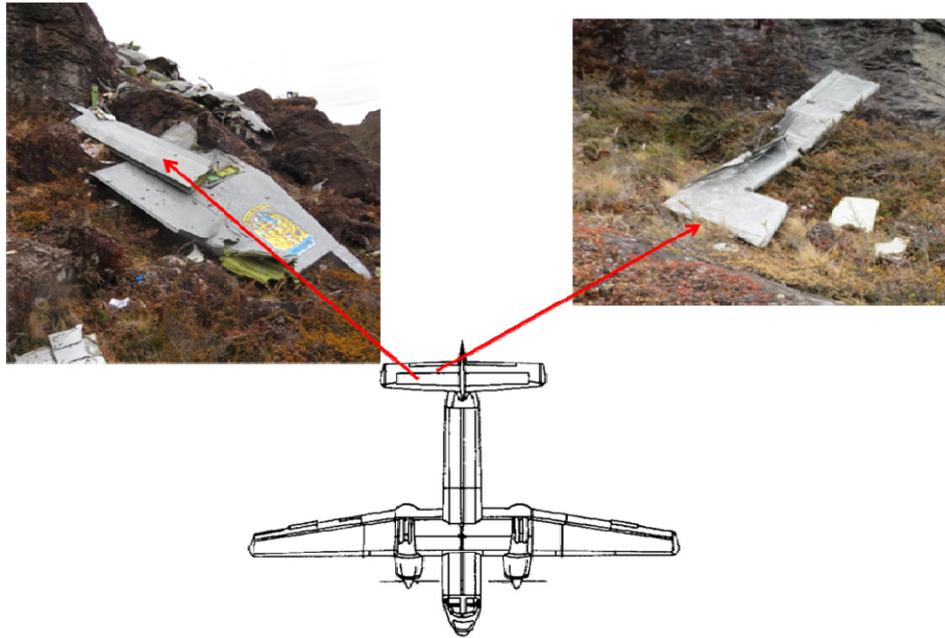
Figure 6: Horizontal stabilizer and elevator wreckage

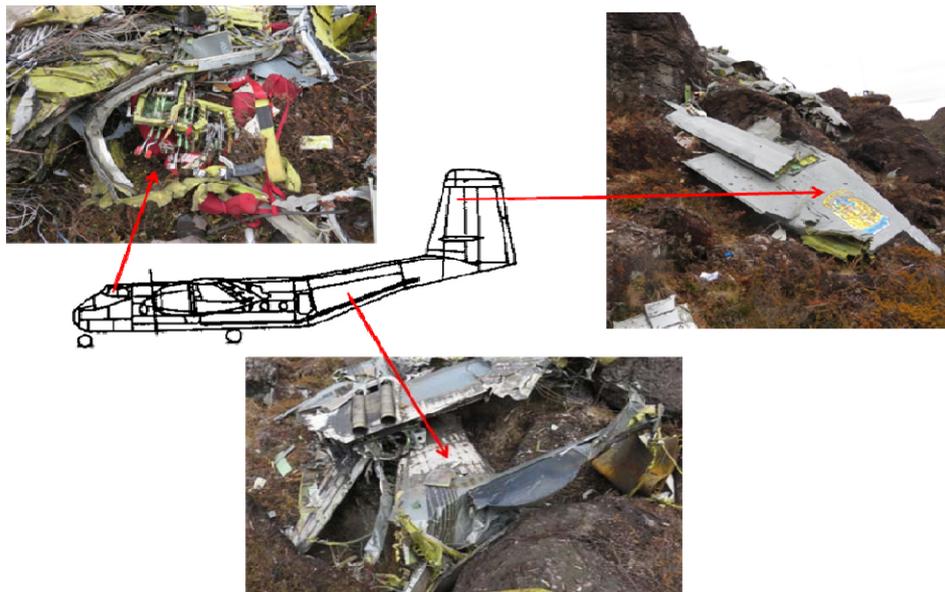
Figure 7: Cockpit, vertical stabilizer and part of empennage wreckage
