FINAL REPORT

Aircraft AN-26B; Flight S2-AGZ21

Cox's Bazar, Bangladesh

FATAL ACCIDENT WHILE GOING AROUND WITH ONE ENGINE OPERATIVE

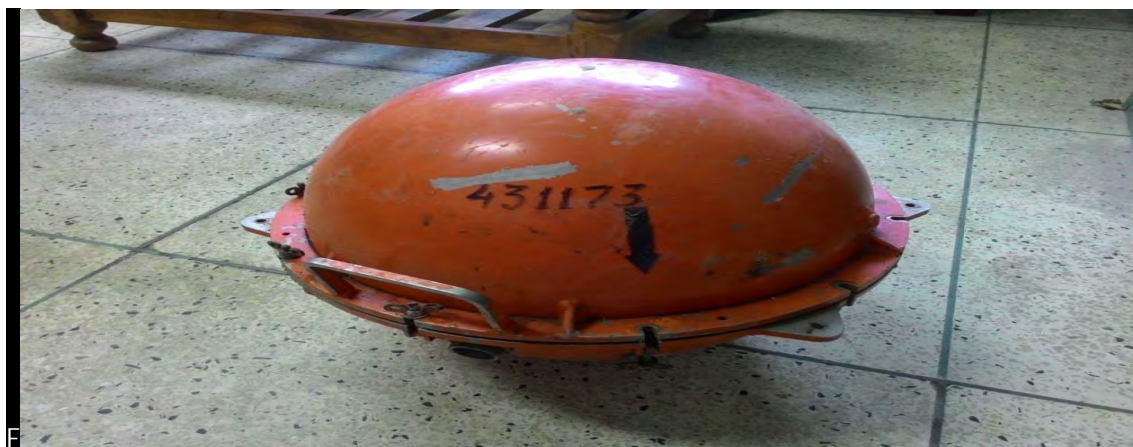
Photo 1 : Cockpit Voice Recorder

According to NBAAI the read out from CVR was not possible due to internal damage to the equipment. The FDR was apparently in good shape. The FDR data was decoded and an animation version of the aircraft in flight was sent by the NBAAI.

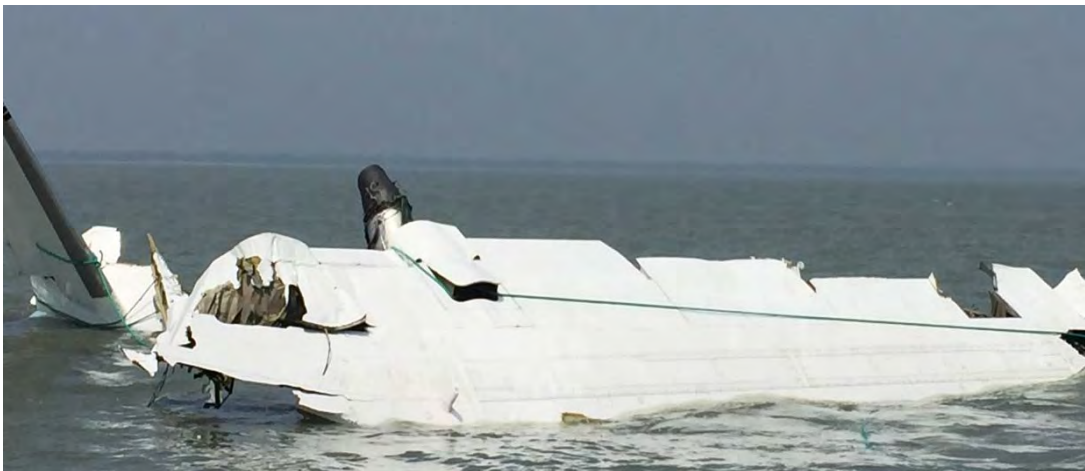
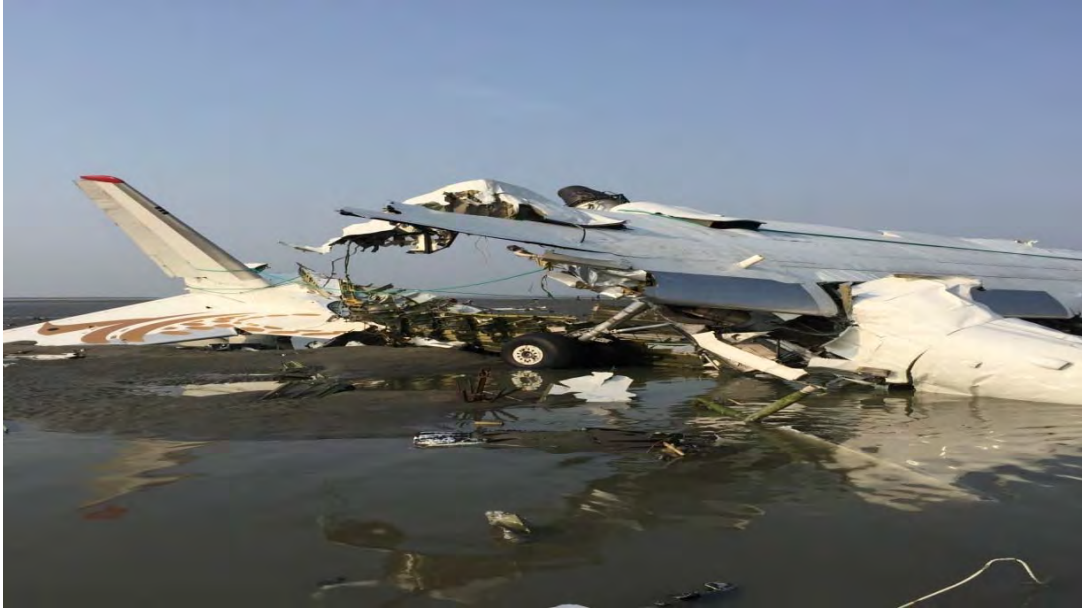
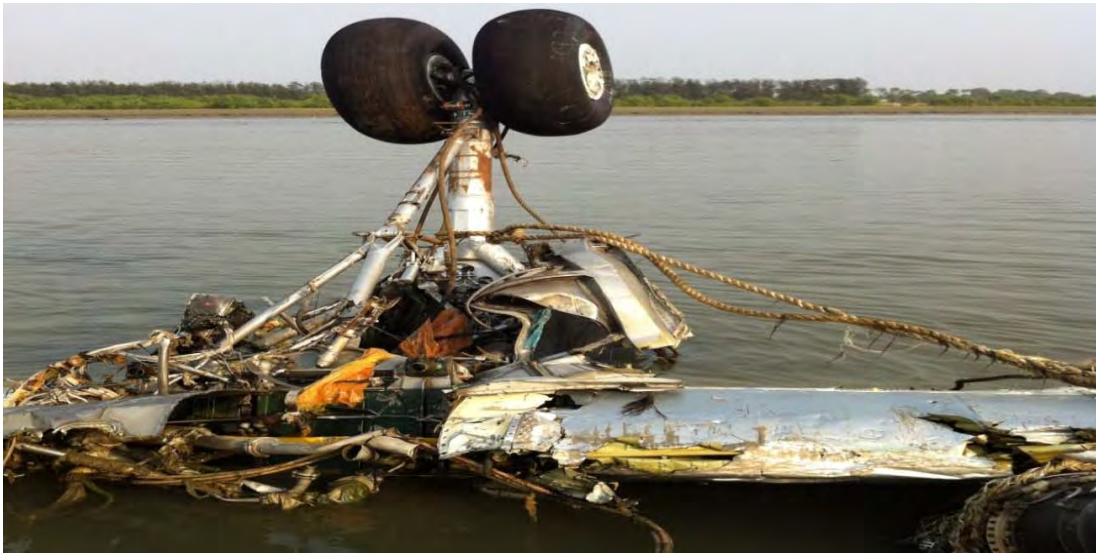
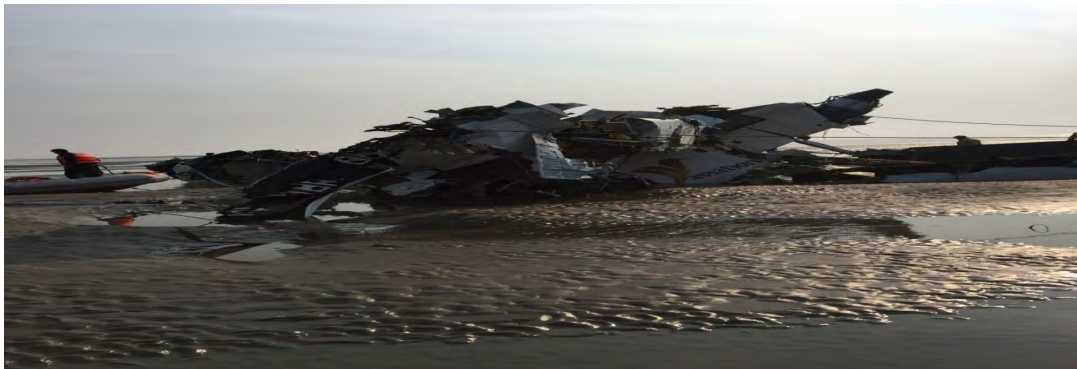
PHOTOS OF THE WRECKAGE

Wreckage Distribution : On visit to the crashed site on the day of the accident the aircraft debris was found half submerged in sea water. During high tide the debris went totally under water. The pieces of the aircraft were seen spread over a large area in the shallow water during the low tide. Some parts were brought to the shore on the following day. Some photographs are also attached with this report as evidence. The visiting representative from the engine manufacturer from Ukraine had carried out baroscopic inspection of the failed left engine. The report is enclosed as Appendix 4.

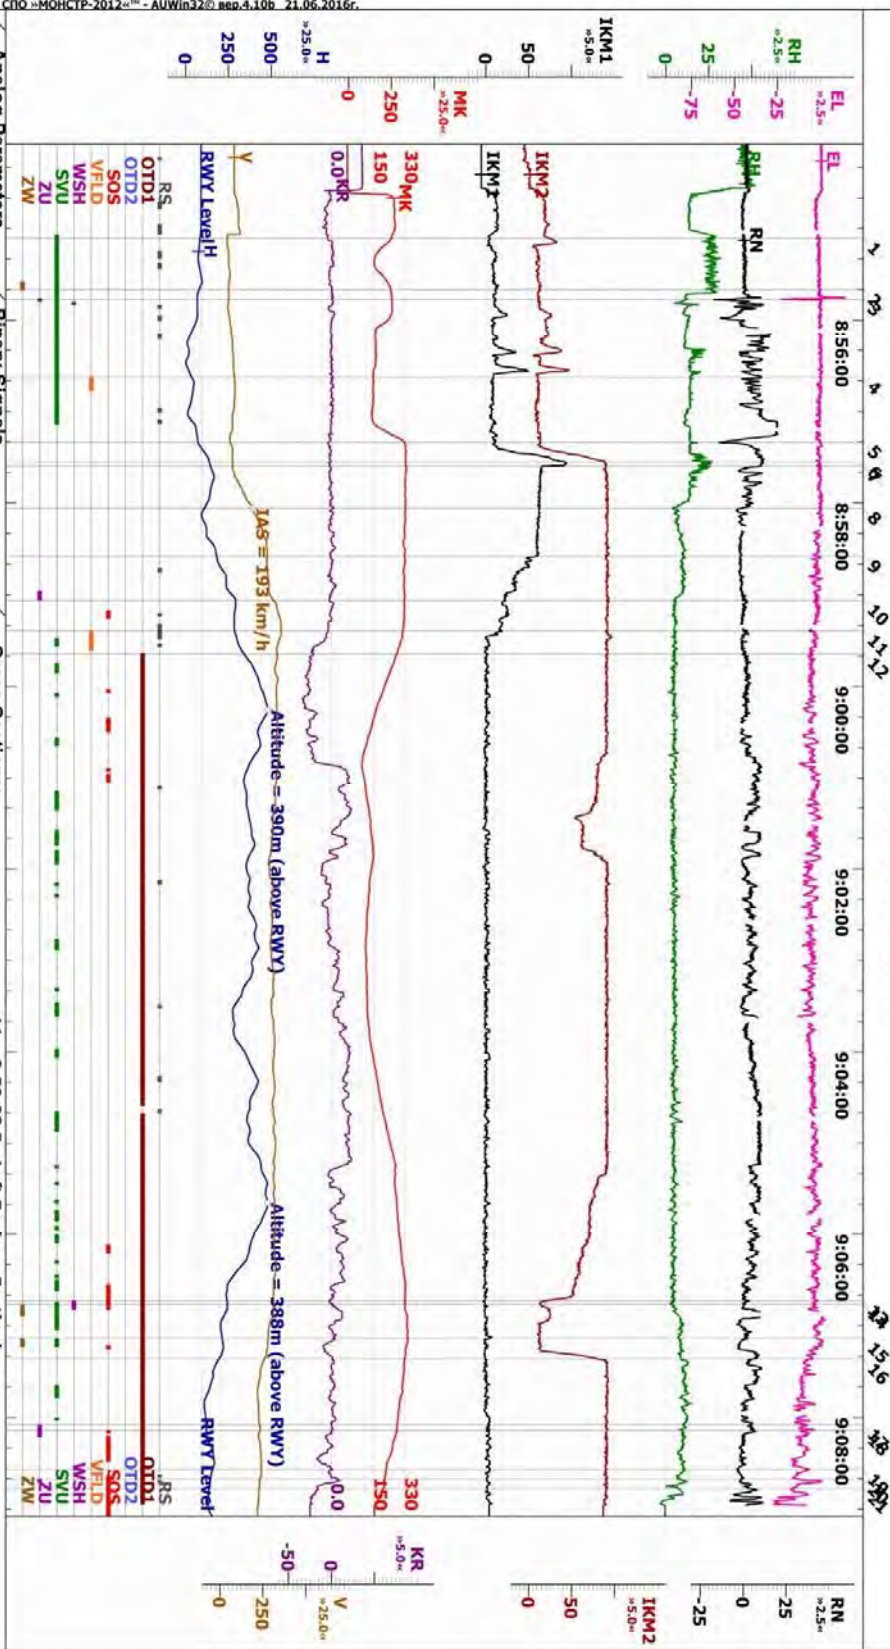
Binary Signals	Cross Sections:
WSH: Landing Gear Is Extending	1. 8:55:06.4 - FDR ready
RS: Radio Transmitter Keying	2. 8:55:40.2 - Flaps Extended
SOS: EGPWS Signal	3. 8:55:46.2 - Control Surfaces Check
ZU: Flaps are Retracting	4. 8:56:38.0 - Feathering Check
ZW: Flaps are Extending	5. 8:57:20.2 - RWY 35
OTD1: Left Engine Negative Power	6. 8:57:33.5 - Full Throttle
OTD2: Right Engine Negative Power	7. 8:57:36.2 - Left Engine - Loss of Power to Cruise Mode
SVU: Propeller Unlatched	8. 8:58:03.5 - Rotation
VFLD: Feathering Pump Operate	9. 8:58:34.8 - Left Engine - Beginning of Full Step

10. 8:59:03.8 - Flaps Retracted
	11. 8:59:23.5 - Left Engine - Feathering
	12. 8:59:38.5 - Left Engine - Failure Signal
	13. 9:06:43.5 - LG Extending
	14. 9:06:46.2 - Flaps Extending 1st Step

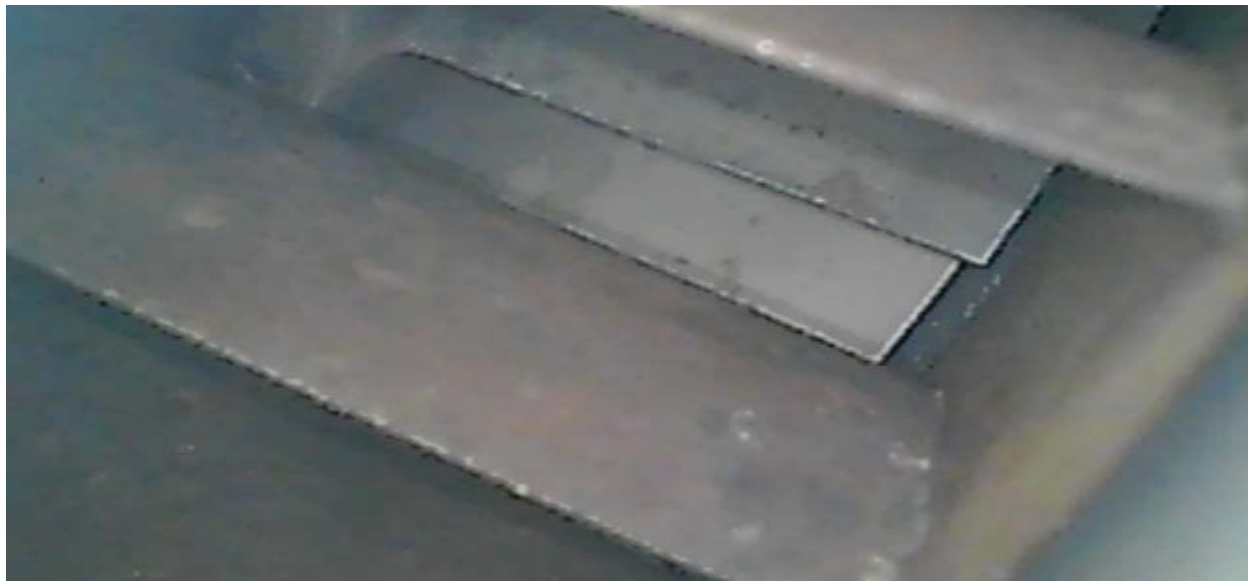
Направляющие и рабочие лопатки 10-й ступени компрессора

Осмотрены направляющие и рабочие лопатки 10-й ступени компрессора – видимых повреждений не обнаружено (см. фото).

Inspection and guide blades of the 10th stage of the compressor - visible damage is detected (see photo.).

After these works, determine the cause of the engine shutdown in flight with feathering propeller, due to the care of the engine oil (according to the navigator) - failed.
