# Collision with terrain involving Cessna 208 Caravan, VH-WTY

11 km north-east of Hamilton Island Airport, Queensland on 28 January 2016

**ATSB Transport Safety Report**  
Aviation Occurrence Investigation  
AO-2016-007  
Final – 25 June 2020

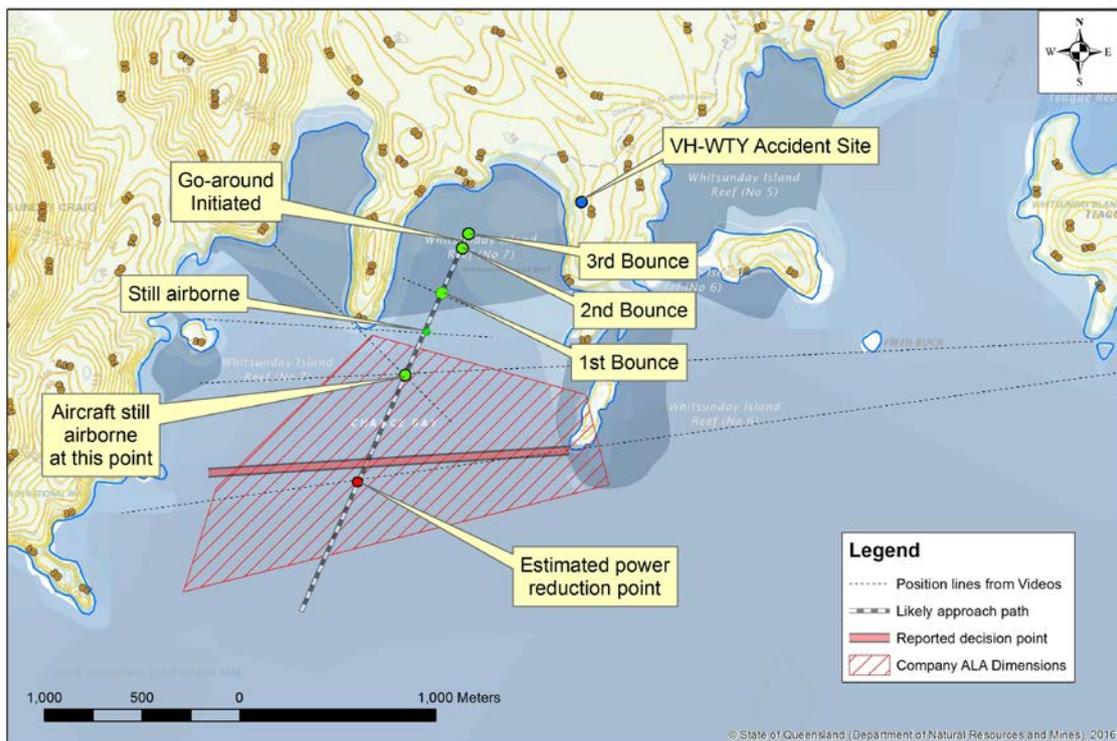
**Figure 2: Aircraft track toward Chance Bay main beach, showing approximate bounce locations and VH-WTY final position**

The ATSB found that the aircraft was flown beyond the aircraft landing area northern boundary before the first bounce off the water. This, combined with the delay in initiating a go-around, reduced the options and margins available for a safe outcome.

The pilot reported setting up for landing at about 50 ft above the water and then delayed the landing in order to fly through an observed wind gust. Passenger video footage indicated that, during the subsequent landing, WTY bounced three times on the surface of the water (Figure 2). After the second bounce, with WTY getting closer to the beach and terrain, the pilot increased engine power and initiated a go-around. The third bounce, which occurred almost immediately

after the second, was the most pronounced and resulted in the aircraft rebounding about 30 to 50 ft above the water. While increasing power, the pilot perceived that the torque was indicating red, suggesting an over-torque for the selected propeller configuration. Noticing that the climb performance was less than expected with the flaps at 30°, the pilot stopped increasing power and reduced the flap to 20°.

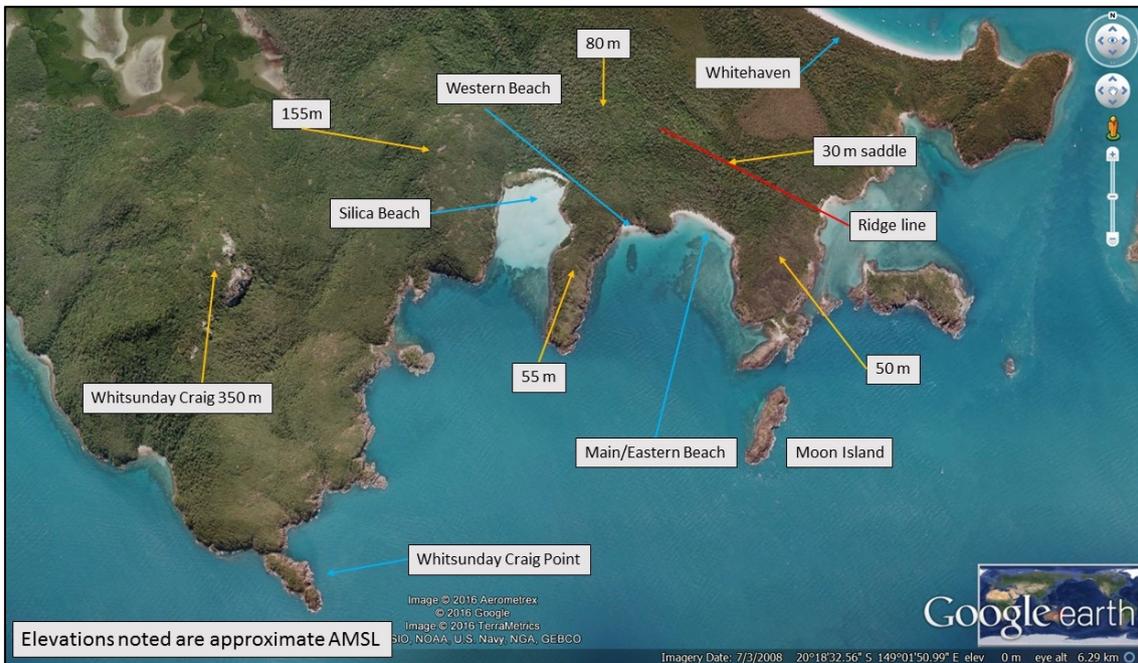
**Figure 3: Chance Bay overview showing local features and elevations**

Chance Bay is characterised by surrounding terrain, being semi-circular in shape (Figure 3). The height of the terrain surrounding the bay is generally from about 35 to 80 m. The ridge line (marked in red) varies from about 60 m elevation in the west to about 50 m at the eastern end of the island. The lowest point (saddle) in this ridge line is about 30 m elevation and is located about 280 m inland from the main beach.

Terrain surrounding the Chance Bay water landing area poses two significant operational landing hazards:

- significant mechanical turbulence/downdrafts in adverse wind conditions
- go-around options reduce to zero the further an aircraft approaches in to the bay.

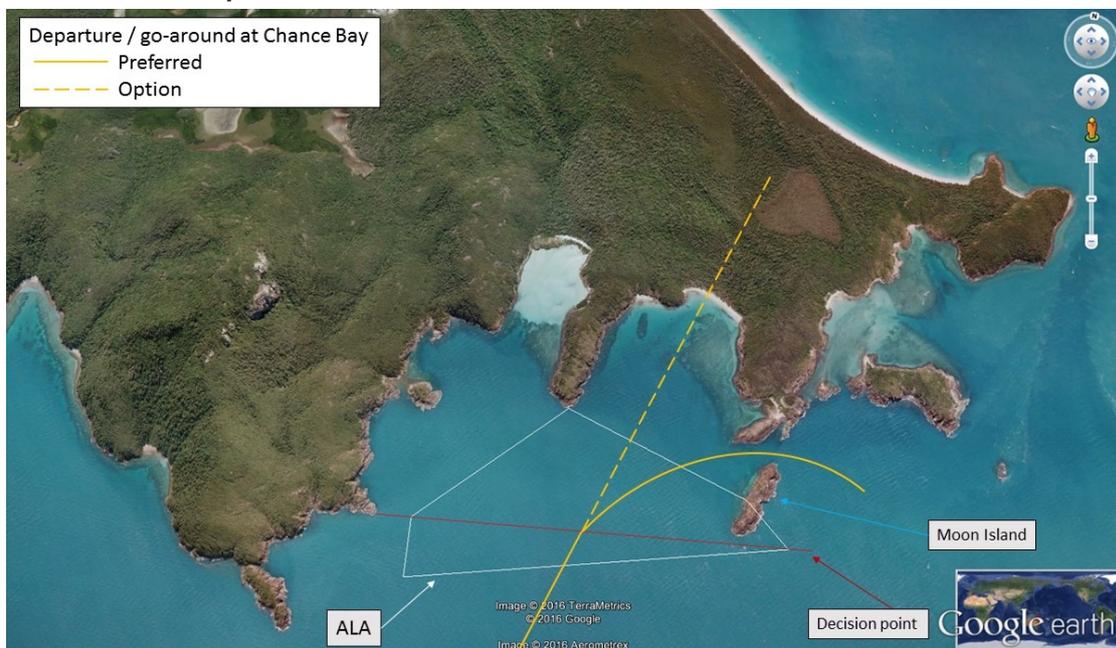
**Figure 4: Typical approach path at Chance Bay showing preferred and optional departure and/or go-around path. Also noted is the location of the ALA boundary and the pilot defined decision point.**

The operator advised their preferred departure or go-around route was a right turn over water, through the approximately 130 m clearance between the south-eastern most tip of Whitsunday Island and the northern tip of Moon Island (Figure 4). The terrain on either side of this route is less than 20 m above mean sea level. Flying straight ahead, over the saddle, was not the preferred departure path, but it was an option shown to company pilots. If a go-around was initiated early, the right turn departure was the safest option and allowed a water landing in the event of a precautionary or emergency situation. The pilot reported utilising either departure track, as dictated by the conditions at that time. Refer to Appendix B for the Chance Bay ALA containing hand written notes and annotations that were in addition to the company register.

The pilot had nominated a *decision point* (aiming point) for his operations into Chance Bay (refer Figure 4 and Appendix B). This point was devised in conjunction with the company senior floatplane pilot as a line between easily identifiable topographical features, being a point of land below Whitsunday Craig and the southern tip of Moon Island, about 1,500 m from the beach. The pilot described the decision point as, ‘if you’re not happy with what you see in front of you, if you’re not stabilised, you go-around’.

On this occasion, the pilot delayed touching down on the water until he assessed that he was past a wind gust. While that decision was motivated by a desire to avoid unsuitable landing conditions, it resulted in the aircraft first touching down beyond the ALA and significantly closer to the terrain surrounding Chance Bay than recommended. That situation was further aggravated by two further bounced water contacts as the approach was continued towards the beach, before the go-around was initiated.

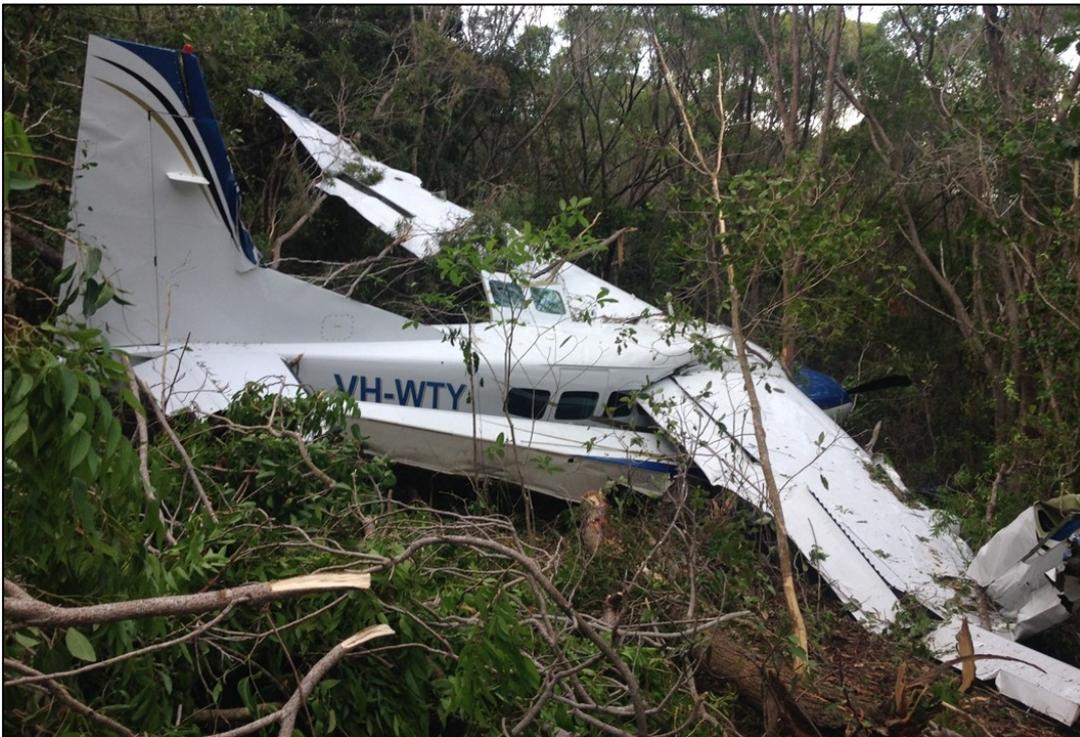
**Figure 5: VH-WTY wreckage, located in dense foliage**

WTY collided with trees and then the terrain, part-way up the ridge about 150 m from the eastern end of Chance Bay main beach. WTY was located at an elevation of about 40 m and the height of the ridge was about 50 m. The aircraft came to rest upright and in dense foliage (Figure 5). WTY was described as being oriented facing back toward the bay, which was consistent with the aircraft being in a right turn and the flight path being disrupted during the collision with terrain. The pilot reported there was no evidence of fuel leak and there was no pre- or post-impact fire.

It was reported that the pilot's door (forward left) was utilised for evacuation, as exit via the rear cabin left passenger door was hindered by foliage. One passenger also reported a drop of a few feet, from the pontoon to the ground, due to the aircraft position on top of foliage. Egress to the ground was via the pontoon and then all persons on board assembled a short distance from the aircraft before the group walked to Chance Bay main beach.
